**A Structural History of the Casemated
Redoubt
Fort Henry
Kingston, Ontario
1832-1957**

**by
David McConnell
November 2002**

prepared for
Dennis Carter-Edwards
Ontario Service Centre
Parks Canada
Cornwall, Ontario

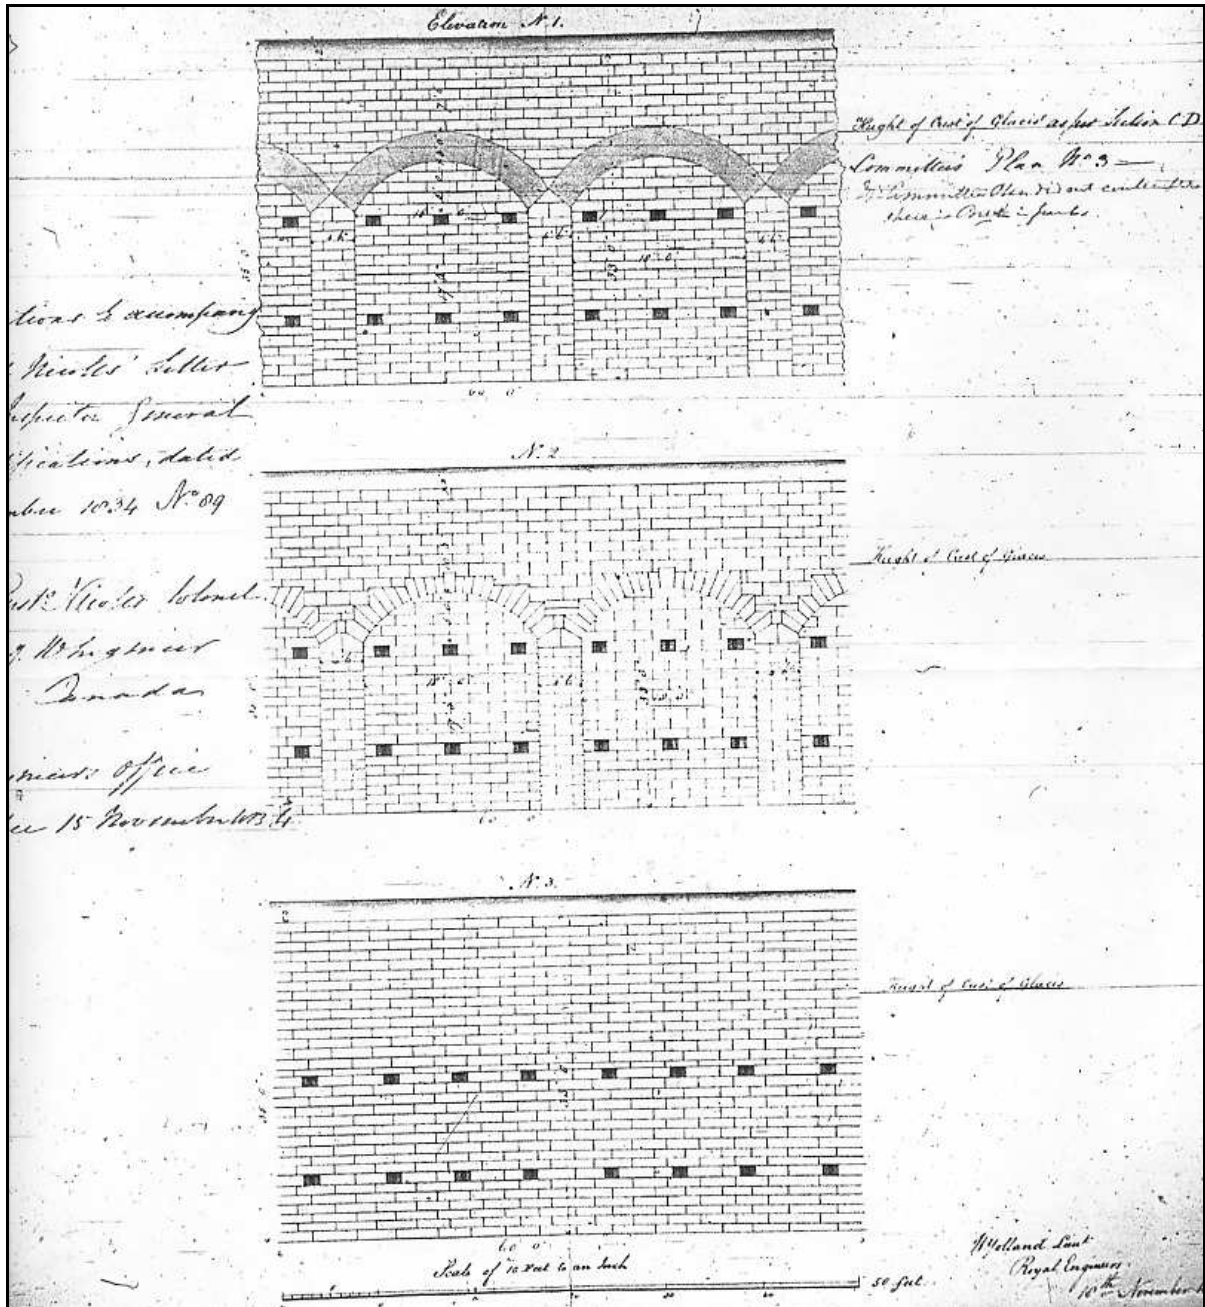
Figure 2 Elevation to accompany Colonel Nicoll's Letter to the Inspector General of Fortifications, dated 15 November 1834. MG13, WO55/872, p. 185. No. 1 and No. 2 were as the scarp should have looked; No. 3 is how it looked.

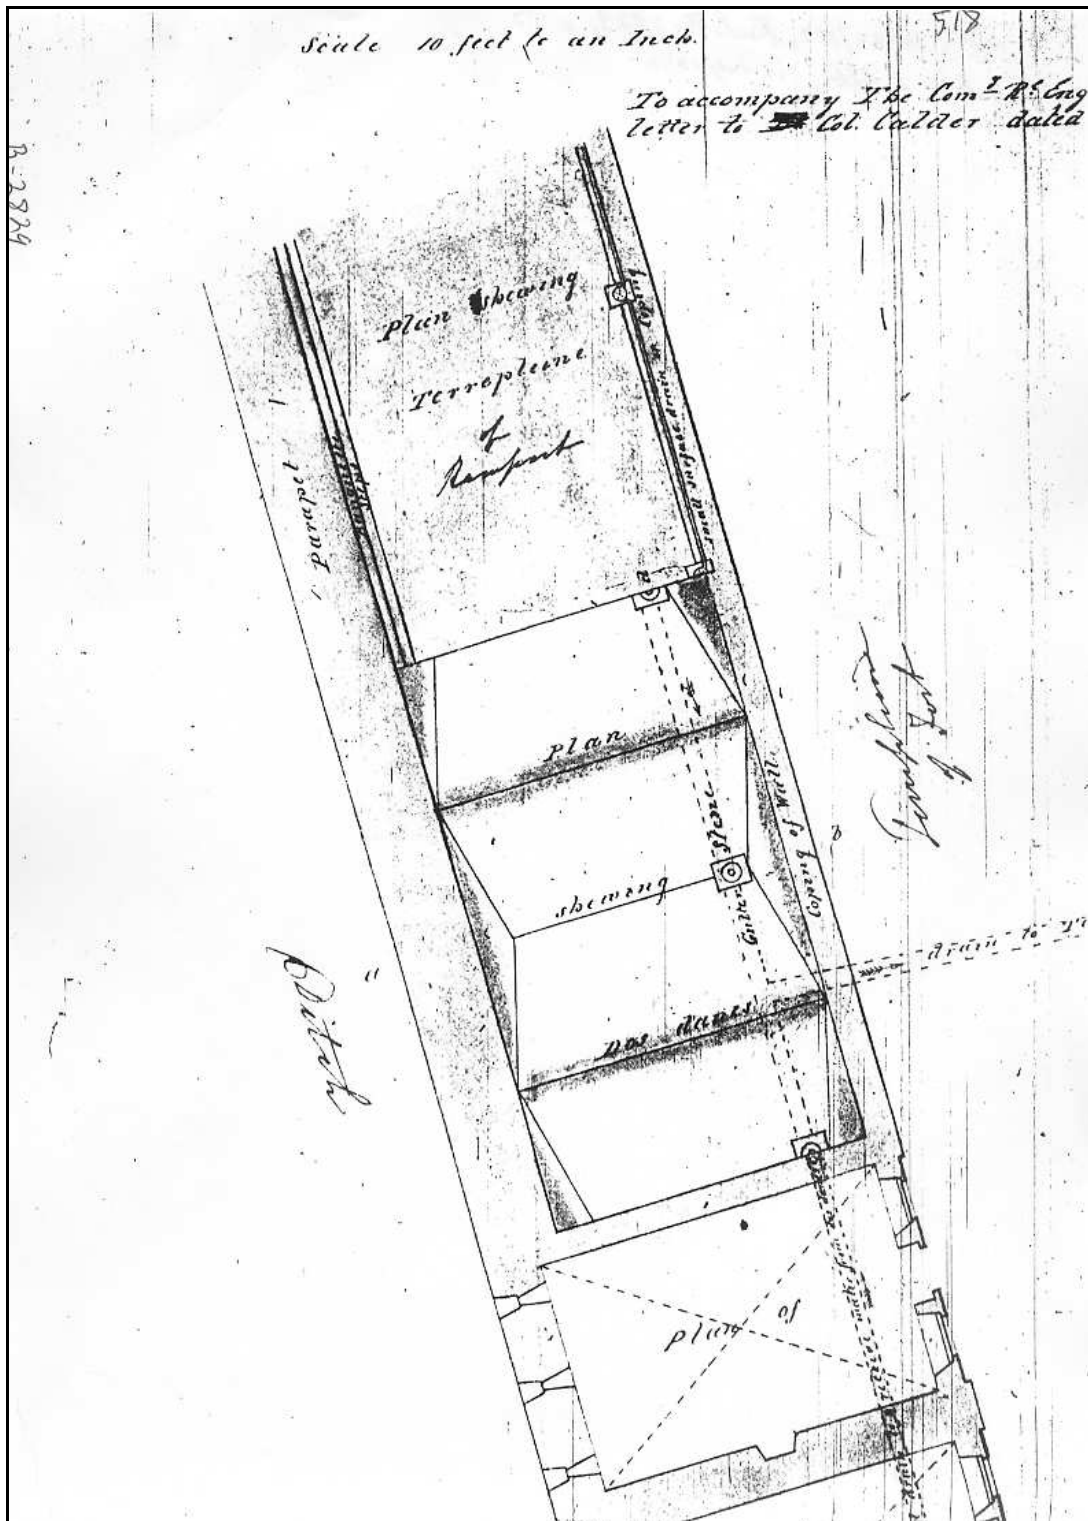
Figure 3 Plan of terreplein of west wall of Fort Henry showing the dos d'anes. NA, MG13, WO55/882, p.518, accompanying Holloway to Calder, 19 July 1848. Note the hipped dos d'anes ; the small surface drain in the coping; underground drains.

Again, to prevent the Congelation of the Water in the Valleys and Communication to be maintained between the moisture in the Dos d'anes Valleys and external Atmospheric Cold Air, perpendicular holes four inches in diameter were drilled and jumped [?] from the lowest points in the Valleys (Gutter Stones with hopper heads being therein inserted and the latter having a fall of 1 ½ inches in every 10 feet of length from the Scarp,) thro' the Masonry of the Arches, and chaced [sic] down to about 1 ½ ft below the Level of the floors, to receive Cast Iron pipes 5/16" thick with Slip joints, whence Communication being made with the general underground Drainage of the Fort, the Water was all carried off. – The heads of the pipes from the Gutter Stones are let into the bottom of the Bassins or Hoppers and bedded in white Lead – the hopper heads of the Pipes, from the perforated Sink Stones on the Terrepleine are let into the underside thereof and likewise bedded in white lead.³⁷ (See Figures 3, 4, and 5)

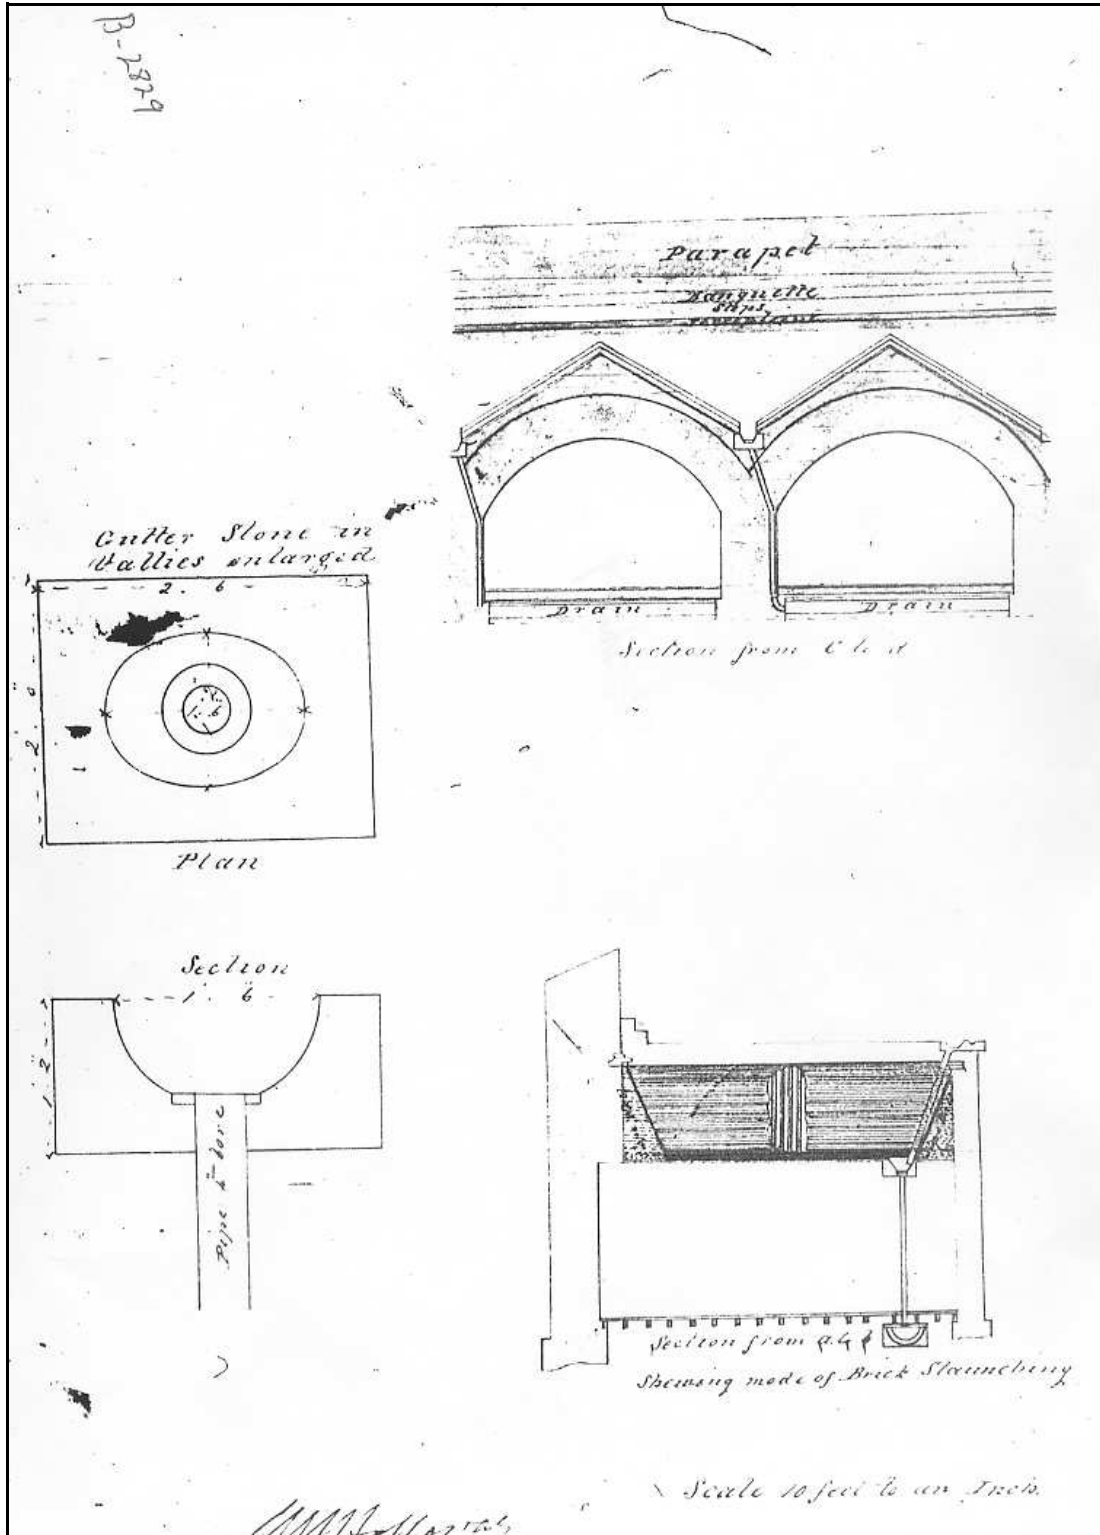
Figure 4 Details of stanching the leaks in the casemates. NA, MG13, WO55/882, p. 516, Holloway to Calder, 19 July 1848. Note the small drains down the side of the dos d'ane.

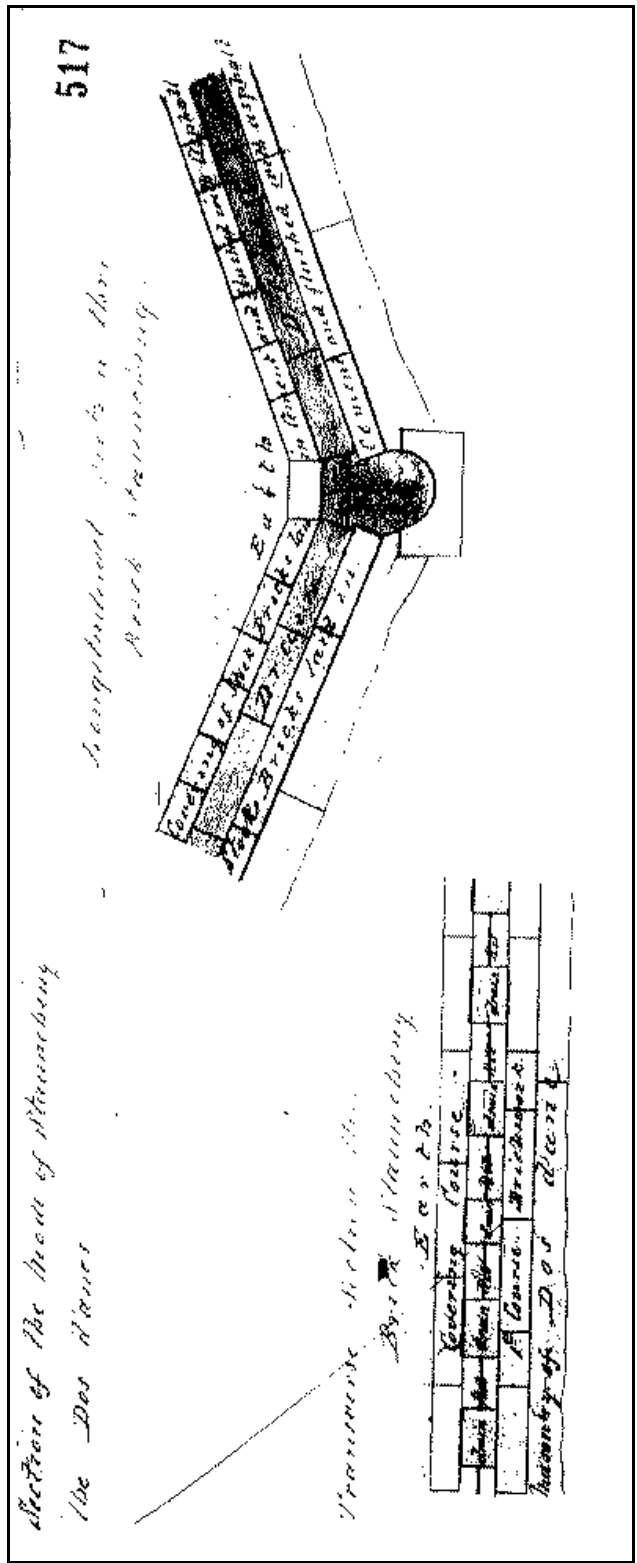
Figure 5 Brickwork on the dos d'anes.
 NA, MG13, WO55/882, p. 517, Holloway to
 Calder, 19 July 1848

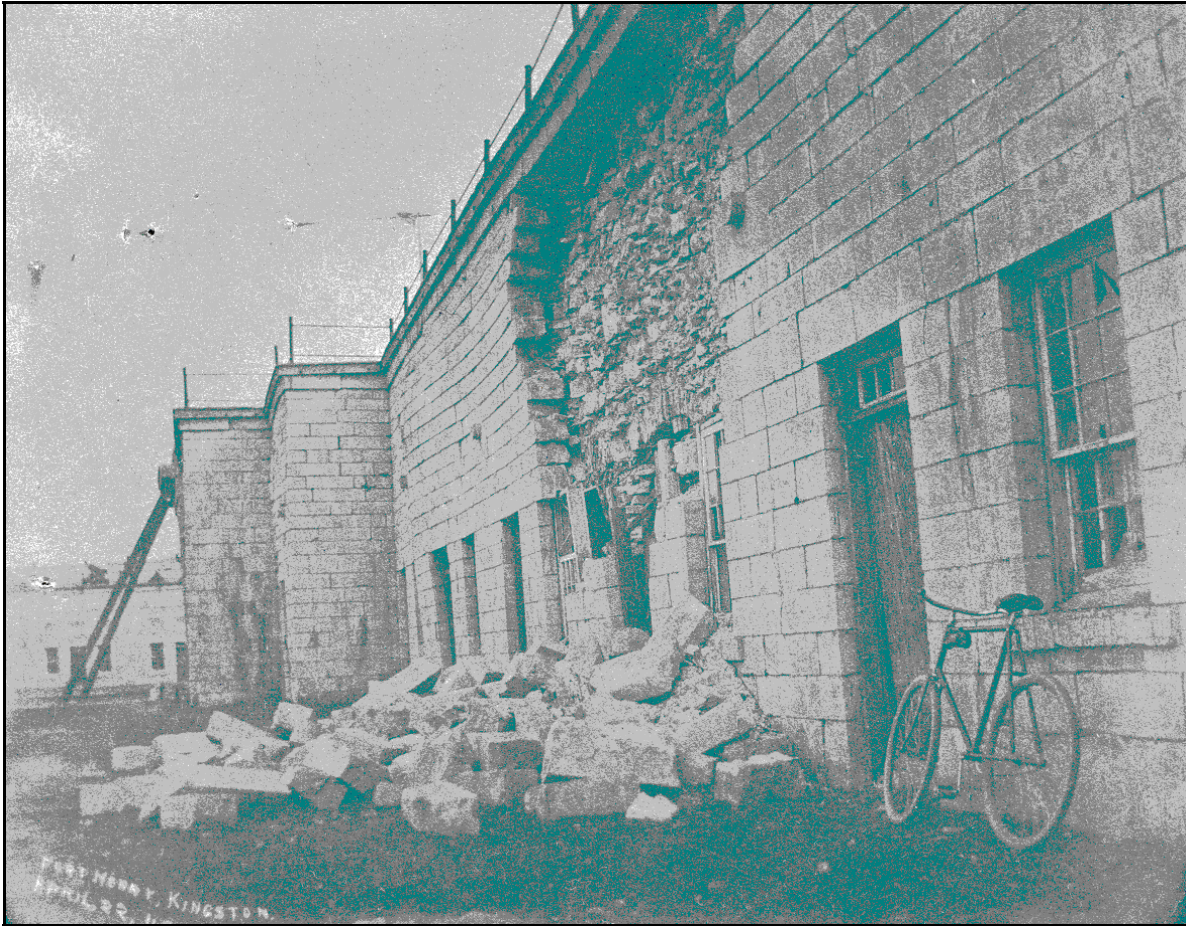
Figure 5 South curtain wall, 22 April 1897, just before it was pulled down. Note collapsed section and props holding up gateway. Ontario Archives, S974.

Whether Middleton's appeal had any effect is unknown for the records are again silent until the early spring of 1897. In March it was reported "that the archway at the approach to the inner enclosure at Fort Henry is in a very unsafe condition, and temporary repairs are recommended." This amounted to propping up the arch while negotiations were carried on with a W. Newlands of Kingston as to whether to rebuild the arch and the gorge wall or to demolish it (see Figure 5). Initially, the Department of Militia and Defence authorized Newlands to take down the dangerous portions of the wall in early June and then on 10 July, the Minister approved the demolition of the whole wall. Throughout the summer and autumn of 1897, Newlands' workmen took down the wall and piled the debris in a line parallel to the demolished wall in the middle of the parade. Most of the work was completed by 9 November when the remainder was ordered to be left over to the spring. Since the wall contained latrines for the NCOs and their families living in the fort, Newlands was instructed to build dry earth closets to replace them.⁶¹

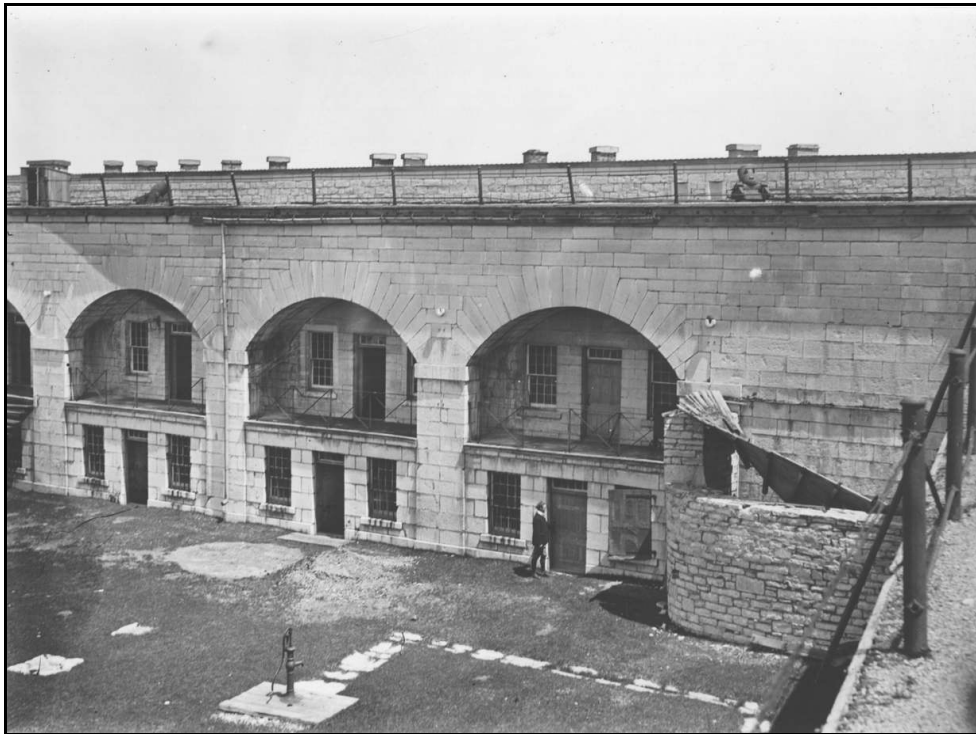
Figure 7 Northeast corner of the Redoubt, circa 1910. Note the powder magazine blast wall, with collapsed roof, and the pump into the water tanks. Marsden Kemp, Ontario Archives, 10003975.

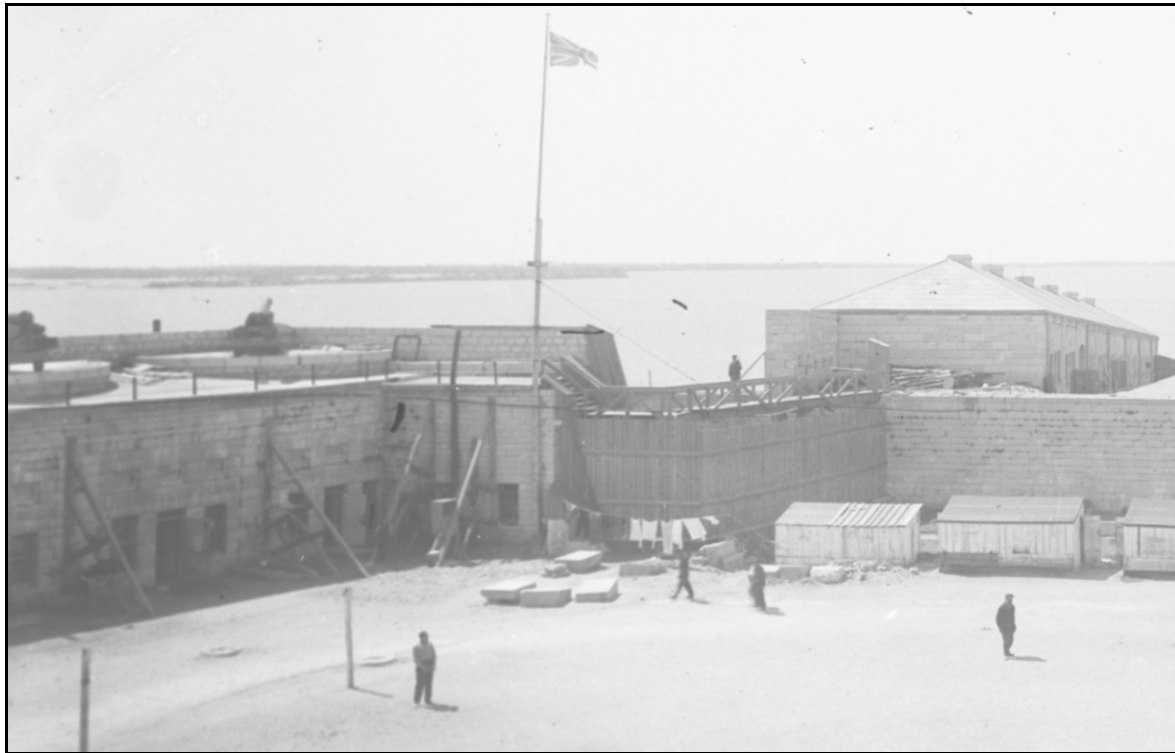
Figure 1 East wall of Redoubt, May 1917: note the props holding the wall up. Detail from G. E. Marrison, National Archives of Canada, C-043233

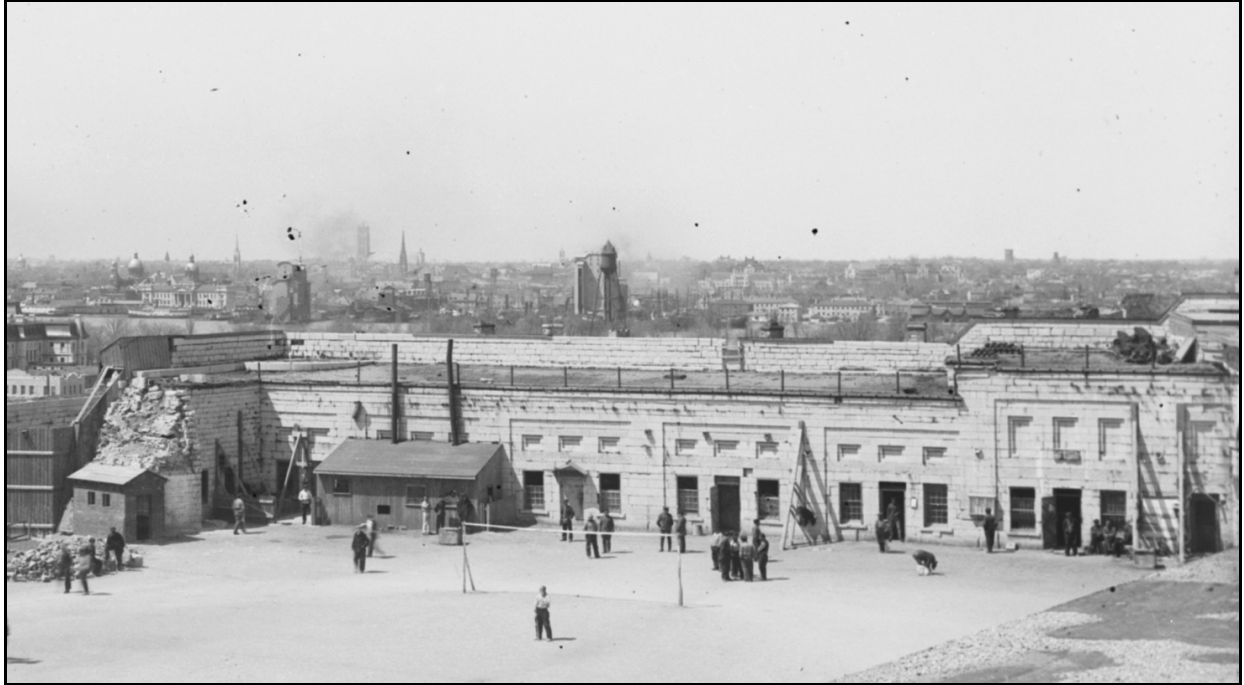
Figure 2 West wall of Fort Henry, circa 1917: note the props holding up the walls. National Archives of Canada, PA-046186.

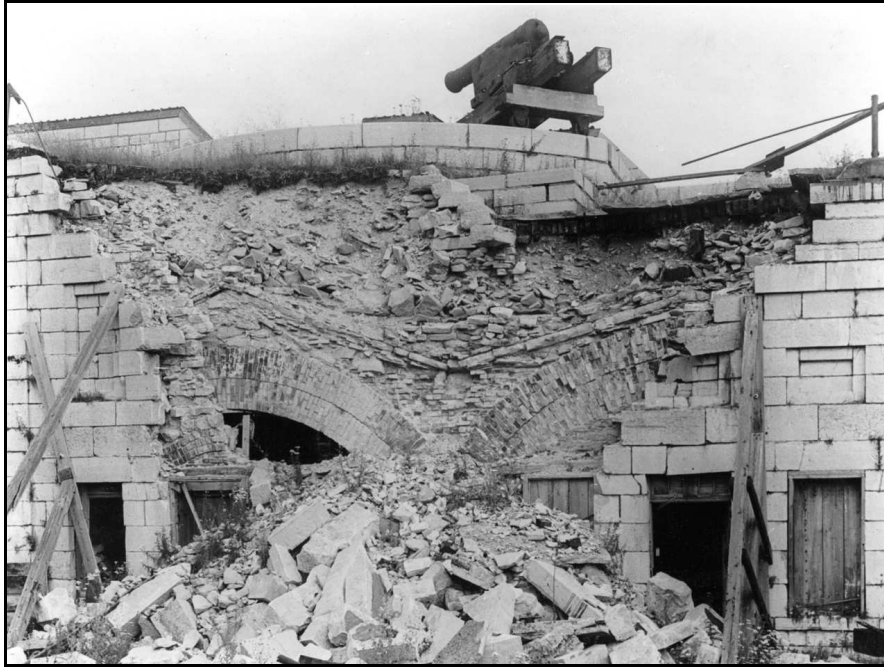
Figure 7 Collapsed section of east wall, officer's quarters. Note arches and dos d'anes, July 1931. Eric Arthur, Ontario Archives, 10002554.

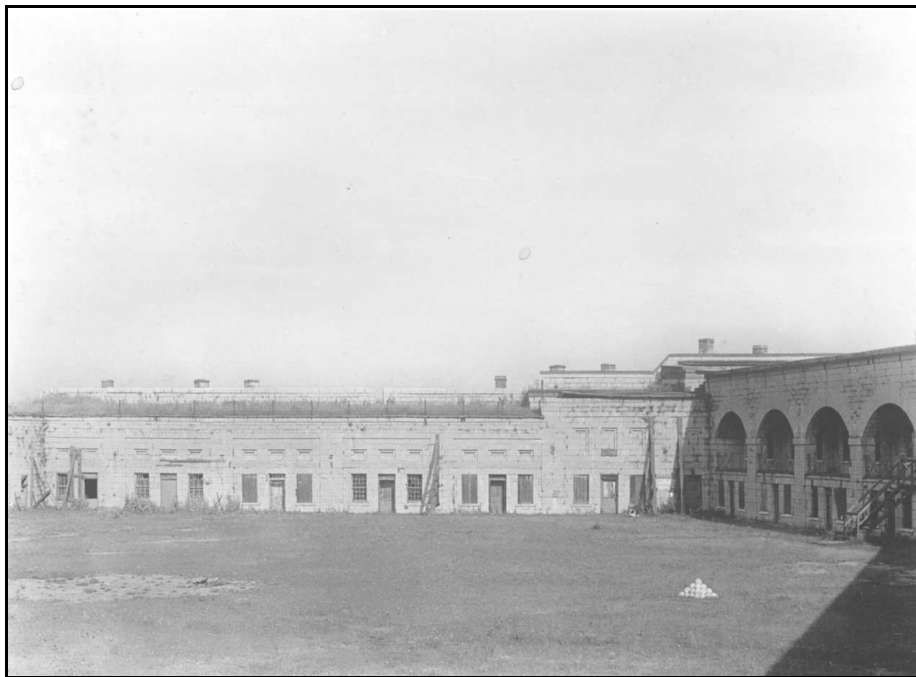
Figure 8 West wall; note supports, July 1931. Cf Figure 6. Eric Arthur, Ontario Archives, 10002550.

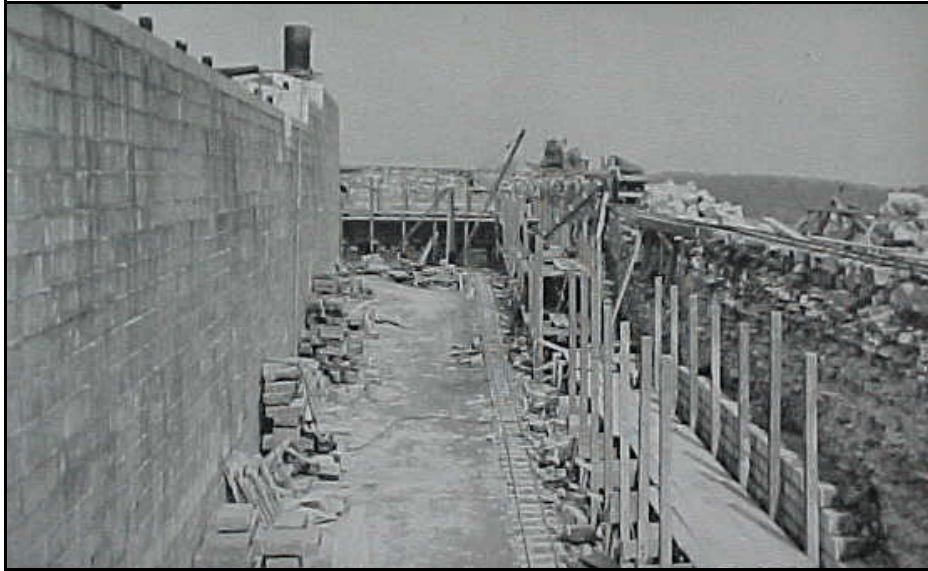
Figure 11 East ditch, looking north, reconstruction of counterscarp. Note railway to move material; facing moved forward slightly from original position. Fort Henry Archives.

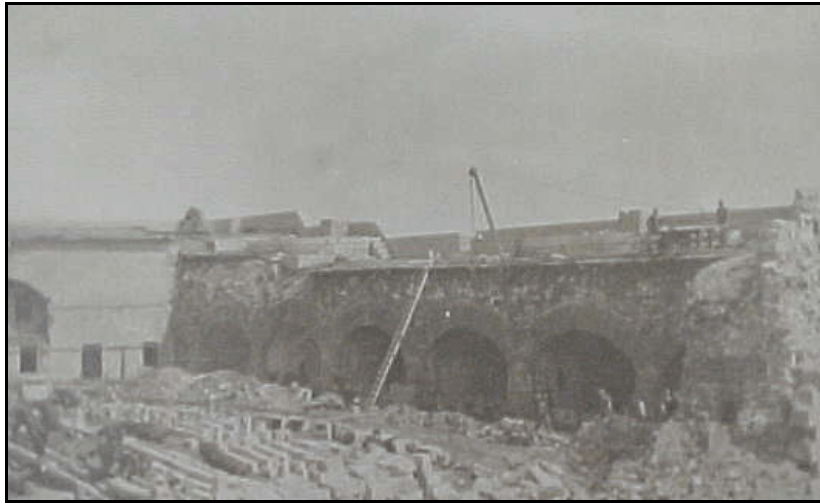
Figure 12 Officers' Quarters, east casemates. Facing entirely removed. Fort Henry Archives

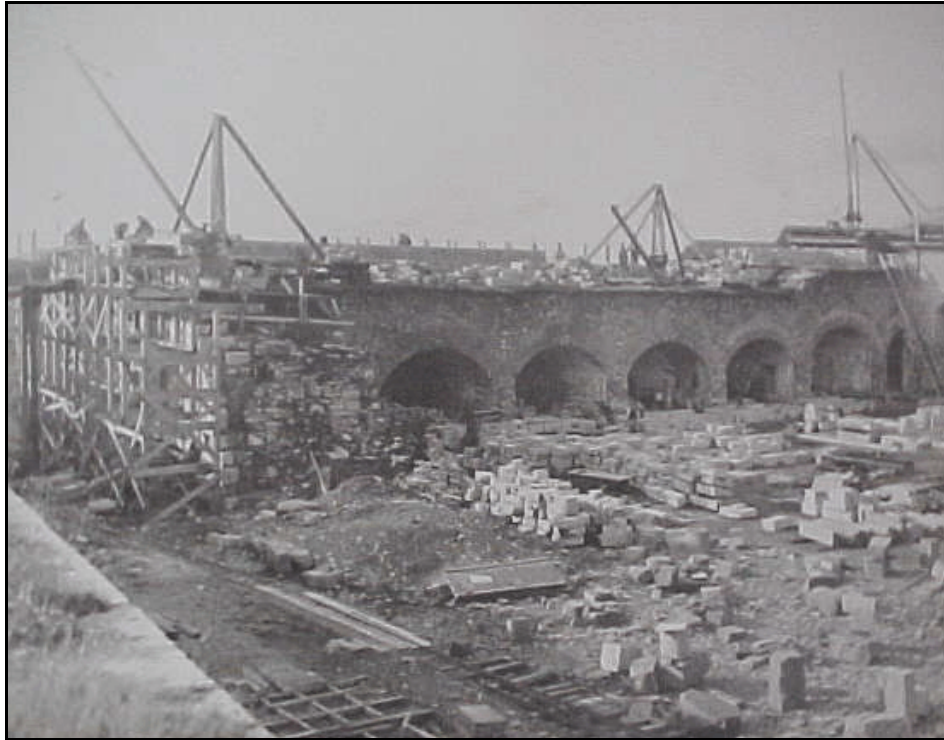
Figure 13 Officers' Quarters, west casemates, facing entirely removed. Fort Henry Archives.
