# Delta Mill Conservation Report

## *DELTA MILL CONSERVATION REPORT*

*Prepared by:*  
*Andre Scheinman Heritage Preservation Consultant*  
*William Trick, Mechanical Engineer*  
*McNeely Engineering Consultants*  
*M.D. Smith*

*For: The Delta Mill Society (6/05/96)*

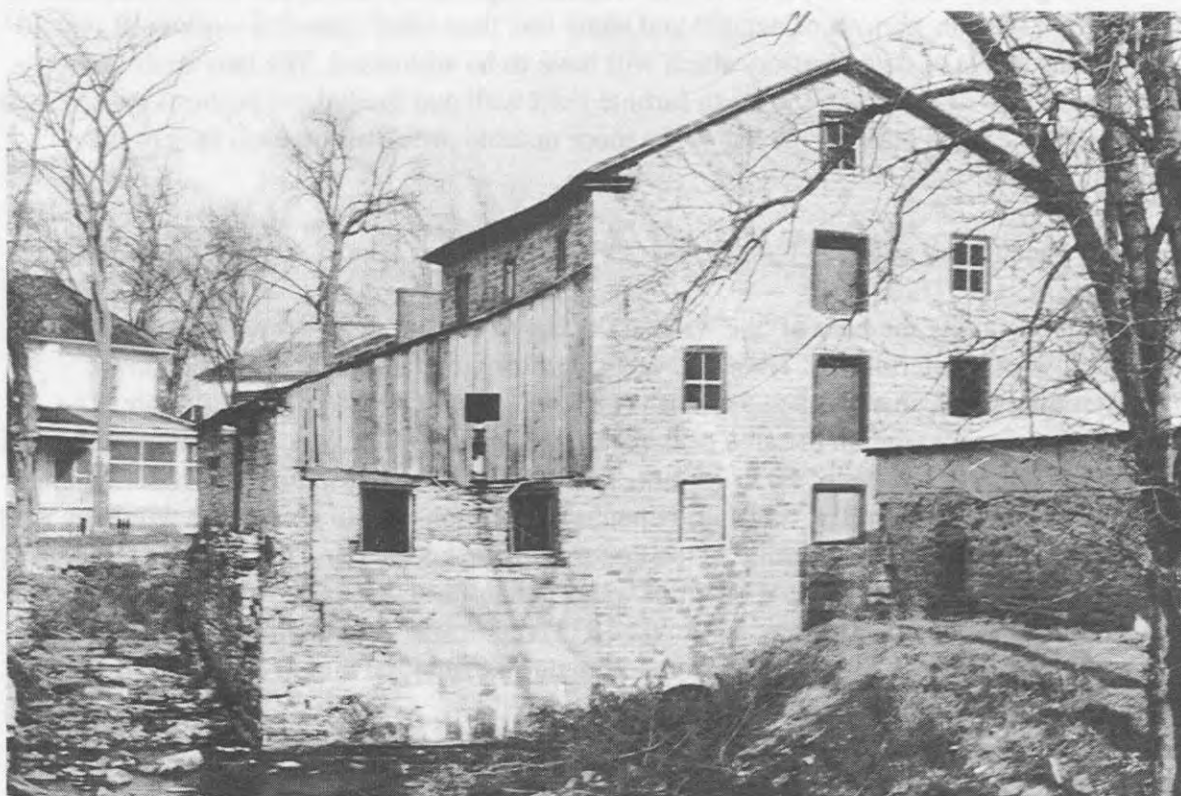
Photos of the complex at this time (Fig.55 ) reveal it to have been in very poor condition with unsecured windows at the mill and the shed and much loose masonry including large gaps on the streamside walls of the turbine shed. Many of the gable boards at the turbine shed were missing. The rendered infilling of the arch for the turbine was still in place. The top window at the southwest had been infilled with masonry. The building was, by then, roofed in corrugated metal, badly corroded with many patched sections over the shed.

Fig.55 Mill c.1963 (MNR Files)

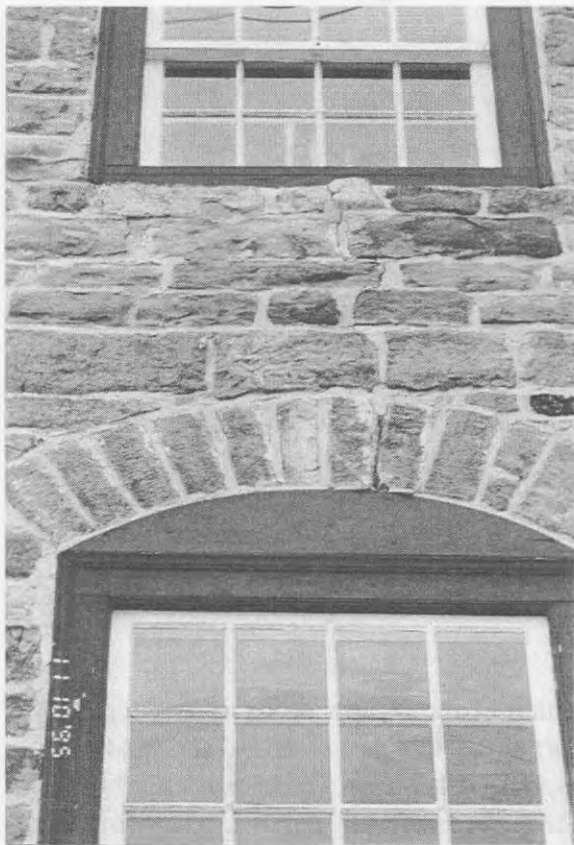
Fig.56

The joints along the base of the wall, at the top of the northeast corner and under the windows are deteriorated. There are vertical cracks under several of the windows, extending between storeys at the north (Fig.56), and at the base of the structure. The exterior stone wythe, in the area of the second and third floor windows at the south end is bulged out in the order of 50 to 75 mm. The deterioration of jointing and cracking under the windows is a result of moisture penetration through the sill area of the windows while the deterioration of the jointing in the upper northeast corner and the bulge in the wall at the south end appears to be a result of water penetration through deteriorated roofing over these areas in past years. Recent (c.1973) repointing appears to have been executed in masonry cement and was superficial in nature i.e. applied directly over deteriorated joint without proper raking out etc.

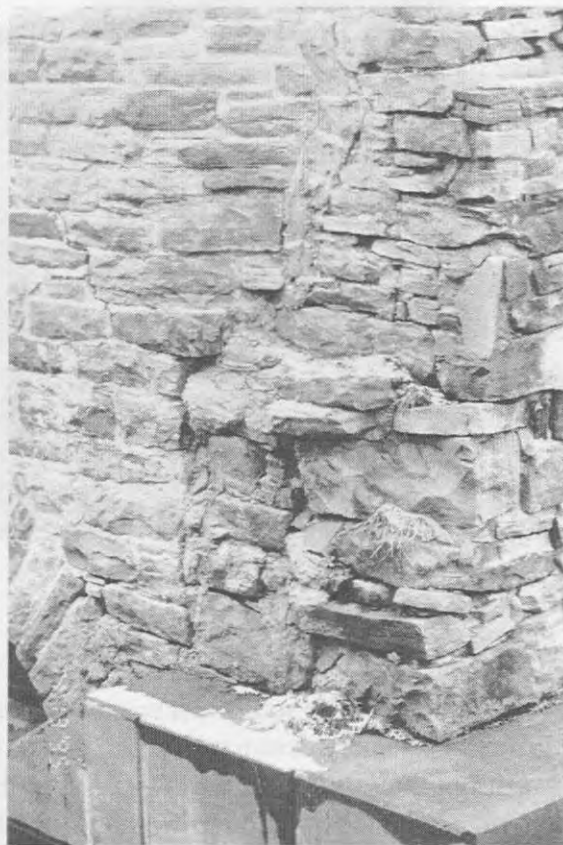
Fig.57

Joint deterioration was noted in the central upper portion of the wall and in the east corner. There is vertical cracking above and below the windows again as a result of water penetration at sill areas. On the north face of the turbine shed there is joint deterioration, major cracking and an unstable area at the arches over the doorway and window. Much of the deterioration in the upper portion of the turbine shed stone work can be attributed to the fact that the stone projects 100-150 mm beyond the vertical siding of the gable above and this allows water to readily penetrate the masonry below. This condition in turn seems to be the result of a discrepancy in planes between the west and north walls which relates to the original angled face at this corner at the conjunction of dam abutment, and sawmill framing.(Fig.58) In any case a ledge exists at the bottom corner and the masonry below is not coursed into the main walling. Between this area and the window a crack radiates. As well the lower portions of this wall experience severe exposure from water in the creek running immediately at the base of the wall. (Fig.57 )

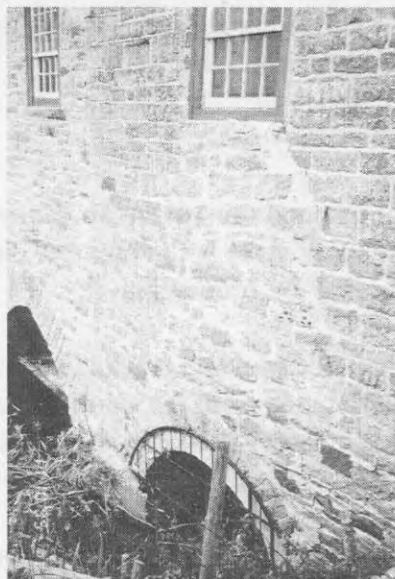
Fig.59

There is some joint deterioration in all other areas of this face as well. Vertical cracking occurs above and below the easterly and central windows and doors. A glass telltale over the east window of the first storey has cracked indicating active wall movement in that location. The masonry in the southwest corner of the turbine shed is badly deteriorated with open joints and cracked stones.

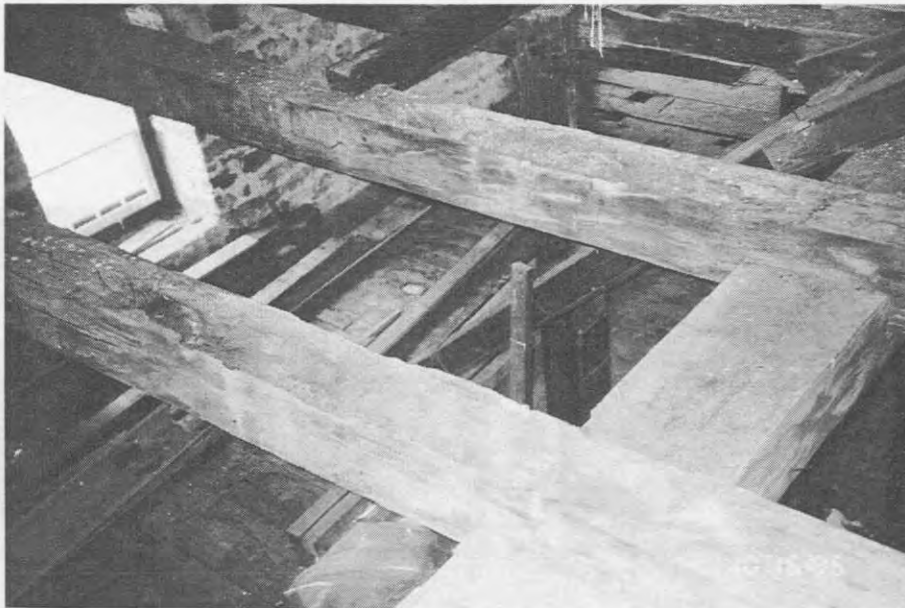
Fig.63

Two of the Denaut columns (northeast quadrant) are riddled with large elliptical exit holes which appear to have been caused by the Round-headed Wood Borer (Monochamus). As this family is not known to attack wood in service, but rather newly felled timber it suggests that the timber for these columns was not subject to proper debarking and drying practice prior to installation. Insect activity seems to have long since ceased however.

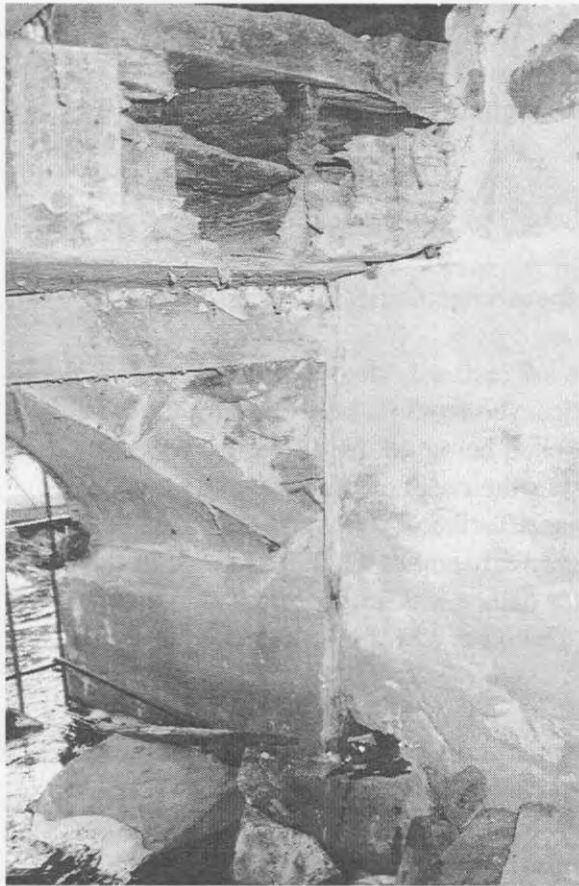
Fig.64

The state of infestation also puts at risk the remaining timber elements within the basement, crawlspace, raceway and turbine pit areas which include the first floor structure and the composite timber lintel ( three beams) at the communicating 'cutout' between the mill and the turbine shed. The lintel currently does exhibit the pinhole sized borings of insect attack at a wany region of the member but so far is otherwise sound. (The lintel bearing and the 'design' of the lintel itself require improvement given the load which it carries over the opening.) The risk of fungal and insect attack is always present where wood bears directly on masonry or is housed into it in a moist environment.

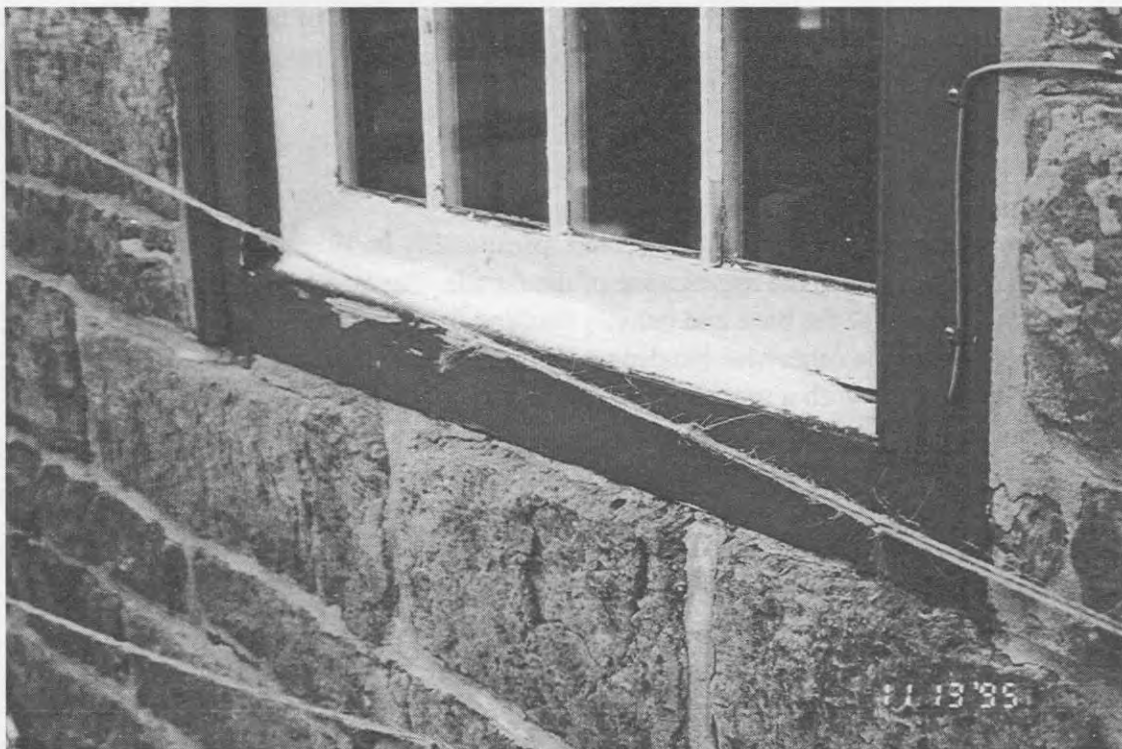
Fig.66

Serious masonry problems have resulted from the existing window frame design where the sill finishes flush to the masonry. Moisture does not therefore drip free of the masonry but is rather carried into the joint below the sill or, at best, over the face of the stone (Fig.66 ). Window sills and the base of the jambs of many windows have decayed due to the pooling of moisture as there is virtually no slope to the sill. The window at the north elevation of the turbine shed does not reflect the original window type for that opening.

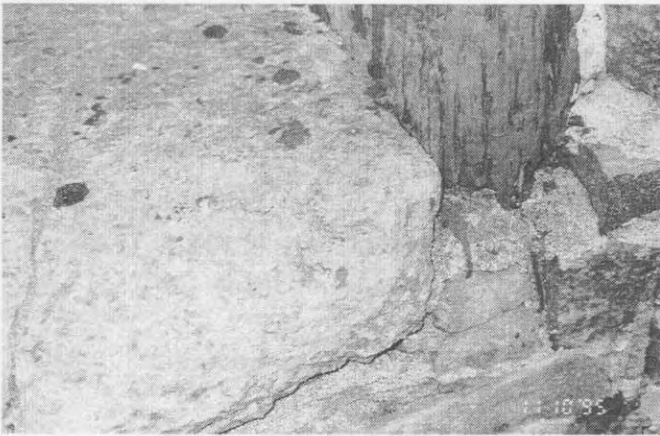
Fig.67

The importance of the main mill door has been discussed. While the historic door is itself remarkably sound, the base of the side jambs has decayed to a height of approx. 18" (Fig.67). The office door is not historically accurate (panel door was original Fig.68), the office area being generally 'fitted out' and finished to a higher degree than the industrial areas of the mill. The north door frame is badly decayed as is the base of the door itself. The west door, similarly, is decayed at the bottom.
