ARCHAEOLOGY AT ST. ANDREW'S RECTORY, 1982

by Peter J. Priess

1983

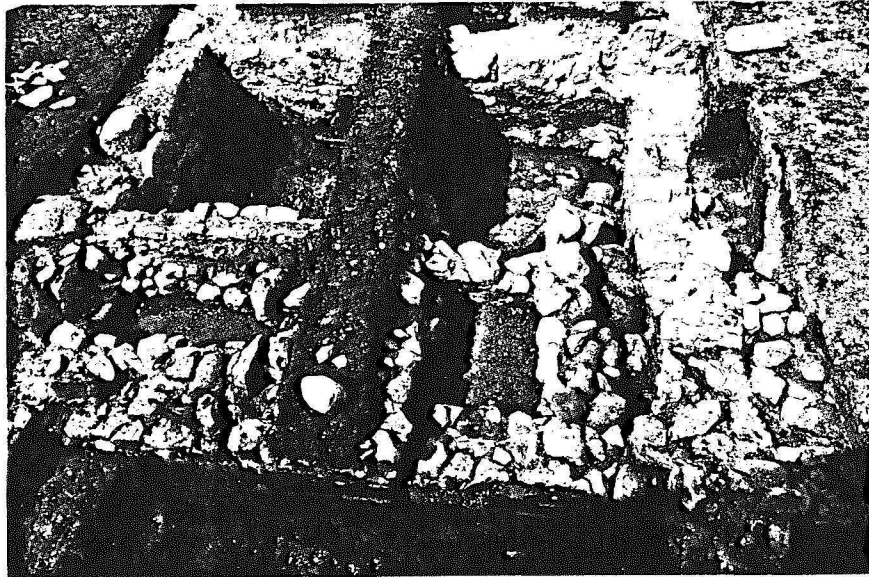
pressure and so they had moved. The north wall, to the extent that it remained, had bowed inward (Fig. 1). Its more deteriorated condition (Fig. 6) may actually be partially due to such bowing. The west wall appears to have been pushed inward at the bottom so that it now appeared to be leaning out (Fig. 21). Such movement inward is also indicted by slumping of the stratigraphy immediately adjacent to the wall's exterior (Fig. 21). At the interior of the southwest corner the two walls had been displaced relative to each other.

Figure 1. Annex foundations, facing west; note bow in north foundation (right side of photo); stonework across bottom of photo is pre-annex foundation. (Photo by author.)

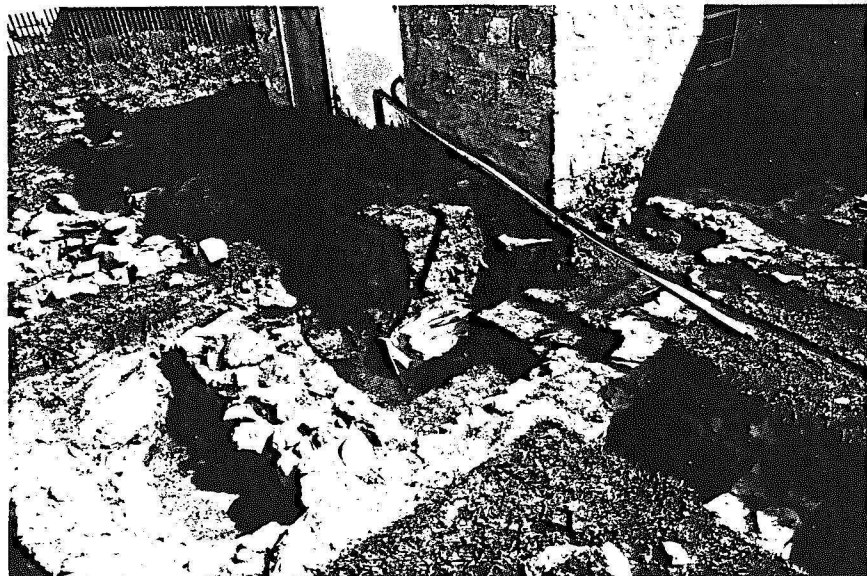
Figure 2. Annex foundations, facing northeast with second annex at top of photo; note connection between annex's south and east foundations in upper right of photo. (Photo by author.)

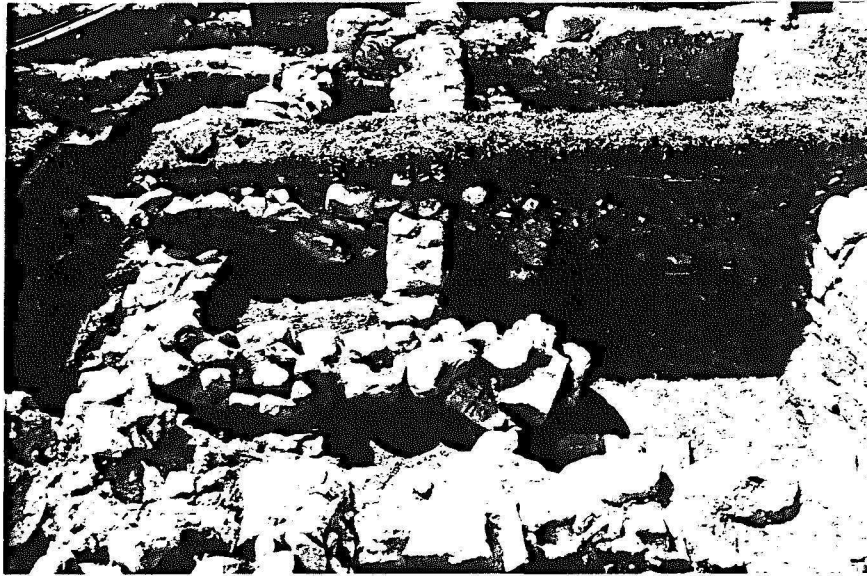
wall or footing, beginning at the south annex foundation and extending toward the north annex foundation (Figs. 3,9,18). Its north end had, however, been removed. This footing had been built on the remains of the cellar's east wall and on the rubble and fill deposited behind this cellar wall. Presence of the cellar had caused continuing ground shifting and resulted in this new wall also becoming bowed.

Figure 3. Annex foundations, facing south; stonework down centre of photo is foundation for annex's new east wall; stonework to left of this is west foundation of pre-annex structure. (Photo by author.)

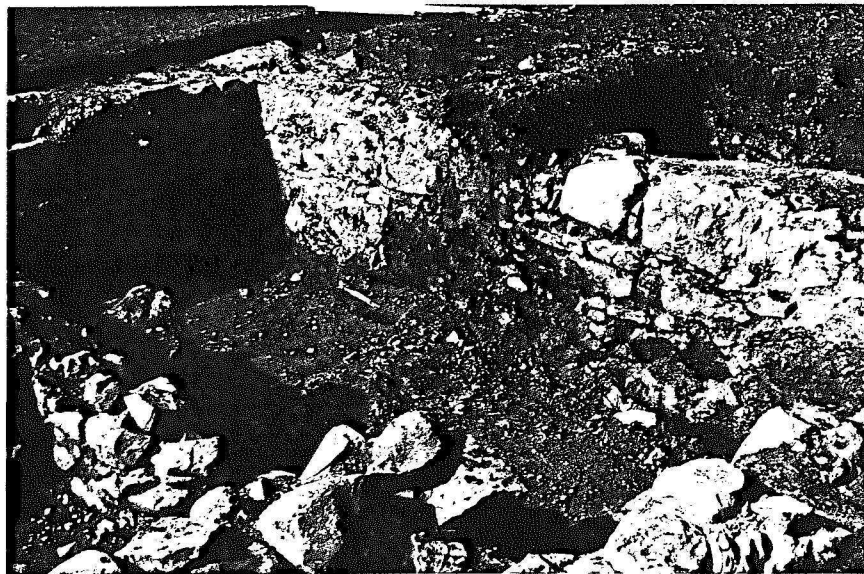
approximately 1 meter above the bottom of the foundation (Figs. 4,5). This course was readily apparent on the south and west walls of the cellar. It was, however, not at a uniform level. Differences in elevation up to 0.13 meter were noted. The intention of actually having a levelling course is probably indicated by the fact that it was created by the use of thin stones throughout.

Figure 4. Annex foundations in cellar area, facing south west; note levelling course. (Photo by author.)

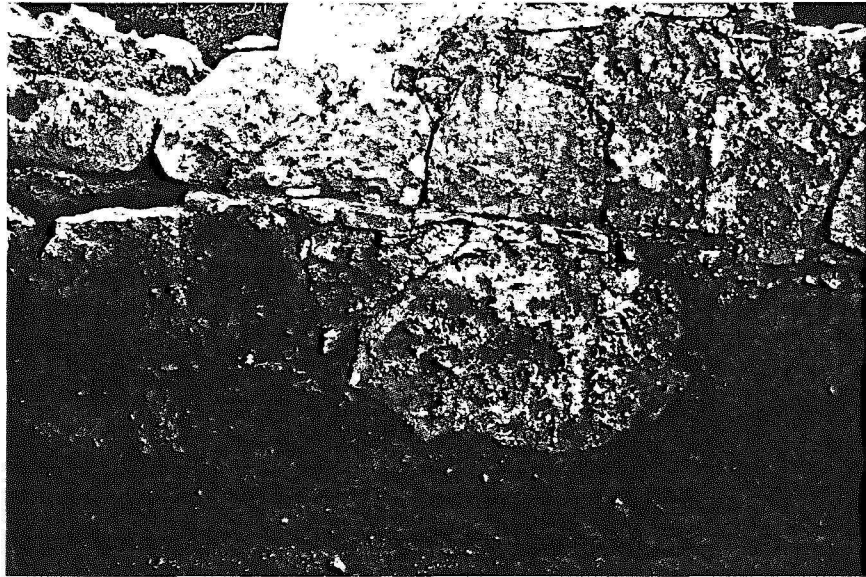
In the area of the annex cellar the foundation had been constructed with more attention to the interior surface (Figs. 4,5,7). Since this surface was to remain exposed it had been finished smooth and with limited gaps between the stones. The exterior surface, in the limited area in which it was exposed, had a similar, more finished appearance although it had been built against the earth wall of the cellar excavation.

Figure 5. Detail of south annex foundation in cellar area; note levelling course; stones above levelling course are relatively thin and have been set on edge. (Photo by author.)

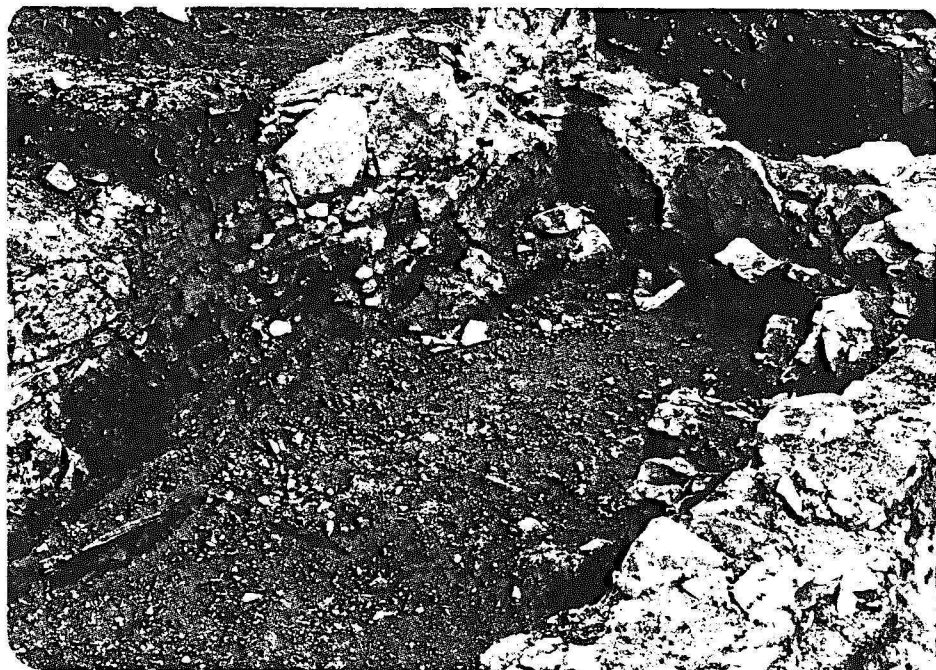
Figure 6. Annex foundations in cellar area, facing north west; note extent to which north wall has been taken down, compared to west wall. (Photo by author.)

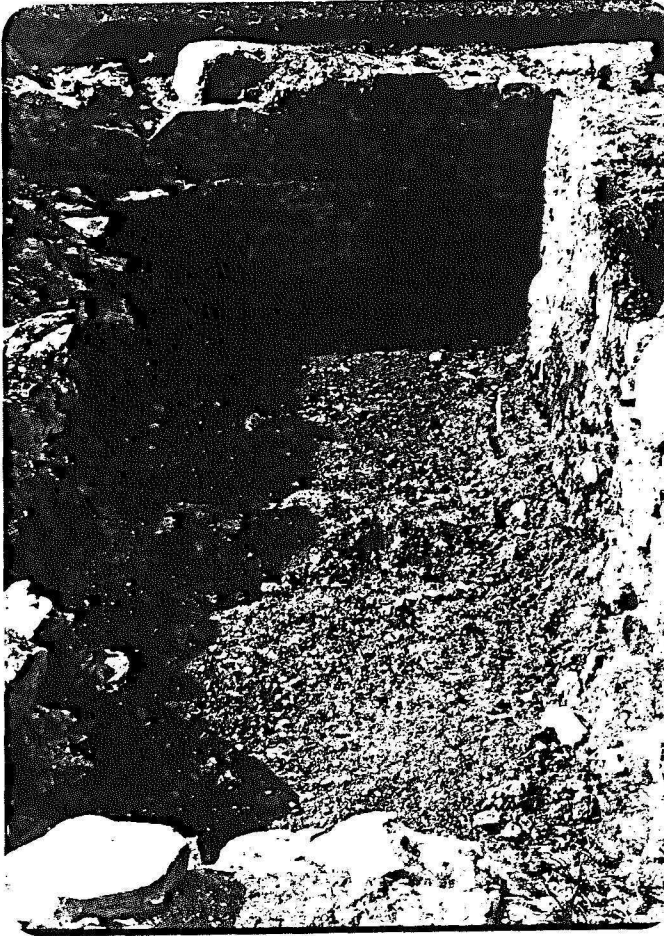
Figure 7. Cellar area, after removal of all fill, facing south; note south foundation, at top of photo, with two small slabs which may represent a levelling course for floor joists. (Photo by author.)

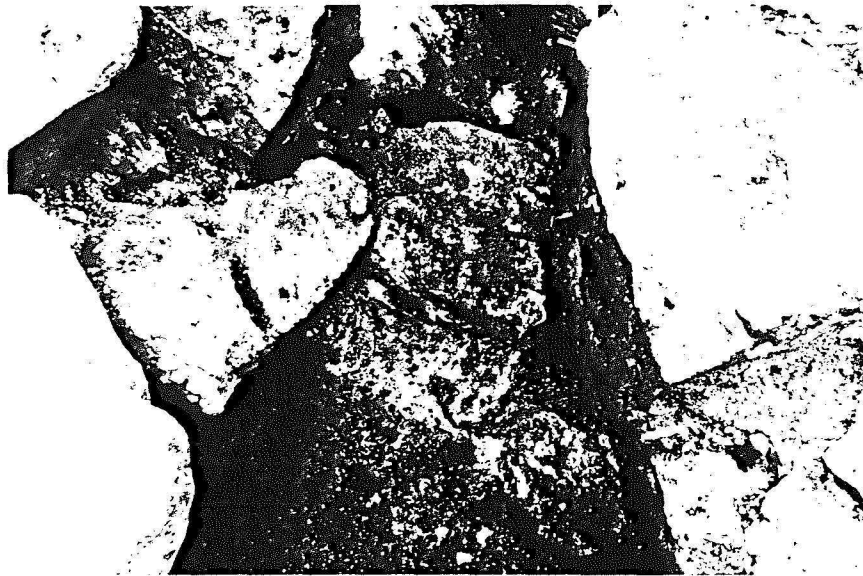
Figure 8. North end of east cellar wall, at point of intersection with annex's north foundation, facing west; stone at centre bottom represents minimum displacement of cellar wall. (Photo by author.)

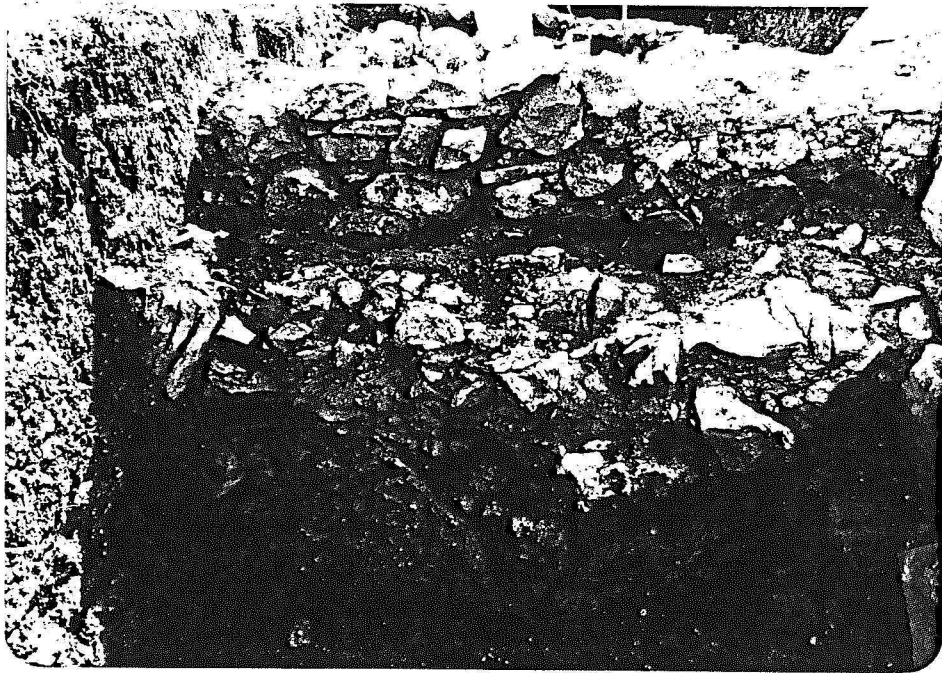
The reduced thickness of the east wall was probably the major cause for the structural problems which developed, possibly even soon after completion of its construction. Being unsupported on one side, as all the other cellar walls were, the east wall was also subjected to differential stress due to around pressure from the outside. But by being thinner than the other walls, it was even less capable of withstanding such pressures with the consequence that its displacement was substantially more severe than that of any other wall (Fig. 9). Possibly only at its north end had the wall remained in its original position (Fig. 8). Elsewhere it is likely to have been moved inwards by distances approaching a metre (Fig. 9).

Figure 9. Section of new east wall for annex, built on distorted and partially dismantled east cellar wall; facing east. (Photo by author.)

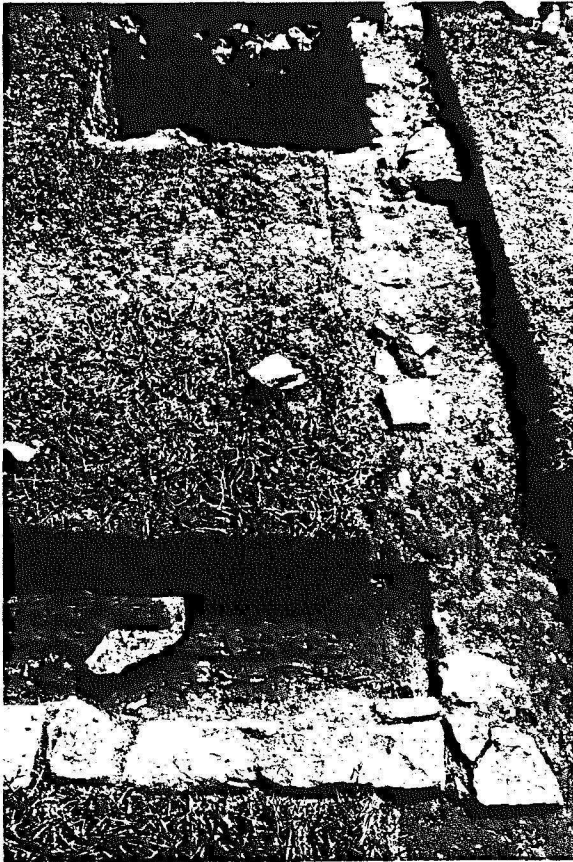
The lean-to had what could be considered an unusual feature. The footing for the north wall was found to be aligned with the outer surface of the annex's north foundation (Fig. 11). However, the south wall was not so aligned; it was situated inside the line of the annex's south foundation. Since the lean-to footings were likely little wider than the walls which rested on them, there is no way that both the north and south walls of the lean-to could have been aligned with the adjacent annex walls. It is evident from the 1858 photograph (Priess 1983, Fig. 1) that on the north side the annex and lean-to walls formed a continuous line. The south side would not have been so aligned; the length of the lean-to (north-south) being less than the width of the annex (north-south).

Figure 11. South side and southwest corner of lean-to footing, facing east; southwest corner of annex foundation appears at top; note how lean-to footing is offset from line of annex foundation. (Photo by author.)

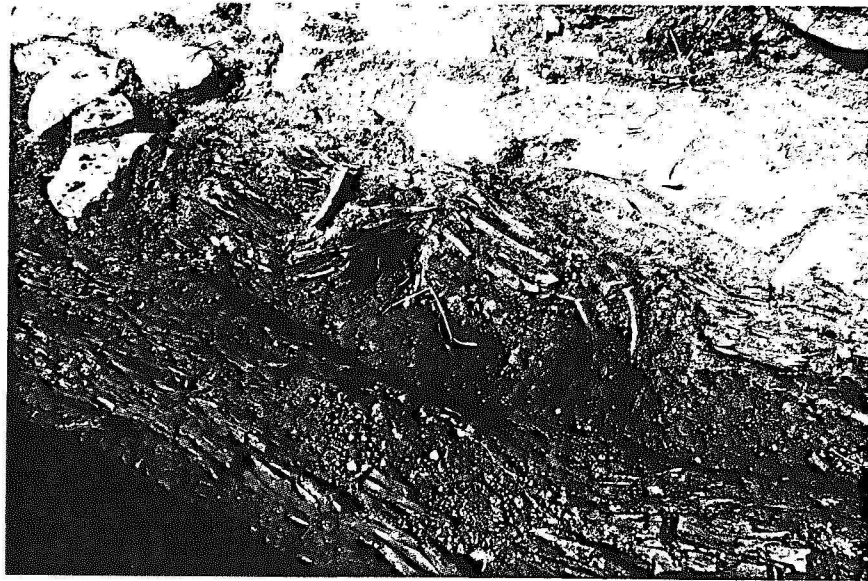
The floor was composed of planks apparently of variable width. Deterioration made width determination difficult but an approximation of 8 centimetres was obtained. The planks had been laid on a limited number of joists; one was noted across the north end and another near the middle. The existence of a joist across the south end was implied by the presence of several in situ nails in the south west corner. The central joist also retained two nails used to hold down the western most plank (Fig. 13). The central joist had a width of 11 centimetres.

Figure 13. Detail of lean-to floor along west footing; facing southwest; note two nails and section of a joist and small strip of metal, being a plate-mounted latch catch. (Photo by author.)

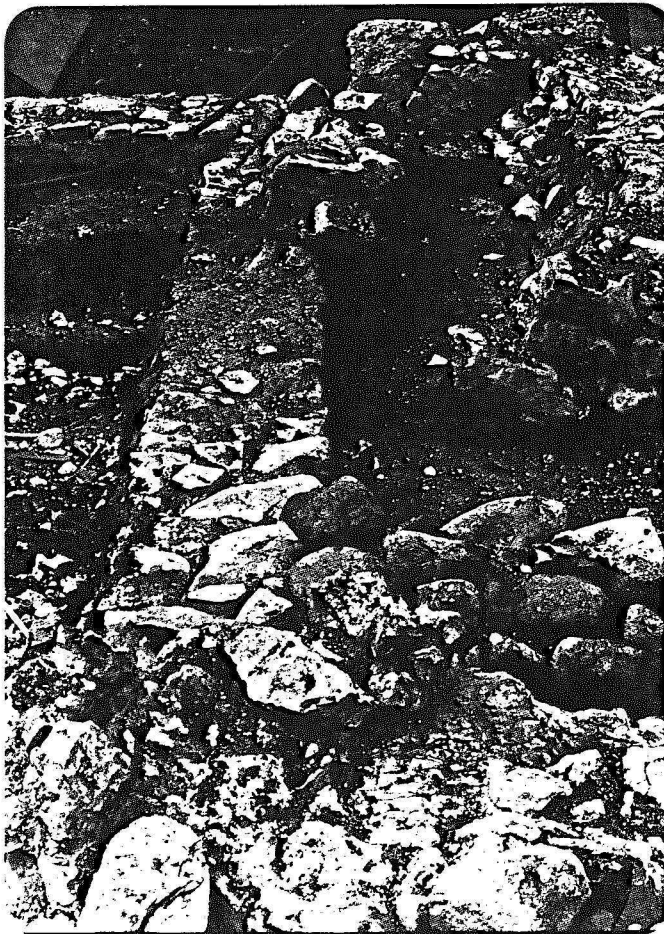
The foundation of this structure was constructed of mortared limestone, generally two courses high and two stones wide (Figs. 14,19-21). Foundation width was generally slightly more than 0.16 m (1.97 ft.); the south foundation, of which only a short section was exposed, was 0.45 m (1.48 ft.) wide. Foundation height was variable, ranging up to 0.26 m (0.85 ft.). Dimensions for the structure can now be stated as 6.0 m (19.69 ft.) east to west by 10.8 m (35.43 ft.) north to south.

Figure 14. Section of west foundation of pre-annex structure, facing south. (Photo by author.)

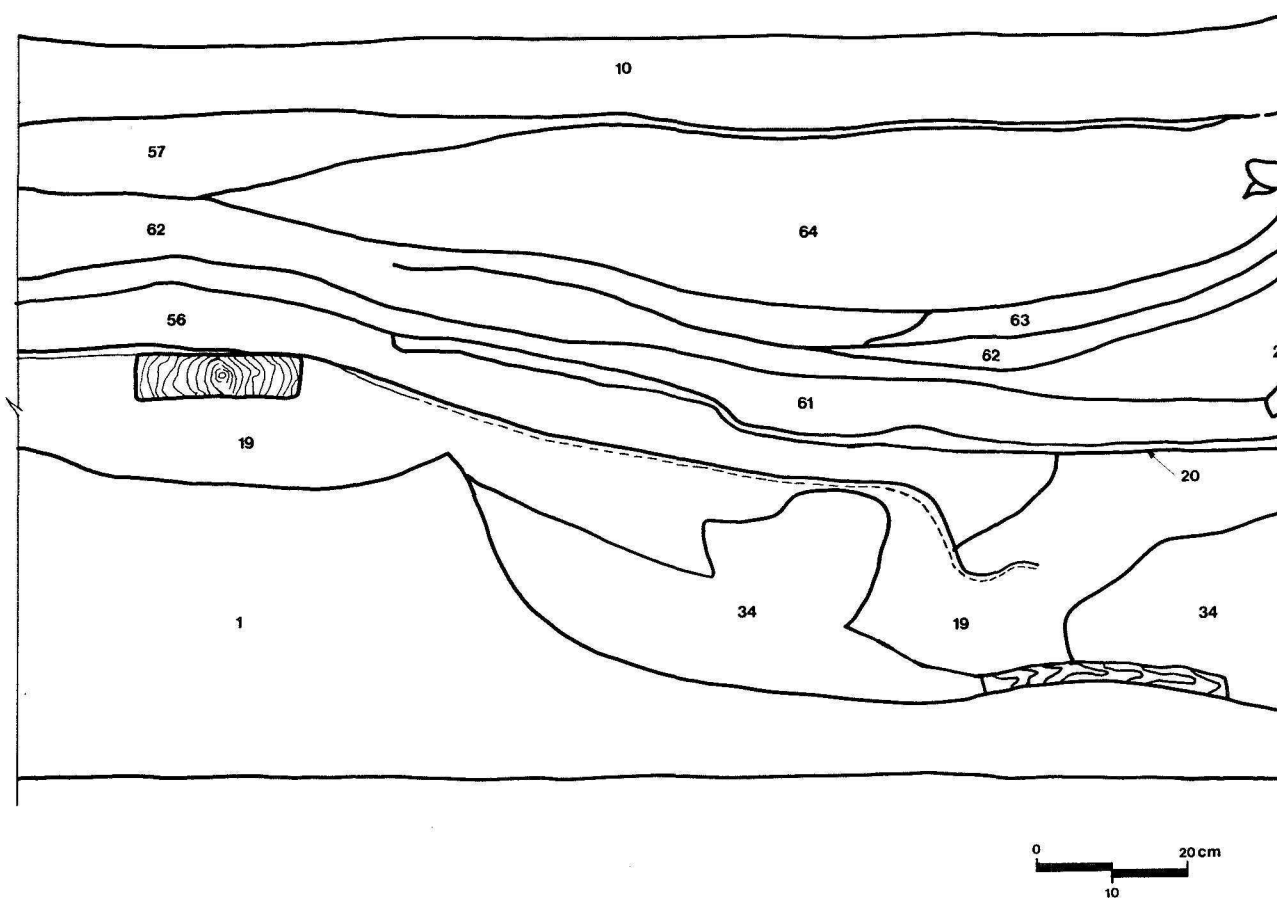
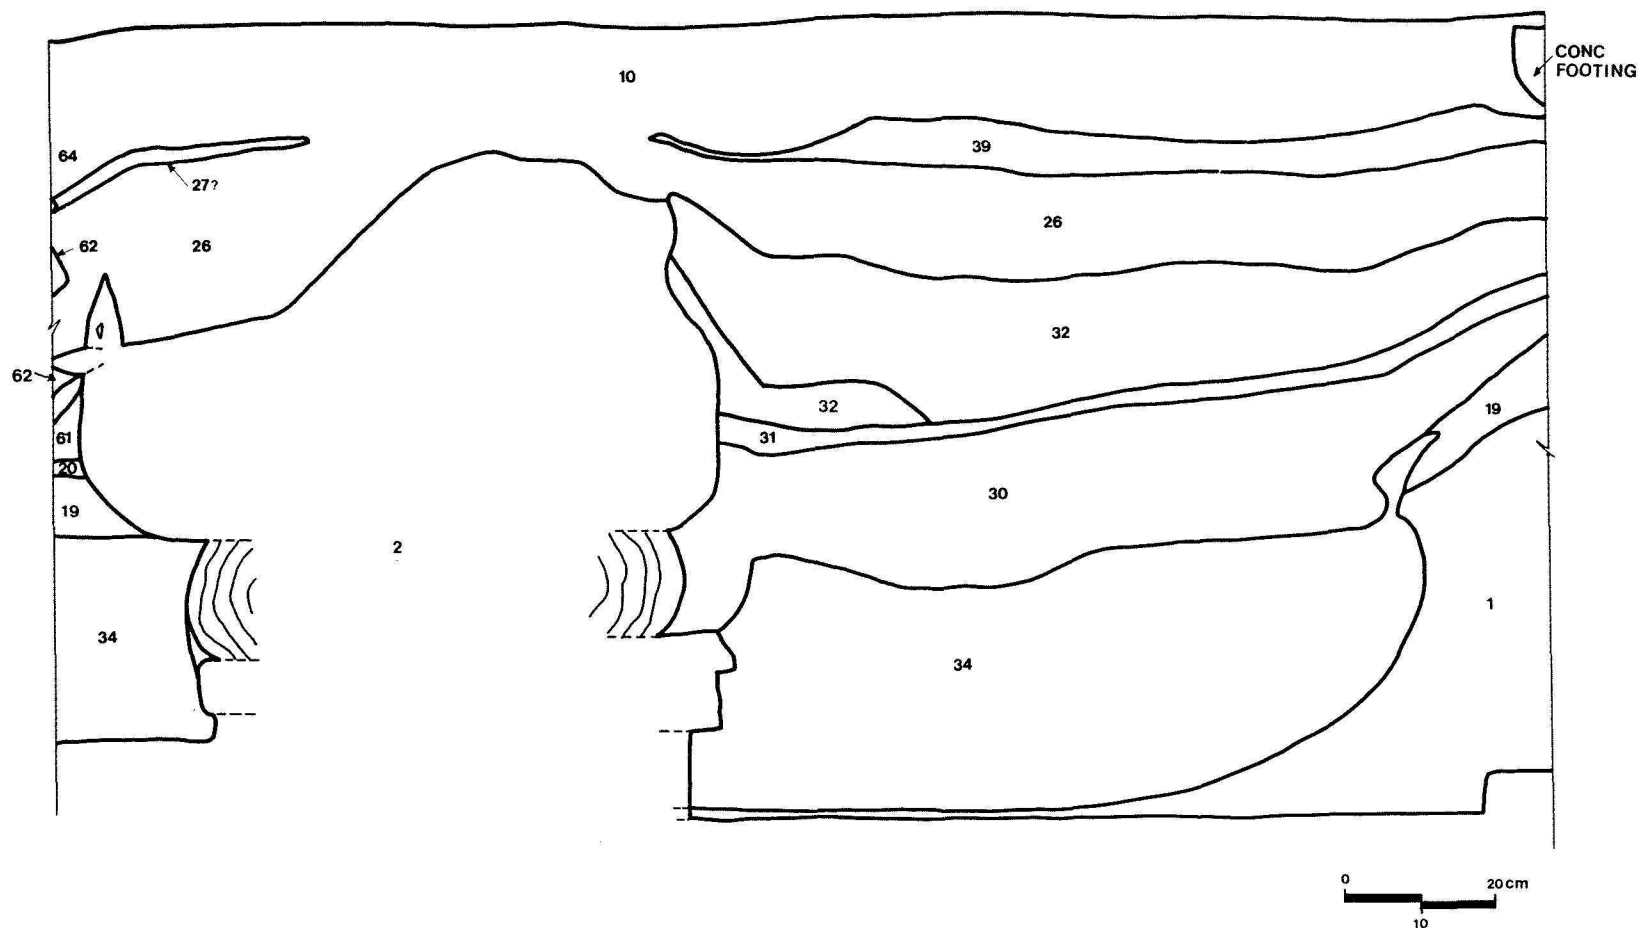
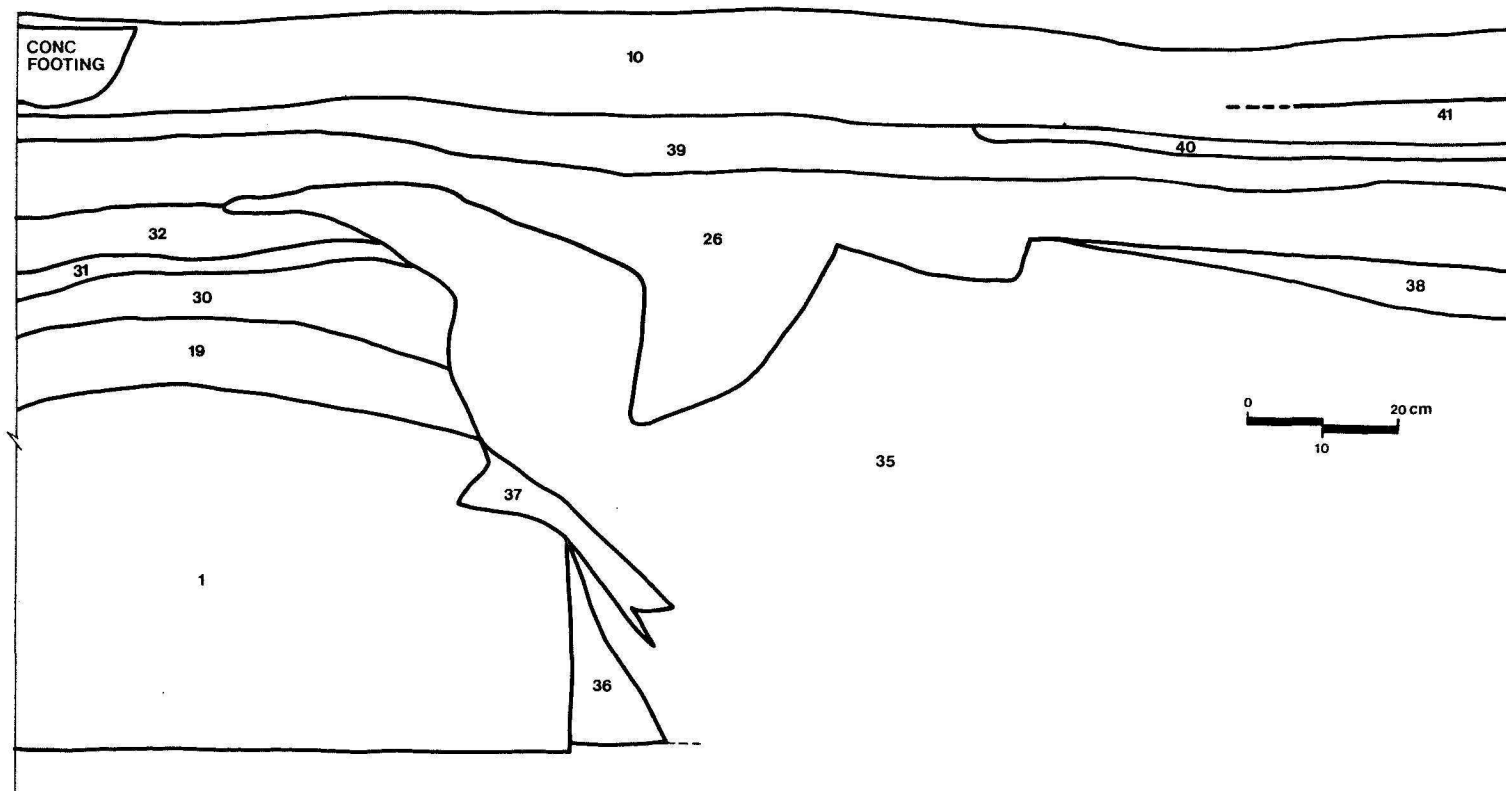
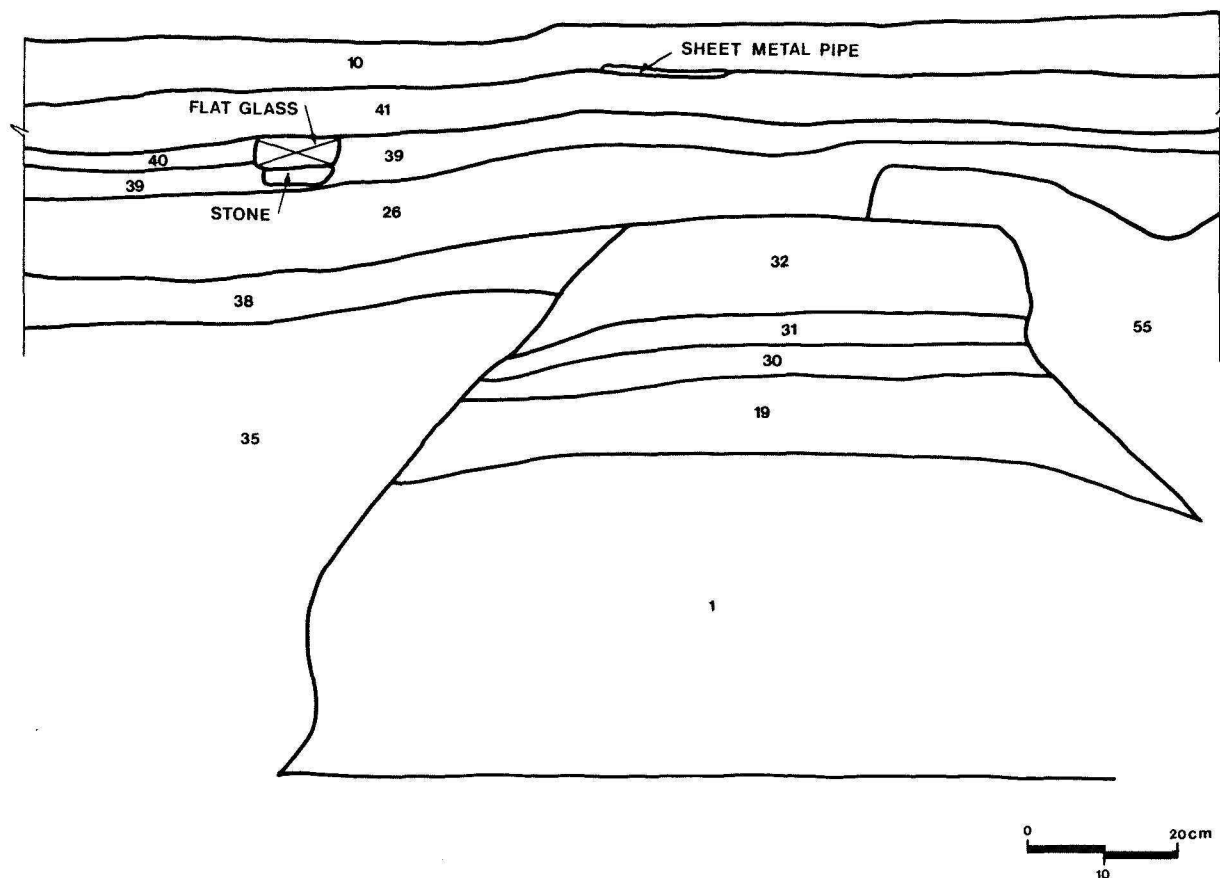
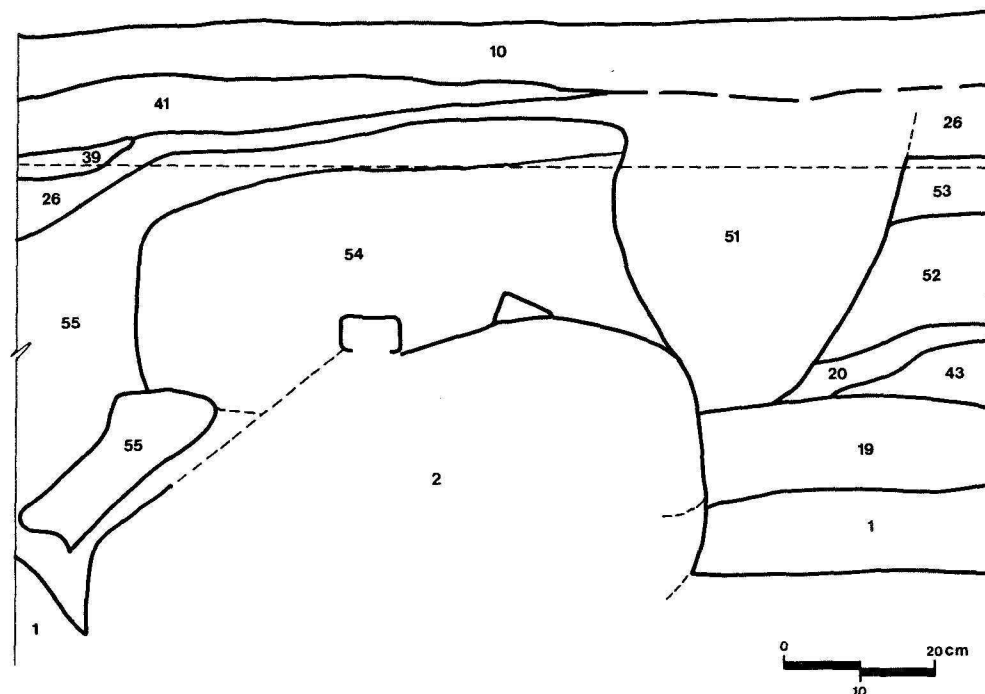
best illustrated by the profiles across the north foundation (Figs. 19,20), in an area where the stone appears to be least disturbed by later activities. In general, the foundation can be seen to be of variable thickness and in one instance (Fig. 20) it becomes thicker towards the top.

The north foundation also contains an unusual feature. The bottom course of stones is followed by a course of logs (Figs. 19,20). The logs have been left in the round, one approximately 30 centimeters in diameter, and are assumed to form a complete course through the foundation thickness. The foundation was not dismantled to confirm the latter assumption, it is based on the fact that the logs appear at the same level on both sides of the foundation and thus could continue through from one side to the other.
