Parks Canada - Technical Reports in Ecosystem Science

Report No. 41

Fish passage and stream habitat restoration in Terra Nova National Park

highway culverts

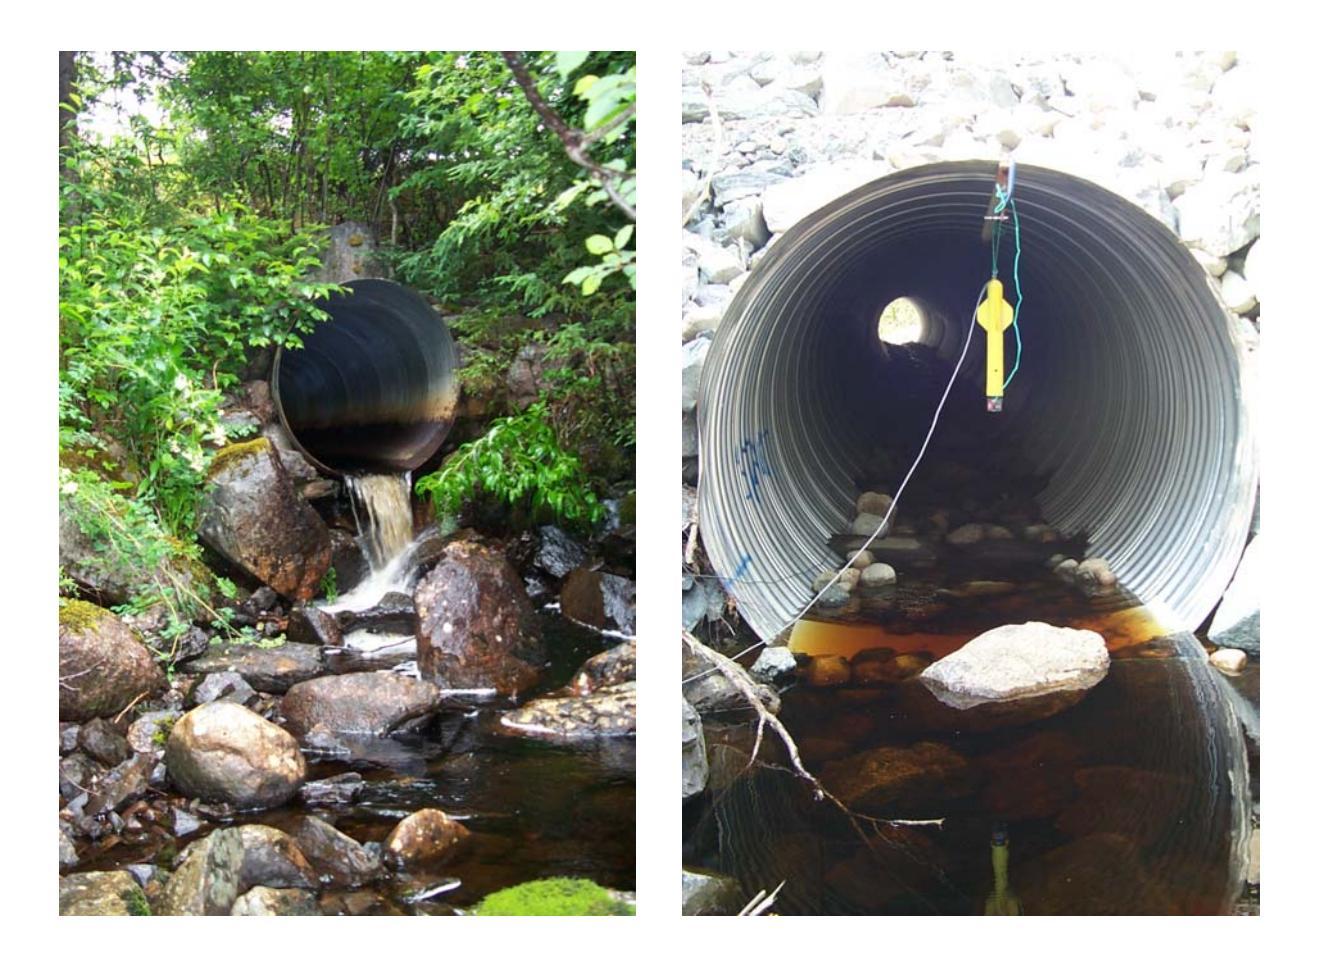
Figure 2: Before (left) and after (right) the restoration of fish passage in the Arnold's Pond Brook culvert located at the TCH (Station 39-224). A video camera set-up is shown at the culvert's outflow (right) monitoring the success of the restoration activities.
