**Stantec Consulting Ltd.**  
130-2886 Sunridge Way NE, Calgary, AB T1Y 7H9

December 01, 2015  
File: 124910481.300

**Reference: Archaeological Impact Assessment for the Proposed Historic Machine Shed Foundation Replacement at the Bar U Ranch NHS; Contract No. 5P420-15-5143**

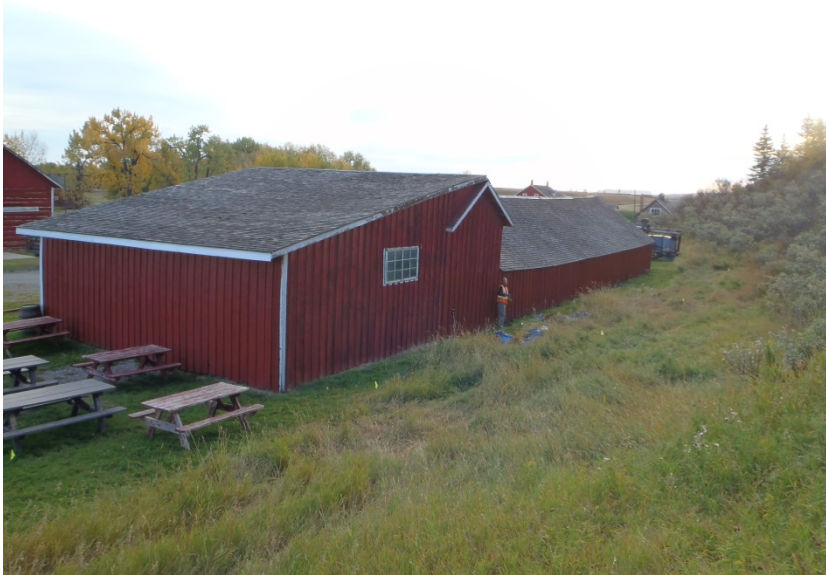
**Plate 1** Northeast view of south and west façades of Historic Machine Shed; note differing rooflines indicating successive phases of building construction

despite the similar outer façades. Outwardly, the entire building sports a dark red stained board and batten siding, which runs the full height of the wall, from the ground up to the roof rafters or overhanging fascia; trim and fascia boards are painted a contrasting white (Plates 1 and 2).

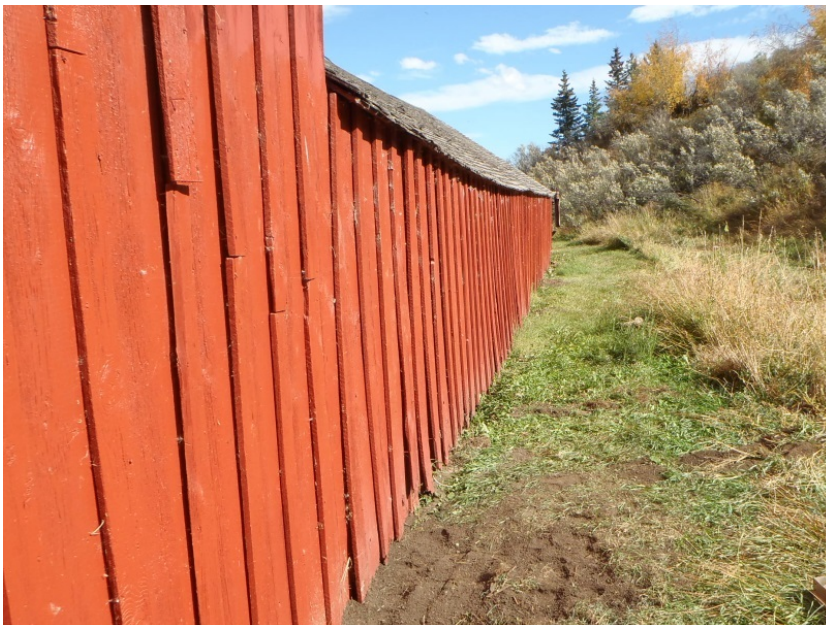
**Plate 2** Northeast view of completed and backfilled shovel tests along outside south wall of Historic Machine Shed

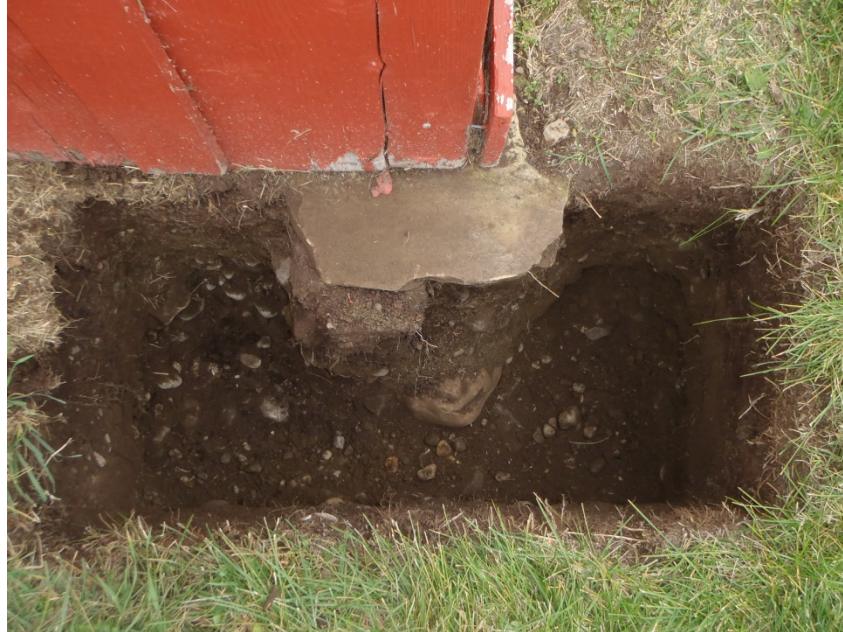
**Plate 3** West view of 50 cm deep shovel tests (Sub-Ops A and B) shows sandstone foundation slab beneath corner; test is 1.0 m wide

- Starting with the earliest section (east wing) of the building, the subsurface tests revealed a preference for the use of sandstone slabs as corner supports. The NE, NW, and SW corners as well as one position midway along the 20 m-long south wall each had a minimum of one flat piece of sandstone in position beneath the corner or support post (Plates 3, 4, 7, 12, and 13). The SE corner, however, was supported most recently by dry (un-mortared), stacked bricks that had come loose and sat on the surface, and earlier by stacked, undressed sandstone rocks that seem to have been set in the bottom of a 45 cm deep trench and subsequently backfilled with gravel (Plate 8). It seems feasible that this back corner of the building shifted or dropped and the bricks were used as a stop-gap measure to slow the imminent collapse. Where the sandstone slabs in the other corners are squared or roughly dressed, average six to eight cm thick and at least 35 cm long by approximately 20 cm wide and located within barely 3 cm of the surface, the sandstones in this corner seem not to have been finished and to have been set in a relatively deep hole instead of simply lying on the surface. It is also possible there was a natural depression in this position that was simply filled with gravel, levelling off the grade, and the sandstones were placed strategically within the depression prior to the erection of the superstructure.

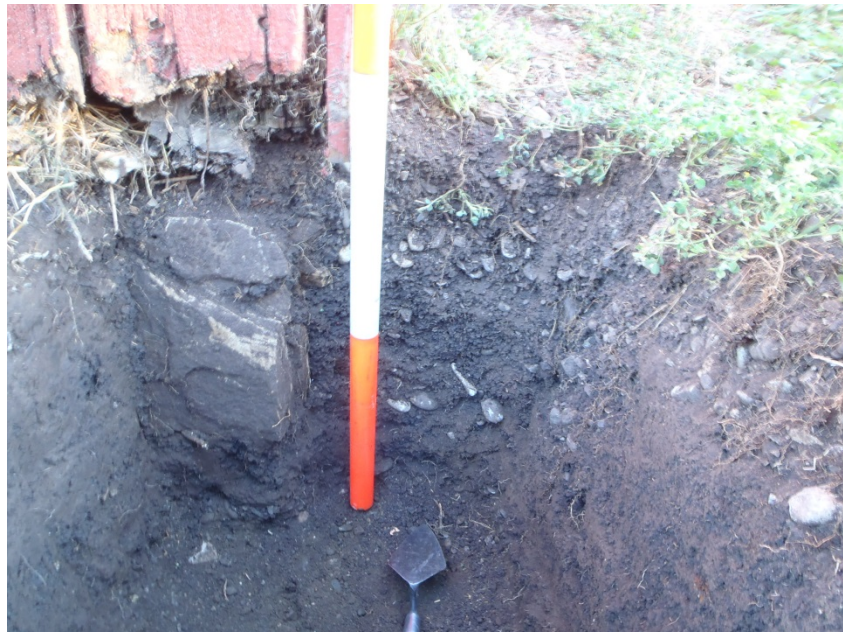
**Plate 4** South view of 50 cm deep shovel test (Sub-Op AA) shows stacked sandstone rocks buried in gravel fill; test is 50 cm by 50 cm square

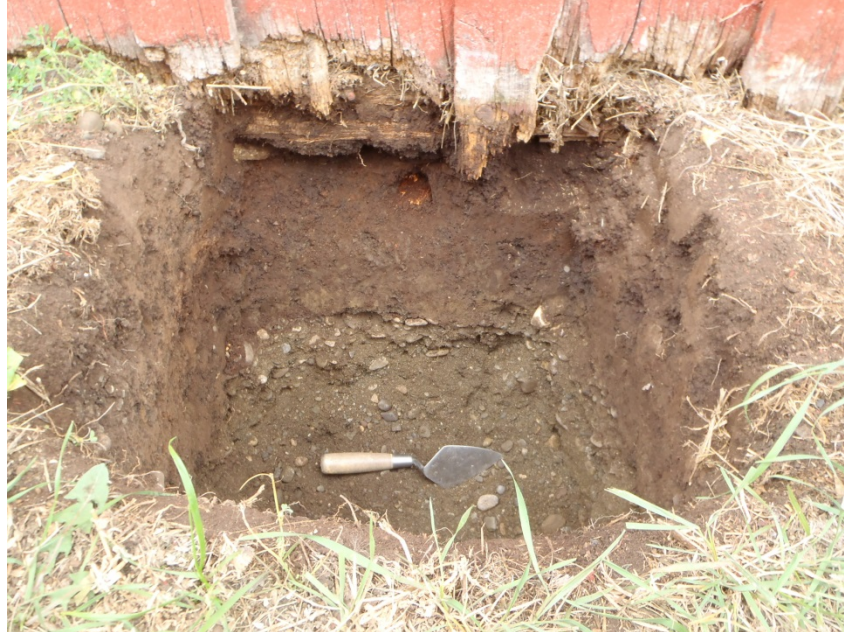
**Plate 5** West view of 50 cm deep shovel test (Sub-Op C) shows wooden sill plate above undisturbed sediments and basal fluvial rocks and gravel

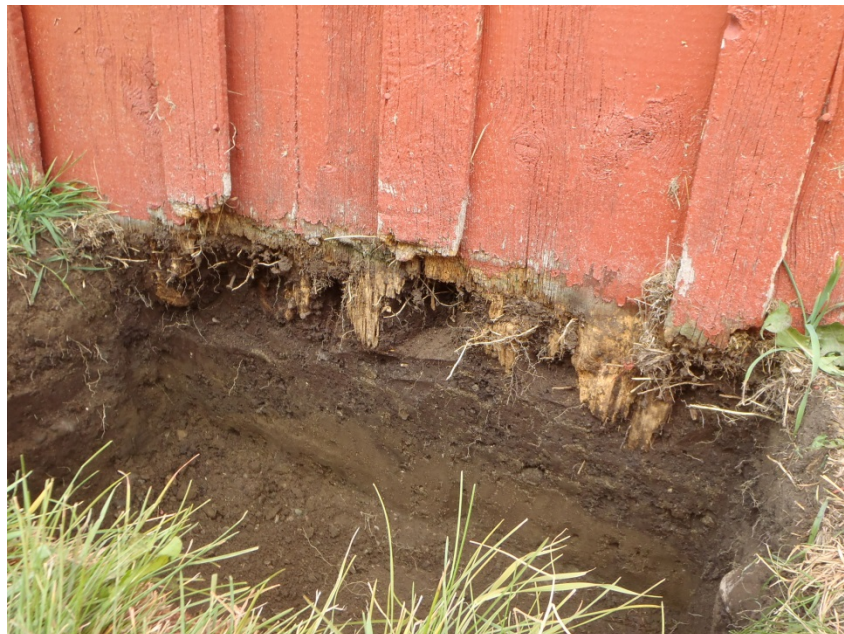
**Plate 6** South view of 60 cm deep test (Sub-Op's D and E) shows rotting sill plate beneath board and batten siding; test is 1.0 m wide

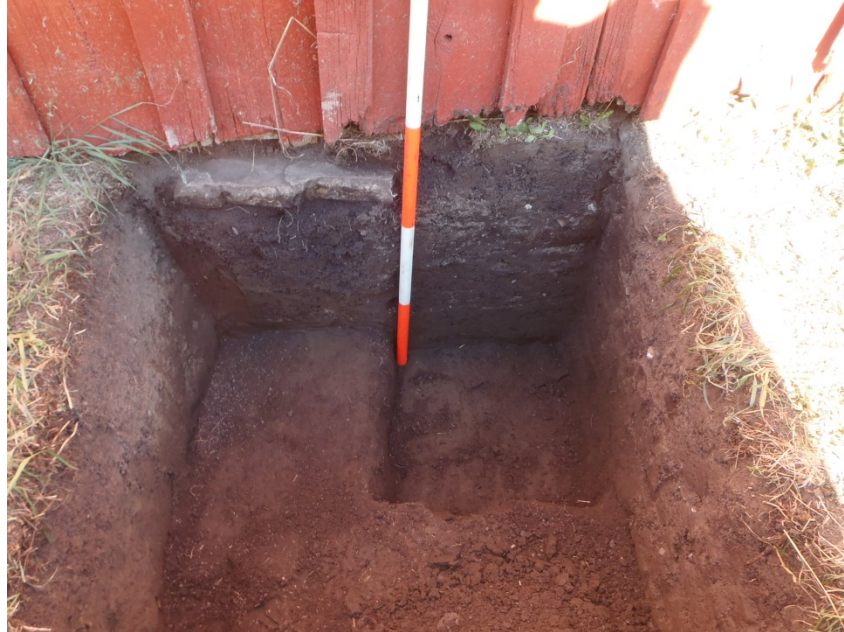
**Plate 7** South view of 60 to 65 cm deep tests (Sub-Op's G,H,J,K) shows sandstone foundation slab beneath original corner; test is 1.0 m square

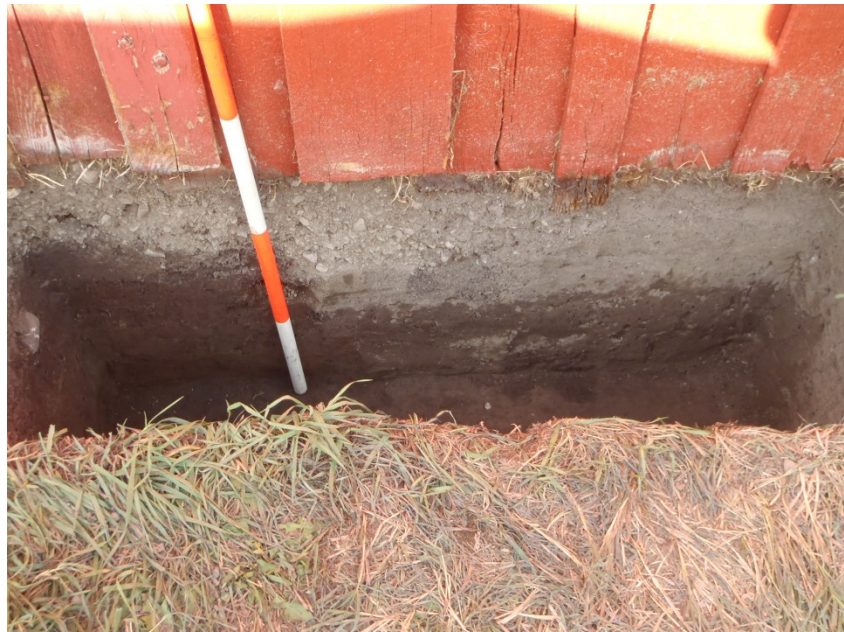
**Plate 8** South view of 60 to 70 cm deep tests (Sub-Op's N, L, and M, left to right) shows gravel fill foundation beneath join of two buildings

- Subsurface tests around the corners of the central tall steam tractor garage addition revealed an inconsistent foundation plan. Three tests along its eastern wall (at the NE and SE corners and at the join between its east wall and the NW corner of the original structure) revealed either sandstone slabs or a combination of sandstone slab supporting a wooden sill plate (Plates 7, 8, and 12). The sill plate supporting the SE corner of the addition is fully rotted and barely distinguishable. Tests at the SW corner revealed only 60 cm (2 ft.) of gravel fill with no stone, brick, or additional wooden support beneath the corner (Plate 8). This may represent a similar strategy to that seen above, where a natural depression was filled with gravel to level off the grade prior to construction. The test at the NW corner revealed a pounded post, similar to those used in the west corners of the west addition. It seems likely that whatever foundation or corner support was used during the initial construction was replaced with a pounded post when the final west wing addition was constructed.

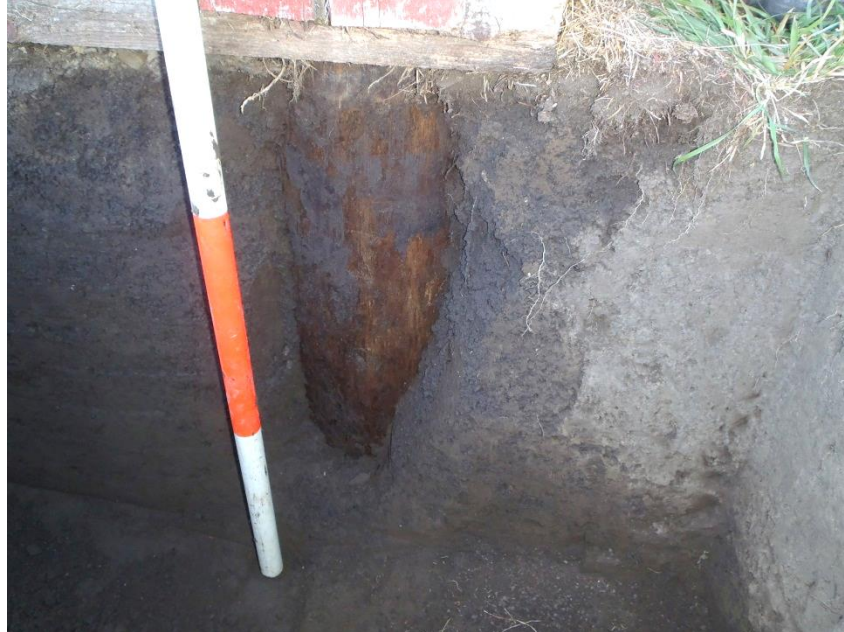
**Plate 9** West view of 60 cm deep tests (Sub-Op's Q and P) shows pounded post as corner foundation; post is not fully exposed

- The subsurface tests around the corners of the west wing addition revealed deeply pounded posts at the NE, NW, and SW positions. Each of these is between approximately 15 cm and 25 cm in diameter and have been pounded at least 60 cm (2 ft.) into the ground. For safety and building integrity purposes, none of these posts was fully exposed, and the bottom of each was never reached (Plates 9 to 11). The supposition that these posts were pounded into place arose due to the observed lack of fill, disturbed sediments, or previously excavated post hole adjacent to these three corner posts. The tests at the SE corner of this west addition revealed only 60 cm (2 ft.) of gravel fill with no post, stone, brick, or additional wooden support beneath the corner. As above, and seen with the original structure, gravel fill may have been used strategically in this position; *i.e.*, a natural depression may have been filled with gravel to level off the grade prior to construction. It is unclear from the AIA tests whether this strategy was attempted during the construction of the steam tractor or west wing addition, or perhaps at some other time altogether.

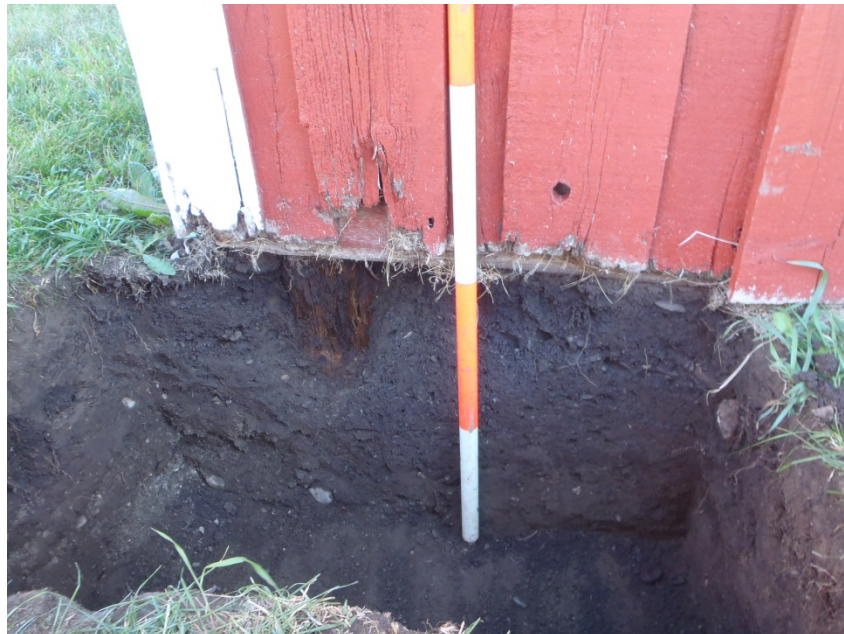
**Plate 10** West view of 55 cm deep tests (Sub-Op's T and S) shows pounded post as corner foundation; post is not fully exposed

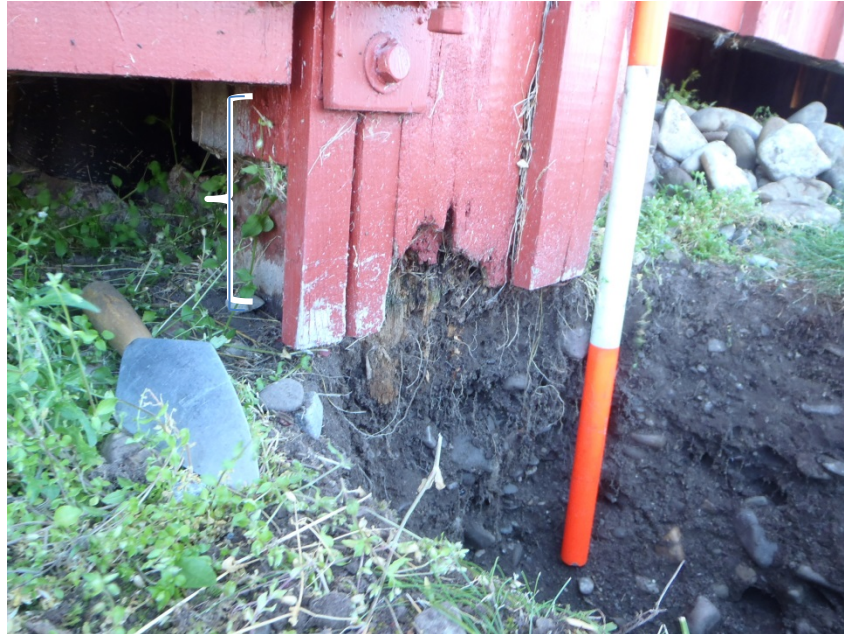
Plate 11 Southwest view of 35 cm deep test (Sub-Op U) shows pounded post as corner foundation; post is visible inside – it is rotting and not fully exposed

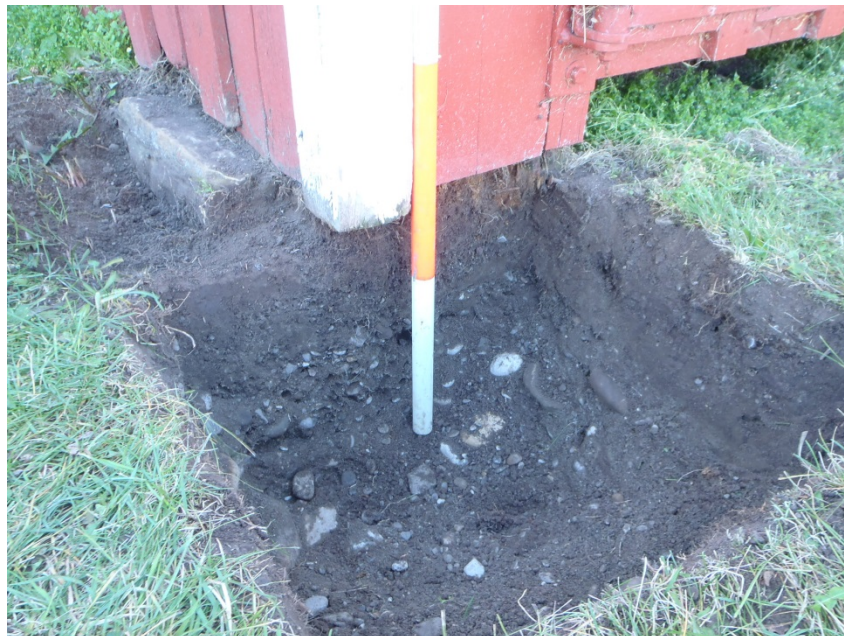
Plate 12 Southwest view of 40 cm deep test (Sub-Op V) shows off-set sandstone foundation slab beneath corner; test is 50 cm square

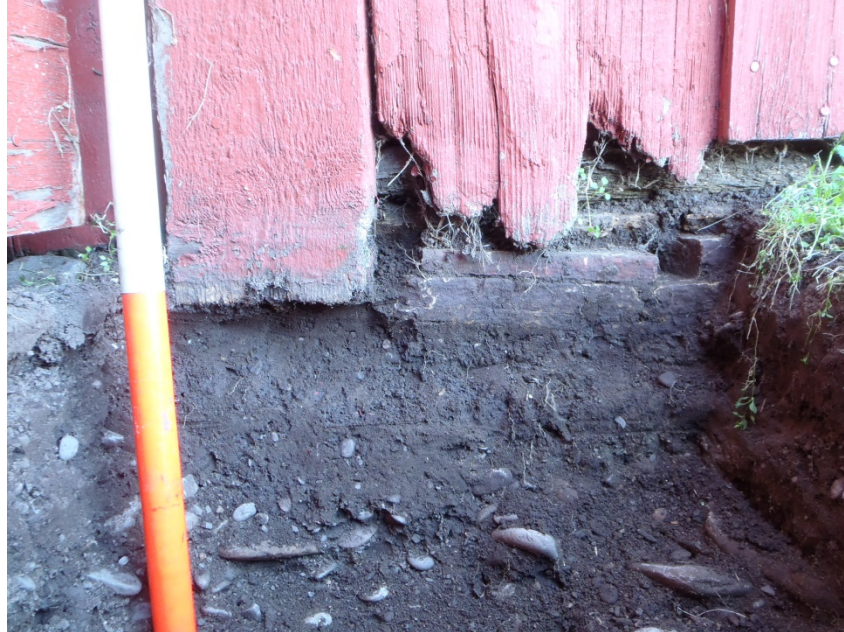
**Plate 13** West view of 30 cm deep test (Sub-Op W) shows sandstone foundation slabs beneath corner; test is 1.0 m wide

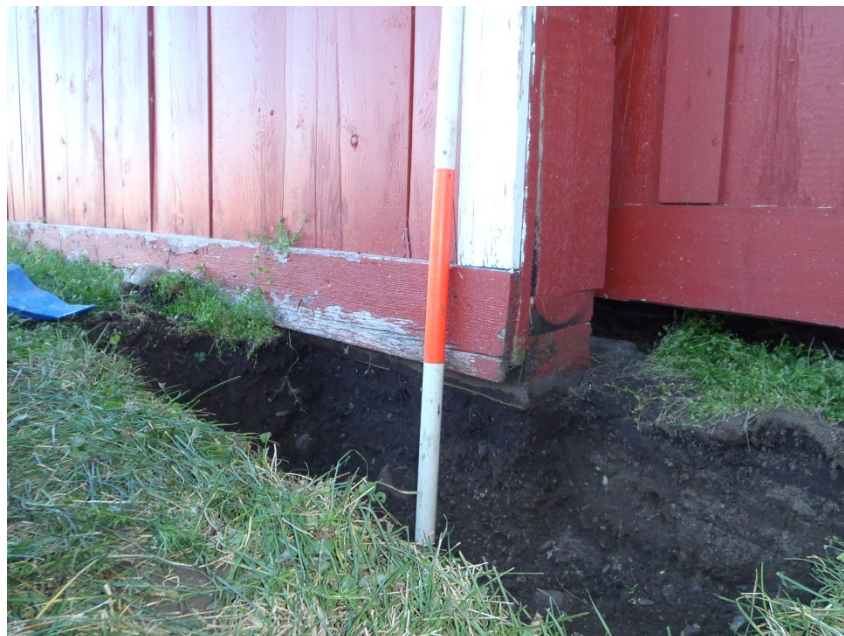
**Plate 14** Southeast view of 30 cm deep test (Sub-Op's Y and X) shows well-preserved wooden sill plate beneath door framework; test is 1.0 m wide

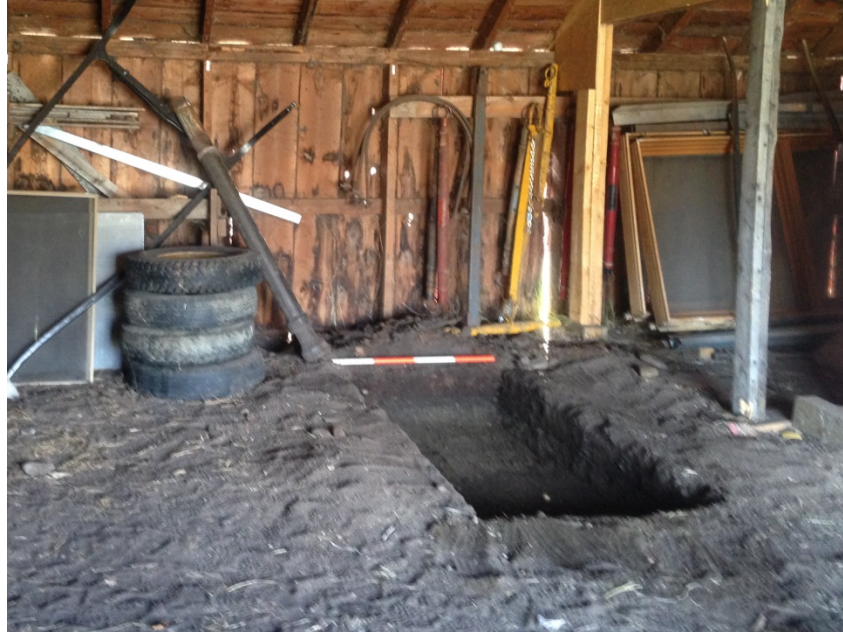
Plate 15 Southwest view of 30 cm deep 1 m by 2 m test unit (Sub-Op's BB to JJ) inside Machine Shed

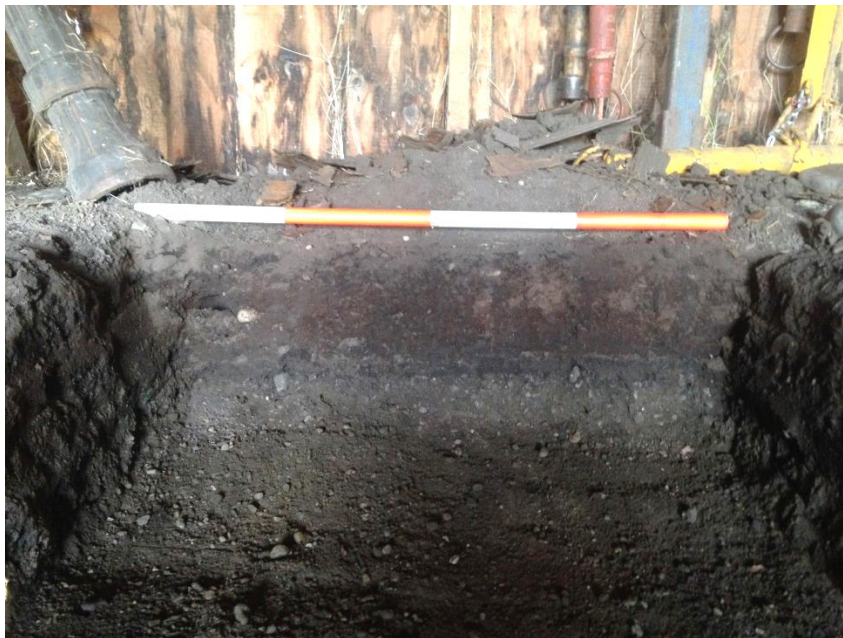
Plate 16 South view of 30 cm deep soil profile (south wall of Sub-Op's BB and CC)

Along the outside walls, the tests revealed a generally thin sod layer overlying a 10 cm thick dark brown silty loam Ah horizon, overlying at least 10 cm of brown sand with increasing gravel, which in turn overlies brown basal gravelly sands and gravels. Inside, the stratigraphy was much simpler, as there was no sod or overlying Ah horizon. Typically, the inside units revealed 15 cm to 18 cm of loose clayey silt transitioning abruptly into coarse gravelly sand, which overlies very rocky gravelly fluvial coarse sands at the base of the excavations. The small block to the east (Sub-Ops BB to JJ) also revealed a red-brown loam with a very high organic content between approximately 12 cm and 24 cm B.S., which could represent decayed sawdust or hay flooring mixed into the substrate.

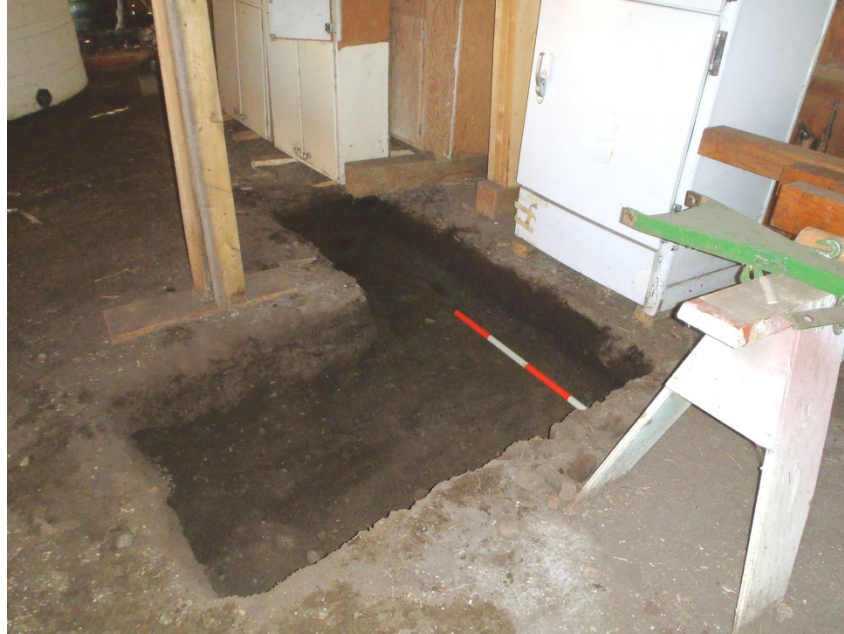
Plate 17 Southwest view of 30 cm deep western test unit (Sub-Op's KK to SS) inside Machine Shed

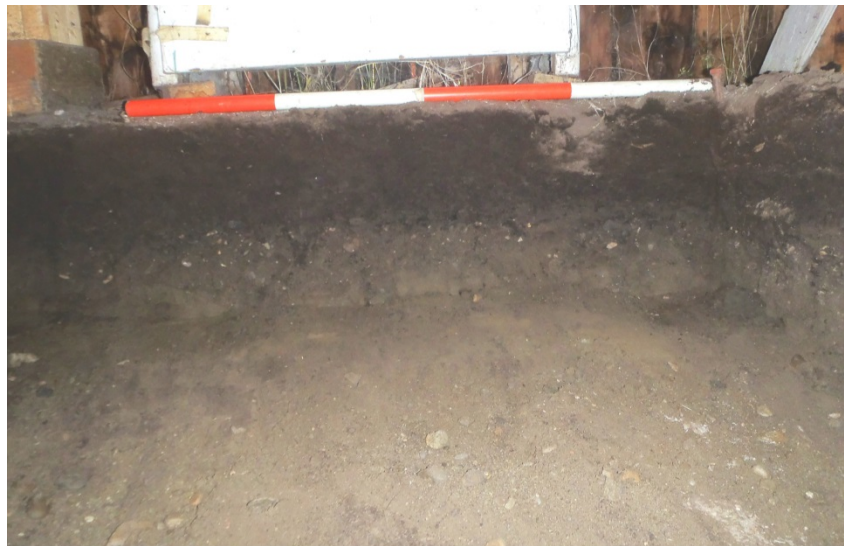
Plate 18 South view of 30 cm deep soil profile (south wall of Sub-Op's MM and NN)
