DENDROCHRONOLOGICAL INVESTIGATIONS OF HISTORIC CABINS IN JASPER AND BANFF NATIONAL PARKS

A REPORT BASED ON FIELD SURVEYS IN
AUGUST, 1999

Dr. Dan Smith
University of Victoria Tree-Ring Laboratory
Department of Geography
University of Victoria

UVTRL Report 2000-04

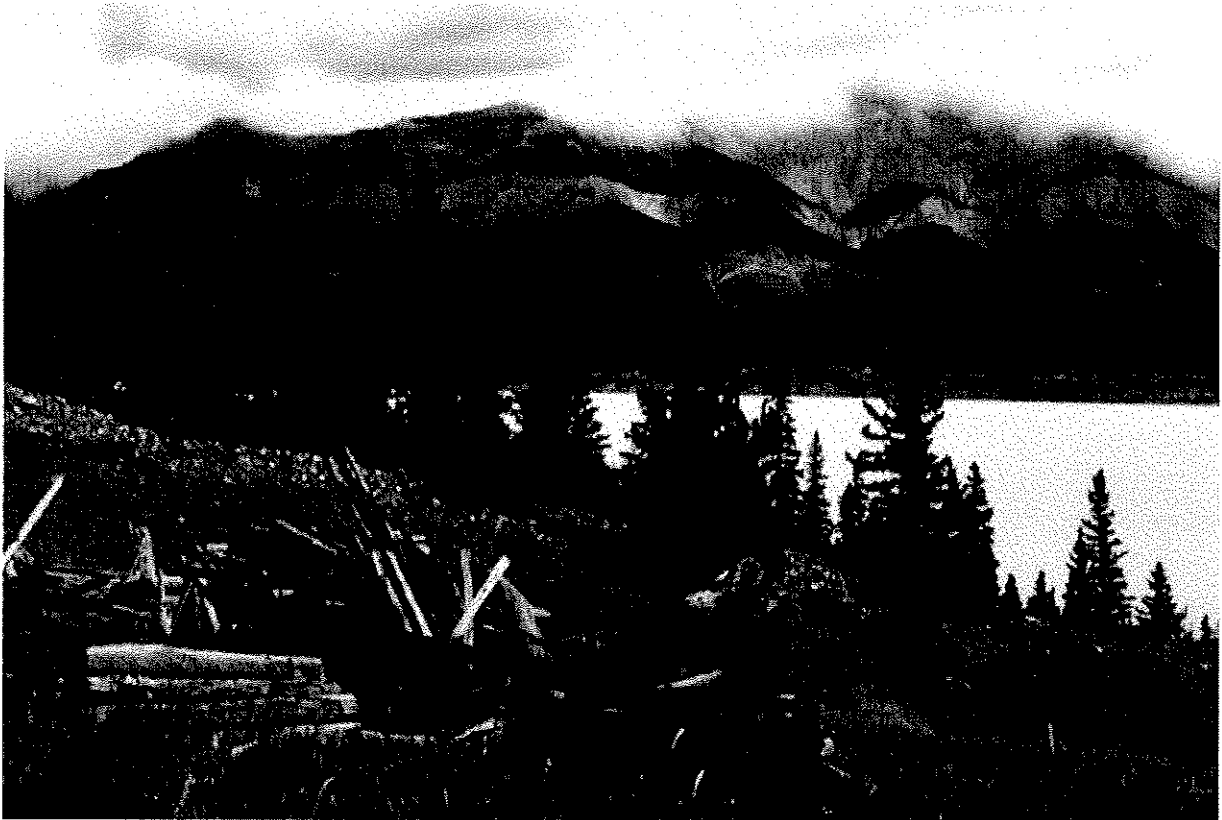
Figure 1. Photograph showing the condition of small cabin (UVTRL 99Q) located above the west shore of Jasper Lake, Jasper National Park.

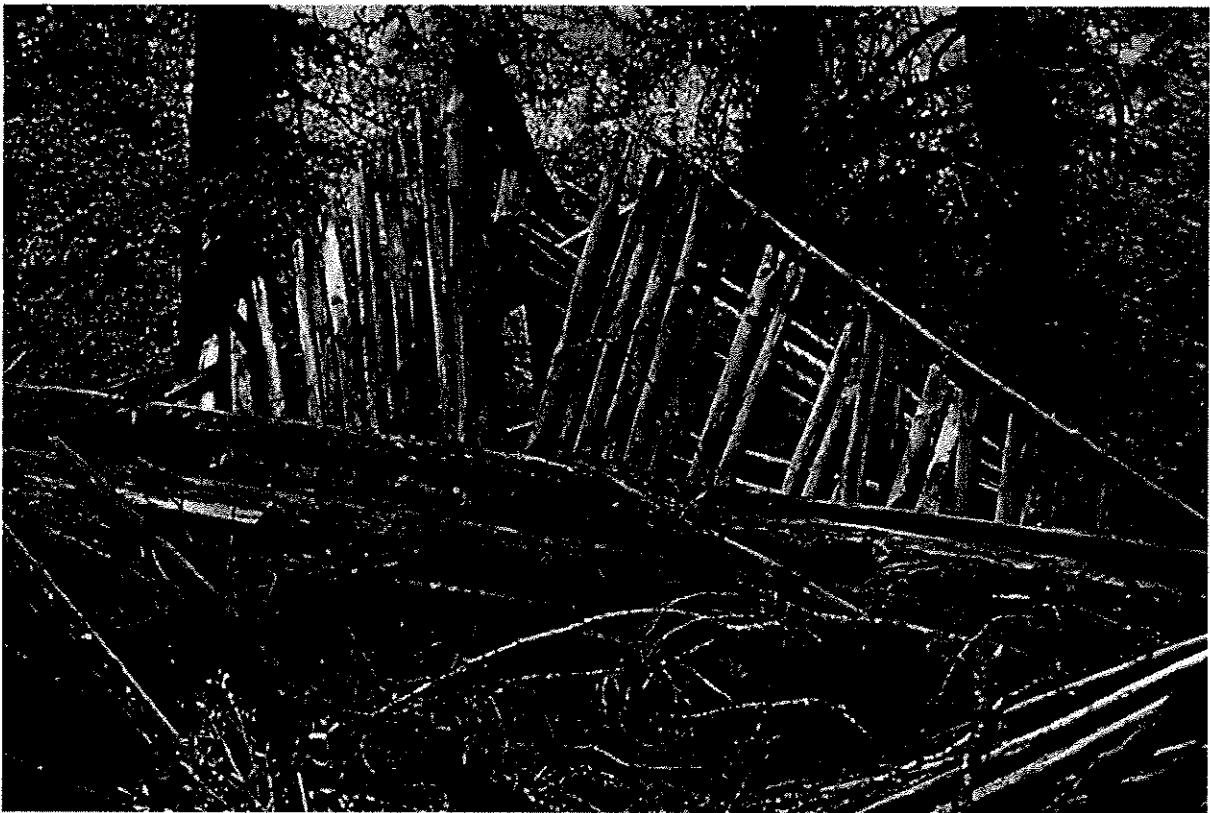
The cabins varied in soundness from sites where the logs were solid from perimeter to pith, to other sites where surface/subsurface rotting was widespread (Figure 2) These variable conditions necessitated the collection of samples using either a two-thread increment corer to extract a 5 mm wide *core* or, in cases where rotting was widespread, by sawing off the butt end of a corner log to create a *disc*.

Figure 2. Condition of Deer Creek Mine Cabin (UVTRL 990).

Description - The roof on this rectangular-shaped cabin has collapsed, resulting in the destruction of large sections of the exterior walls (Figures 2 and 14). The cabin consists of three components: a central room, a root cellar structure and a small room at the front that may have served as a kitchen. The cabin is constructed of a mix of Douglas-fir and spruce/pine logs, with the relatively slender Douglas-fir logs providing structural support at several places.

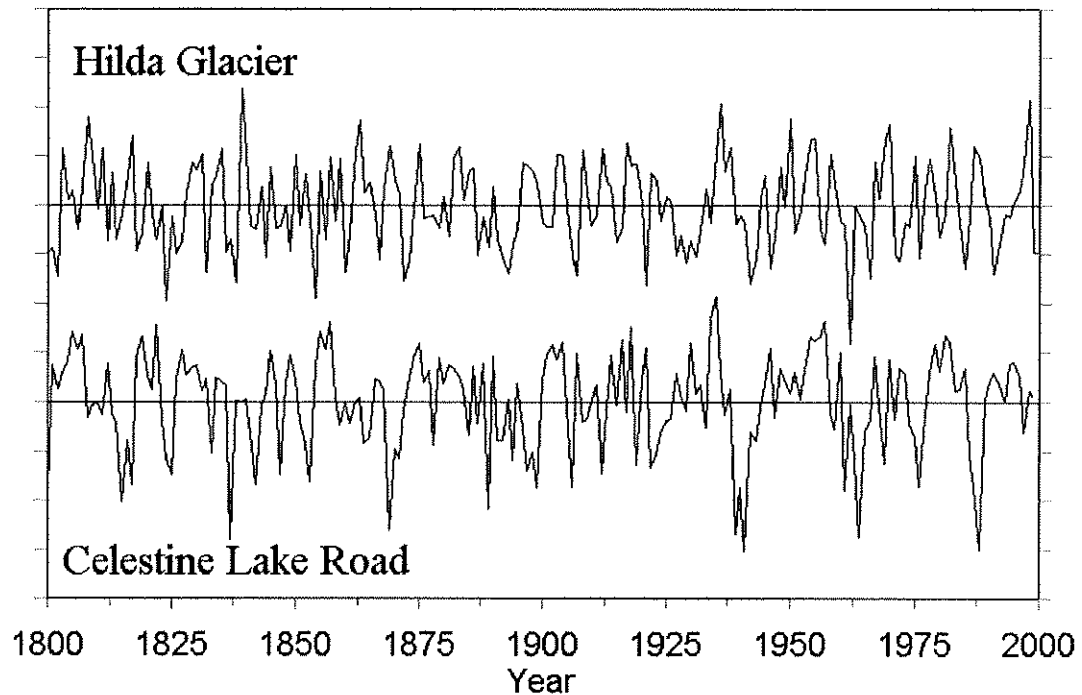
The Celestine Lake Road living white spruce chronology spans the interval between 1800 and 1999. Table 1 presents the principle tree-ring statistics associated with the chronology. The mean series correlation value of 0.629 illustrates the relative strength of the chronology and the mean sensitivity value of 0.243 provides a measure of between-ring variability (Fritts, 1976). Autocorrelation is a measure of the correspondence between successive increments and the value of 0.765 assigned to the chronology suggests that radial growth at the Celestine Road site is conditioned by factors in preceding growth years (Fritts, 1976). Notable pointer years within the Celestine Road series include small rings produced in 1800, 1837, 1869, 1889, 1941, 1964 and 1988 (Figure 3).

Figure 3. Radial growth trends established for living Englemann spruce at Hilda Glacier and white spruce at Celestine Lake Road. Deviation from the average line drawn through each denotes above average radial growth (+) and lower than average radial growth (-).

conditioned by factors in preceding growth years. These values are characteristic of climatically responsive, upper elevation tree species in the area (Luckman *et al.* 1997). Notable pointer years are recorded in 1824, 1854, 1872, 1893, 1921, 1962 and 1991 (Figure 3).

There is little correspondence in growth trends between the Celestine Lake Road and the Hilda Glacier spruce chronologies (Figure 2). The distinct growth trends exhibited by each reflects a species-specific response to different limiting conditions - temperature in the case of the Hilda Glacier chronology (Luckman *et al.* 1997) and, presumably, precipitation in the case of the Celestine Lake Road chronology (Figure 3)

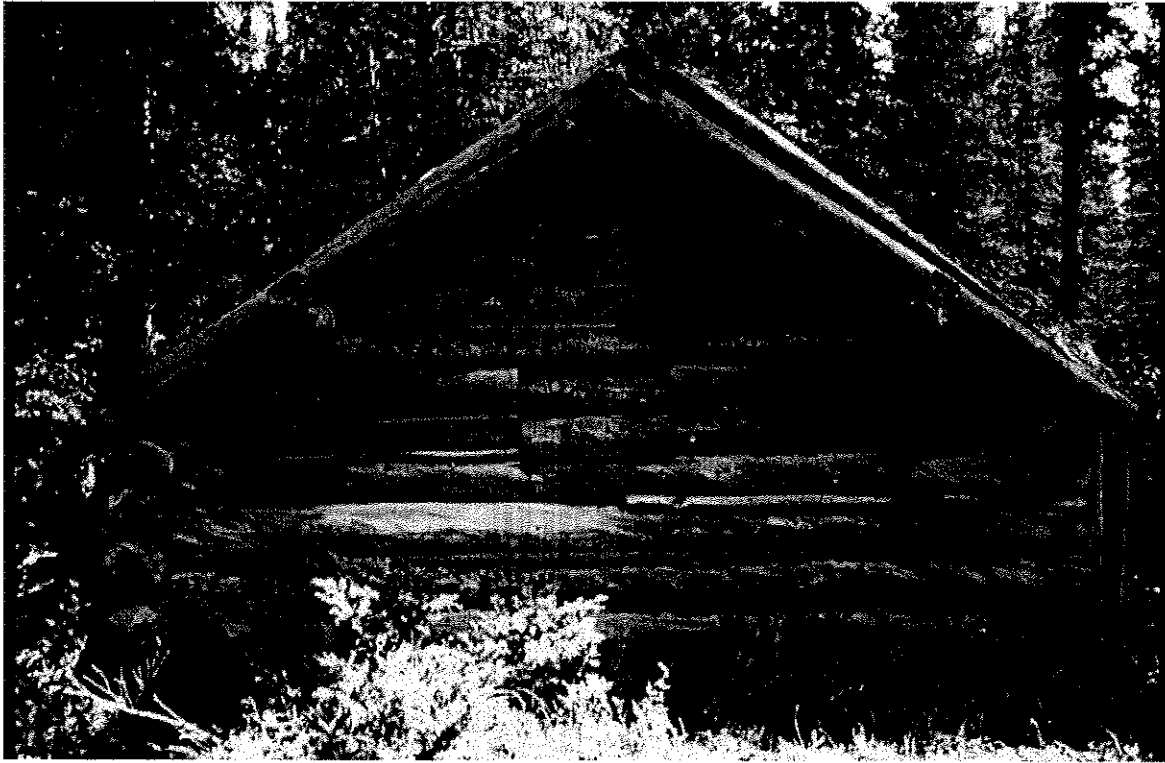
Figure 6. West-facing wall of the Glacier Trail Cabin. Increment core samples were collected from the three lowest logs shown.

Description - This solidly constructed rectangular cabin has two windows and a single door. One window is set into the centre of the west-facing wall which contains 10 courses of logs (Figure 6). The second window is located adjacent to the door on the south-facing wall made up of 6 log courses. A single log stretching the length of the cabin holds the ribbed roof up, on which a number of seedlings have established (Figure 7).

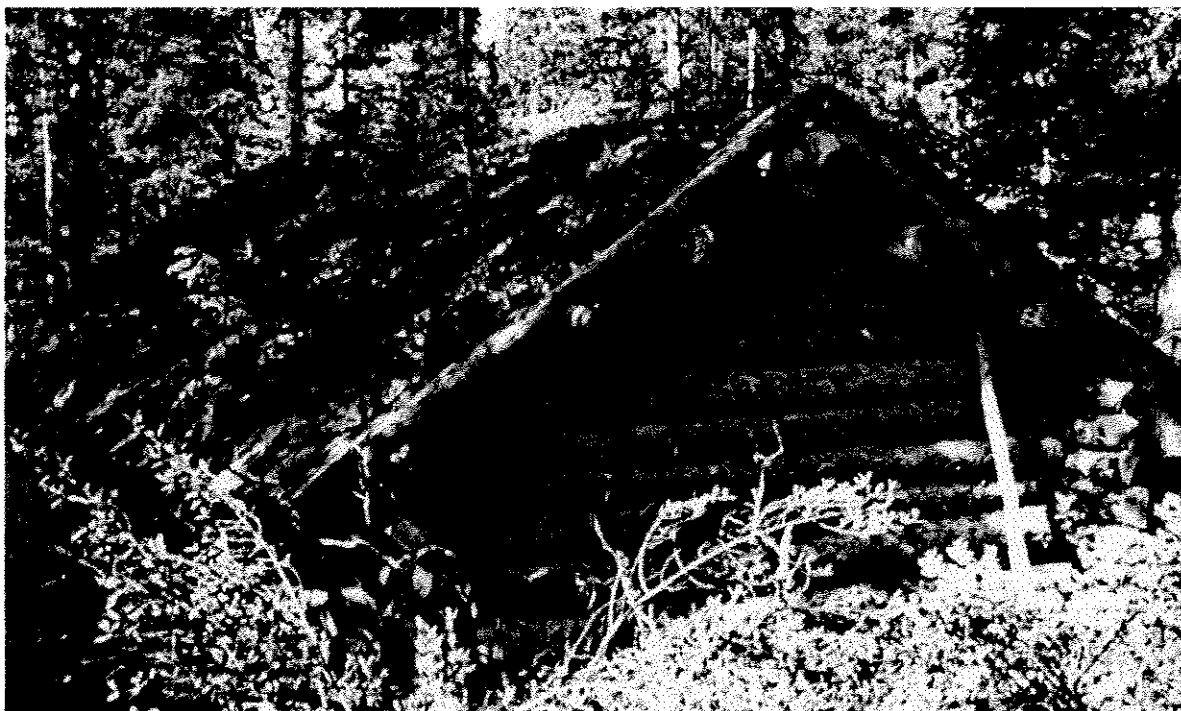
Figure 7. East wall of the Glacier Trail cabin showing seedlings on roof.

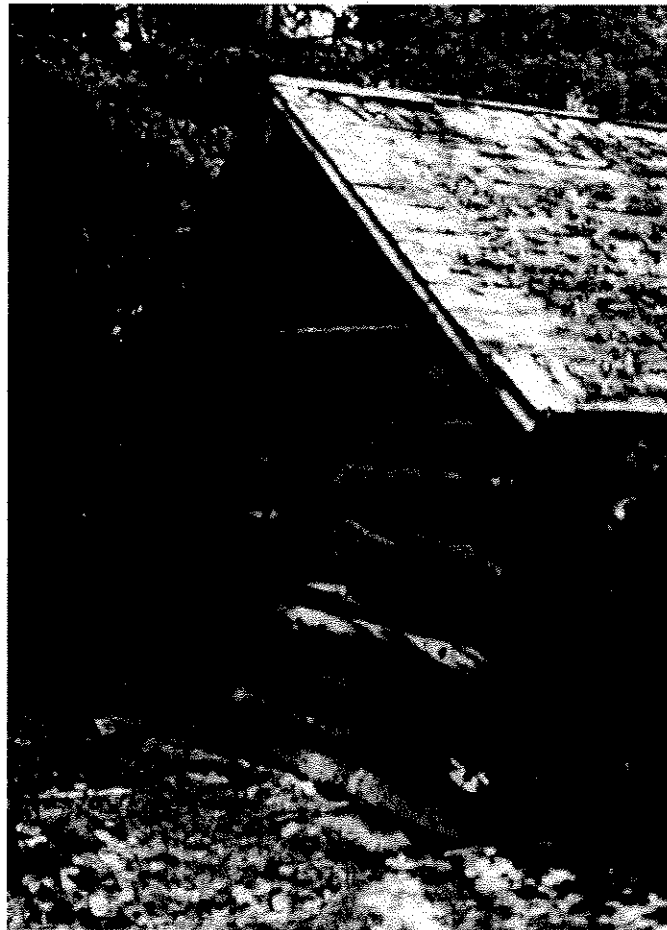
Description - This solidly constructed rectangular cabin has three windows and a single door. One window is set into the centre of the west-facing wall which contains 14 courses of logs (Figure 9). This wall and the north wall show evidence of having been burned after construction. The second window is located in the centre of the south-facing wall made up of 9 log courses (Figure 8). The third window is located on the front wall (east-facing)

Structure Age - The Hector 9 Mile Warden Cabin is built from mature spruce logs that range in age from *ca.* 233 to 377 years (Table 4). Scorching by fire, surface rotting and surface dressing have all removed several decades of perimeter tree-rings at various points on the exterior walls of the cabin. Nevertheless, two increment core samples (one of which retains bark - 99LCOO8b) with complete ring sequences indicate the cabin walls were constructed from trees felled in the late summer of 1915 (Figure 9).

Figure 9. West-facing wall of the Hector 9 Mile Warden Cabin that overlooks Hector Lake. Exterior logs show evidence having been burned.

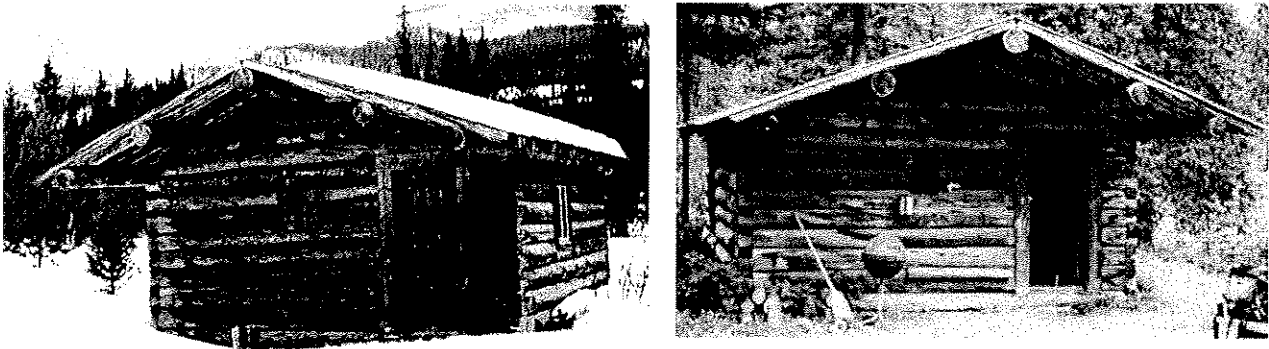
Figure 10. South face of Owen Creek Cabin, BNP. On left the view on March 13, 1948 and on the right the view on August 9, 1999.

Description - This solidly constructed rectangular cabin has two windows and a single door. The corners of the cabin are carefully fitted and show considerable care went into its construction (Figure 10). One window is set into the centre of the west-facing wall which contains 10 courses of logs. The second window is on the opposite east-facing cabin wall overlooking Owen Creek (Figure 10). The door is located on the south-facing wall (Figure 10) made up of 9 log courses. The sides of the logs underneath the front porch of the cabin contain many hand written notations, the earliest of which record visits as early as 1932.

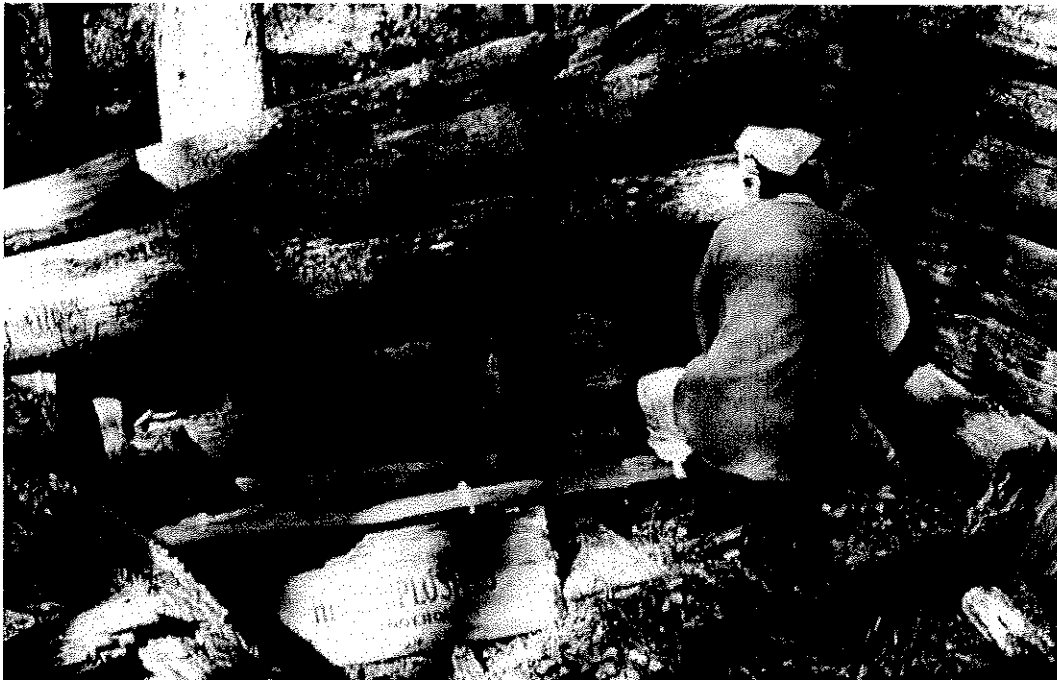
- a) **UVTRL 99NA** - a large two room cabin that appears to have served as a storage building. This structure is in disrepair, the roof has collapsed and all that remains are 6 to 8 courses of logs along the cabin walls (Figure 12).
- b) **UVTRL 99NB** - a small one room cabin that has largely fallen down. All that remains are the lowest courses of logs (two to three high)(Figure 13).

Figure 12. Northwest interior corner of storage structure at 99N. The printed box label found inside the cabin reads *High Explosives, Dangerous*.

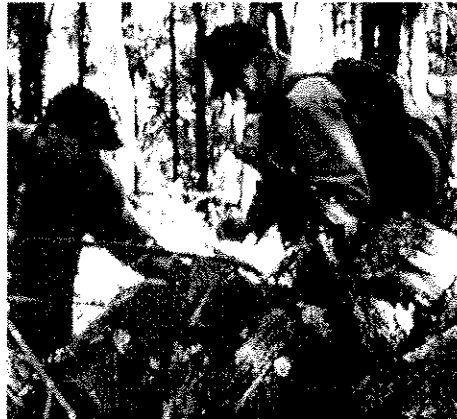
Figure 13. Cutting of butt ends of logs at Railway Construction Camp (99NB).

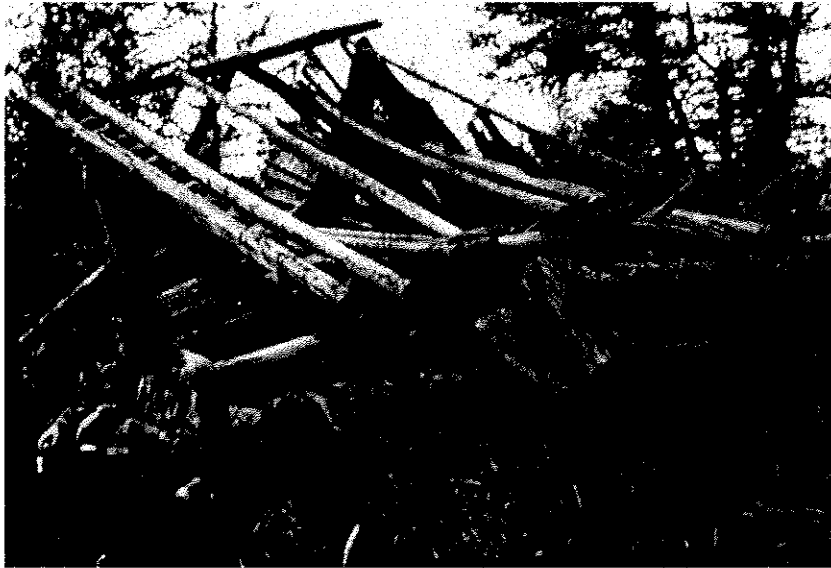
Figure 14. Frontal view of the Derr Creek Mine Cabin.

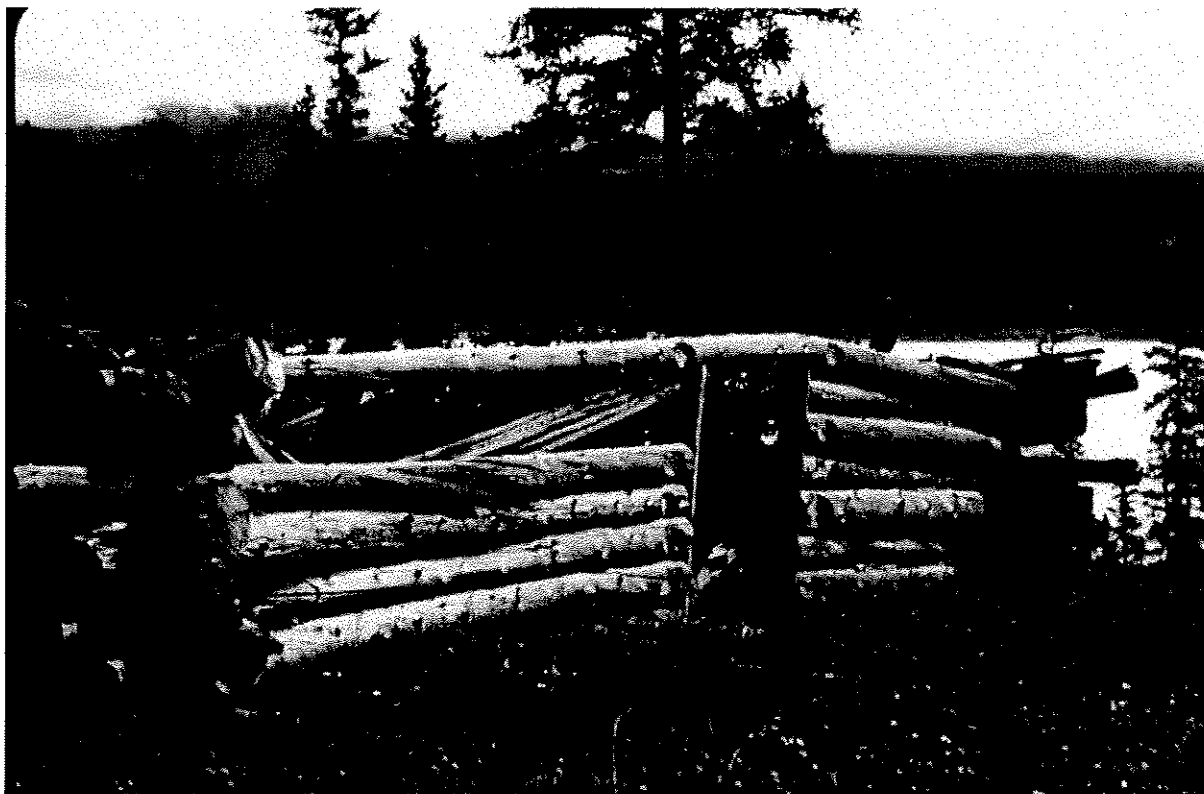
Figure 16. Doorway in 99P1 located in walkway between 99P1 and 99P2.

Description - 99P1 is a large rectangular log structure (bunkhouse?) located immediately adjacent to 99P2. While the walls of the structure are still standing, the roof of the building has collapsed. The cabin has a single door framed by two wooden planks on either side of the opening (Figure 16) and windows at several points. The walls are constructed of 5 to 6 courses of large-calibre boles.

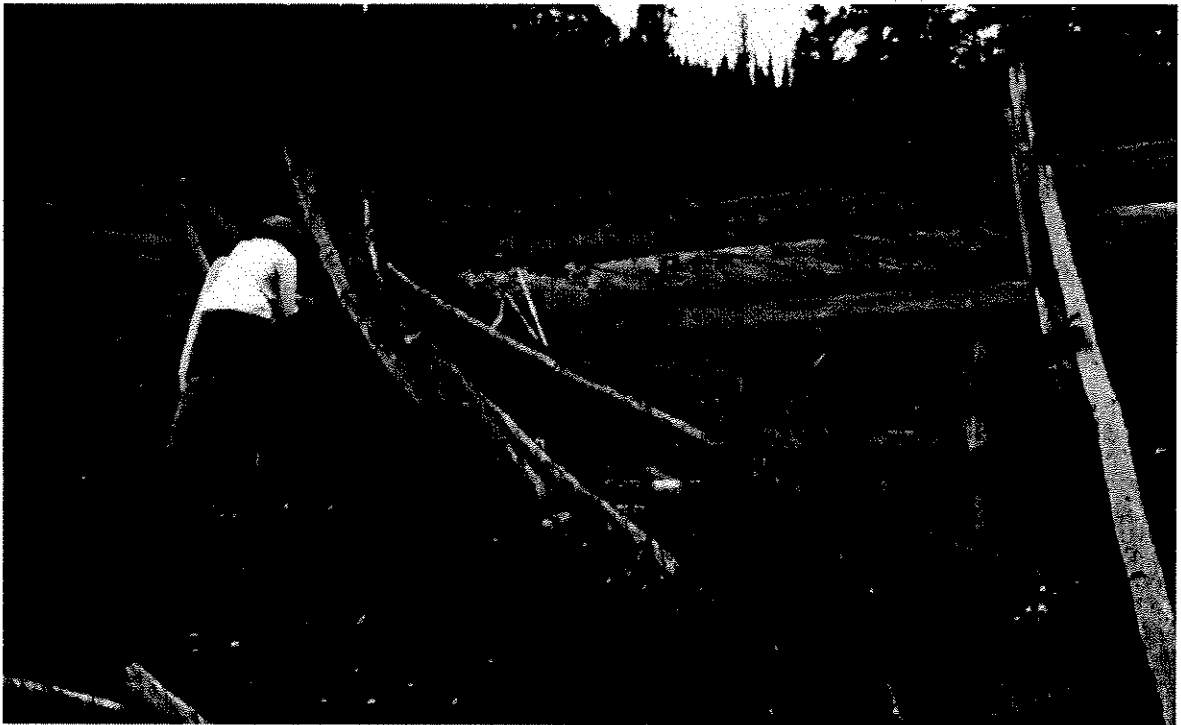
Figure 17. Inside of 99P2 showing increment core sampling sites.

Description - 99P2 is a large rectangular log structure located immediately adjacent to 99P1. While the walls of the structure are still standing, the roof of the building has collapsed (Figure 17). The cabin has two door openings framed by wooden planks and windows at several points. The walls are constructed of 5 to 6 courses of large-calibre boles.

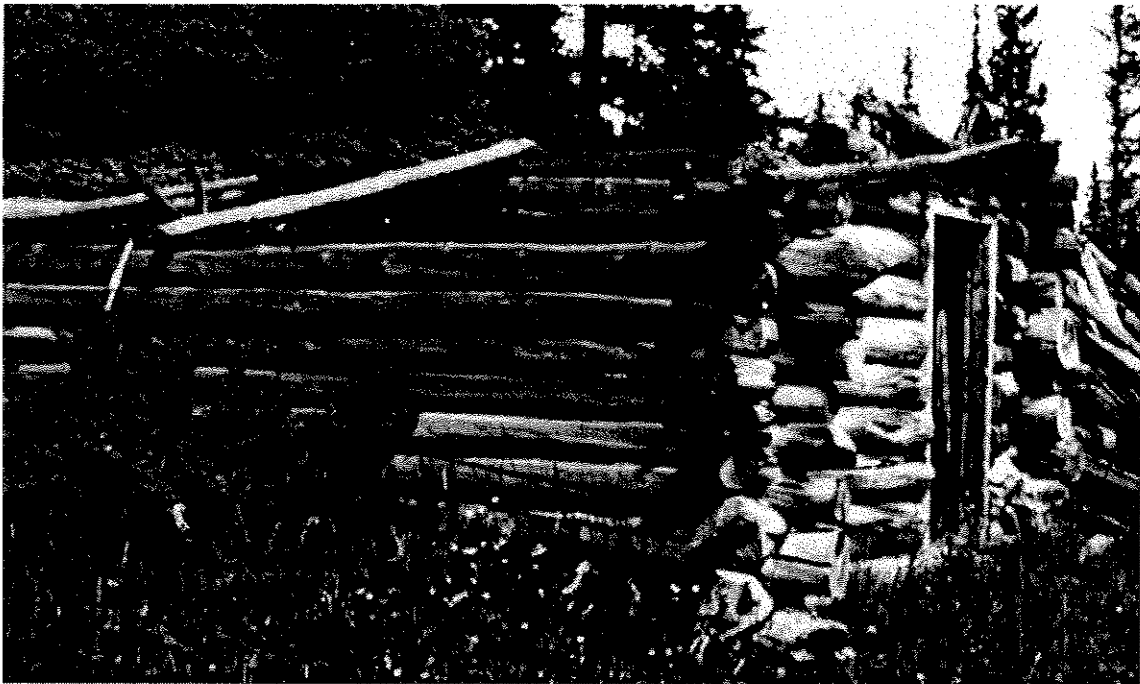
Figure 18. Photograph showing the annex attached to 99P3.

Description - 99P3 is a small rectangular two-roomed log structure located immediately upslope from 99P2. While the walls of the structure are still standing, the roof of the building has collapsed. The larger room of the structure comprises the northern two-thirds of the building and has a door along its north wall and window along its east wall. The smaller annex is accessed through a door located along the southern end of the east wall (Figure 18).

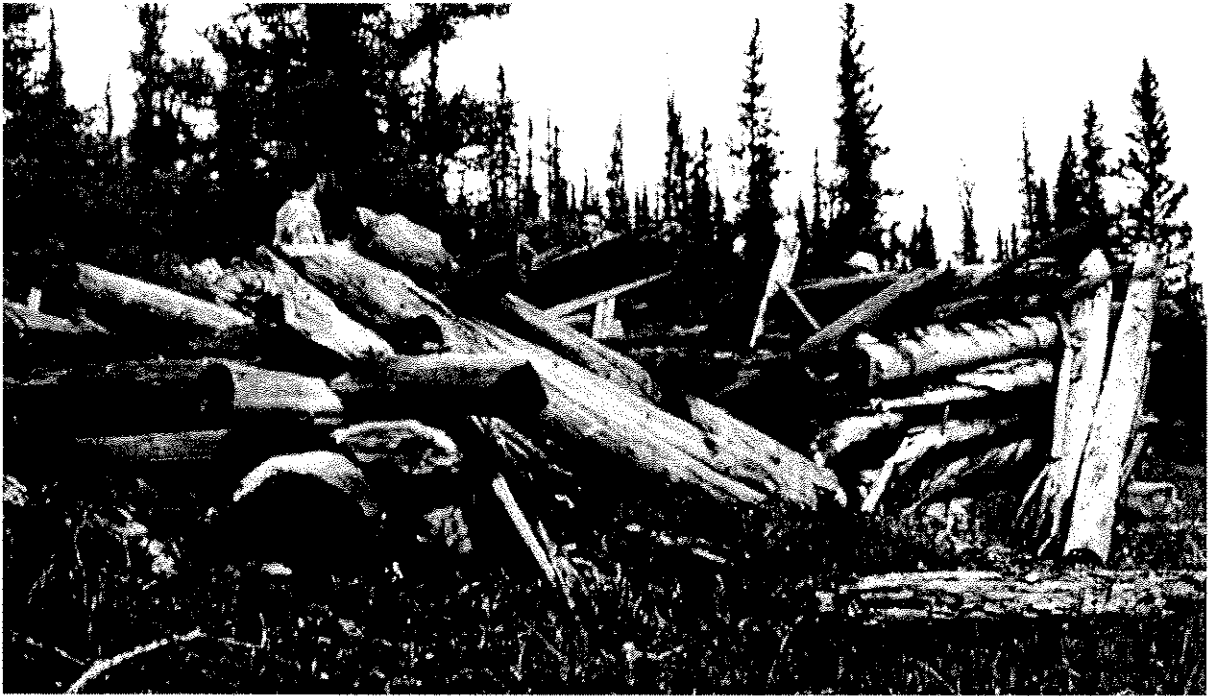
Figure 19. Photograph showing the collapsed character of 99P5.

Description - 99P5 is a large square-shaped cabin located near the upper end of the site. The cabin is in an advanced state of collapse, with failure of the roof structure apparently having pulled the walls down. The downslope face of the cabin contains a window opening (Figure 19). A single door provided access to the cabin interior.

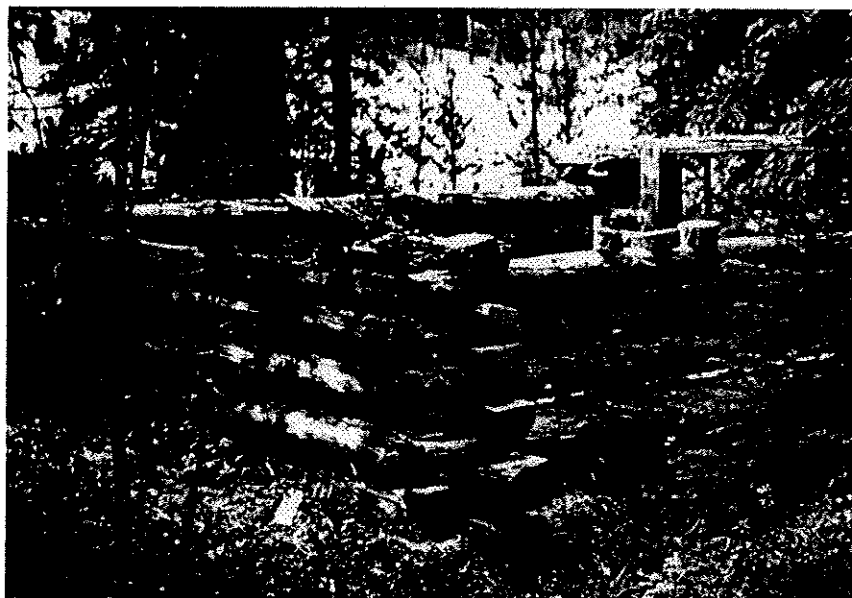
Figure 23. Maligne Lake Outlet Cabin showing location of disc samples

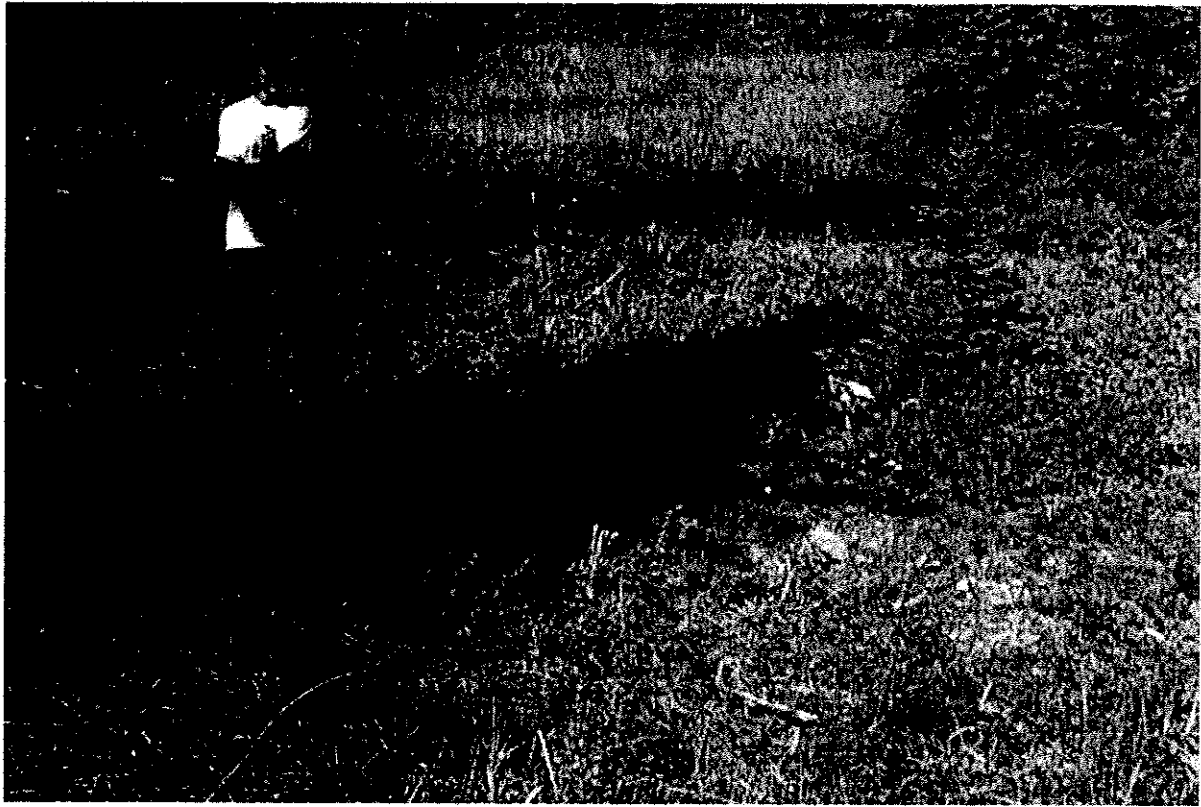
Figure 27. Location of Talbot Lake foundation. Dated log was found at feet of person.

Samples - The single foundation log at the site was excavated and two cross-sectional cookies were retained for analysis. While no bark remained on the sample and there was some evidence of perimeter wood loss, the morphological characteristics of the ringwidth
