## FEDERAL HERITAGE BUILDINGS REVIEW OFFICE

### BUILDING REPORT 88-12

**TITLE:** Nineteen Dawson buildings: (1) Dawson Daily News, (2) Telegraph Annex, (3) K.T.M. Building, (4) Bank of British North America, (5) B.Y.N. Ticket Office, (6) Robert Service Cabin, (7) Customs House, (8) Macaulay House, (9) Black Residence, (10) Commanding Officer's Residence, (11) St. Andrew's Manse, (12) St. Andrew's Church, (13) Ruby's Place, (14) Third Avenue Hotel Complex, (15) Harrington's Store, (16) Mme. Tremblay's Store, (17) N.C. Company Warehouse, (18) Bigg's Blacksmith Shop, (19) West's Boiler Shop,

**SOURCE:** Joan Mattie, Architectural History Branch

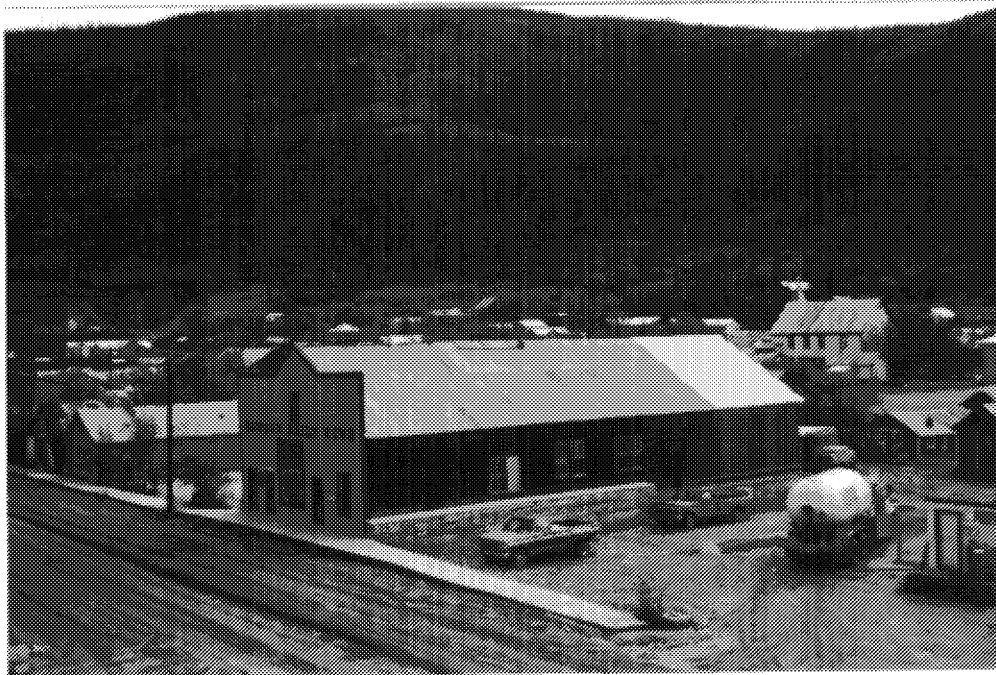
- 1 Dawson Daily News, 123 Third Ave., Dawson, Yukon; constructed in 1901 as a warehouse; converted to newspaper plant in 1910; aerial view from southwest. (Joan Mattie, Architectural History Branch, Environment Canada - Canadian Parks Service [hereafter cited as J. Mattie, AHB, EC-CPS], 1988.))

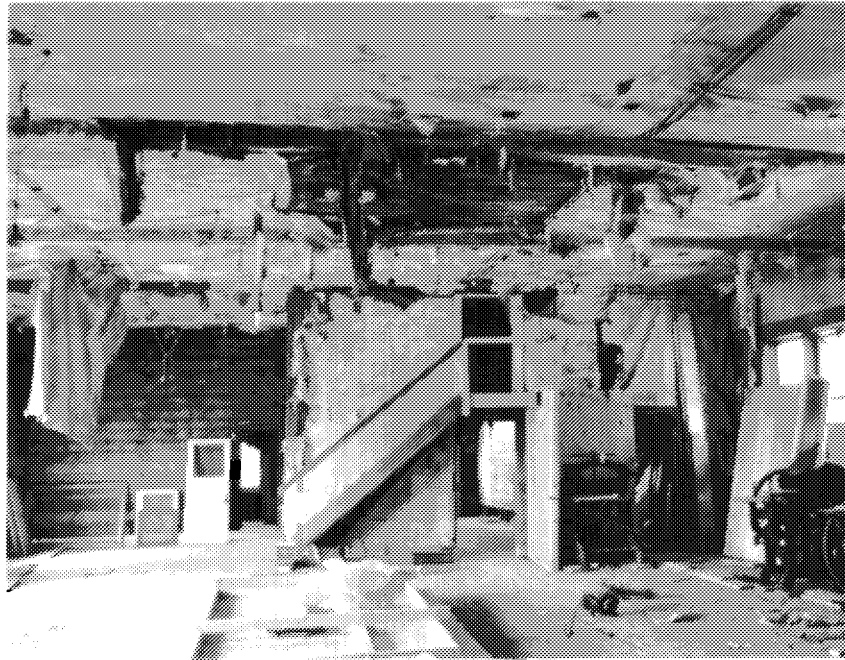
- 3 Dawson Daily News; interior view from print shop area toward front offices and stairs leading to mezzanine room. (J. Mattie, AHB, EC-CPS, 1988.)

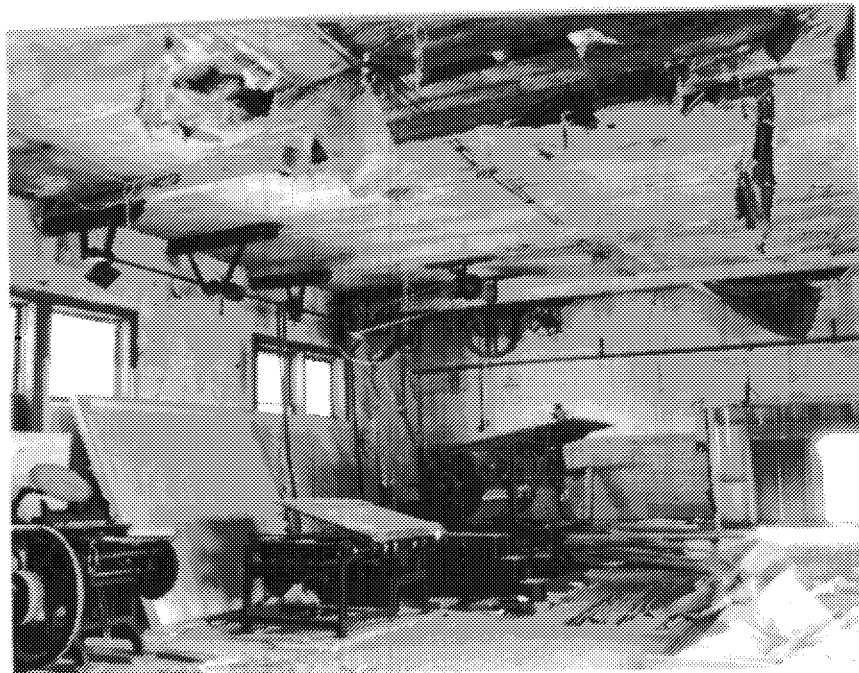
- 4 Dawson Daily News; interior view, print shop. (J. Mattie, AHB, EC-CPS, 1988.)

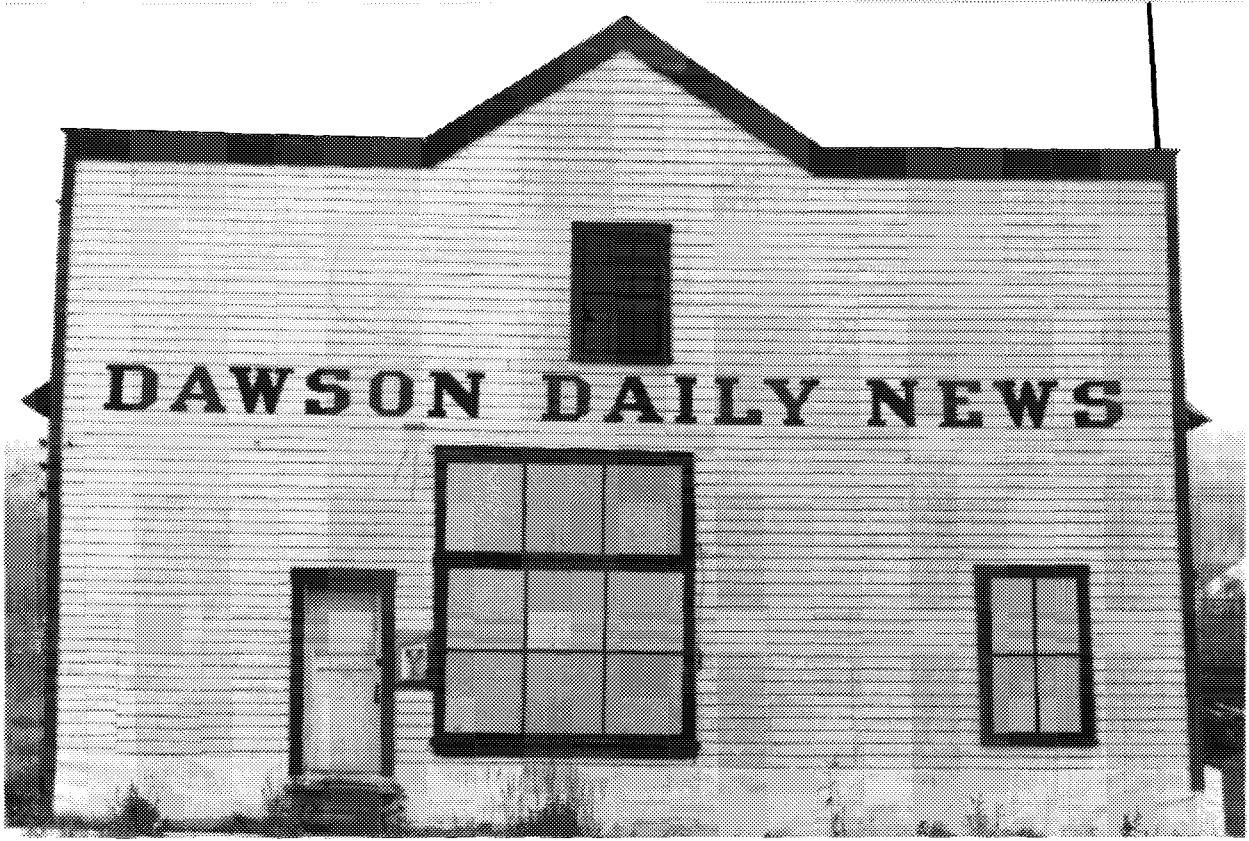
9 Dawson Daily News before restoration of the facade.  
(Canadian Inventory of Historic Buildings, Environment  
Canada - Canadian Parks Service [hereafter cited as CIHB,  
EC-CPS], 1973.)

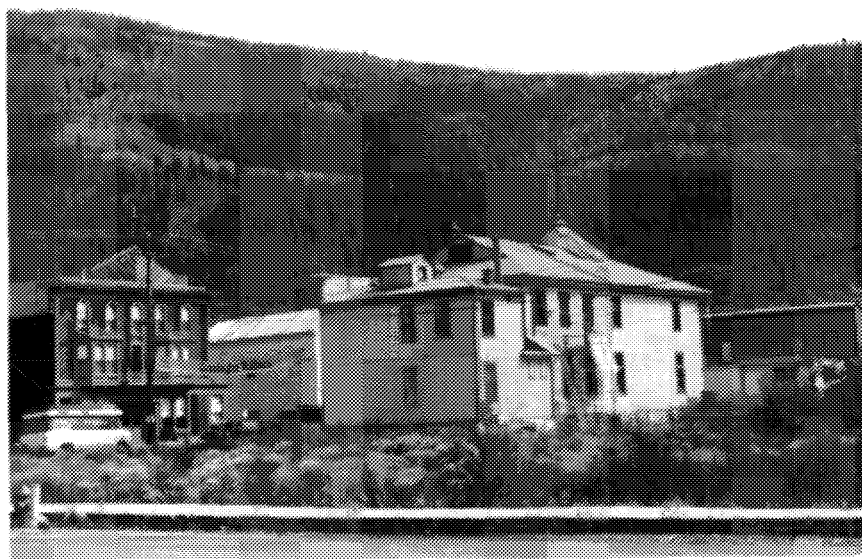
- 4 Rear view of Telegraph Annex and Post Office from Second Ave. (J. Mattie, AHB, EC-CPS, 1988.)

The Telegraph Annex and Post Office occupy all but the southerly eight feet in width of the lot at the corner of King Street and Third Avenue. The unoccupied portion was acquired on the recommendation of Fuller in 1901 to provide some insurance against the spread of fire<sup>23</sup> - a grave concern in Dawson in view of two conflagrations that had virtually wiped out the business district in the winters of 1897-98 and 1898-99. The ground floor of the Annex is contemporary with the main building, while the second storey addition and conversion to a telegraph office came about in 1902. This expansion and change to a new function did not alter the site configuration significantly, but it did have considerable impact on the building's relationship to the street. Although still set back some 3.2 metres from the boardwalk, the Annex was accorded a new prominence both in visibility and in use. Visibility has increased even more with the disappearance of the neighbouring buildings west along King Street, leaving a weed-filled vacant lot (Figure 4).

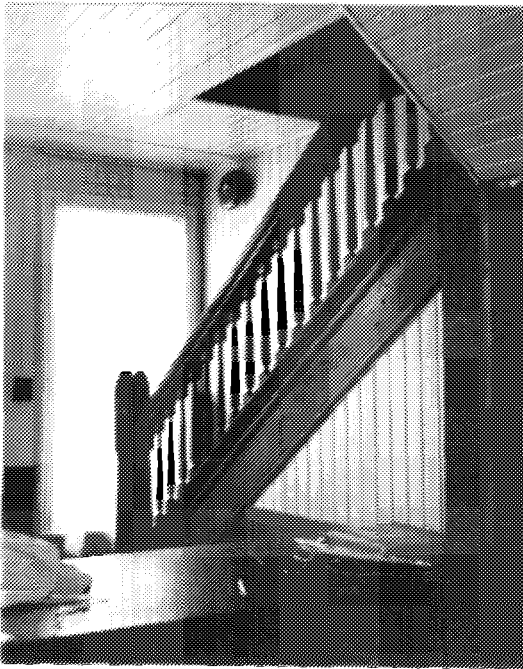
- 7 Telegraph Annex; ground floor interior view looking toward front window and stairs (left); partial view of stairs, pressed tin wall cladding in stove area, and doorway leading to Post Office (right). (J. Mattie, AHB, EC-CPS, 1988.)

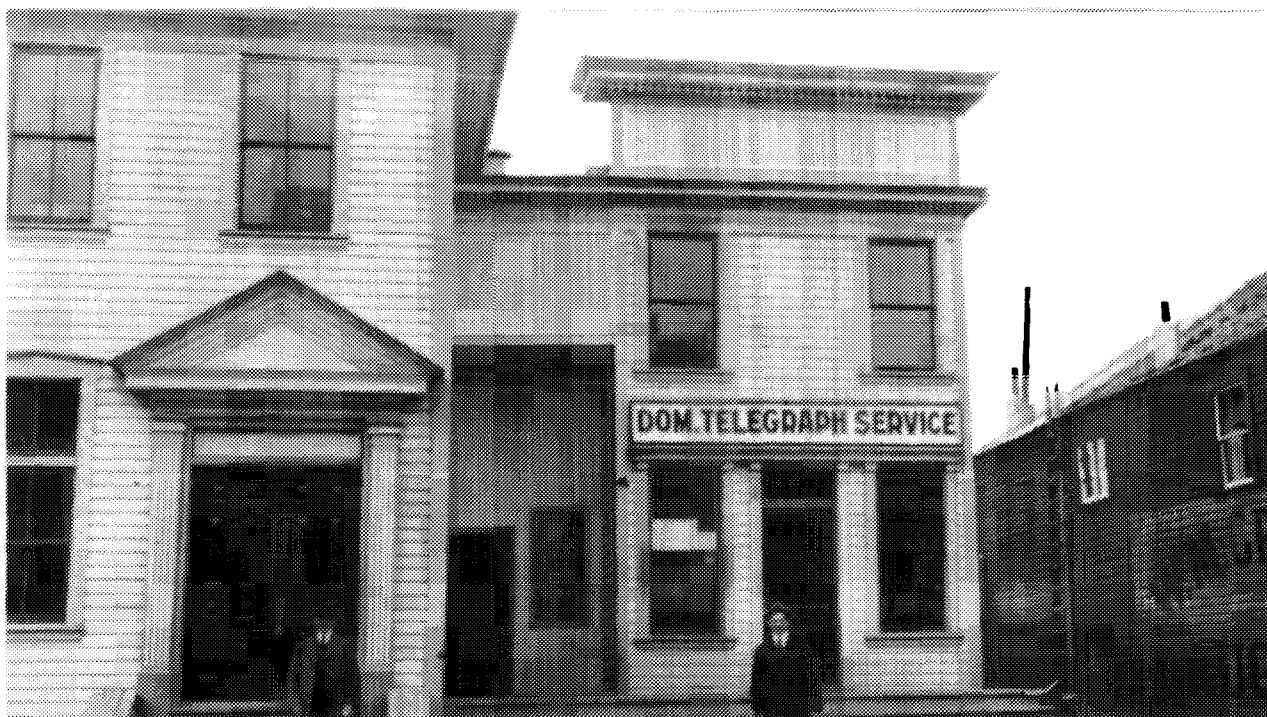
11 Telegraph Annex attached to Post Office, ca. 1902. (NA/AN PA100456.)

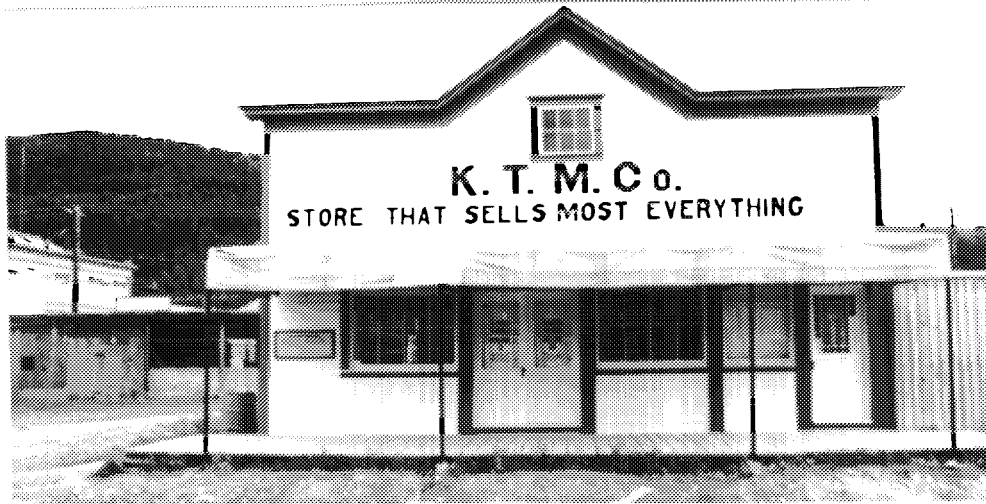
- 1 K.T.M. Building, Third Ave. north of Princess, Dawson, Yukon; constructed in 1899 as a warehouse for H.H. Honnen; shopfront spaces were probably installed in 1903 while occupied by M. Rosenthal, wholesale grocer; signage probably in place by 1913 under ownership of the K.T.M. Co. (KNHS, EC-CPS, 1987.)

The K.T.M. Building is a false-fronted storey-and-a-half structure (9.7m x 19.4m) with corrugated iron cladding on its sides and roof (Figures 1, 3). Probably constructed in 1899, it was in poor condition when Parks began restoration in 1979. So many components had to be replaced, in fact, that very little of the original fabric remains. During renovations, cases for window displays oriented to pedestrians on the street were created in the front room, formerly a shop front. Behind this, a large space was fitted with shelving and climate controls for KNHS artifact storage. Current plans call for a more public use of the building - something reasonably compatible with its long-term use as a warehouse of the K.T.M. Company. For this association with one of the Klondike's most important mining service businesses, the building was put on HSMBC's high-priority "A" List in 1967 and thus has the status of a National Historic Site. The FHBRO board, however, may want to consider if this largely reconstructed building is in effect less than 40 years old and not eligible for evaluation.

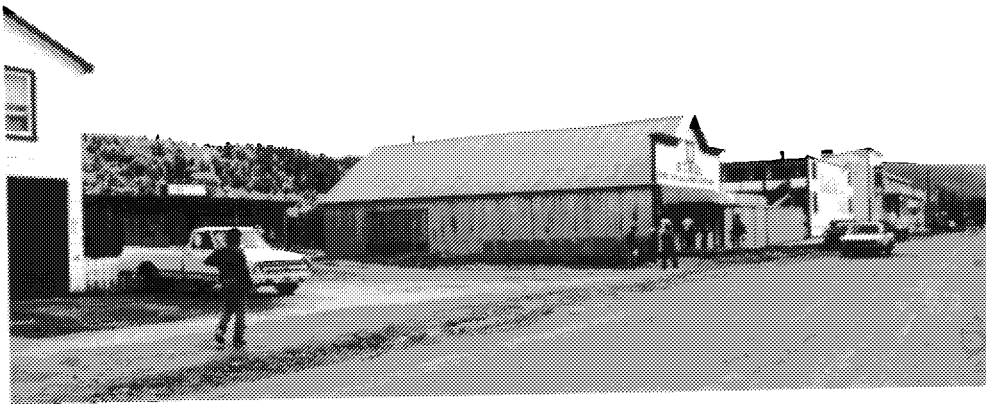
- 3 Three views of K.T.M. Building: north side and façade fronting Third Ave. between Queen and Princess streets (top); south side from parking lot of Eldorado Hotel (middle); north side from former fire hall (bottom). (KNHS, EC-CPS, 1987.)

The false front with horizontal wood siding was in place by 1904. By 1905, fire inspection reports indicated that the vertical boards on the north and south sides were covered in corrugated iron (compare Figures 3 and 4). This material found favour in Dawson, presumably for its low cost, ease of handling, fire retardant qualities, and effectiveness against the weather. The K.T.M. Company seems to have done little to change the building except to have its own sign painted on the façade.

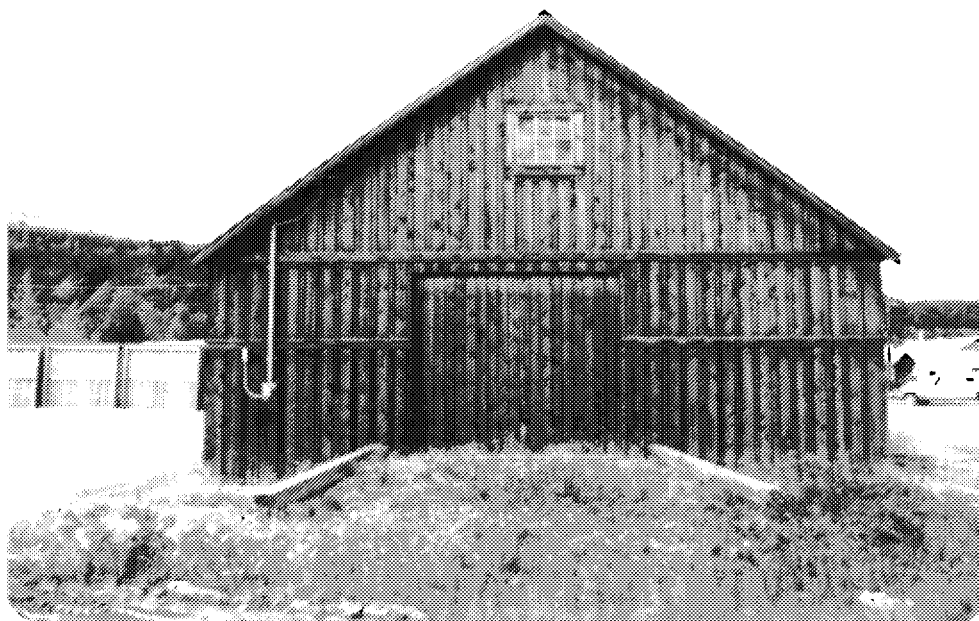
4 Rear view of K.T.M. Building. (KNHS, EC-CPS, 1987.)

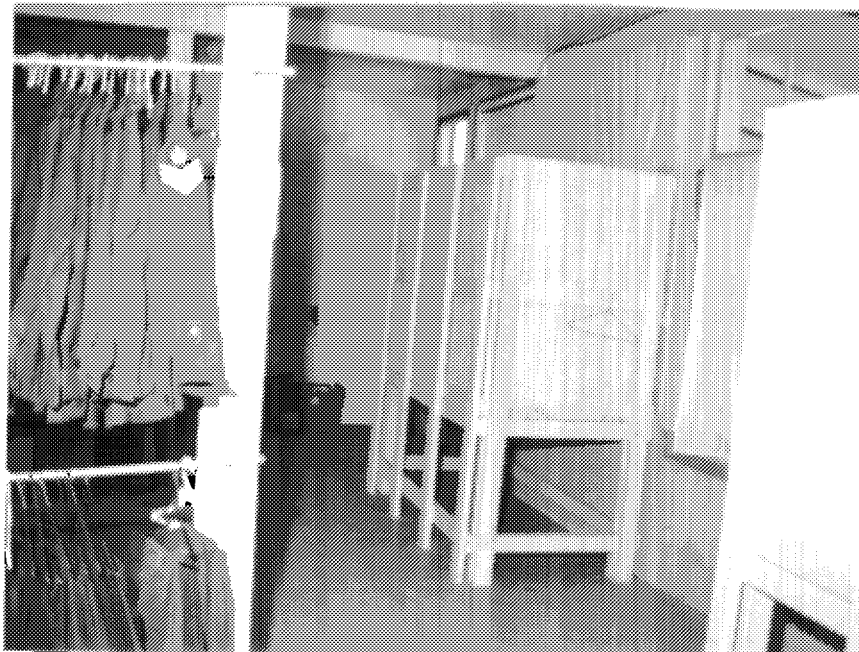
- 7 K.T.M. Building; interior view of front room. Note cases for front window displays (right). (KNHS, EC-CPS, 1988.)

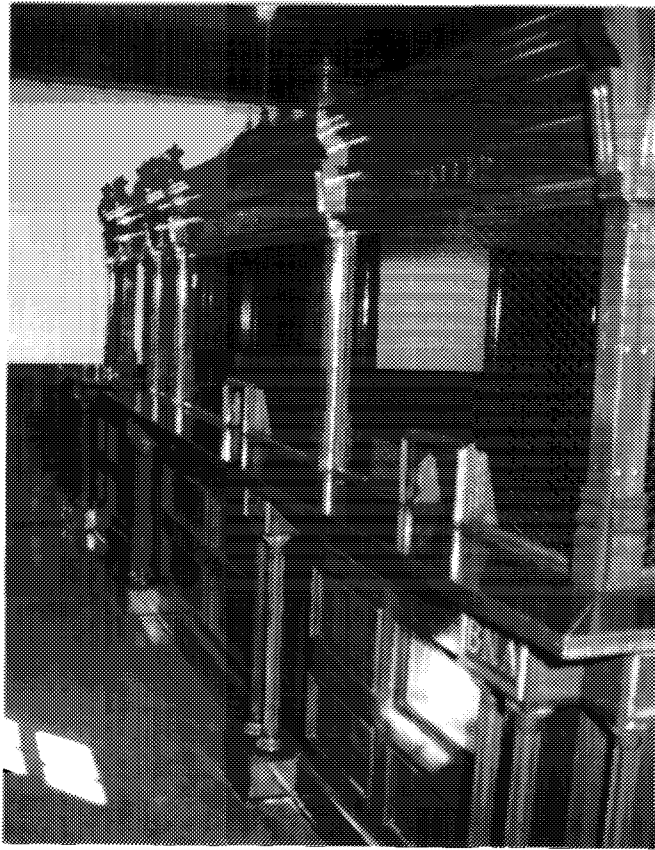
5 Bank of B.N.A.; banking counter looking south. (KNHS, EC-CPS, 1988.)

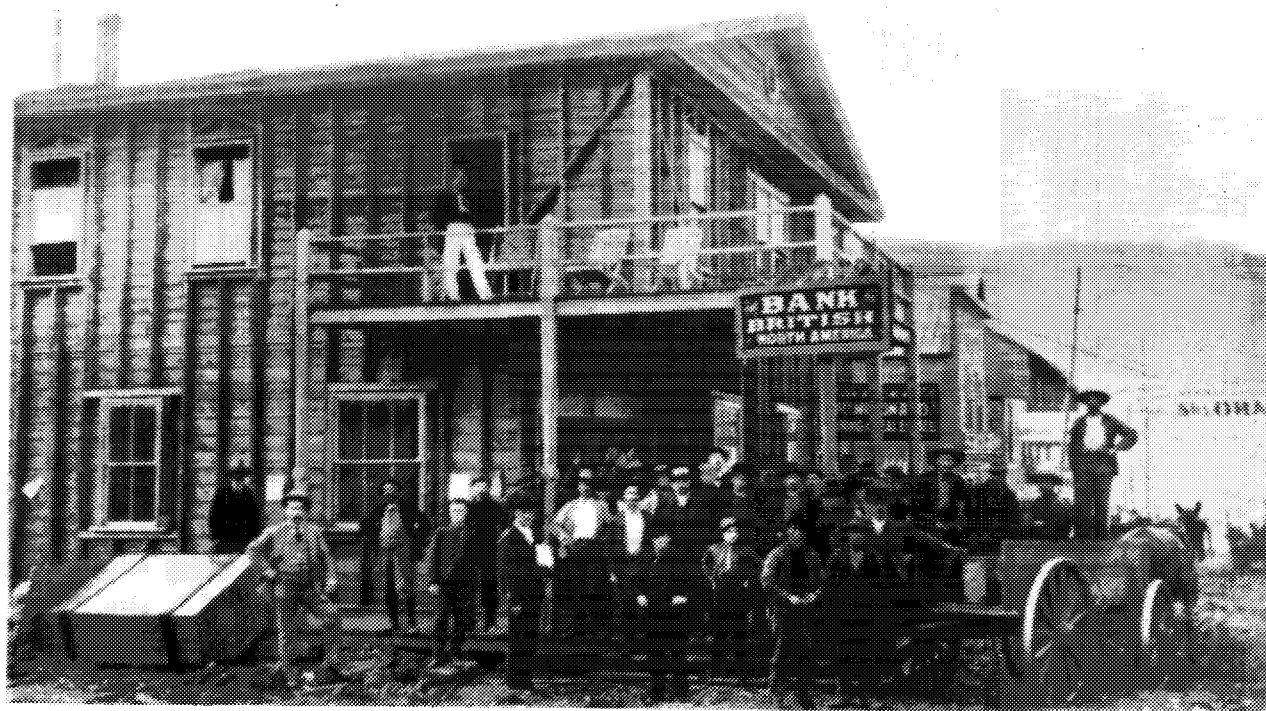
18 Bank of B.N.A. under construction in 1900. (NA/AN - C53169.)

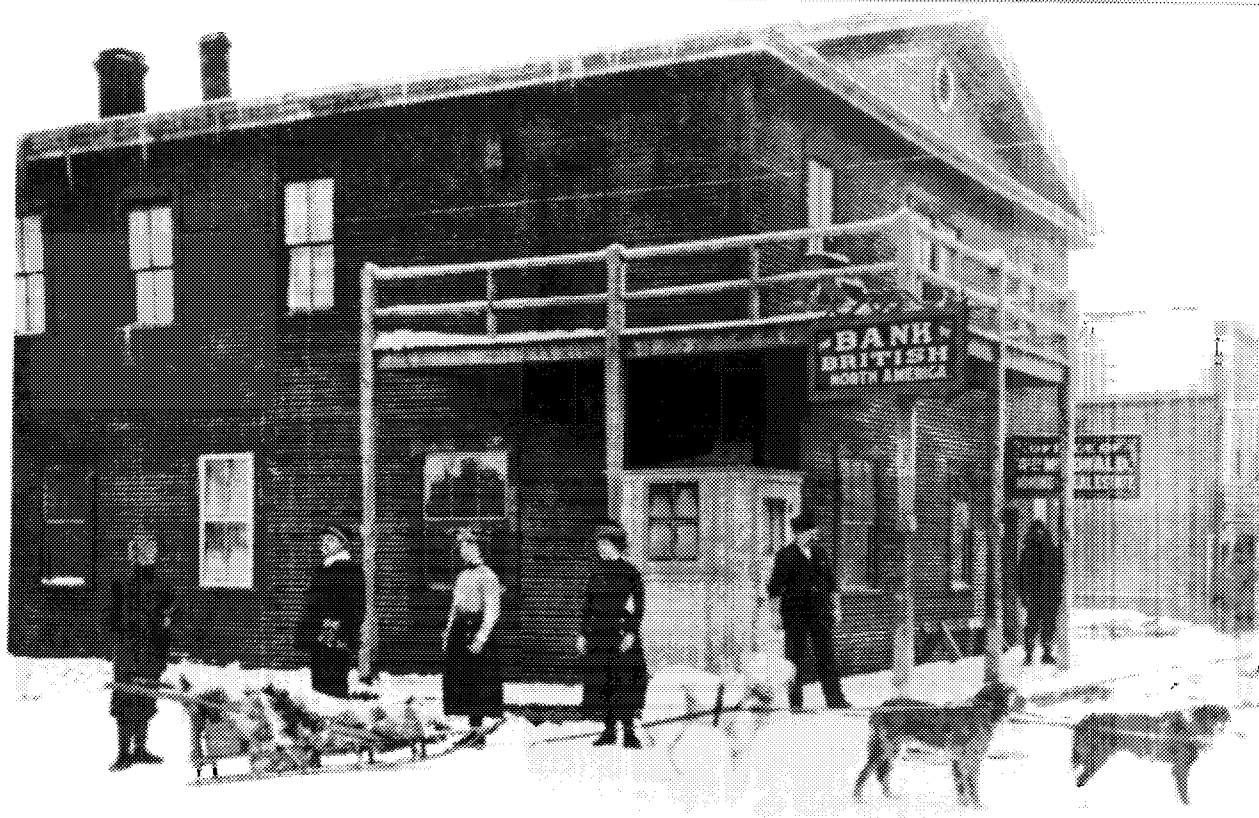
19 Bank of B.N.A., probably in winter of 1900-01; removeable winter porch is in place, but metal shutters have not yet been hung, and bottom portion of corrugated iron has not yet been painted in a darker shade of grey. (NA/AN - C53172.)

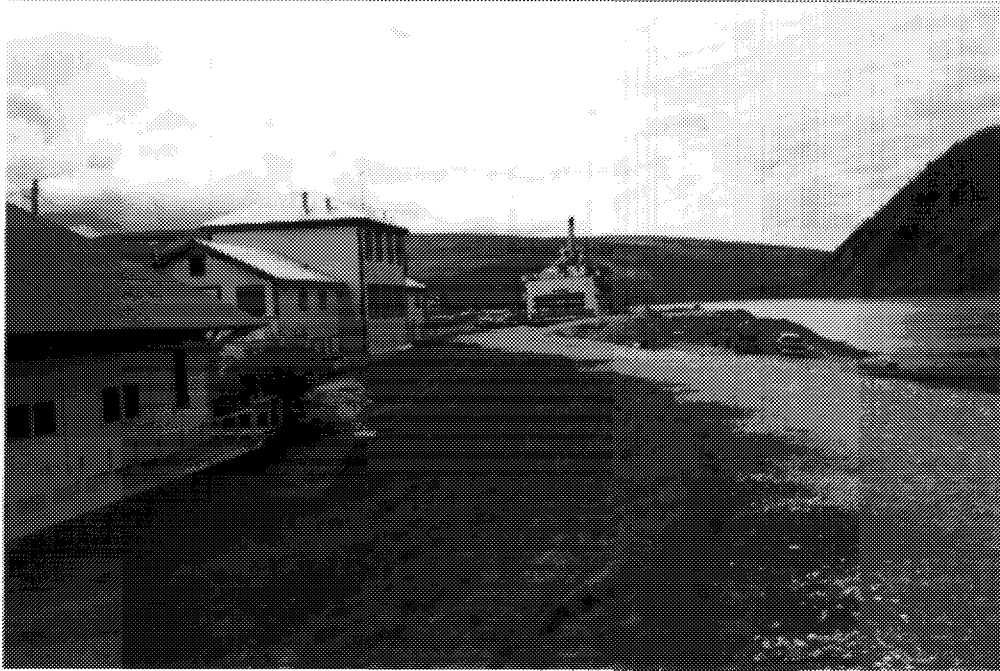
- 9 Dawson waterfront looking south, showing 1987 dike (centre and right); B.Y.N. Ticket Office (left); S.S. Keno (centre). (J. Mattie, AHB, EC-CPS, 1987.)

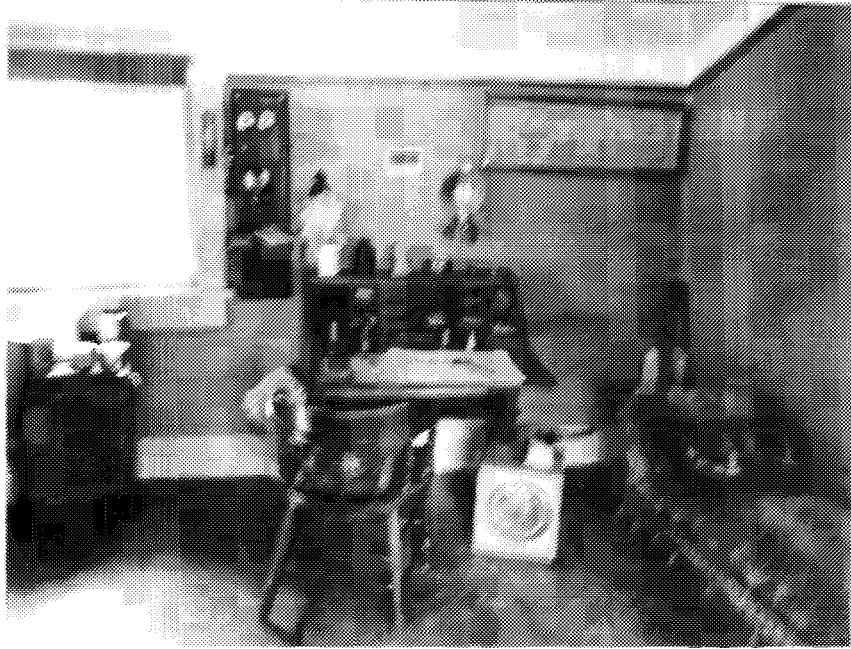
7 Robert Service cabin interior, north side of large front room. (J. Mattie, EC-CPS, AHB, 1988.)

The cabin's interior (Figures 7-9) has been described in great detail by Service and others - mostly the functional arrangements of furniture, stove, wall hangings, etc. Words and phrases such as "monastic simplicity" and "rustic" have been used to indicate its lack of pretensions. Still, it was cosily furnished and attractively decorated with photographs and penned mottoes - typical of the times, but perhaps somewhat less cluttered than other cabin interiors. When Service returned to Dawson after a trip outside in the summer of 1911, he was glad to be back in his

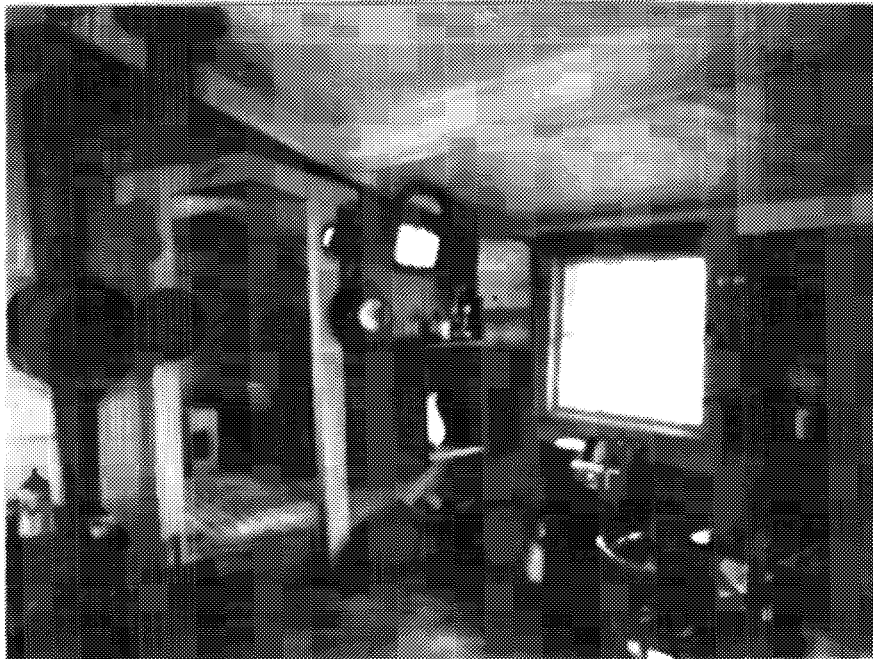
8 Robert Service cabin interior, south side of large front room. (J. Mattie, EC-CPS, AHB, 1988.)

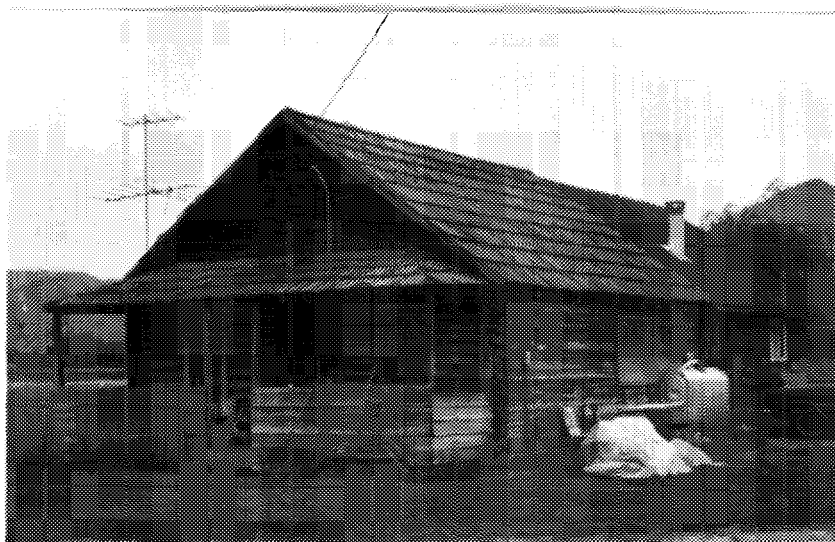
15 Log cabin, Grand Forks, British Columbia; built ca. 1914.  
(EC-CPS, CIHB, 1975.)

The article, which includes more detail than noted here, could easily be applied to the Robert Service cabin, illustrating how typical it was of its type (for others in the genre see Figures 14, 15, and 16).

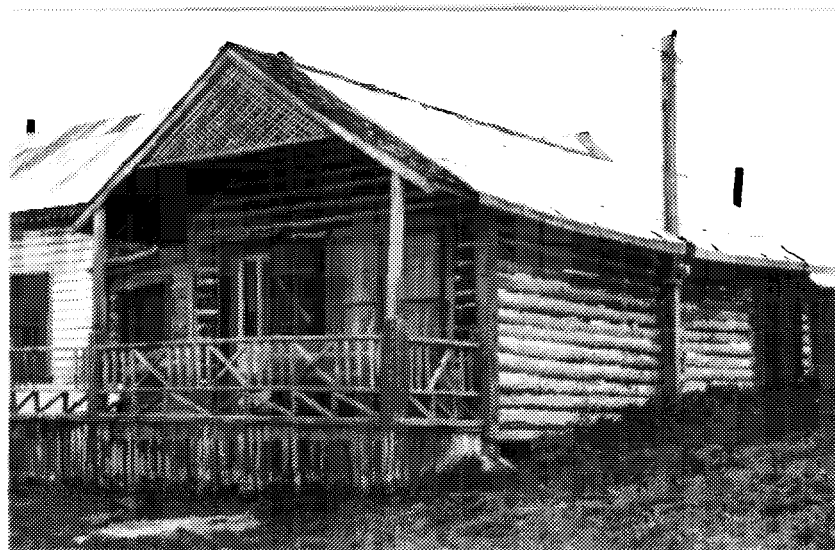
16 Log cabin, Atlin, British Columbia, built ca. 1910.  
(EC-CPS, CIHB, 1976.)

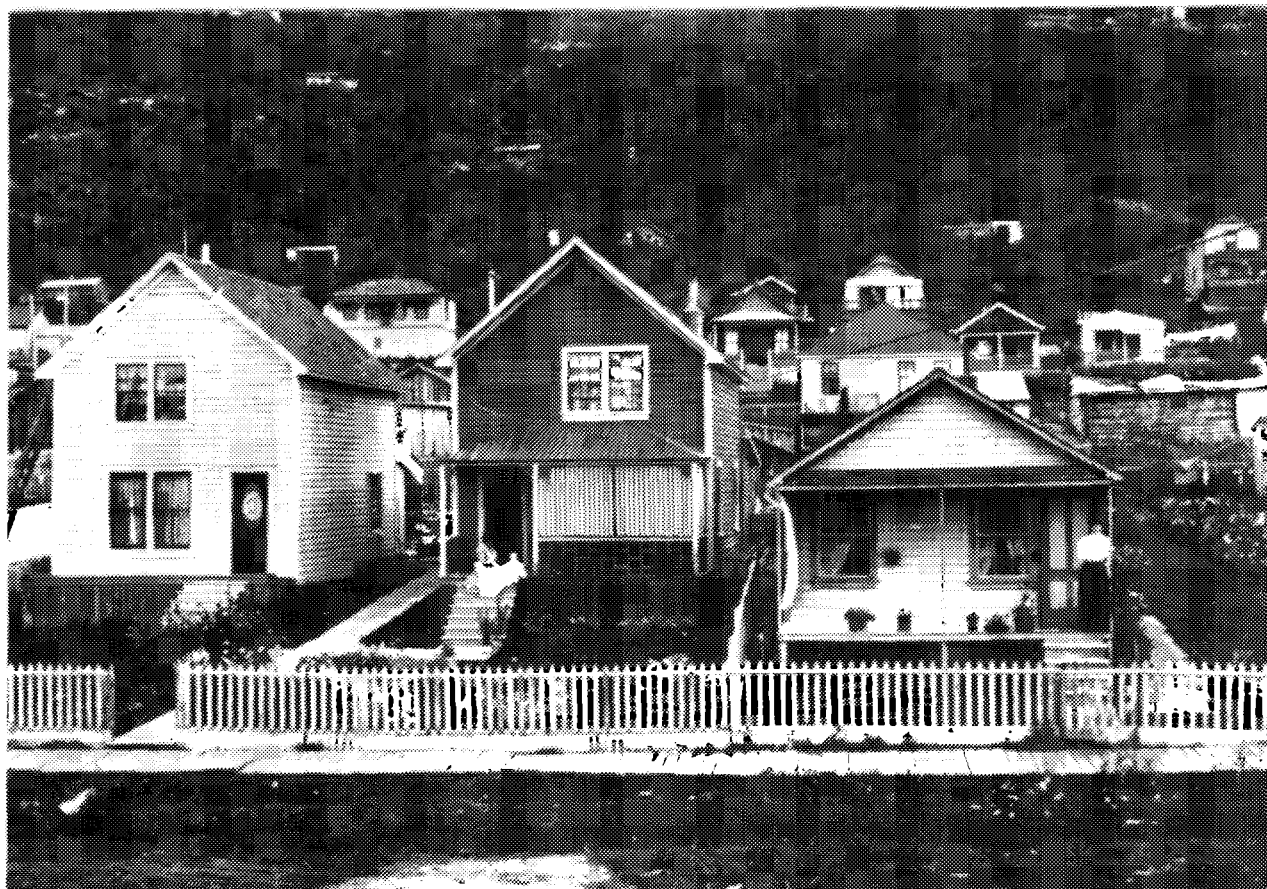
- 17 Frame houses in Dawson, probably Fifth Ave., ca. 1905. Some show general form of Robert Service cabin with gable front facing the street and simple verandah across the façade. (NA/AN, PA-20547.)

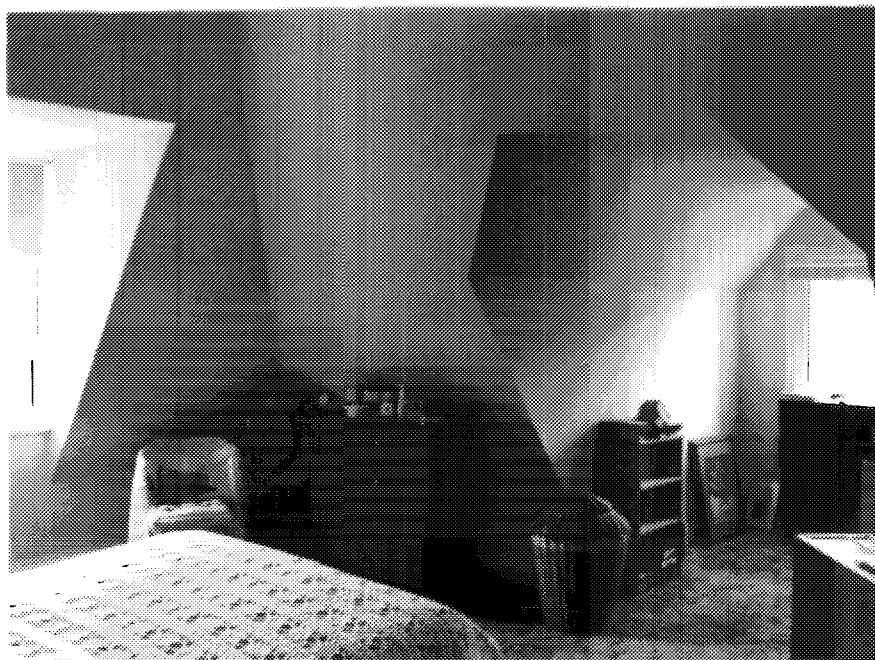
7 St. Andrew's Manse; upstairs bedroom. (J. Mattie, EC-CPS, AHB, 1988.)

Upstairs, there are three bedrooms (Figure 7), a storage room and a bathroom, all modernized by CPS with new materials. A full basement has also been created - apparently the only one in Dawson. Made possible by adequate drainage on this particular site, and by the absence of permafrost, it has pressure-treated wooden walls and is well insulated so as to be fully useable.

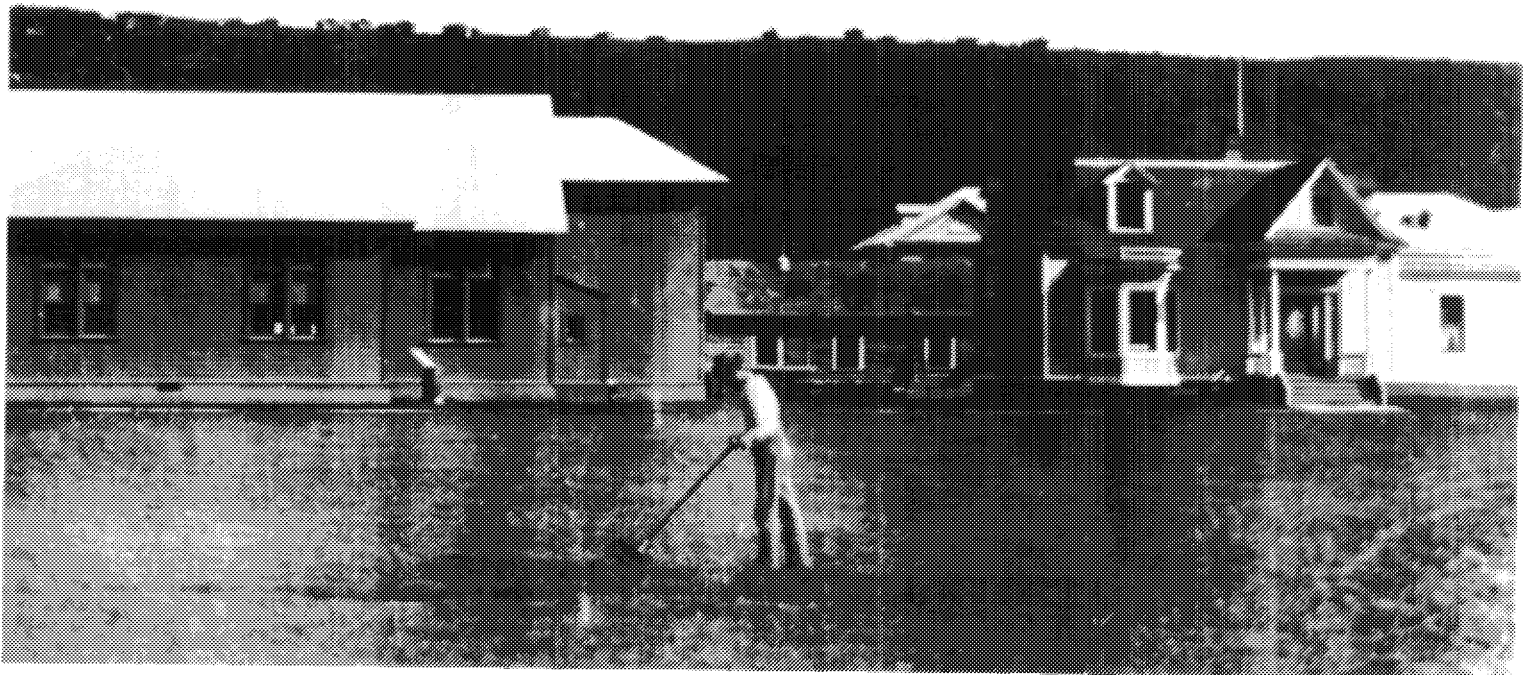
13 St. Andrew's Manse (right); St. Andrew's Church (left); log building behind the two is the former church, at this time used as a church hall; behind the manse (both left and right of it) is the Administration Building on Fifth Ave. View from west, ca. 1910. (EC-CPS, HRB, Dawson Photo Collection.)

What remains of the exterior today is a careful restoration done by CPS, with a relatively small amount of new material used to replace deteriorated members. The building now appears little changed from early views of it in historical photographs (Figure 13).

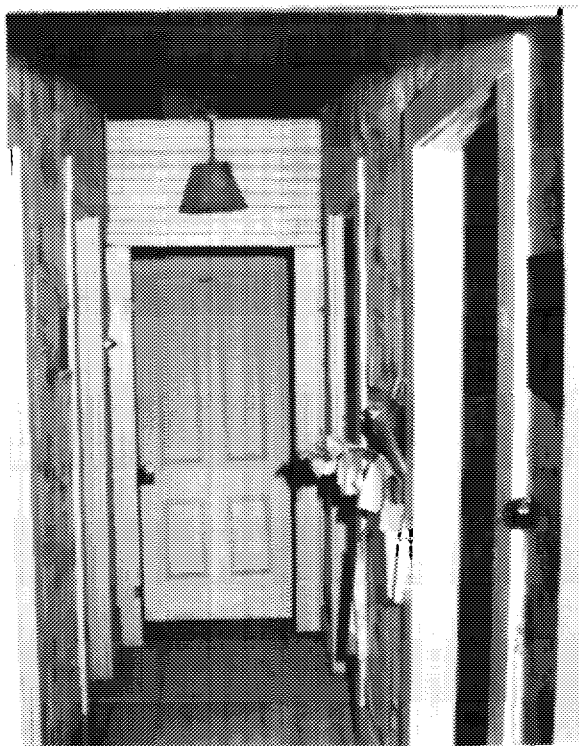
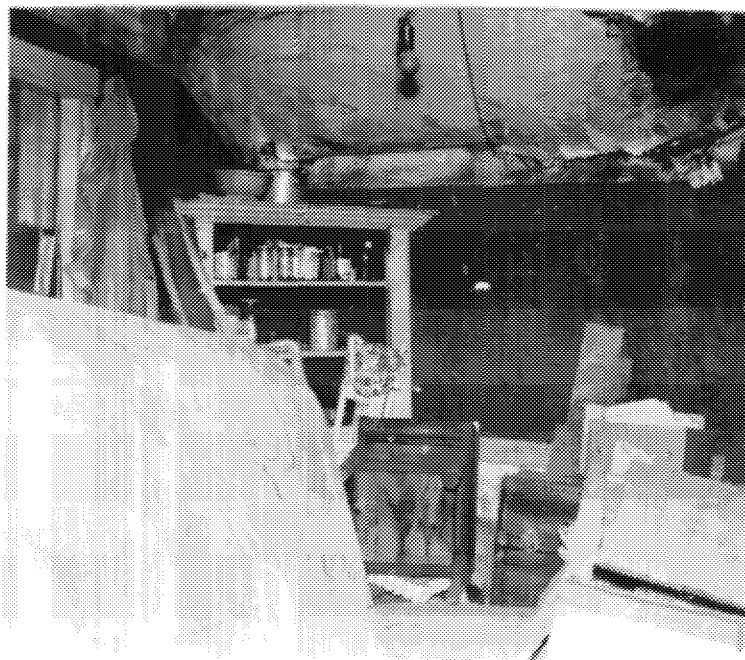
- 5 Ruby's Place; interior views. Upper left: staircase at rear; upper right: doors and windows enclosing oriel window space; lower left: second floor hallway; lower right: interior of one of the cabins. (EC-CPS, KNHS, 1988.)

Although CPS has restored the façade of Ruby's, it has only undertaken minimal stabilization measures to maintain the rest of the structure which is in poor condition. Jacks underneath the building have replaced the rotted foundation. Above this, the flooring consists of some new supporting members, some original fabric, and some early renovation materials. This includes (in descending order from interior to exterior crawl space underneath): several layers of linoleum, masonite sheeting, 3/4" rotted planks, 2" x 4" joists, 4 inches of sawdust insulation, asphalt paper, linoleum paper, 3/4" rotted planks again, new 2" x 5" joists, girders and screw jacks<sup>28</sup> - a real mess of partial measures undertaken to preserve this building throughout its history.

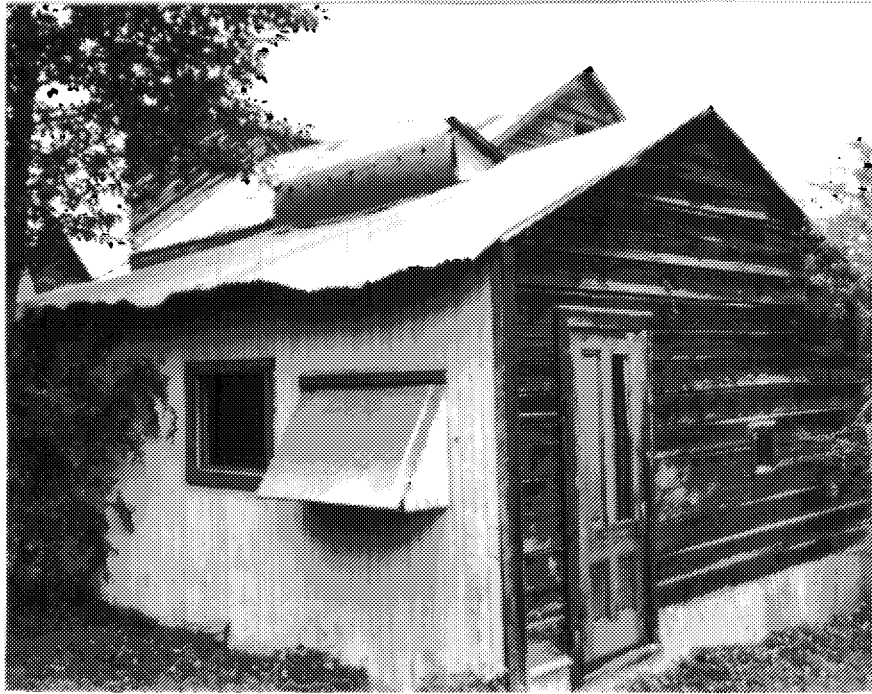
12 Third Ave. Hotel Complex; view of E.O. Ellingsen's photographic studio in south annex. (J. Mattie, EC-CPS, AHB, 1988.)

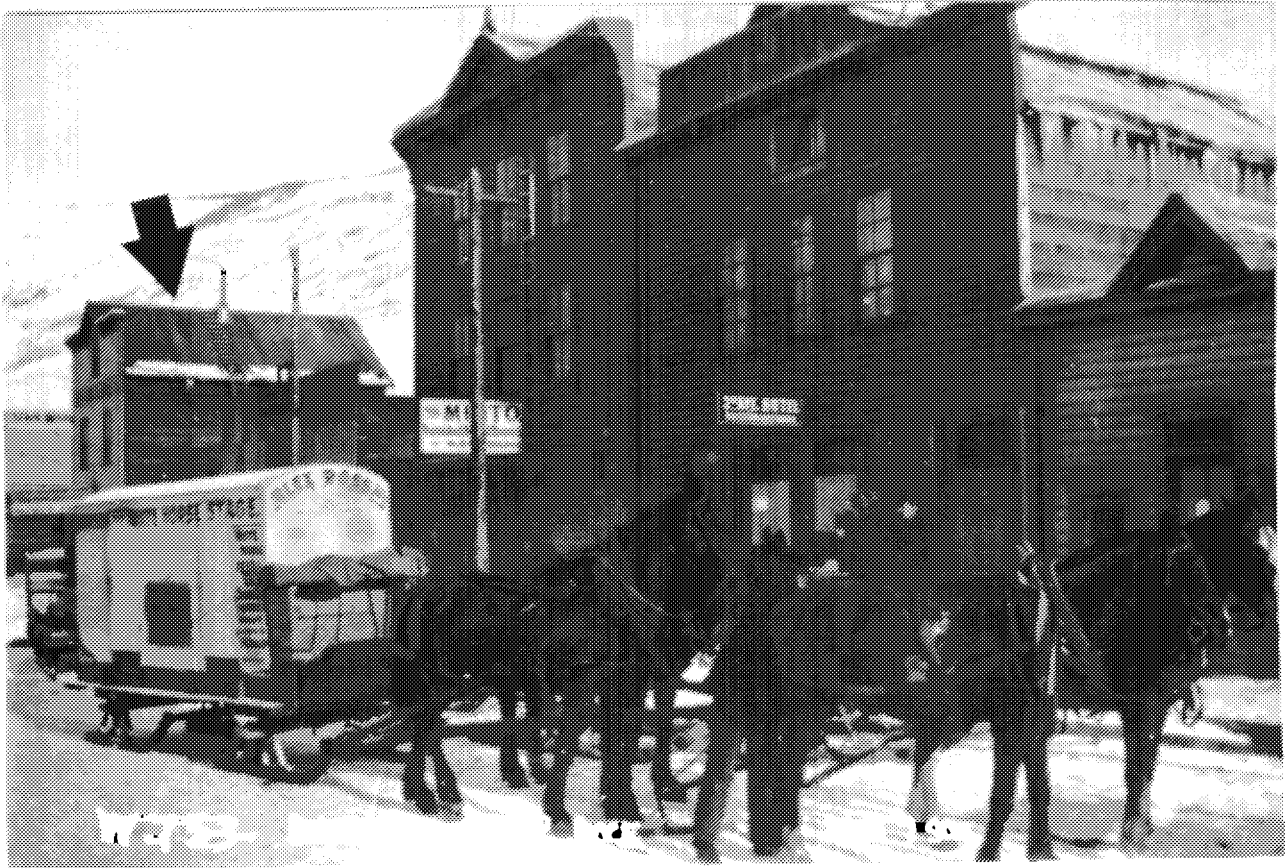
- 15 Third Ave. Hotel Complex, March 1901. Note the 2 1/2 storey hotel building at left (arrow) which was later shortened and became Biggs' Blacksmith Shop (Report No. 18). (NA/AN, PA-16987.)

**The Third Ave. Hotel Complex** was probably built about the same time since it already appears in place in a photograph dated March 1901. This shows the hotel without its extended boomtown front (Figure 15). The two adjacent annexes in this photograph look much as they did in another photograph of 1908 (Figure 17). By this time, the street had become more urban looking with a greater diversity of businesses. These were more oriented to local patronage rather than to the creek trade - not surprising since by this time, corporate mining had replaced the labour-intensive mining previously done by individuals. The number of miners in the region was accordingly reduced. In keeping with the street's newer character, E.O. Ellingsen's photographic studio went into the south annex in 1912, and later expanded into the north one. It remained in business here until 1933. This use of the annexes had replaced three known earlier ones. A blacksmith had the south one until 1904 and a freighter had used it for storage some time after that. A tobacco shop is the first known business to occupy the northern annex. This was between 1902 and 1912, thus bridging the period when Third Avenue was transformed from a freighting district to the time when it became

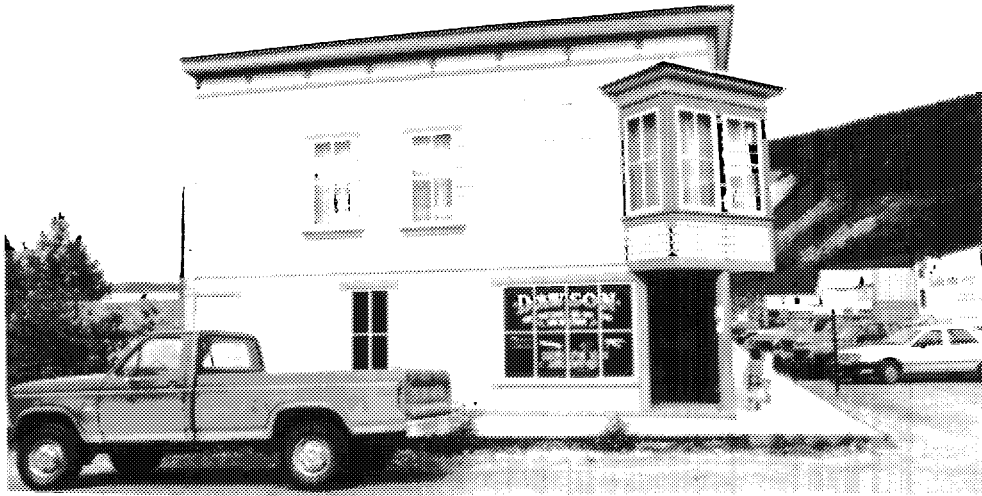
- 19 Harrington's Store, Third Ave. at Princess St., Dawson, Yukon; constructed ca. 1900; view of Princess St. façade and north along Third Ave. (right). (EC-CPS, KNHS, 1987.)

Harrington's square-sided oriel window set in the corner, above the main entrance, is the most awkward-looking but this adds to its particular charm (Figure 19). This building also has very fine double entrance doors which are highly decorative and in amazingly good condition, having been well protected by the

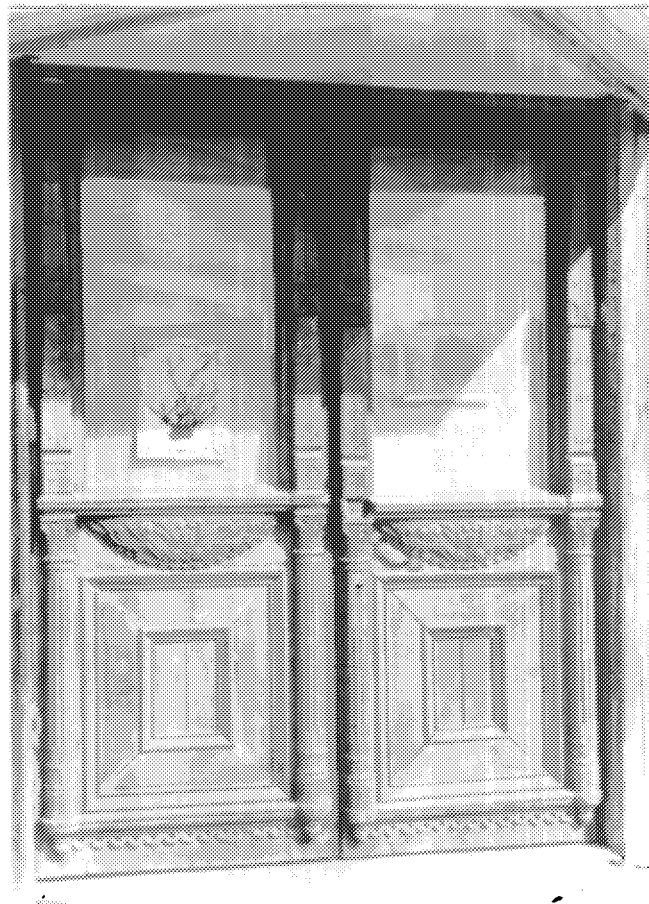
- 22 Harrington's Store; detail of double doors at corner of Third Ave. and Princess St. (AES, PWC, DU, EC-CPS, Chris Grant Photo Collection, 1970.)
