## FEDERAL HERITAGE BUILDINGS REVIEW OFFICE

### BUILDING REPORT 88-12

**TITLE:** Nineteen Dawson buildings: (1) Dawson Daily News, (2) Telegraph Annex, (3) K.T.M. Building, (4) Bank of British North America, (5) B.Y.N. Ticket Office, (6) Robert Service Cabin, (7) Customs House, (8) Macaulay House, (9) Black Residence, (10) Commanding Officer's Residence, (11) St. Andrew's Manse, (12) St. Andrew's Church, (13) Ruby's Place, (14) Third Avenue Hotel Complex, (15) Harrington's Store, (16) Mme. Tremblay's Store, (17) N.C. Company Warehouse, (18) Bigg's Blacksmith Shop, (19) West's Boiler Shop,

**SOURCE:** Joan Mattie, Architectural History Branch

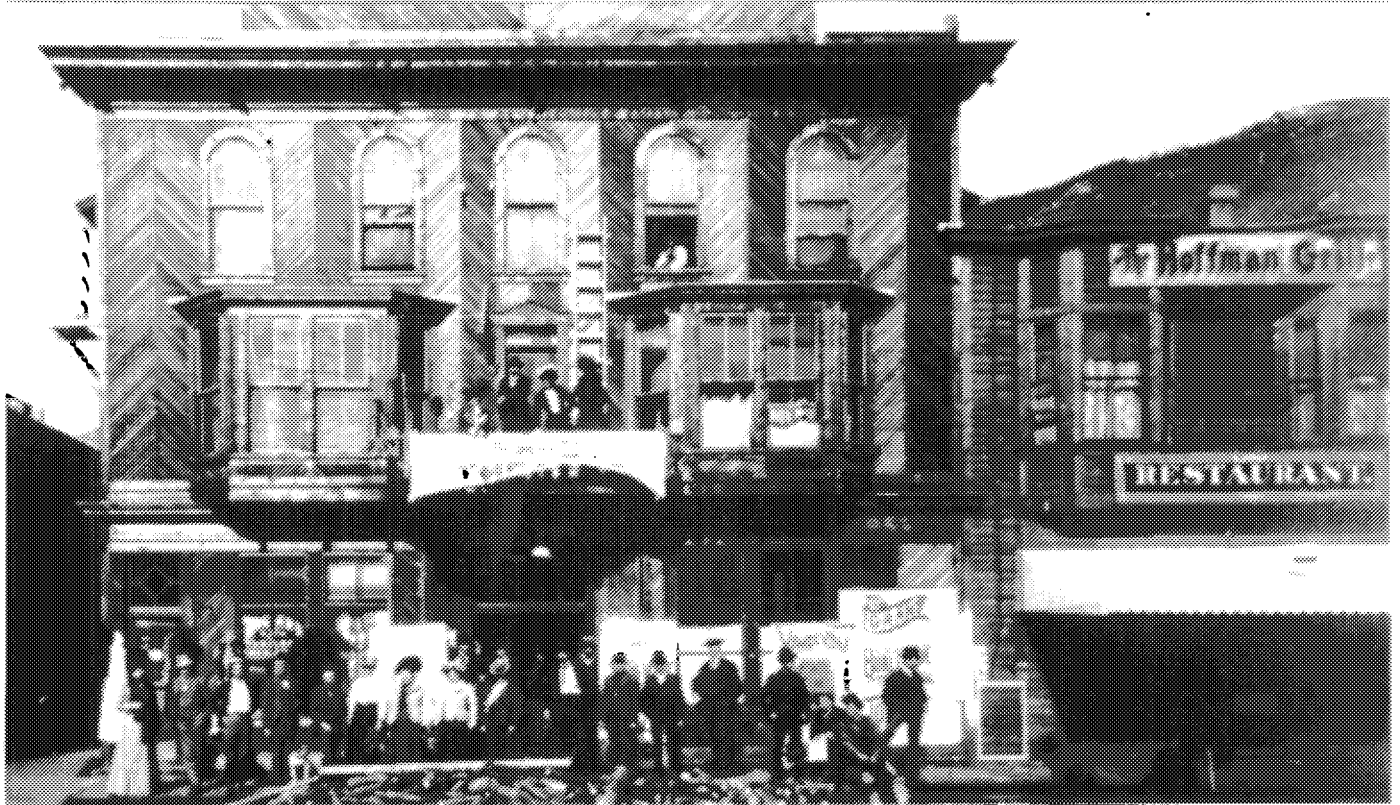
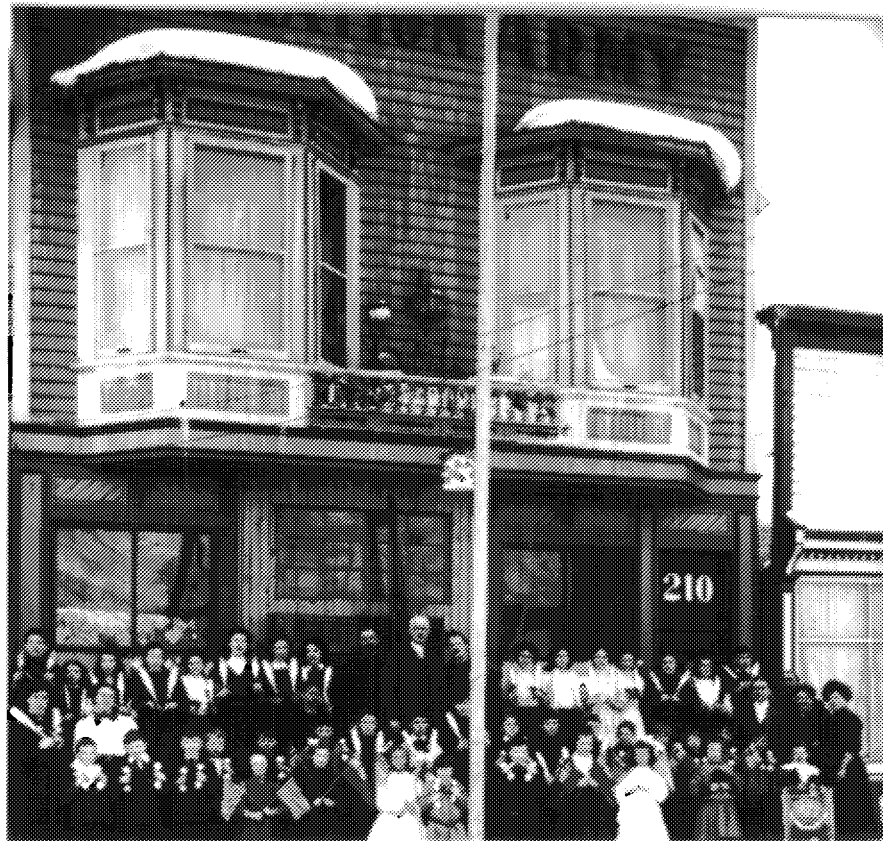
- 38 Photographs showing three of the many other oriel-windowed buildings in early Dawson. Palace Grand Theatre (formerly the Savoy) (upper left); commercial building (upper right), King Street; both constructed ca. 1899; view in 1901. (EC-CPS, HRB, Dawson Photo Collection). Salvation Army Building [Front Street] (lower photo); constructed ca. 1899. (NA/AN, PA-13302.)

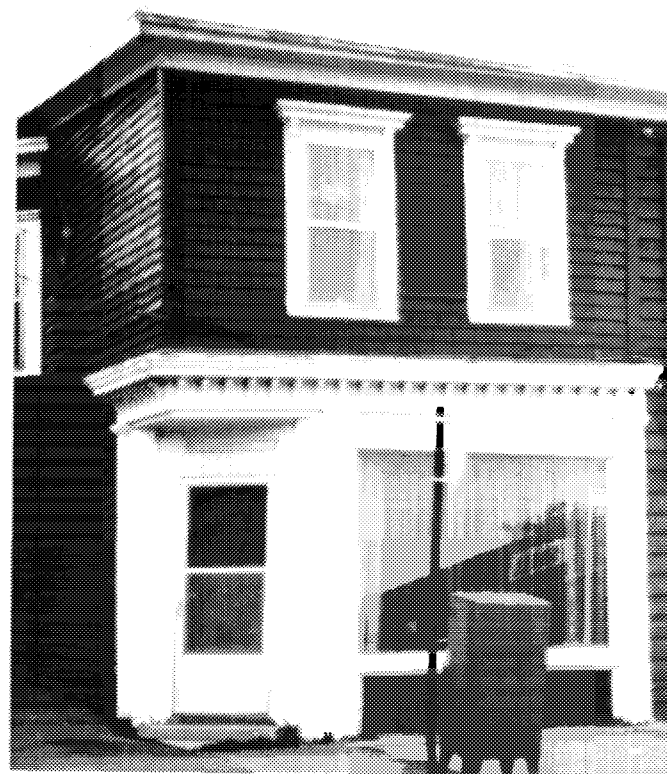
- 39 Building at 141-143 Rodney St., Saint John, New Brunswick; constructed ca. 1900; oriel window in left photo is partially visible in photograph of façade (right). (EC-CPS, CIHB, 1979.)

Few other examples of Canadian wooden structures with oriel windows have been found in the CIHB inventory. Of those 14 that did come to light, most are houses. Two commercial buildings - both at Saint John, New Brunswick (Figures 39, 40) - are among the rare urban ones that show any relationship at all to the Dawson examples, although they lack the boomtown façades so characteristic of the West.

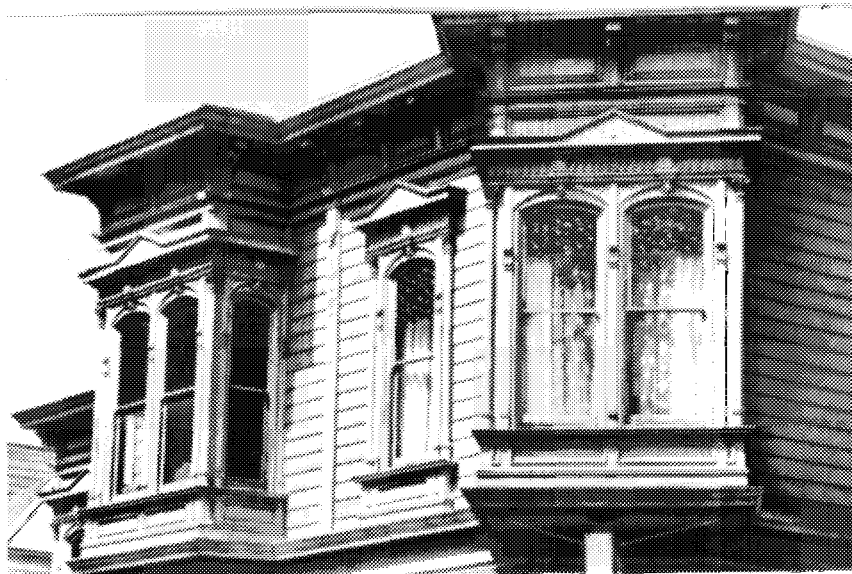
- 42 Building with oriel windows at 802 Page St., San Francisco, California; constructed ca. 1906. (Great Houses . . ., p. 112.)

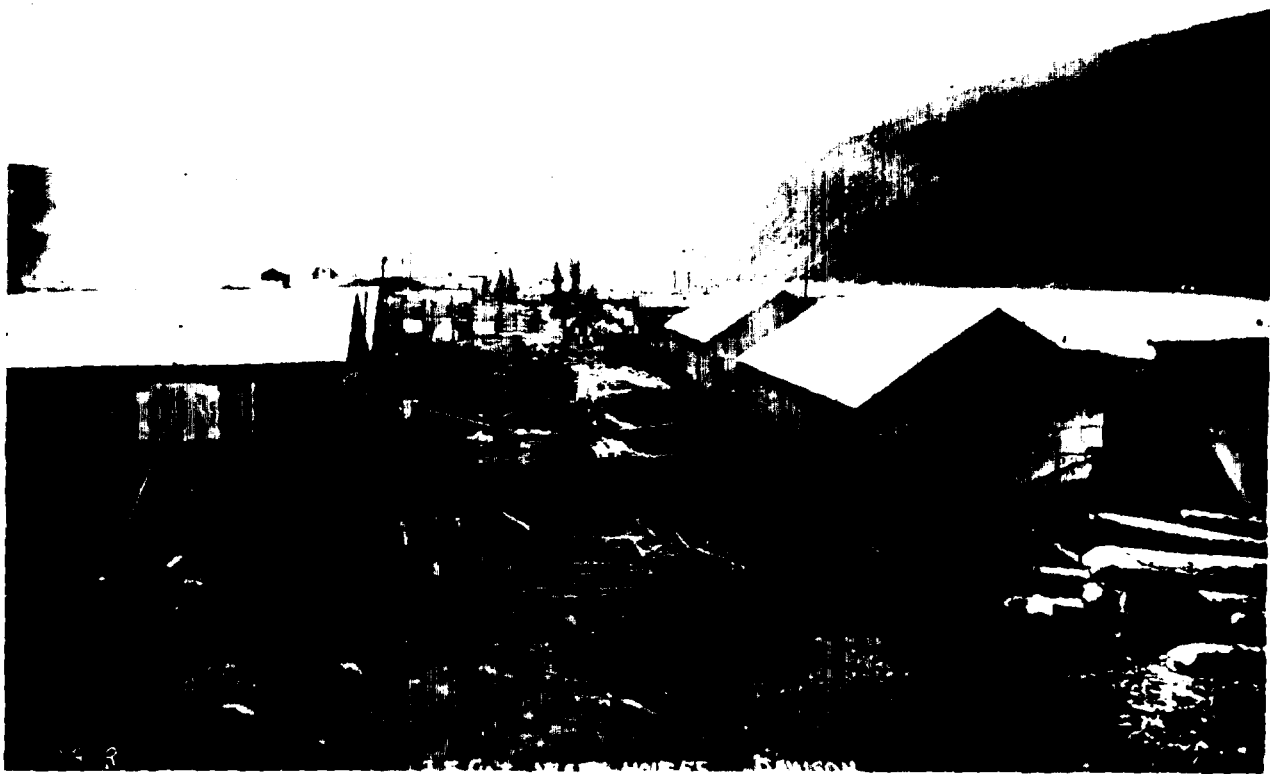
15 Warehouses being erected for the Alaska Exploration Co. in Dawson, ca. 1898. (NA/AN, PA-13298.)

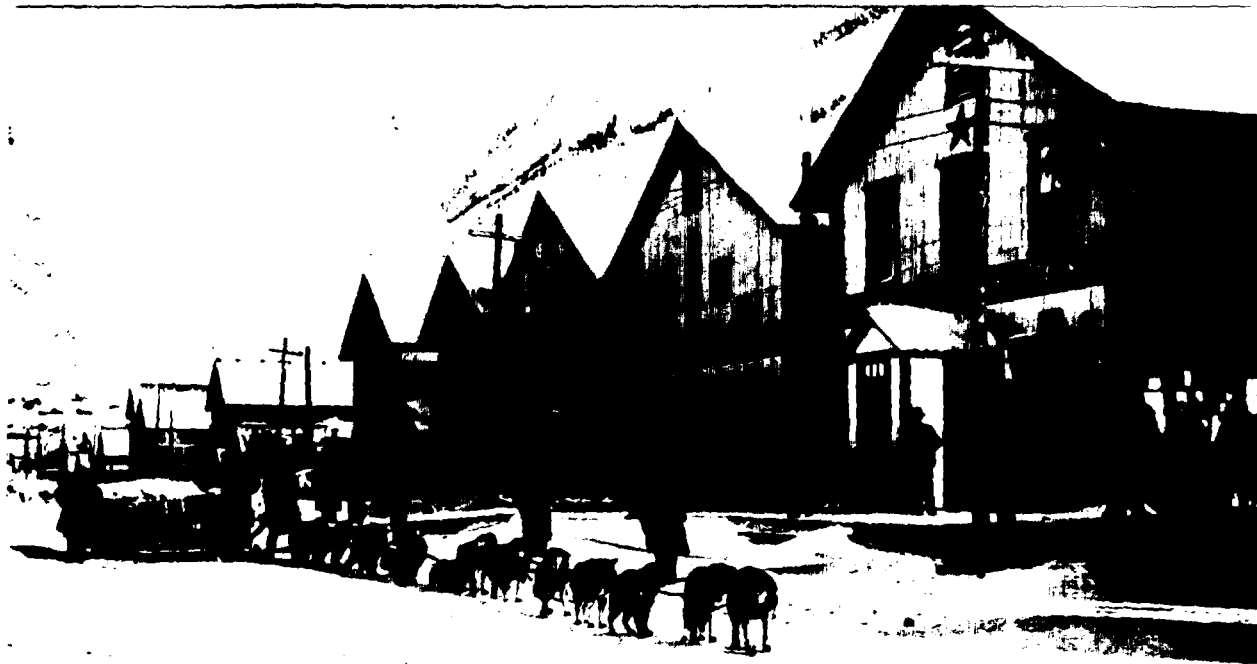
16 North American Transportation and Trading Co. warehouses in Dawson, just north of the N.C. Co. retail store and warehouses, Front St. north of King, ca. 1900. (NA/AN, C22344.)

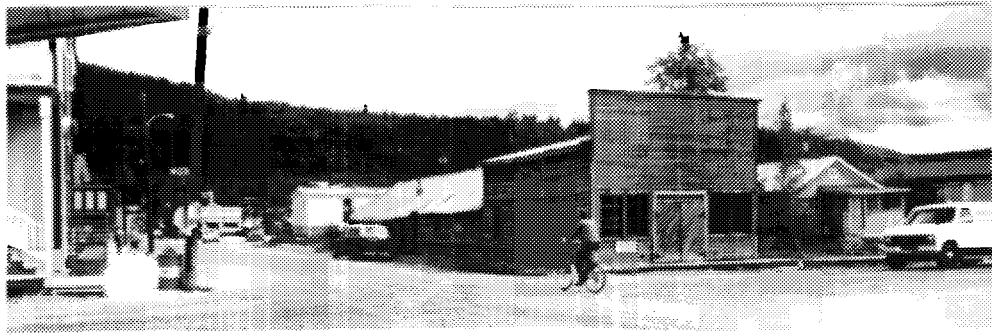
- 1 Biggs' Blacksmith Shop, Third Ave. at Princess St., Dawson, Yukon; front portion constructed in 1899 as the Great Northern Hotel; rear annexes appended in 1913; view from Harrington's Store on north west corner of intersection, 1987. (EC-CPS, KNHS, 1987.)

When HSMBC made up its "A" List (buildings to be acquired and restored at Dawson) it simply specified "a blacksmith shop." At the time, two were available and subsequently purchased. Of these, Biggs' was in far better condition than the Third Avenue Blacksmith Shop (now a ruin)<sup>1</sup> and so has become "the blacksmith shop" of KNHS (Figures 1, 2).

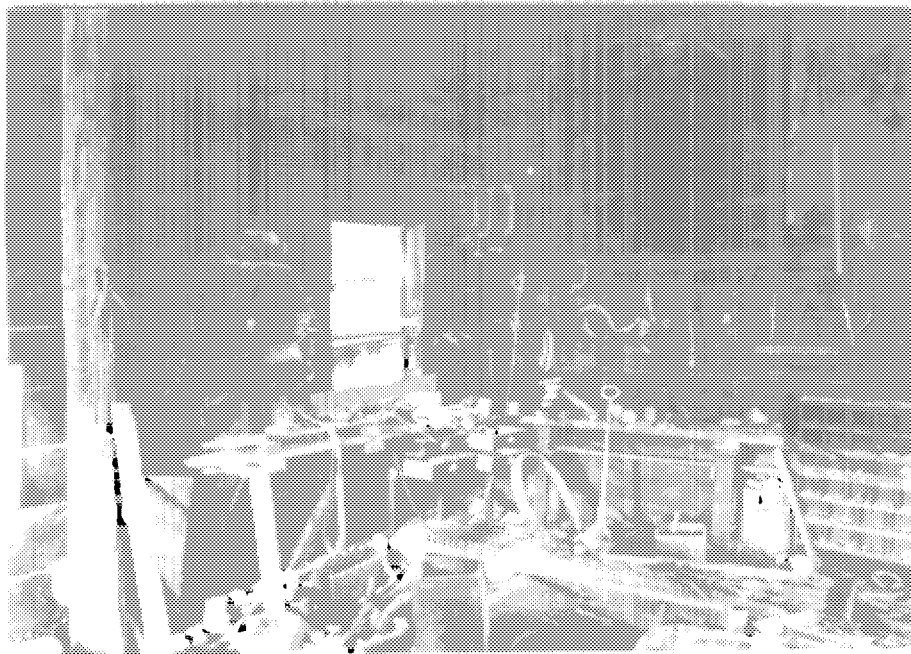
- 9 Biggs' Blacksmith Shop; interior "as found" condition showing some of the in situ artifacts acquired by KNHS in 1970. (Grant, 1970.)

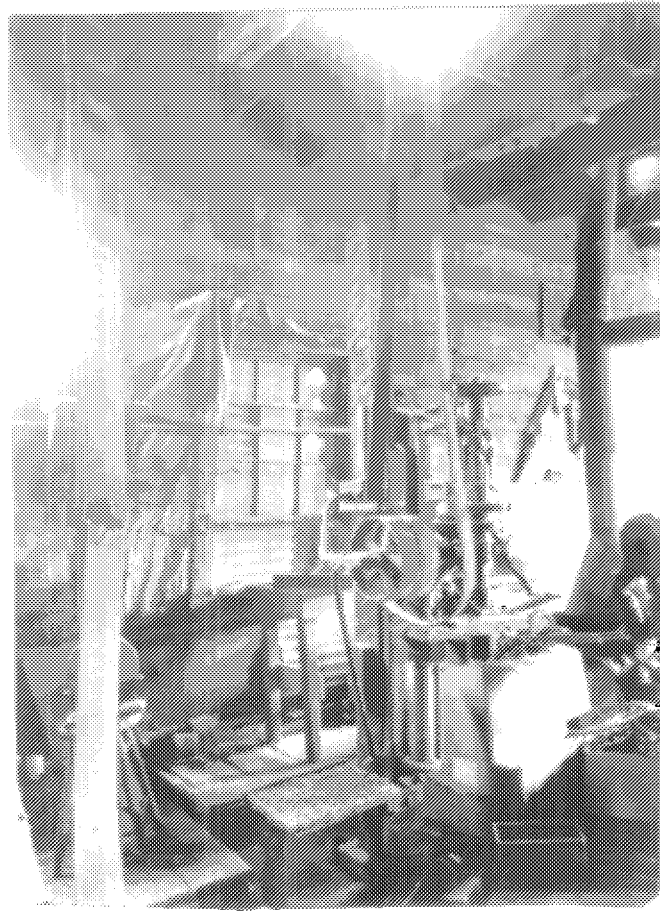
10 Biggs' Blacksmith Shop, interior view in 1970 before KNHS removed most of the artifacts and carried out stabilization measures. (Grant, 1970.)

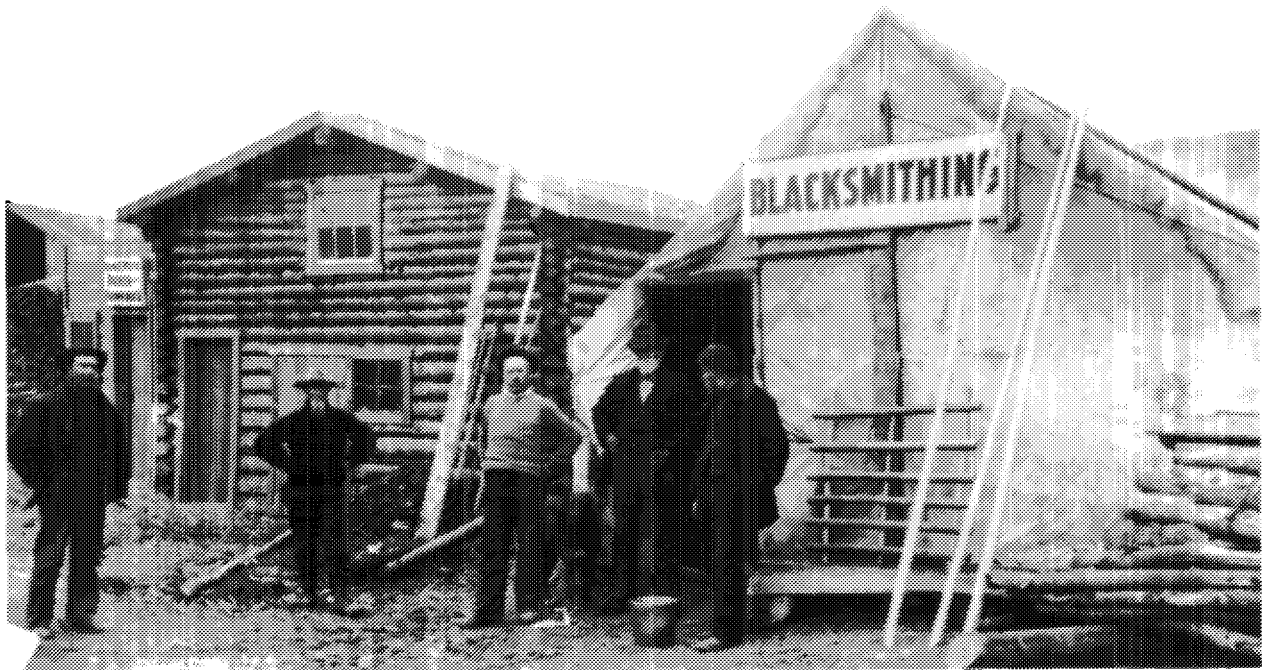
11 Makeshift blacksmith shop in Dawson ca. 1898. (NA/AN, PA-13476.)

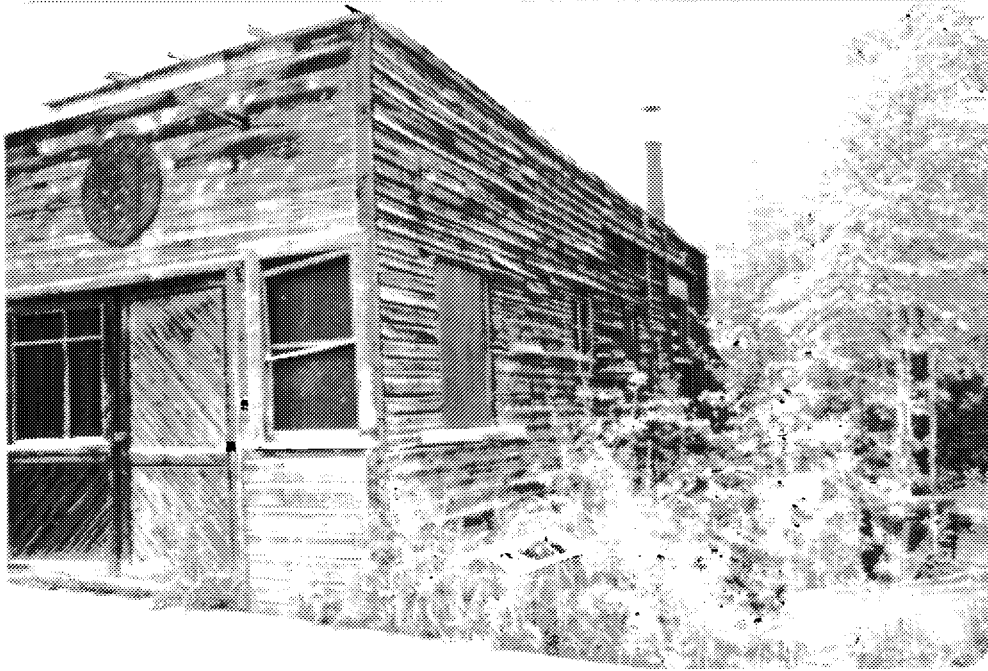
16 West's Boiler Shop, south side. (EC-CPS, KNHS, 1987.)

Very little indeed is definitely known about the history of this building (Figures 14, 15) and its operations. What is recorded is that Jesse A. West, a machinist and a blacksmith, was the owner in 1914. The 1915-16 Polk Directory of the city lists him as "J.A. West, Boiler Manufacturer and General Repairing."<sup>8</sup> His business subsequently became known simply as West's Boiler Shop; it was functioning until the late 1940s.<sup>9</sup> Although these are the bare facts of the place, a fair bit can be conjectured about its history by what is known of the boilermaker's trade, by requirements for boilers of various sorts in Dawson at the time, and by the wealth of artifacts left in the building.

boilers was directed through rubber hoses and iron pipes ("points") which were driven into the ground.<sup>11</sup> The K.T.M. Co. (Report No. 3) was the first to supply this equipment in the Klondike, but J.A. West could well have serviced it when necessary, and perhaps also helped repair the large-scale thawing equipment used with the giant dredges later on (Reports No. 21 and 22). Found within his workshop, which KNHS purchased in 1978, were the tools of his trade: a forge, sheet metal rollers, a drill press, an arc welder, work benches, drawers and storage cupboards (Figure 18), and many other metal pieces and tools, some of which still litter the yard south and east of the building (Figures 15, 19).

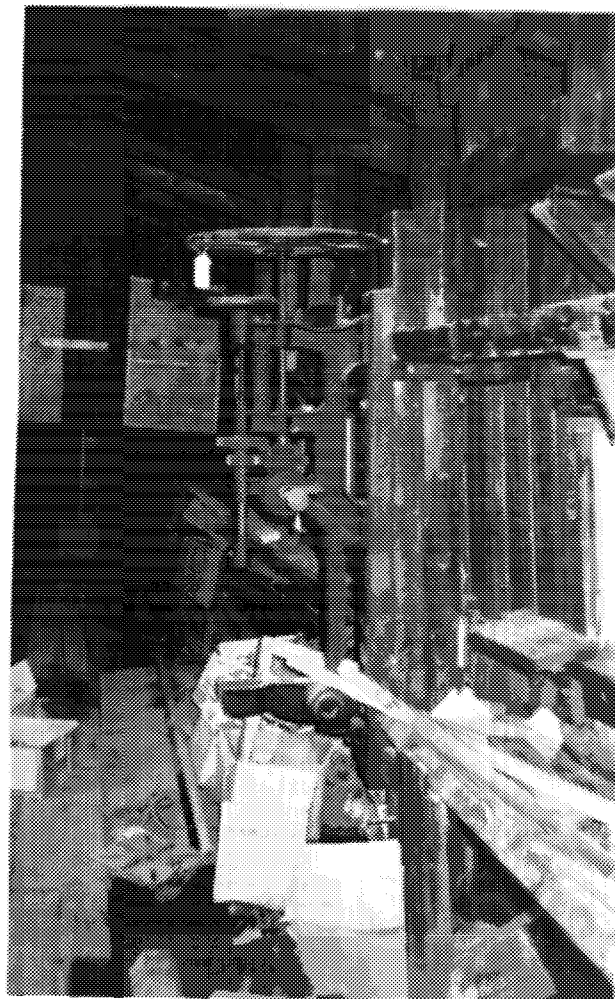
18 West's Boiler Shop; interior view in 1988. (J. Mattie, EC-CPS, AHB, 1988.)

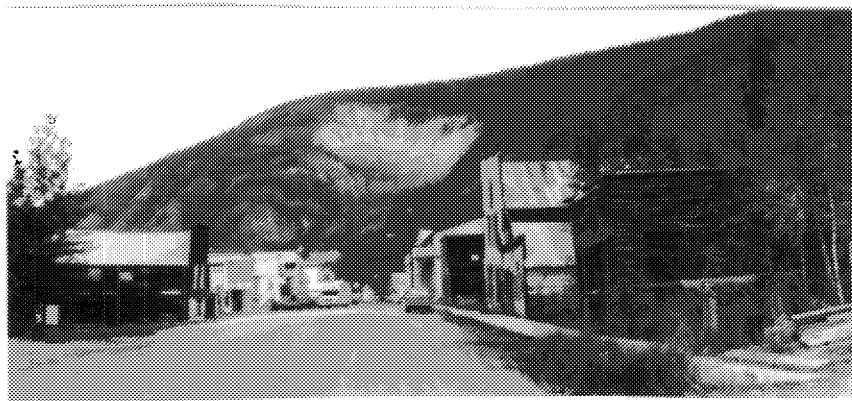
- 20 Third Avenue, Dawson. West's Boiler Shop is in right foreground; to the north is the Third Avenue Hotel Complex, then Biggs' Blacksmith Shop. Across the street (near left) is West's Machine Shop, the Third Avenue Blacksmith Shop, Red Feather Saloon, and Harrington's Store. (J. Mattie, EC-CPS, AHB, 1988.)

In the preceding 11 years before 1910, Third Avenue had gone through considerable change. When Biggs' shop (the better documented of the two) was built as the Great Northern Hotel in 1899, Third Avenue was only beginning to be developed, and Princess Street was a mere slash through the top layer of moss and permafrost. A photograph taken about that time shows very rough conditions, with crude log shacks, uneven ground, and building materials littering what is supposed to be a street.<sup>19</sup> The Great Northern Hotel stands out in this photograph as one of the better buildings of the area. Drainage improvements to the boggy land stretching beyond the east side of Third were made throughout the next several years. In addition, the Third Avenue road surface was macadamized in 1902, making the street the main trunk road to the creeks and also making it much more attractive for further development. More varied types of businesses soon began to locate here, including the Red Feather Saloon on the south west corner of Princess and Third, and Harrington's Store on the north west corner of this intersection (Figure 20).
