CITY OF WINDSOR

# PRELIMINARY WILDLIFE CROSSING STUDY OJIBWAY PRAIRIE COMPLEX

PROJECT NO.: IM22104012  
DATE: AUGUST 28, 2023

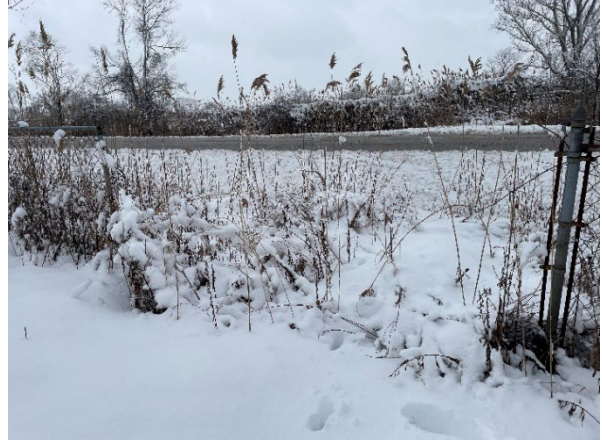
2. Fence break along Matchett Road (near OPPNR), White-tailed Deer using as crossing. January 27, 2023.

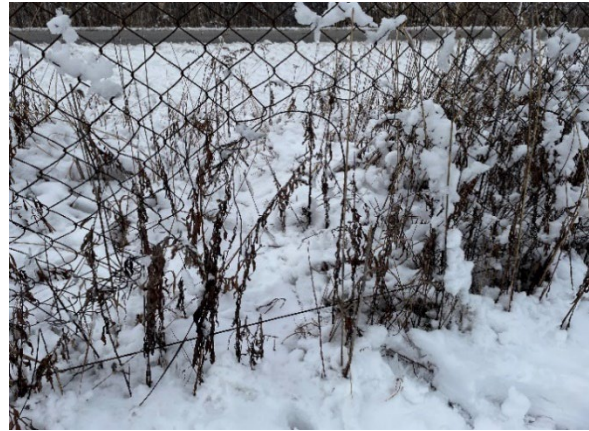
6. Hole in fence along Matchett Road, wildlife using as a crossing point. January 27, 2023.

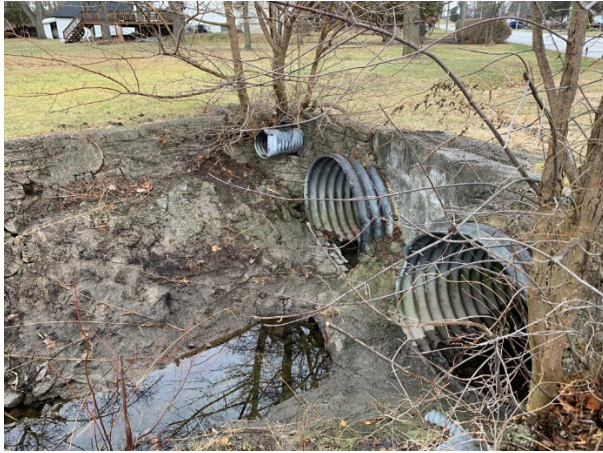
1. Basin Drain culverts under Spring Garden Road.

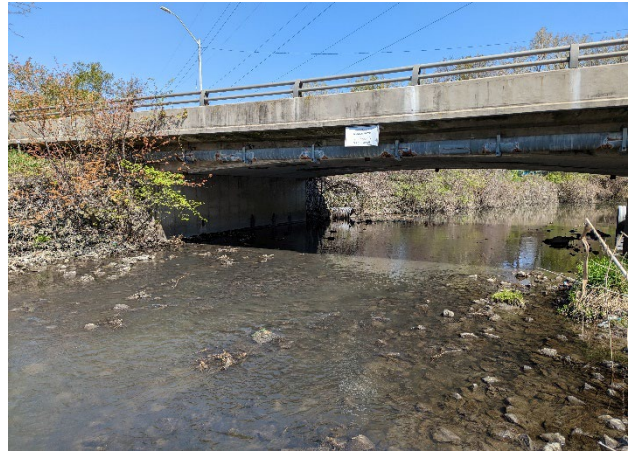
2. Todd Lane at the Turkey Creek bridge crossing.

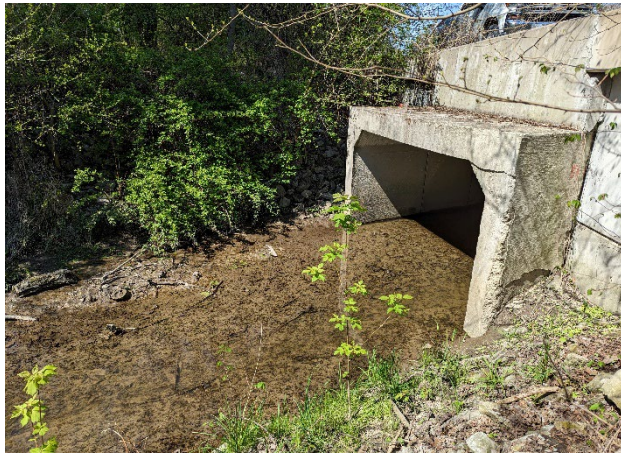
3. Basin Drain culvert under Malden Road (west).

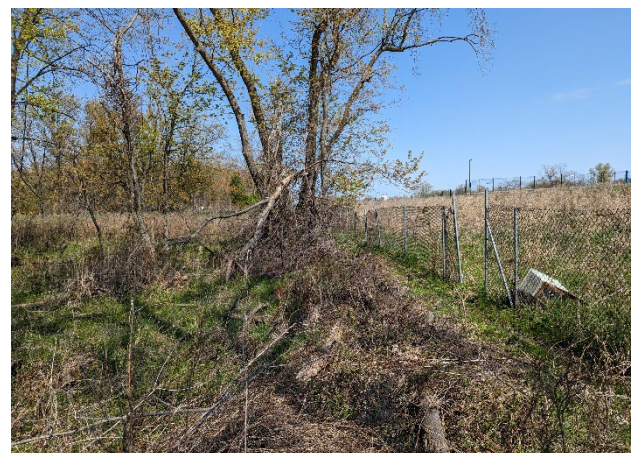
4. T5 Ecopassage west entrance from Spring Garden Natural Area.

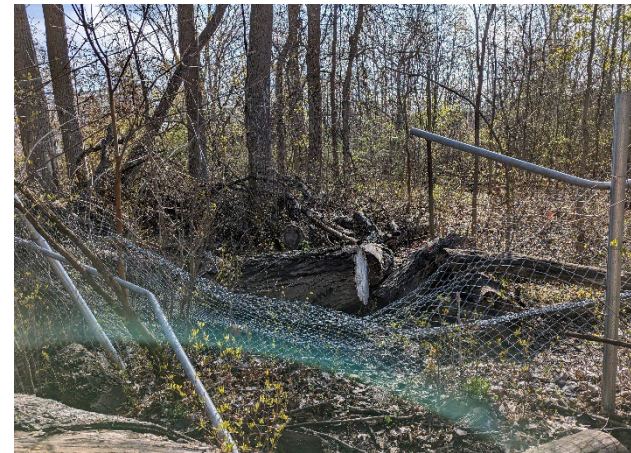
6. Fence opening along property boundary in Black Oak Heritage Park.

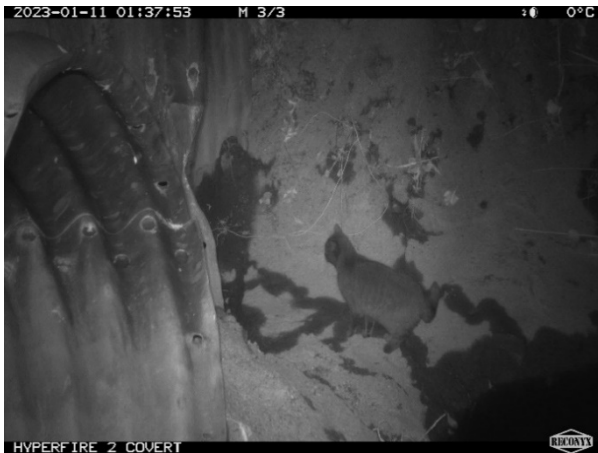
3. Domestic Cat entering the culvert.  
January 10, 2023.

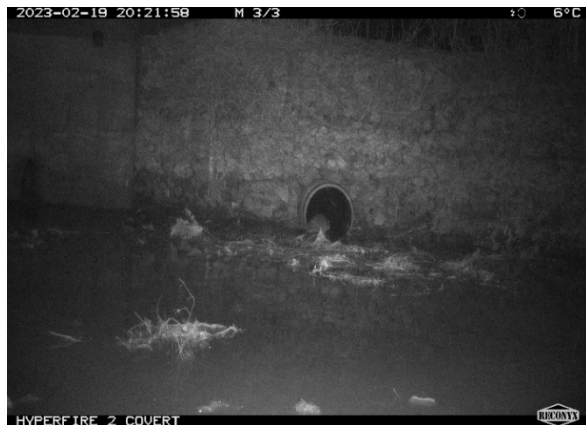
10. Raccoon entering small culvert on the west wall. February 19, 2023. (NE corner)

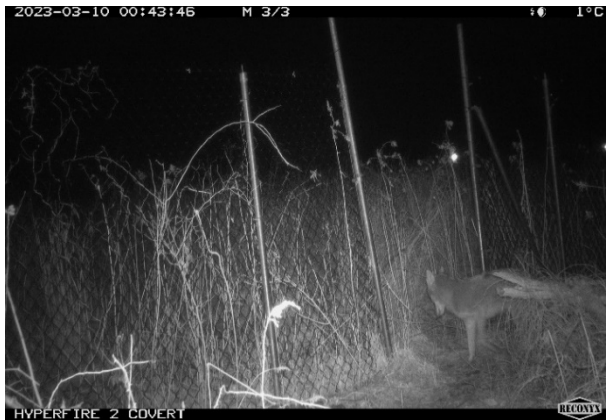
1. Coyote crossing onto T5 Ecopassage.  
March 10, 2023.

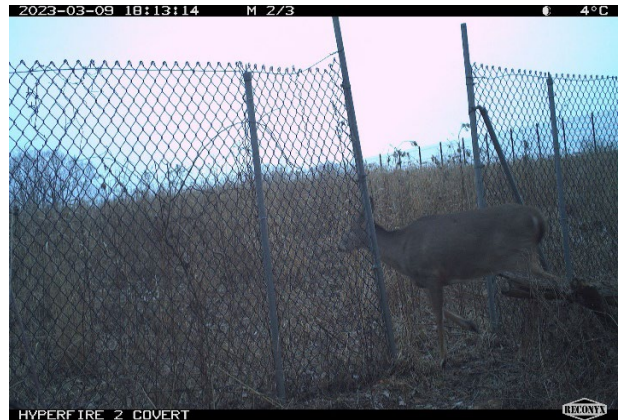
2. White-tailed Deer crossing onto T5 Ecopassage.  
February 9, 2023.

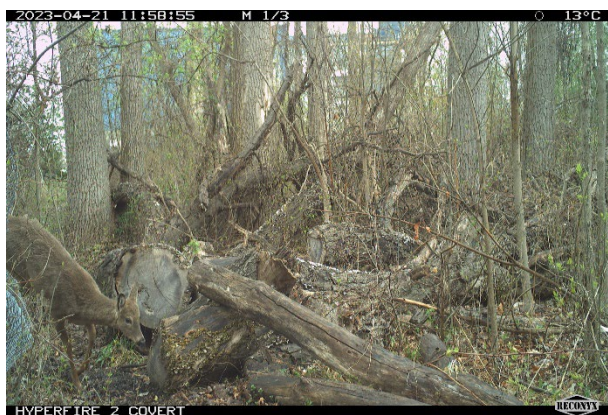
5. White-tailed Deer walking through the fence break. April 21, 2023.

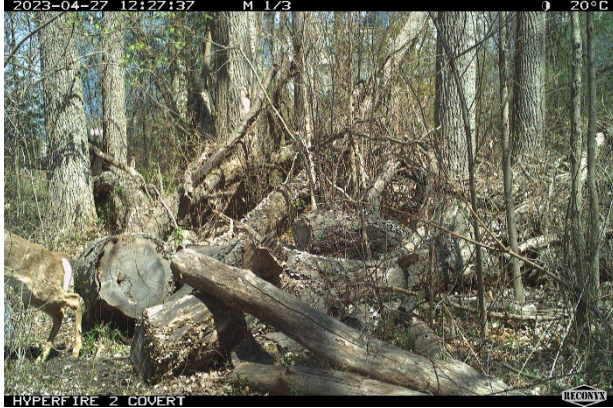
7. White-tailed Deer jumping through fence break. April 27, 2023.

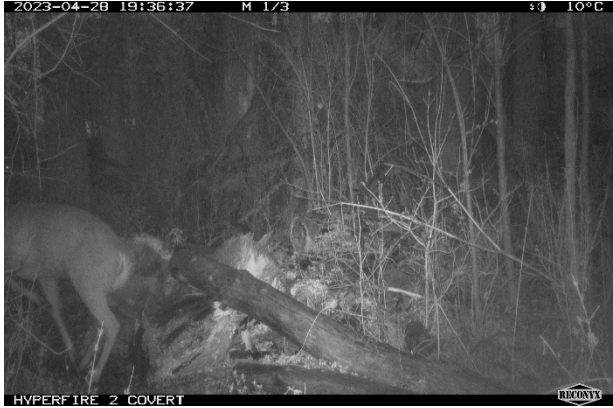
8. White-tailed Deer jumping through fence break. April 28, 2023.

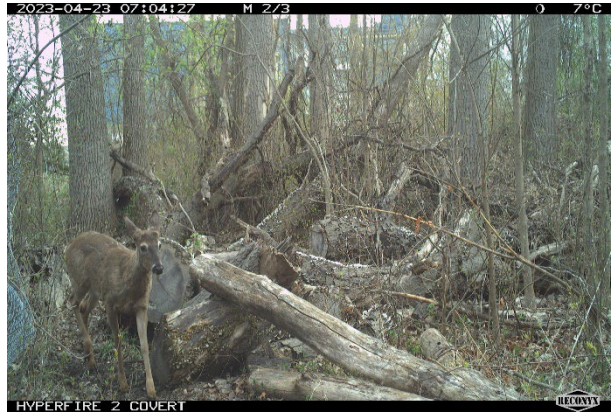
10. White-tailed Deer walking through the fence break. April 23, 2023.
