**TLA-O-QUI-AHT FIRST NATION ESOWISTA INDIAN RESERVE #3
EXPANSION LAND TRANSFER
ENVIRONMENTAL SCREENING DOCUMENT**

**Project No. 8812
July 2006**

**Re: Environmental Screening Document
Tla-o-qui-aht First Nation Esowista Indian Reserve #3 Expansion
Land Transfer**

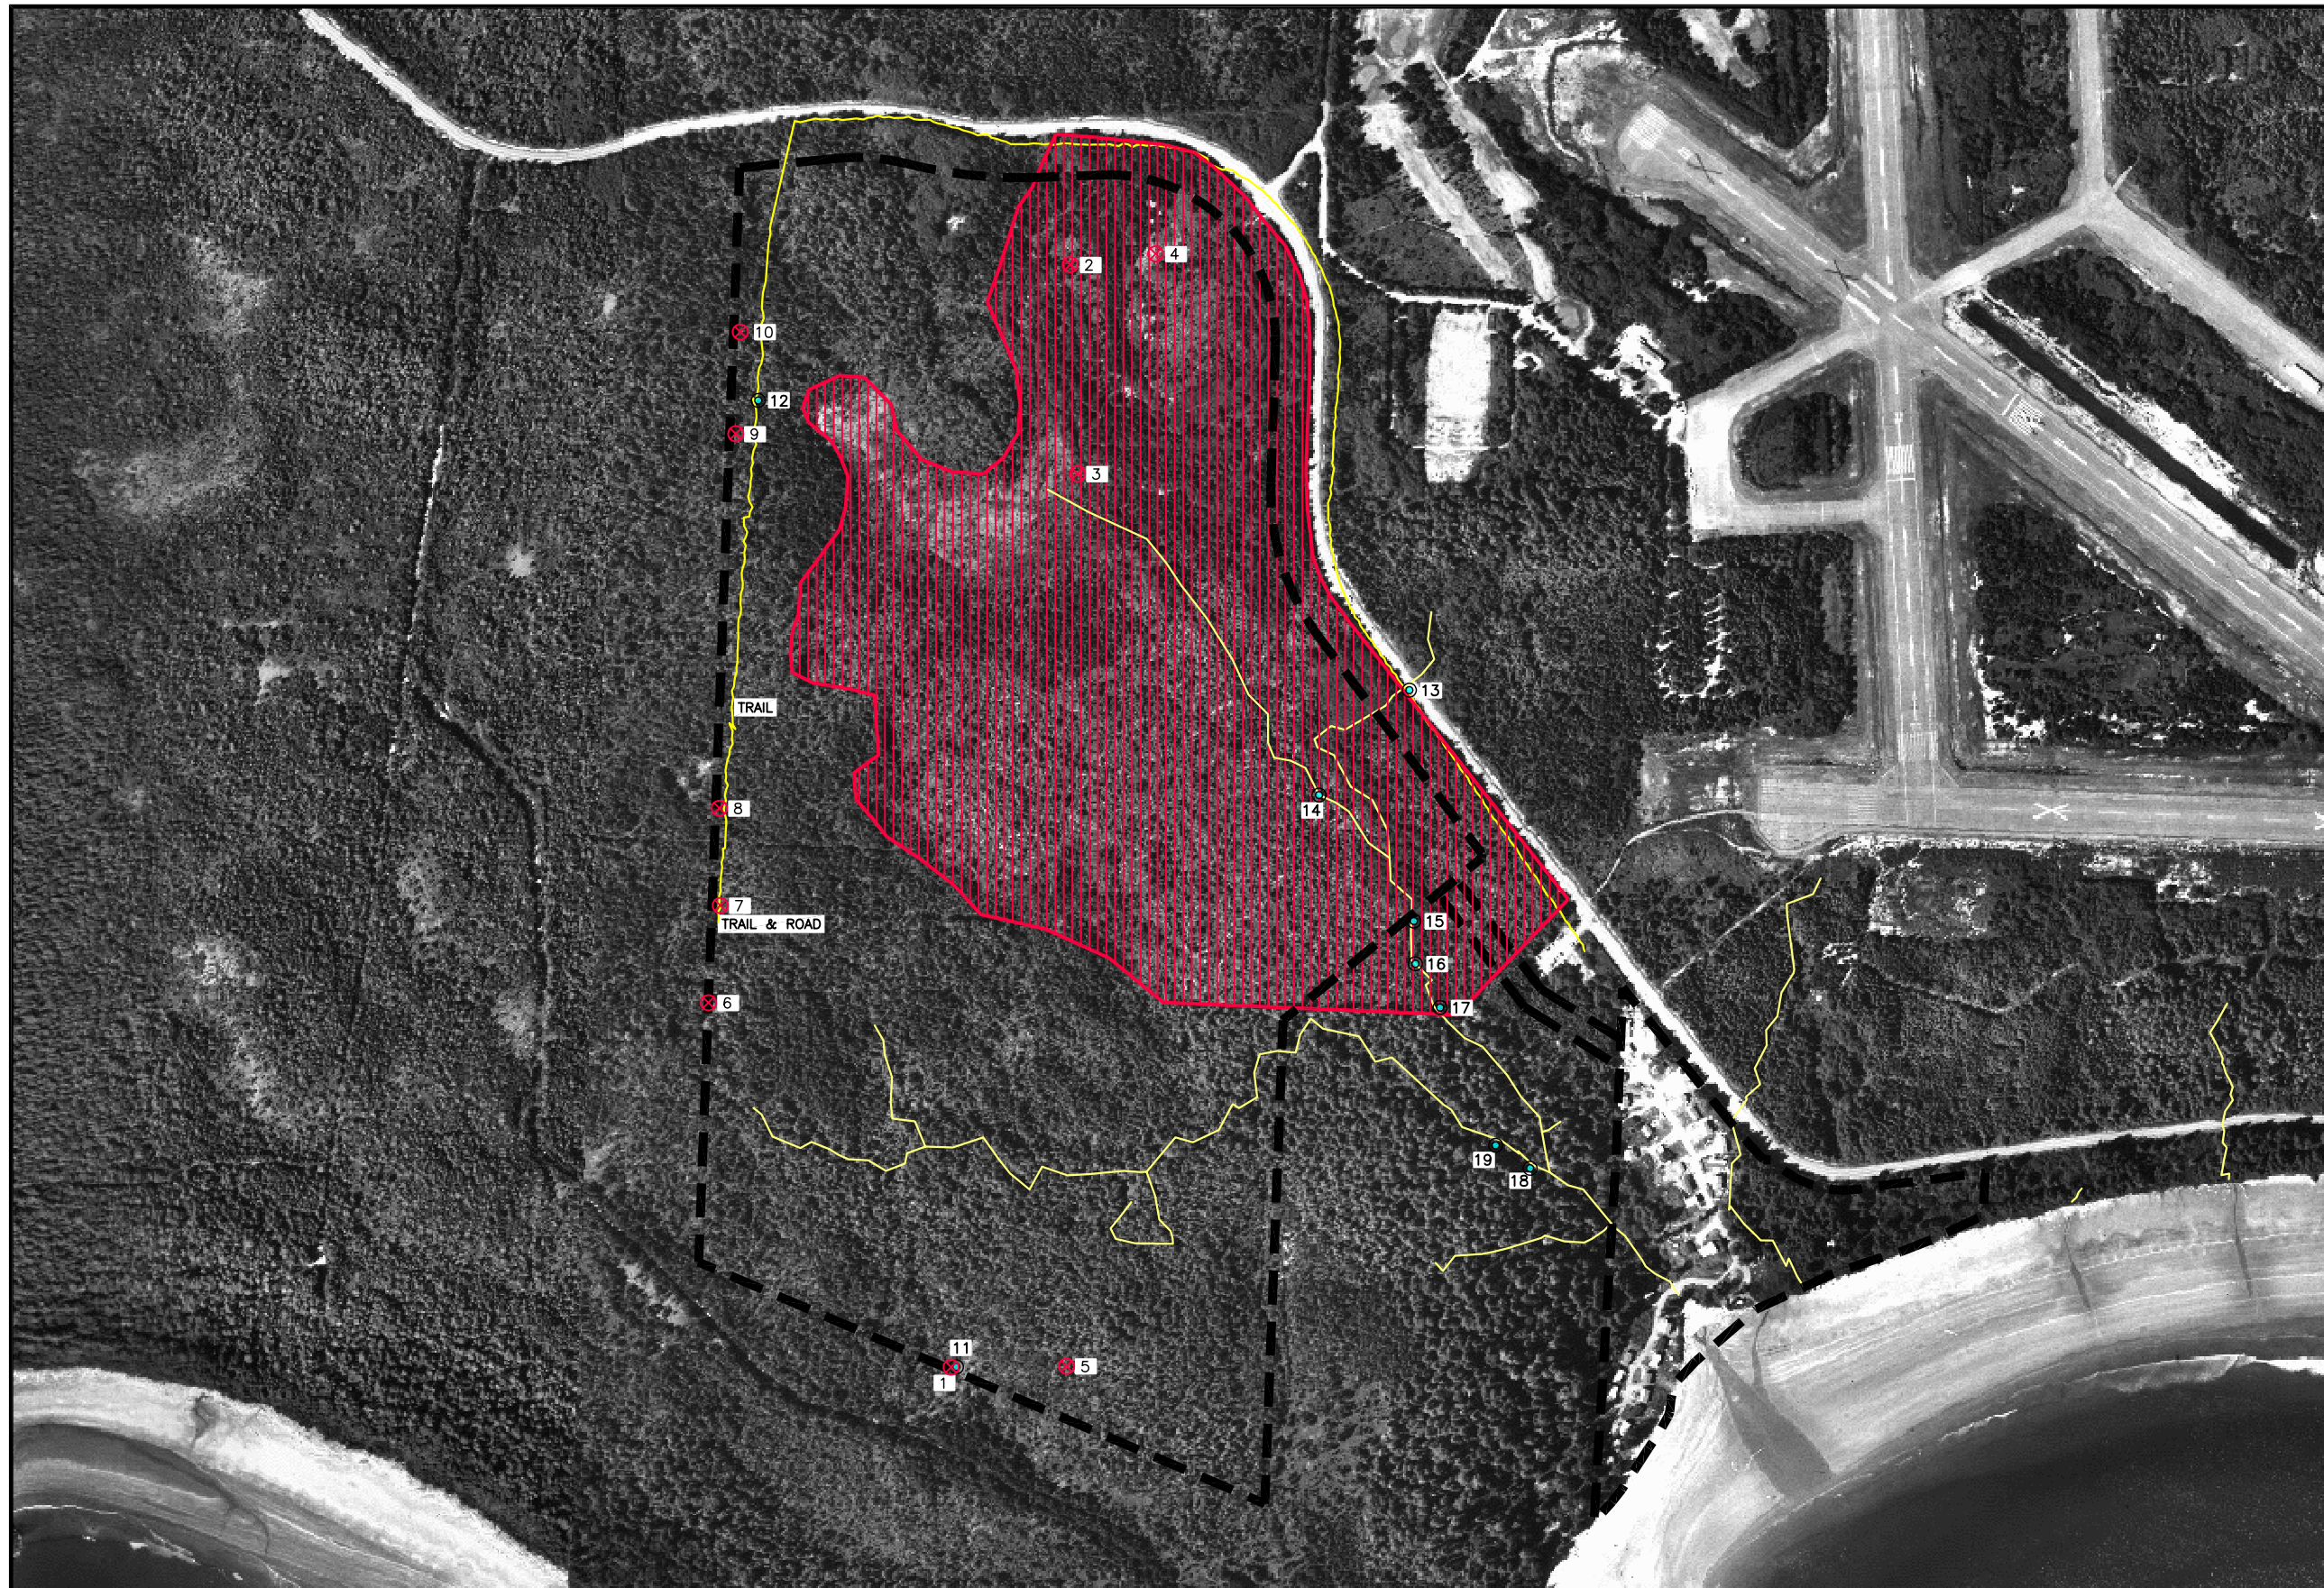
Figure 3
Disturbed Area

During the Site visit, non-native roadbase / structural fill material, consisting of gravel, cobble and fines was observed on the northern and northeastern portions of the Site and covering an area of approximately 8 hectares. This area corresponds to former residences, cleared, unvegetated areas and unpaved road networks previously used as an overflow campground, which were observed in the 1970s and 1980s historical aerial photographs. The origin, quality and/or quantity of fill material could not be determined. Based on Site visit observations and historical aerial photographs, there is considered to be a potential for constituents of concern associated with roadbase / fill material to be present in the Site soil and/or groundwater at levels of concern.

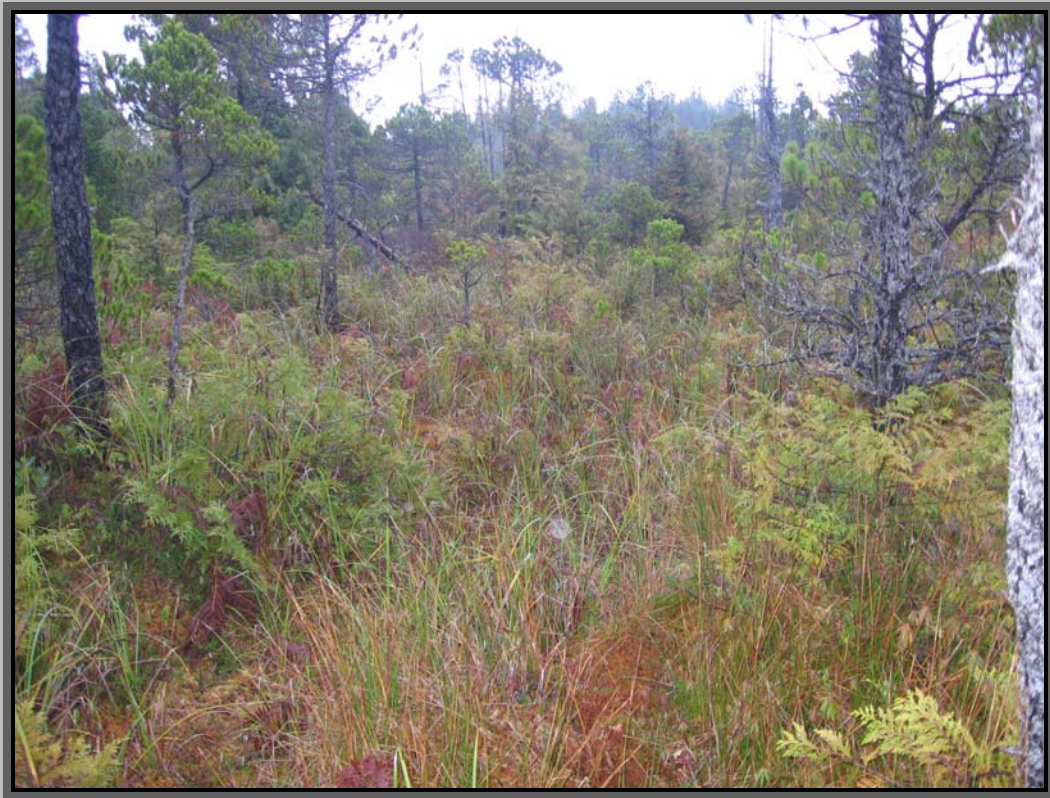
Open Bog habitats are delineated by Polygons 8, 9 and 12 on Figure 2. The largest open bog (Polygon 12) is located in the northern portion of the study area (Photo A). Dominant vegetation includes various sphagnum species (Appendix D), stunted Shore Pine, Western Hemlock and Western Red Cedar, Labrador-Tea, Crowberry, Bracken Fern, Western Bog-Laurel, Bog Blueberry, Bog Cranberry, Three-leaved Goldthread, sedges and occasional Skunk Cabbage in wet depressions. A single Sweet Gale plant was also observed. The edges of the bog are characterized by Shore Pine of increasing vigor and size as they approach the boundaries of the Pine Dominated Forest – Open Bog habitat. Polygon 8 has a similar plant species composition to Polygon 12 and a similar transition to Pine Dominated Forest – Open Bog habitat on its western margin (Photo B). On the northern boundary, the Pine Dominated Forest habitat class in transition areas is narrow. Old-growth Coniferous Forest is present immediately to the north of this transition zone. Polygon 9 is unique in that open wetland portions are not only dominated by sphagnum but also Silverweed, and sedges including Pale Sedge (Photo C).

Photo A: Polygon 12 – Open Bog

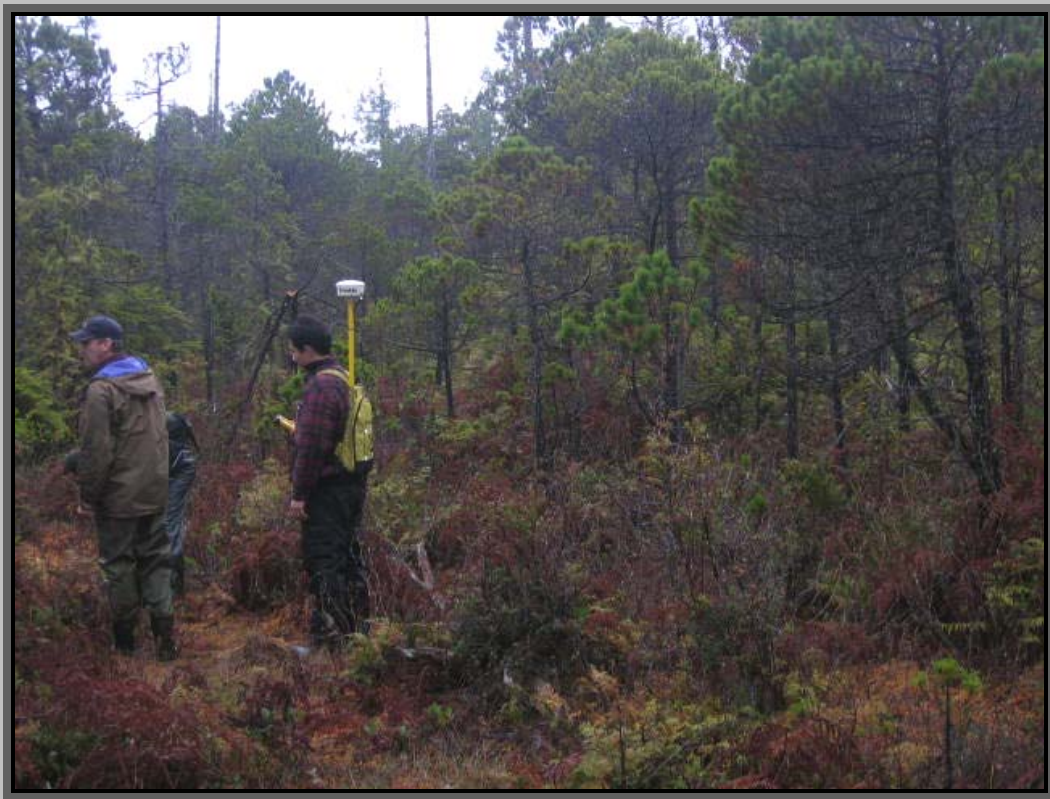
Photo B: Polygon 8 – Open Bog

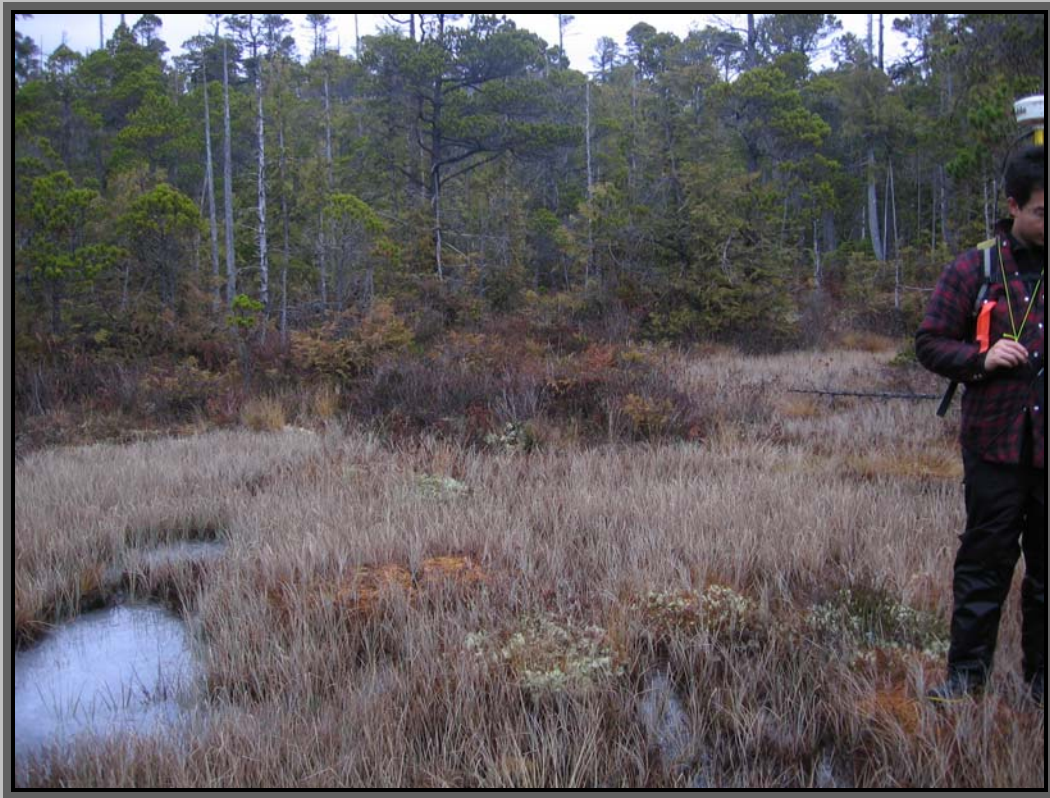
Photo C: Polygon 9 – Open Bog

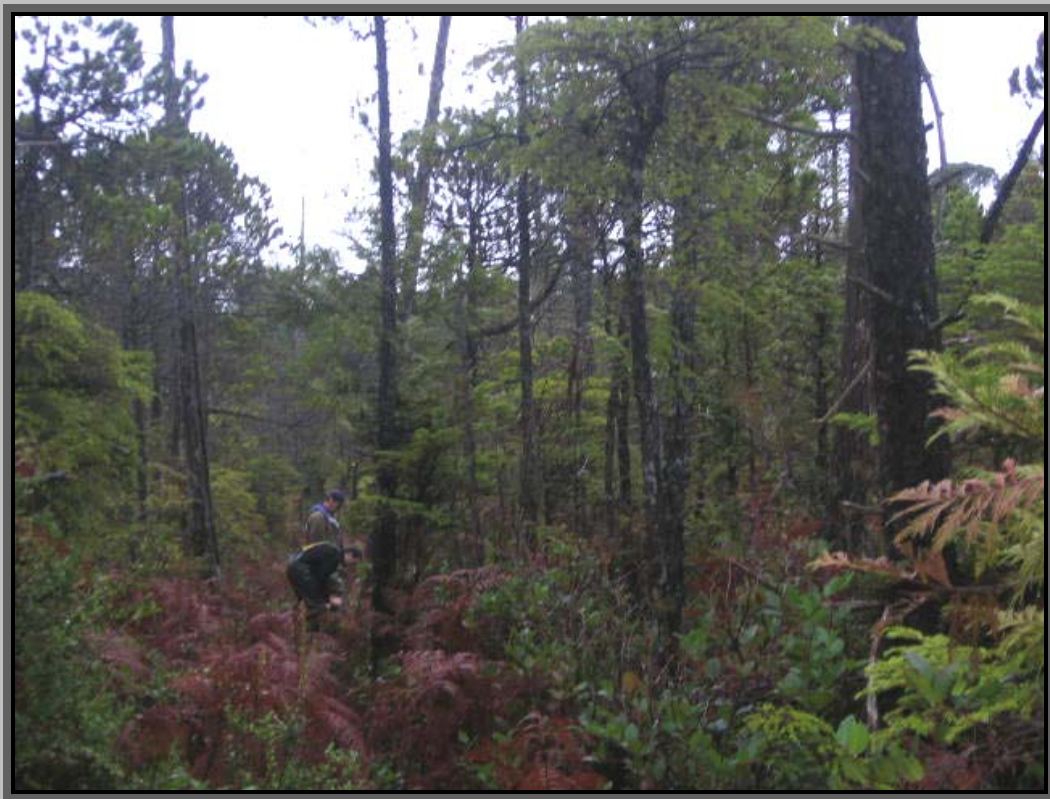
Polygon 10 delineates a large area of Pine Dominated Forest habitat in the study area (Photos D and E). Forests are old-growth or mature and dominated by Shore Pine in most areas, with lesser numbers of Western Red Cedar and Western Hemlock. Some portions were burned in a forest fire, a very rare event on the west coast, approximately 80 to 100 years ago (Parks Canada, 2003). Tree species composition varies considerably, but Shore Pine is consistently dominant. Understorey shrub and herb species include Evergreen Huckleberry, Salal, Red Huckleberry, Labrador-Tea, False Azalea, Running Clubmoss, Deer Fern and Bracken Fern. Sphagnum and Slough Sedge are present in open areas in the forest with better light penetration.

Photo D: Polygon 10 – Pine Dominated Forest

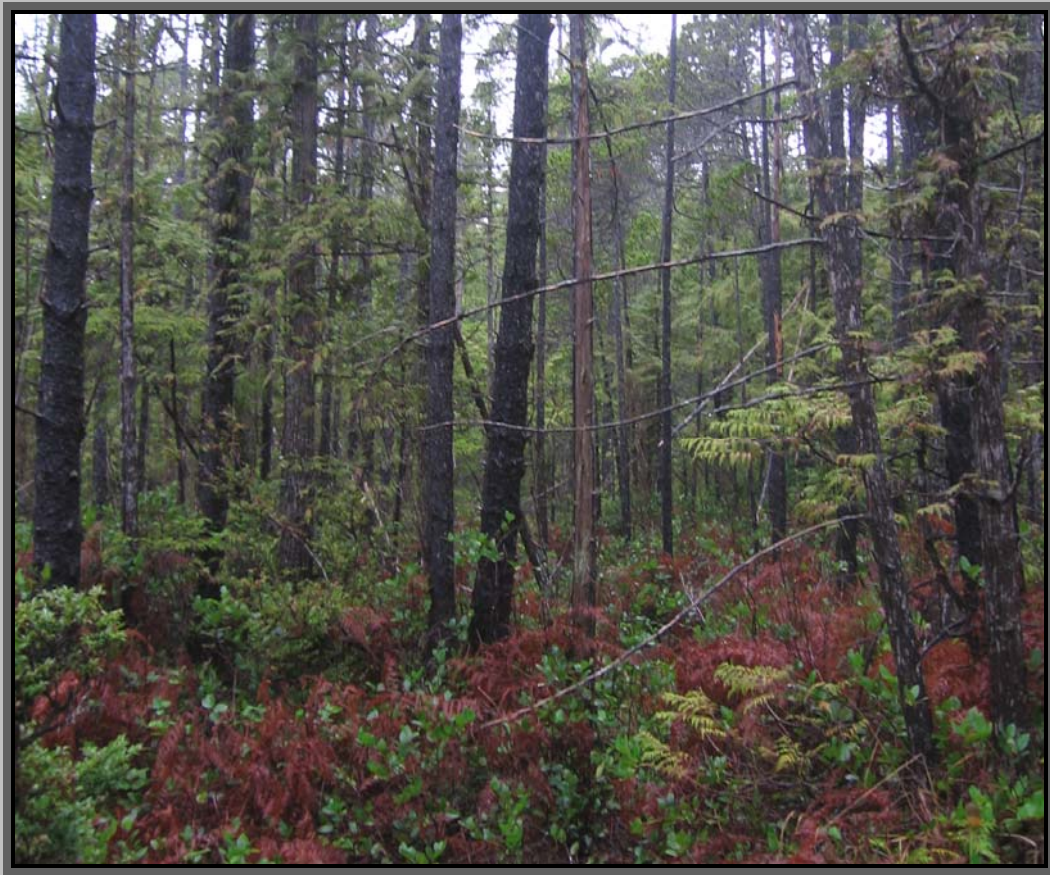
Photo E: Polygon 10 – Pine Dominated Forest

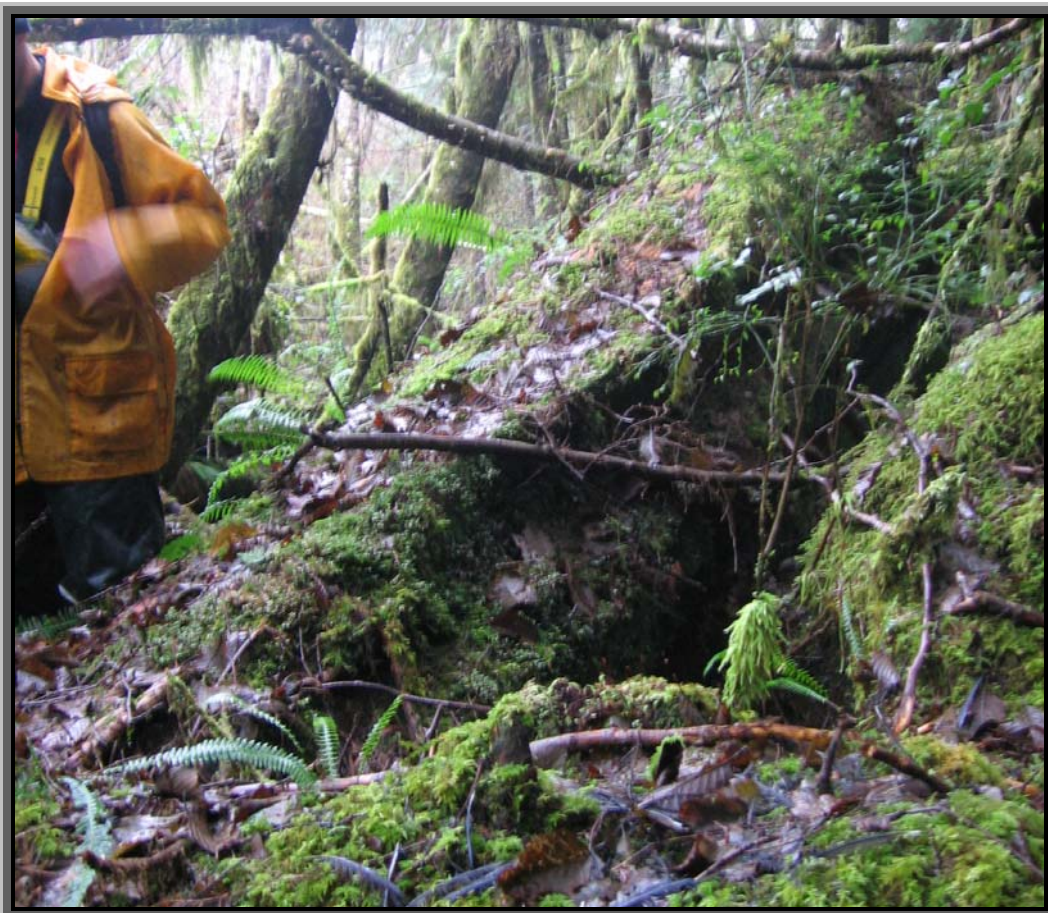
A potential red-listed Northern Goshawk (*Accipiter gentilis* ssp. *laingii*) plucking station was found within this polygon (Photo J). Other potential rare or endangered species inhabiting riparian forests include the blue-listed and Special Concern Red-legged Frog (*Rana aurora*) and the Threatened Dromedary Jumping-Slug.

The only sign of a raptor observed during the site reconnaissance was a plucking station where a Steller's Jay had been plucked and eaten. Either the red-listed Northern Goshawk or the Cooper's Hawk (*Accipiter cooperi*) are possible species utilizing the site. Other raptor species that may occur on the site include Red-tailed Hawk (*Buteo jamaicensis* – may nest), American Kestrel (*Falco sparverius* – mainly during migration), Merlin (*Falco columbarius* – may nest), and Peregrine Falcon (*Falco peregrinus* – mainly during migration) (Campbell *et al.*, 1990).

Photo J: Polygon 4 – Riparian Forest

- If active nests or living areas of raptors, or Red- and Blue-Listed plant or wildlife species are found within the proposed disturbance area, a management plan should be developed that protects the location while it is active or occupied.

- Minimize construction and road-building activities during the critical breeding bird and wildlife period.
- If active raptor nests are found, implement buffer zones to reduce sensory disturbance until chicks have fledged.

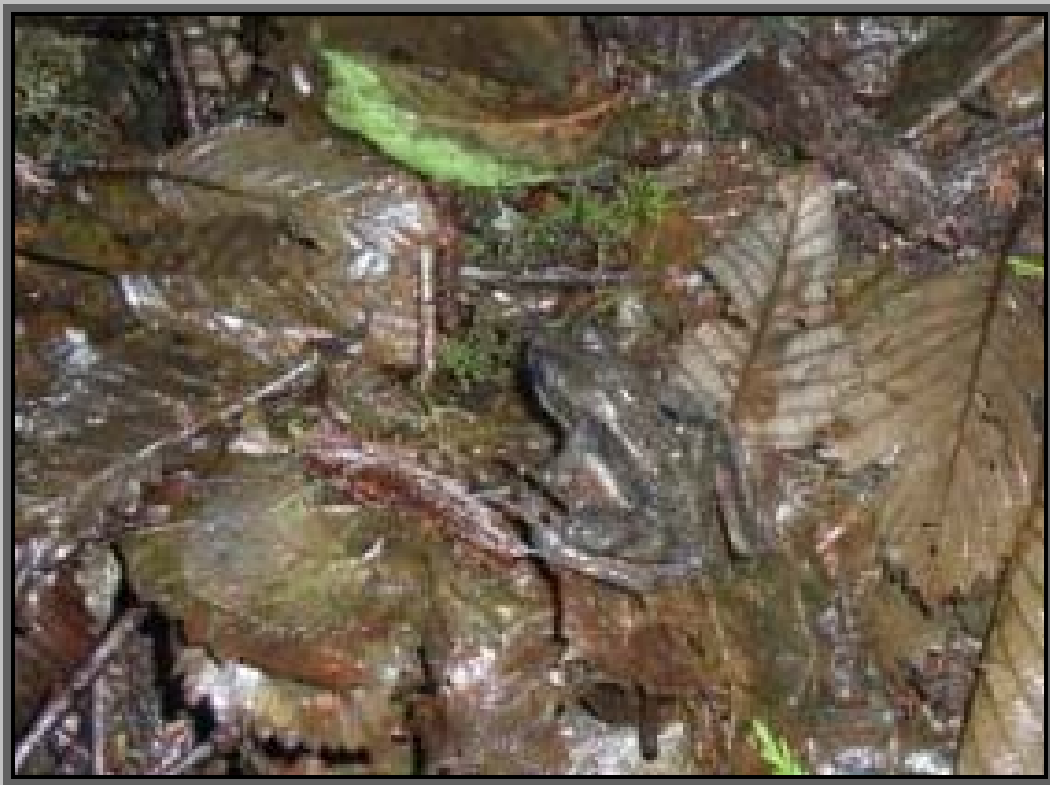
Only two amphibian species were observed during the site reconnaissance of the Esowista site. An adult Red-legged Frog (Blue-Listed; Special Concern) was found and photographed along Esowista Creek (Photo N) and a Pacific Treefrog (*Hyla regilla*) was heard calling on one occasion. Red-legged Frog and Pacific Treefrog breeding areas and movement corridors are being studied by a local naturalist from Ucluelet. A number of breeding locations and movement corridors have been identified in close proximity to the Esowista site (Barb Beasley, pers. comm., 2006; Beasley, 2004) (Figure 5). Between fall 2000 and spring 2004, SPLAT surveys found a cumulative number of 20 Red-legged Frog and 29 Pacific Treefrog carcasses along the section of highway to the north of the Esowista site (Appendix E, 12-14 km from Tofino). Additional information on Red-legged Frogs in the area is provided below under section 'Rare and Endangered Wildlife Species'.

Photo N: Red-legged Frog

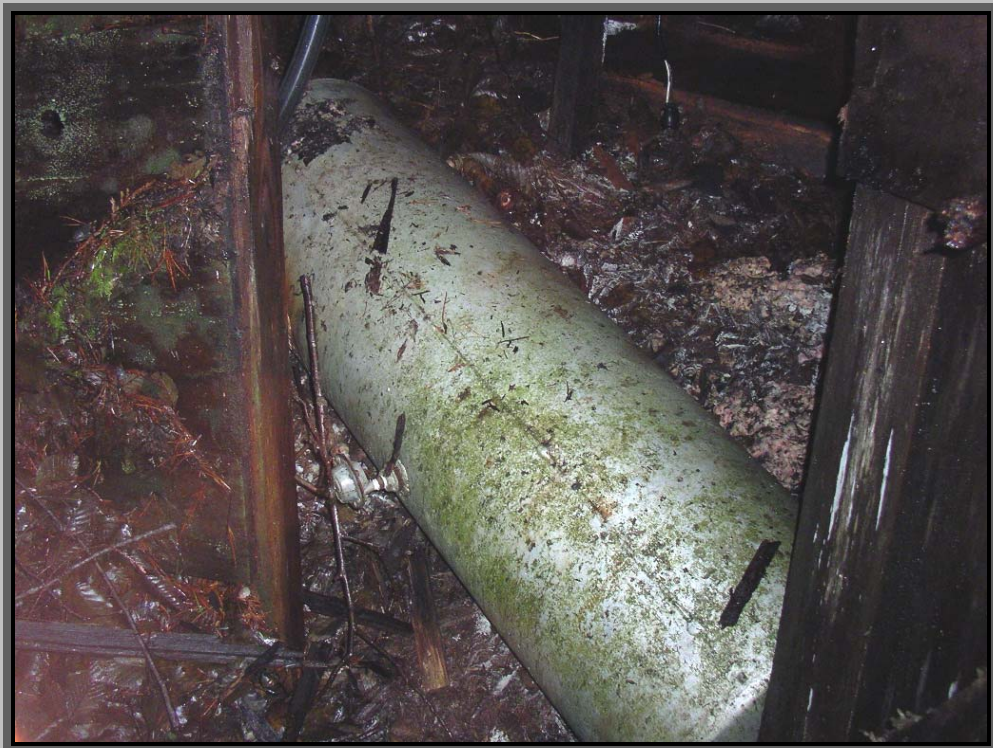
A magnetic locator and electromagnetic survey located numerous miscellaneous metal debris objects but no USTs were discovered. A remnant Aboveground Storage Tank (AST) was observed in the area of a former residence at the northern edge of the site. A soil sample collected below the AST stand was below applicable guidelines. Remaining soil samples collected along the northern portion of the site were also below applicable guidelines for Petroleum Hydrocarbons (PHCs) and is therefore concluded that there is a low potential that heating oil USTs and associated COPCs are present on-site at levels of concern. A depression containing two 48 gal (182 L) drums was observed in proximity to a former residence. A surface water sample was collected in the vicinity of the drums and results were below the detection limits for PHC C₁₀-C₁₆ and C₃₄-C₅₀ and slightly above the detection limits for C₁₆-C₃₄. The soil sample was non-detect for analyzed constituents.

Picture 2: Hot-water tank in vicinity of make-shift shed / shack

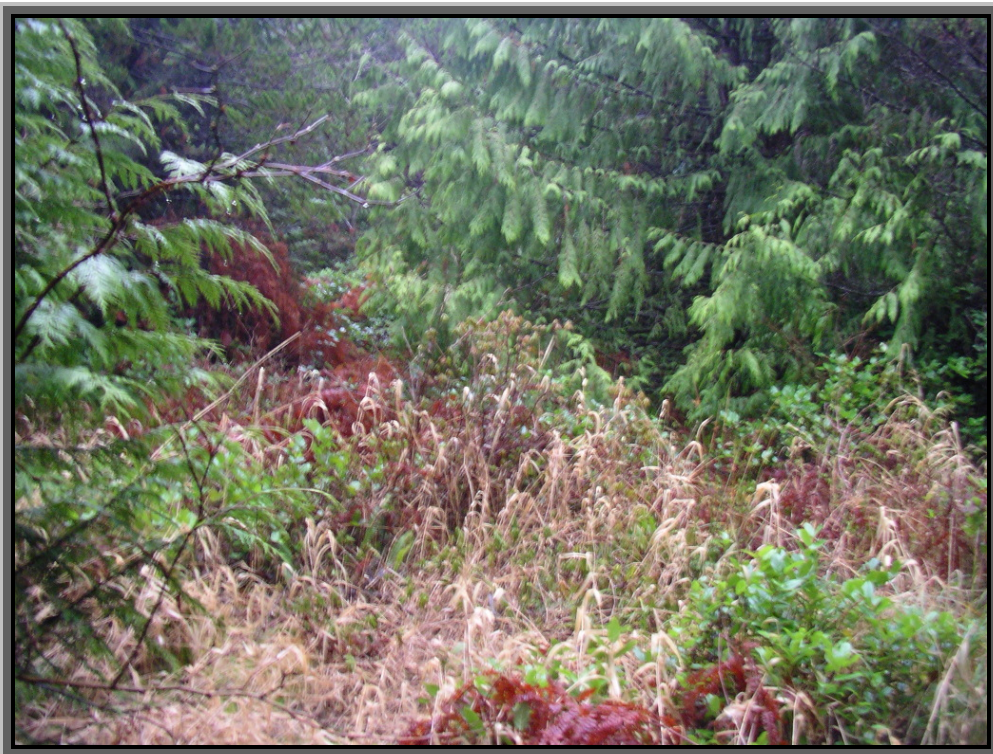
The report concluded that constituents of concern were present in fill material at concentrations exceeding the CCME criteria at one test pit located in a former residential area at the northern edge of the site, and further investigation was warranted. As metal debris and refuse were noted in some excavated areas along the northern portion of the site, there was the potential for constituents of concern to be present in localized areas where refuse is buried on-site, and further investigation may be required during potential future development.

Picture 4: Clearing in northern portion of the Site in vicinity of former single-family residence.
