2008

Environmental Investigation and Remediation of Contamination at Quttinirpaaq National Park, Ellesmere Island, Nunavut

Environmental Sciences Group
Royal Military College
Kingston, Ontario

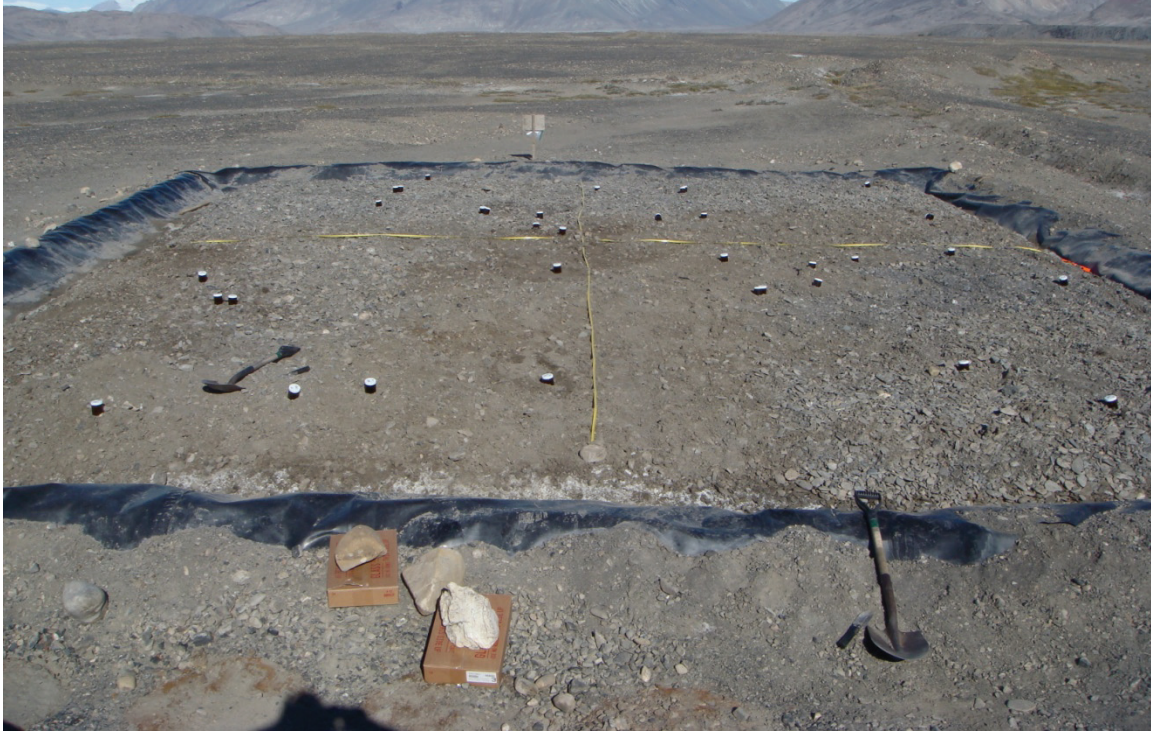
Photograph III-1: Location of Tanquary Fiord landfarm samples collected in the 2008 field season as part of the long-term monitoring plan.

ESG collected 36 more soil samples (08-11880 to 08-11915), including three scoop blanks and three duplicate pairs, from the landfarm in 2008 for PHC analysis (Table B-1) and another set of samples for nutrient analysis (Table B-4) and plate count of HC degraders (Table B-2), using the same procedure used in 2007. At each location, samples were collected at a depth of 15-25 cm. The collected samples and their locations are shown in Photograph III-1. The PHC results for the 19 samples analyzed from the landfarm indicated a 95% UCL of 2,400 ppm, which is below the cleanup criteria of 2,500 ppm. This indicates that the landfarm may be decommissioned in 2009. The soil in the landfarm may be removed and disposed of, as it no longer requires remediation.

Results from the 2008 monitoring samples indicate that the soil in the landfarm has been successfully remediated and the landfarm no longer needs to be maintained. It is recommended that the soil be removed from the landfarm carefully, to prevent damage to the fragile geotextile liner. The landfarm structure may be reused for future remediation of soil contaminated by new fuel spills. The remediated soil should be spread in a thin layer around the incinerator for disposal. While the soil is below criteria, it may still contain hydrocarbons and have a noticeable odour. The soil should not be placed in areas used for recreational activities and personnel handling the soil should be aware of the hazards of hydrocarbon contamination and wear long pants, boots, gloves and protective glasses when disposing of the soil.

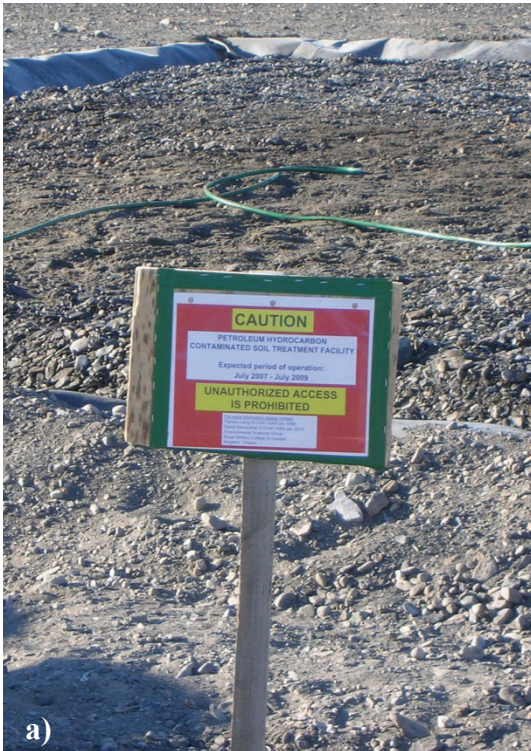
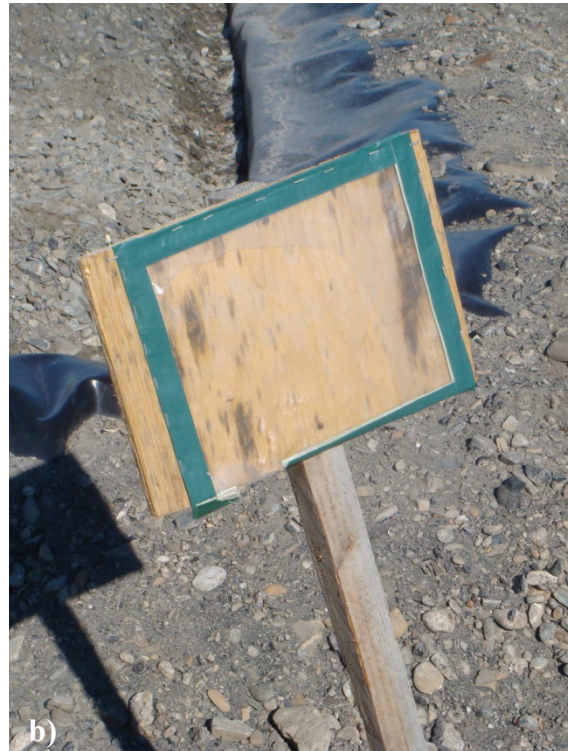
Photograph III-2: Warning sign posted at the landfarm at Tanquary Fiord a) in 2007 and b) in 2008.

At the time of establishment of the landfarm in 2007, four signs were posted around its perimeter to warn people of the presence of contaminated soil. In 2008, ESG staff noticed that all but one of the signs had either fallen down or been damaged by the wind or snow during the winter (see Photograph III-2). Since the soil in the landfarm has been remediated, the signs are no longer needed. If, however, the landfarm is used in the future to remediate soil contaminated by new fuel spills, additional signs should be posted to warn bystanders to stay away from the contaminated soil.

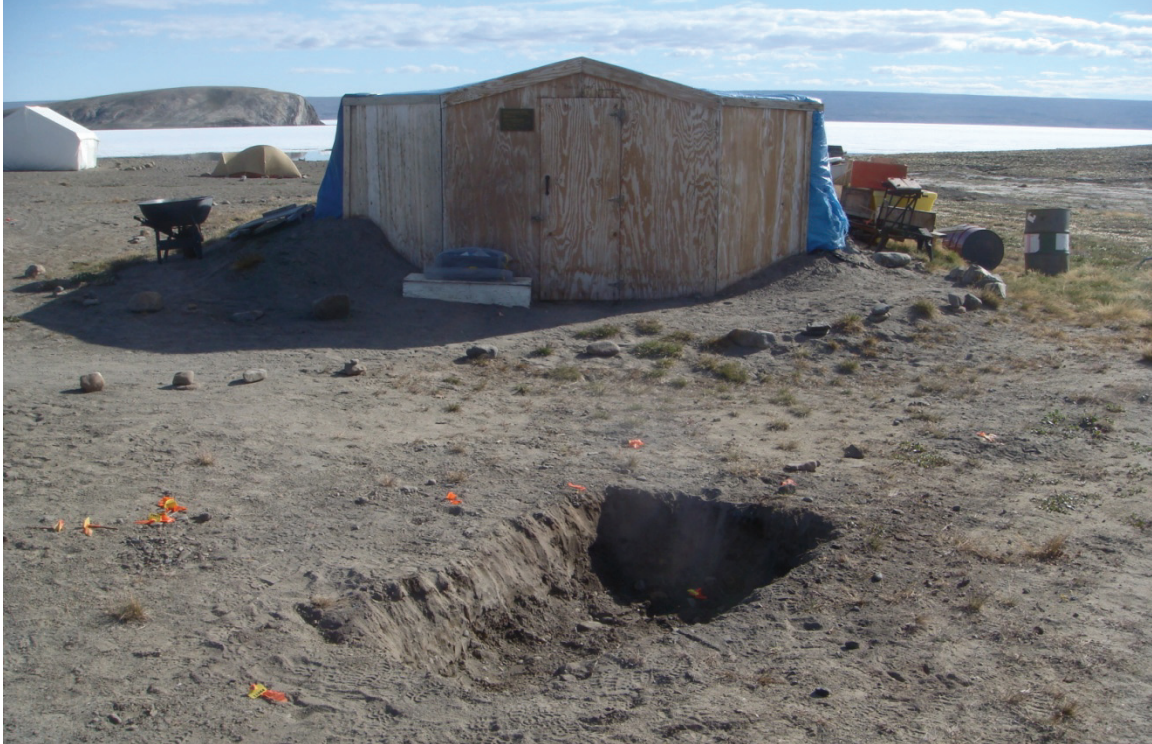
Excavation 04-376: This stained area, north of the barrel shed, south of the grey water discharge area and west of the kitchen shelter (Map IV-4), was contaminated with Type A hydrocarbons (F3 and F4 fractions), with a maximum TPH concentration of 30,000 ppm at surface (sample 04-376; Table B-1, ESG 2005a). Delineation samples from the 2008 field season and prior field seasons were used to determine the horizontal extent of contamination and, following the hydrocarbon risk assessment framework, the area was excavated to 0.5 m (Photograph IV-3). Three confirmatory samples were taken around the perimeter at the bottom of the excavation and all were below criteria.

Photograph IV-3: Excavation 04-376.

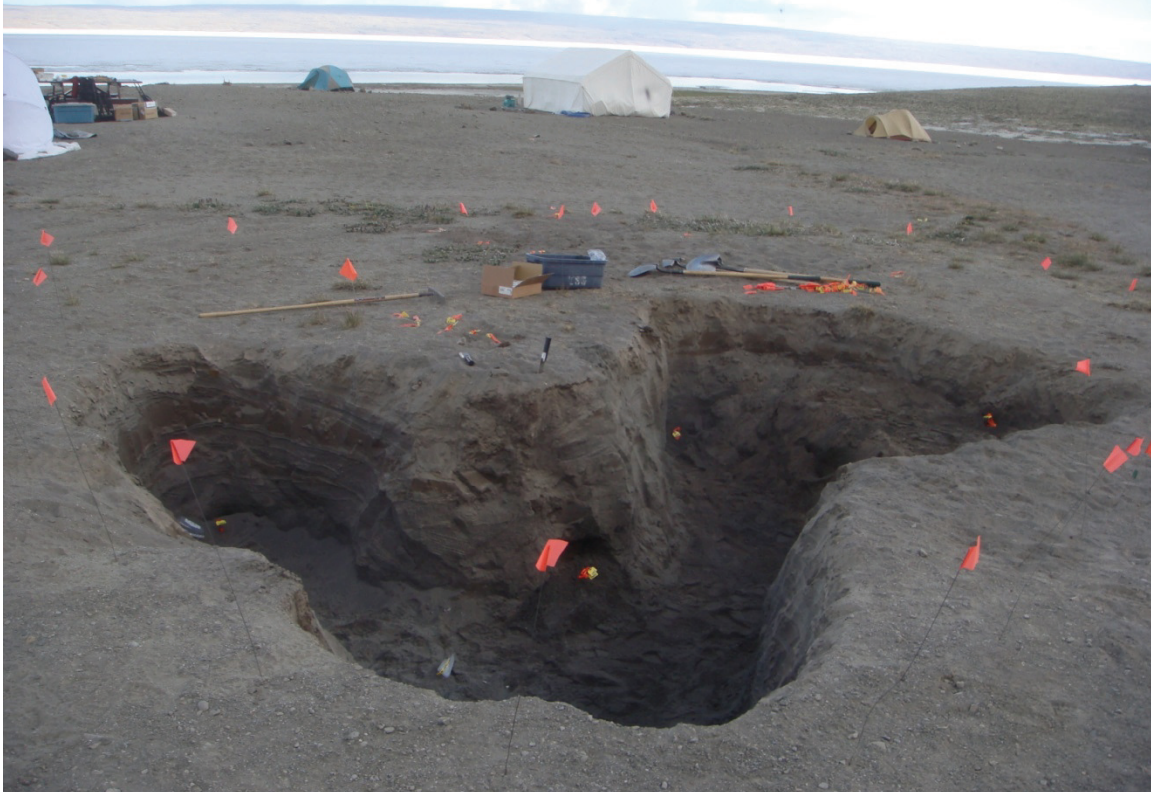
Excavation 04-472: This was the largest excavation area on site, located south of the snowmobile trailer on the main camp pad (Map IV-6). It had one large stain at its centre (Photograph IV-5). Soils at surface and depth were contaminated with Type B hydrocarbons (fractions F2 and F3), with a maximum total PHC of 12,000 ppm (ESG, 2008). Based on delineation results, the area was excavated to 1.10 m on the east side and to 0.5 m on the west side. Confirmatory samples (08-12007 to 08-12014; Table B-1) taken from around the bottom of the excavation area were all below criteria.

Photograph IV-5: Excavated area 04-472.

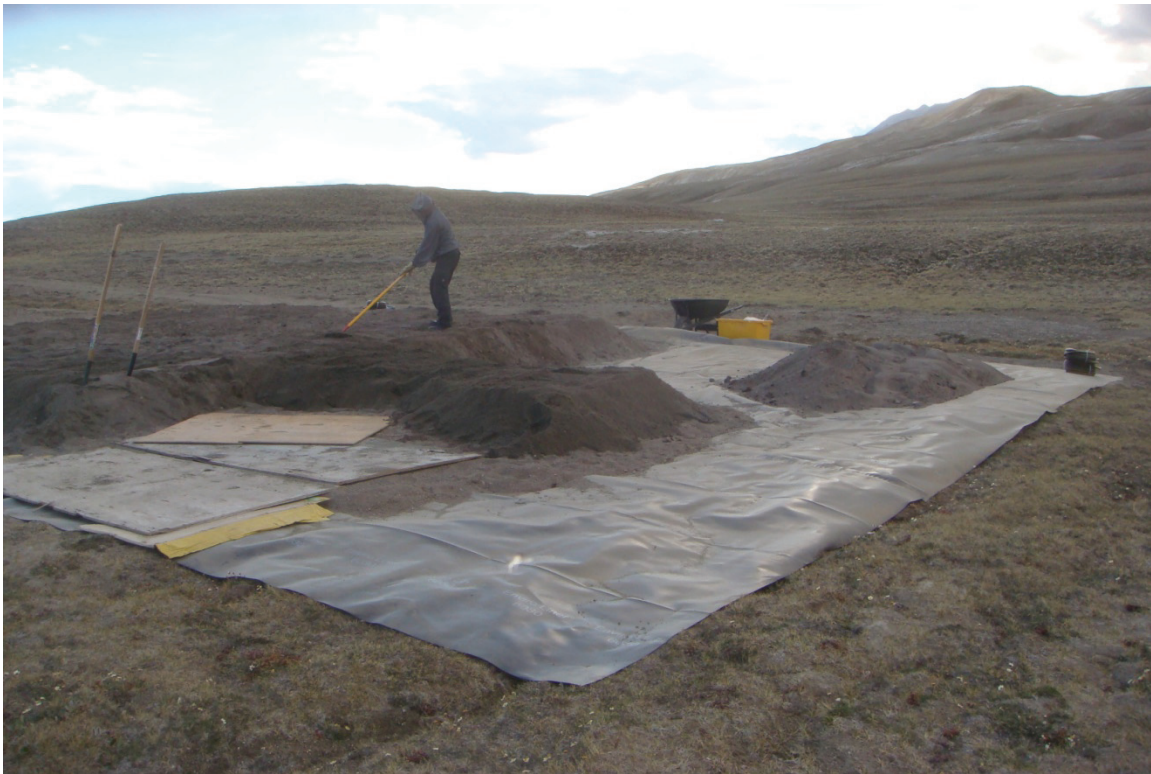
Photograph IV-8: Construction of the Lake Hazen landfarm: addition of the 30 cm layer of hydrocarbon-contaminated soil.

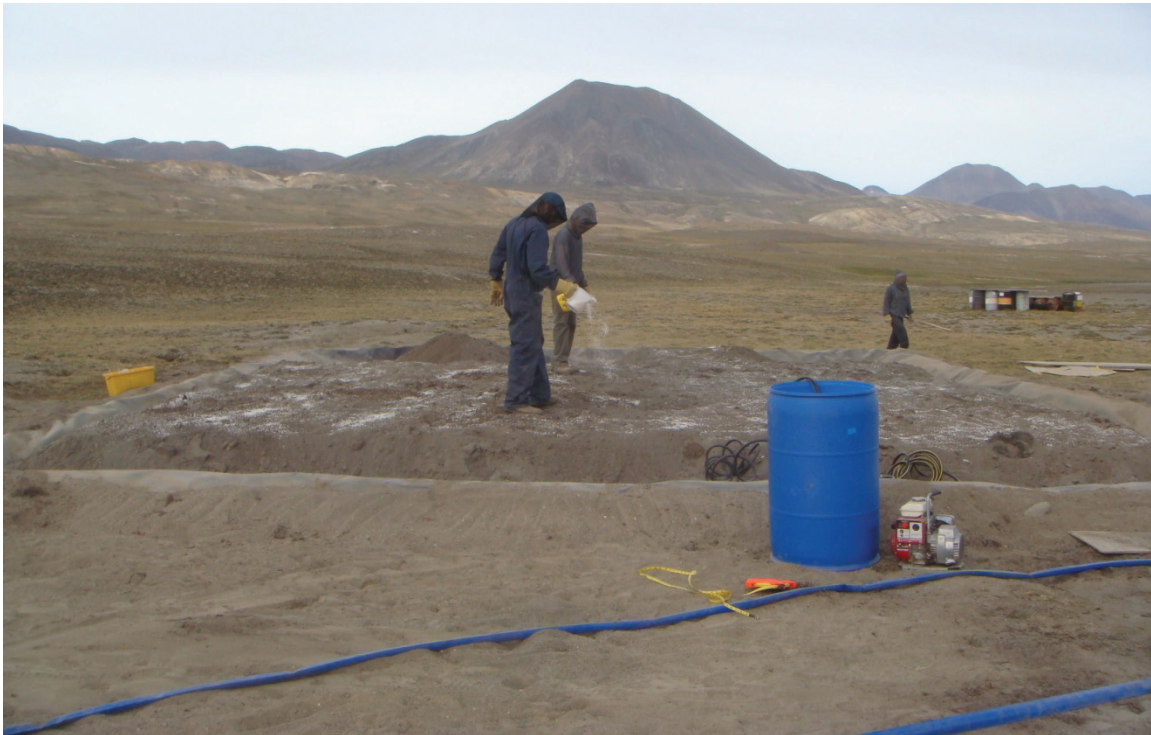
Photograph IV-10: Fertilizer was added evenly across the landfarm.

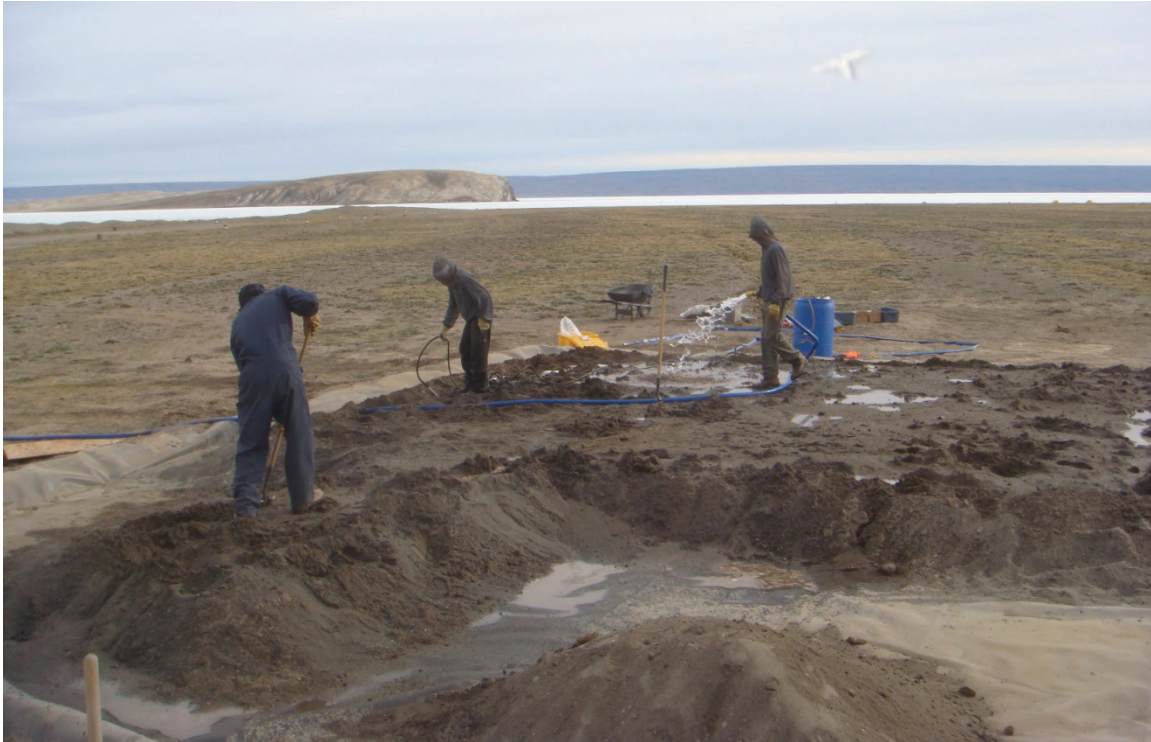
Photograph IV-11: Landfarm treatment: fertilizer and Biosolve[™] were mixed into the soil, which was homogenized using a shovel.
