Archaeology at Fort Walsh

FORT WALSH FRONTIER POST

Frontier Post

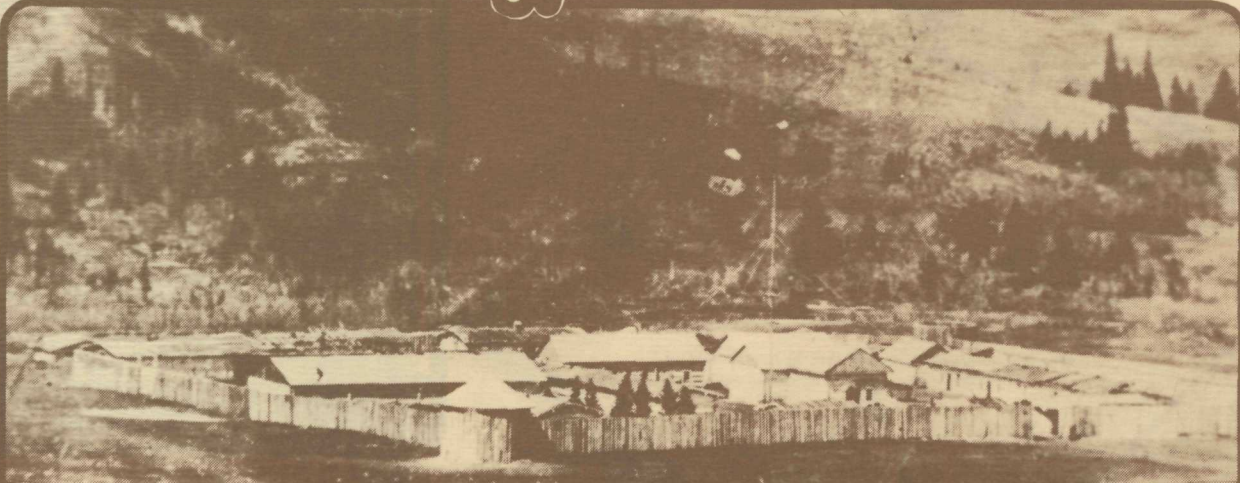
Fort Walsh, viewed from the east (in late 1879). Construction of the roof over the bastion (centre right background) at the NW corner of the palisade was not completed at the time the photograph was taken. Credit: Public Archives of Canada, C-17602A.

addition, the square bastion was removed from the east palisade and replaced by circular bastions at the northwest and southwest palisade corners.

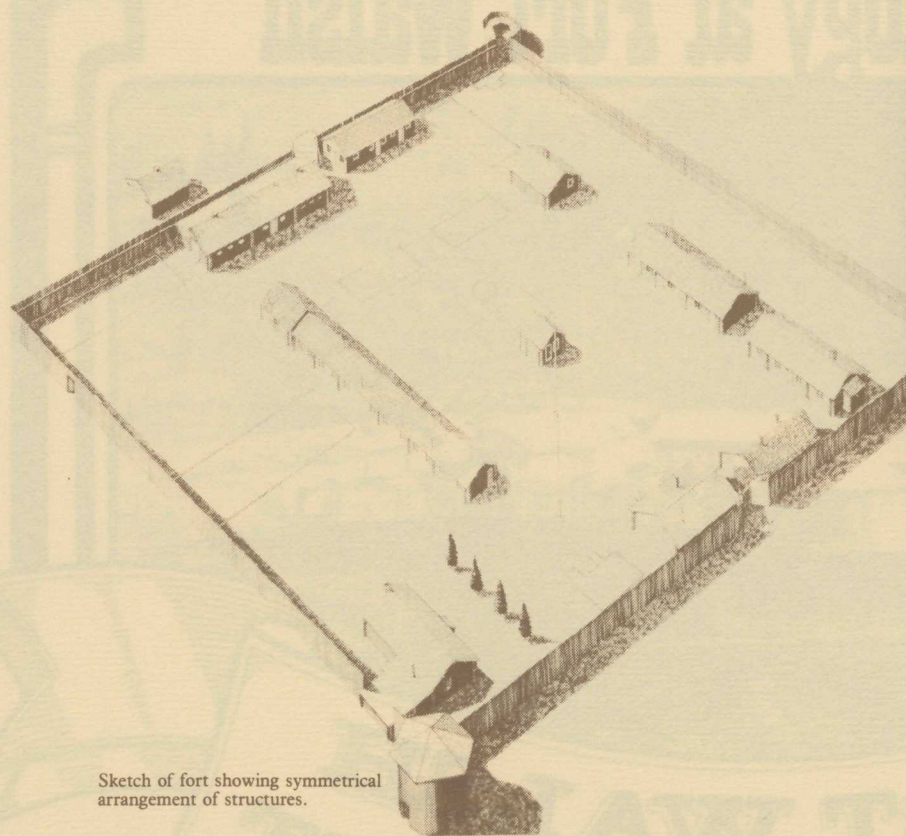
Sketch of fort showing symmetrical arrangement of structures.

Originally constructed in 1875, Fort Walsh was built entirely from logs and only those structures essential to the immediate needs of the force were provided. The fort was arranged symmetrically on an east/west axis. Seven structures were set around an open square and the complex was partially enclosed by a vertical log wall (palisade). Two structures divided the enclosure into distinct areas — the smaller stable compound on the west side of the fort, and the residential area on the east. The residential area was also divided on the basis of rank, with commissioned officers occupying the east side of the compound and the enlisted men located next to the stable and artisan shops.

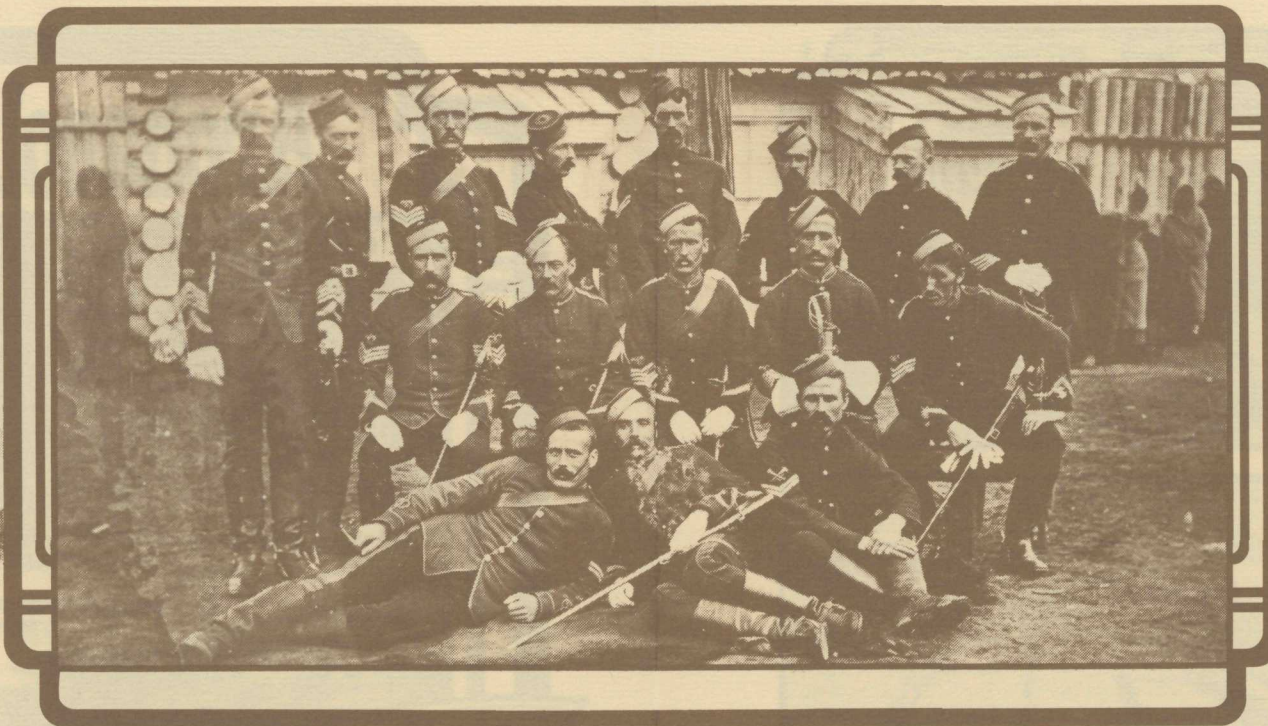
A favourite past time at Fort Walsh — posing for a picture. Fortunately such portraits provide a valuable source of architectural data; in this case, the library constructed in 1881. Credit: Glenbow-Alberta Institute, NA-659-30.

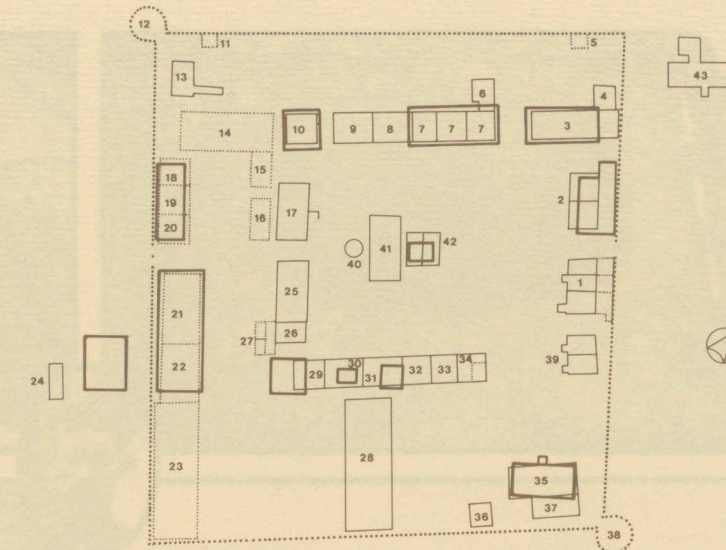
The 1883 layout of Fort Walsh as superimposed over the modern buildings (shown in bold outline).

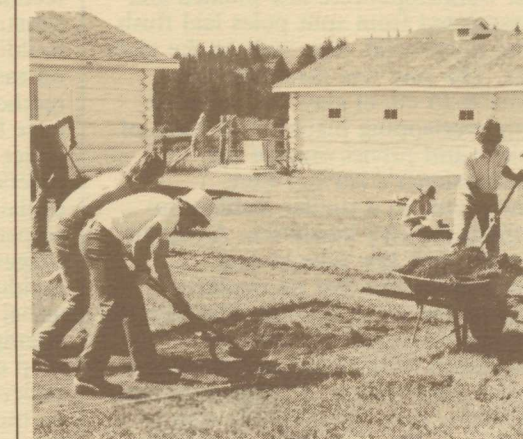
Archaeologists removing sod from a NWMP building site. The foundations will be uncovered to collect information on building architecture and construction detail.

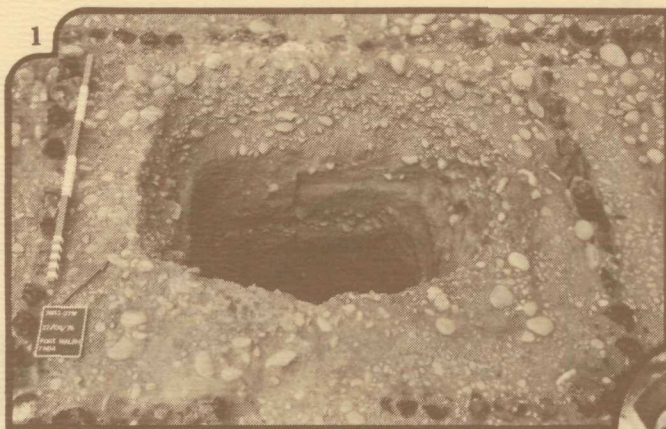
1 The remains of the log walls and pit in the officers' privy as uncovered by the archaeologists. The entrance to the structure is delineated by the opening in the wall at the bottom of the photo.

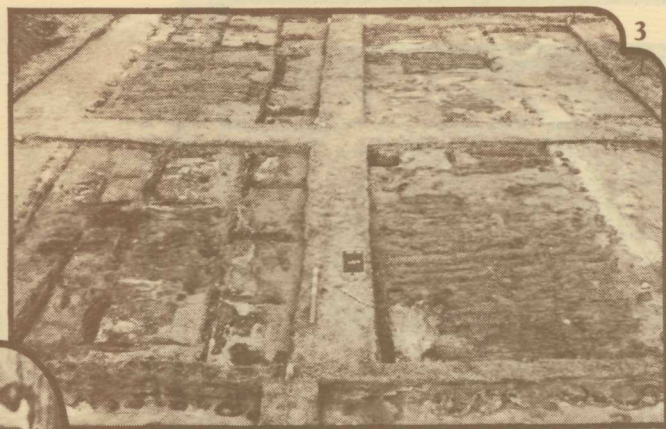
3 The remains of the north stables as uncovered by the archaeologists. Floorboards, joists, and vertical log walls can be seen in the photo (view facing northeast).

All the structures at Fort Walsh were single storey, constructed from skinned, unshaped logs, chinked with a mixture of clay and sand. The buildings, including the palisade, were also whitewashed on the interior and exterior surfaces with a coating of local white clay. Methods of construction generally conformed to one of two techniques. Utilitarian structures such as the stables and some storage buildings and privies were built of upright logs placed side by side in a

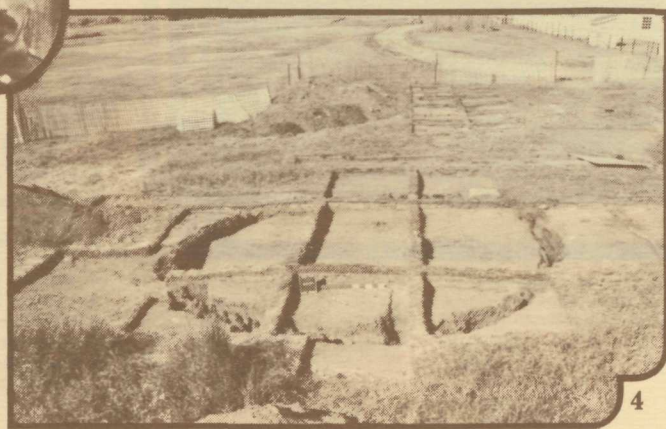
4 The excavation of the northwest bastion footing trench (view facing northeast).

Of particular importance, archaeological research has shown that, despite the popular concept of a "wild" frontier, defense was not a major concern in the construction and layout of Fort Walsh. The palisade merely consisted of logs, thirteen feet in length, set vertically in a shallow footing trench. Rocks or other materials were not used to stabilize the wall base and the upper section was only secured by a single horizontal log nailed about four feet from the top of each post. The varying log sizes and the irregular spacing of the posts probably gave the wall a makeshift appearance. In addition, the acidic soil acting on the untreated logs created a lack of stability resulting in the collapse of a section of the palisade in a wind storm.

The military significance of the bastions was also secondary. Archaeological investigations have indicated that the structures were not built with firing platforms but were roofed and used for grain storage. Although the bastions would probably provide some protection in an emergency, they were primarily designed and built as granaries.
