Wood Buffalo National Park Flood Report, Spring 2014

Jason Straka and Queenie Gray
Fort Chipewyan, AB
Contact jason.straka@pc.gc.ca

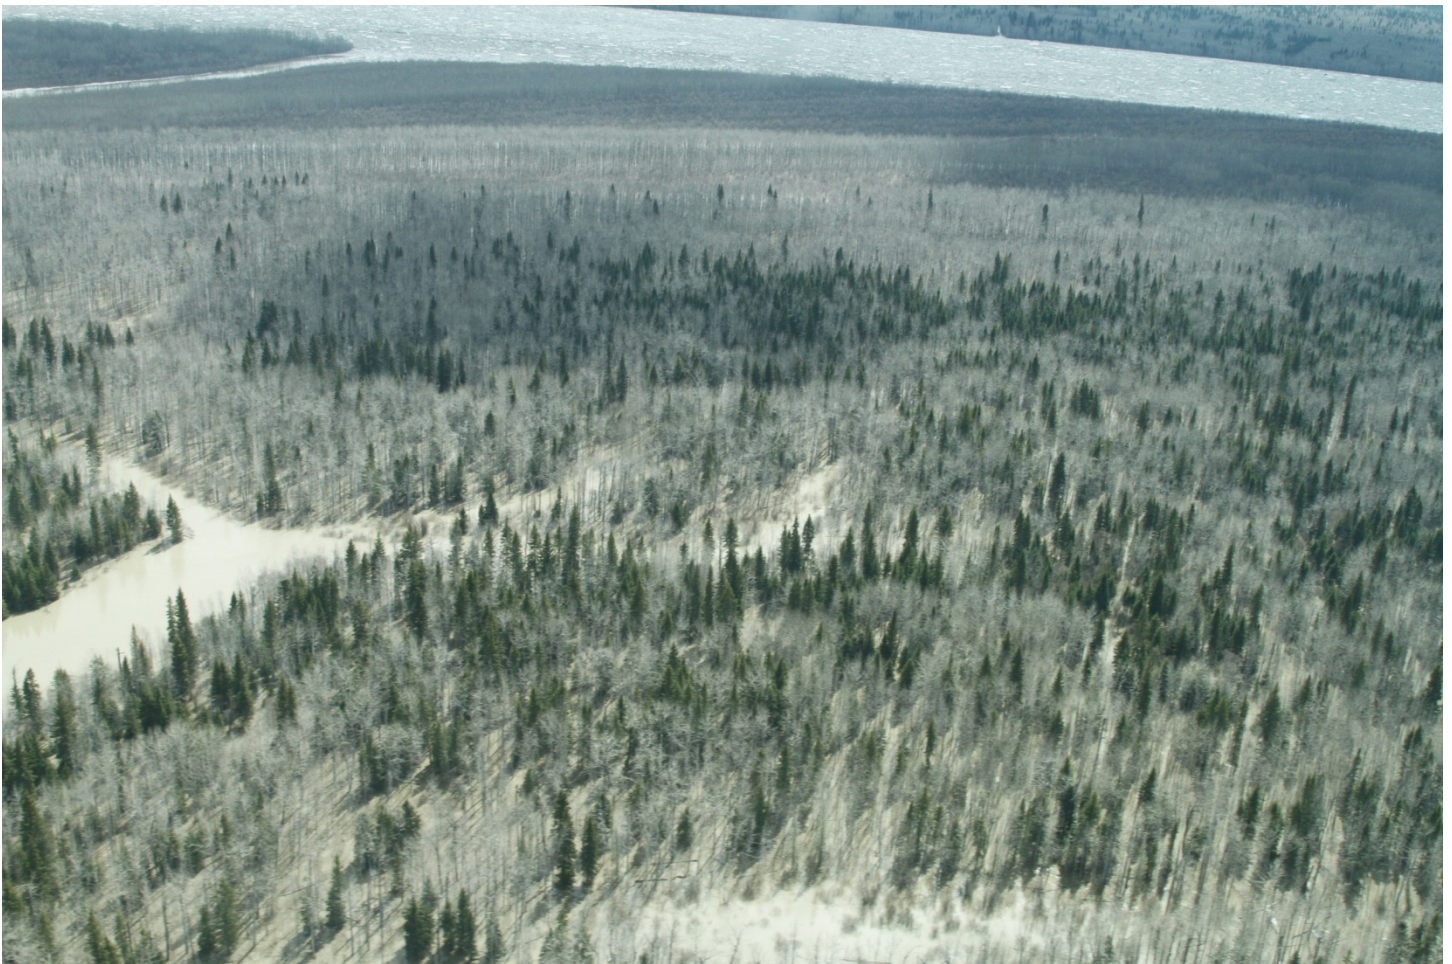
The water level rose an estimated 6 metres on parts of the Peace downstream of Garden River, in the areas around Peace Point (59.1237°N, -112.4479°W) and Sweetgrass Landing (58.9280°N, -111.9265°W). Maximum water levels probably occurred around May 5-6, while a large ice jam was in place between Burnt Thumb (59.005486°N, -112.062549°W) on the Peace, and 30th Baseline (59.075086°N, -111.419856°W) on the Slave. Many islands were inundated, as were low-lying areas within the floodplain (Figure 2).

Figure 2 – Overbank flooding on north side of the Peace River (58.943158°N, -111.896172°W) near Sweetgrass Landing (May 6, 2014).

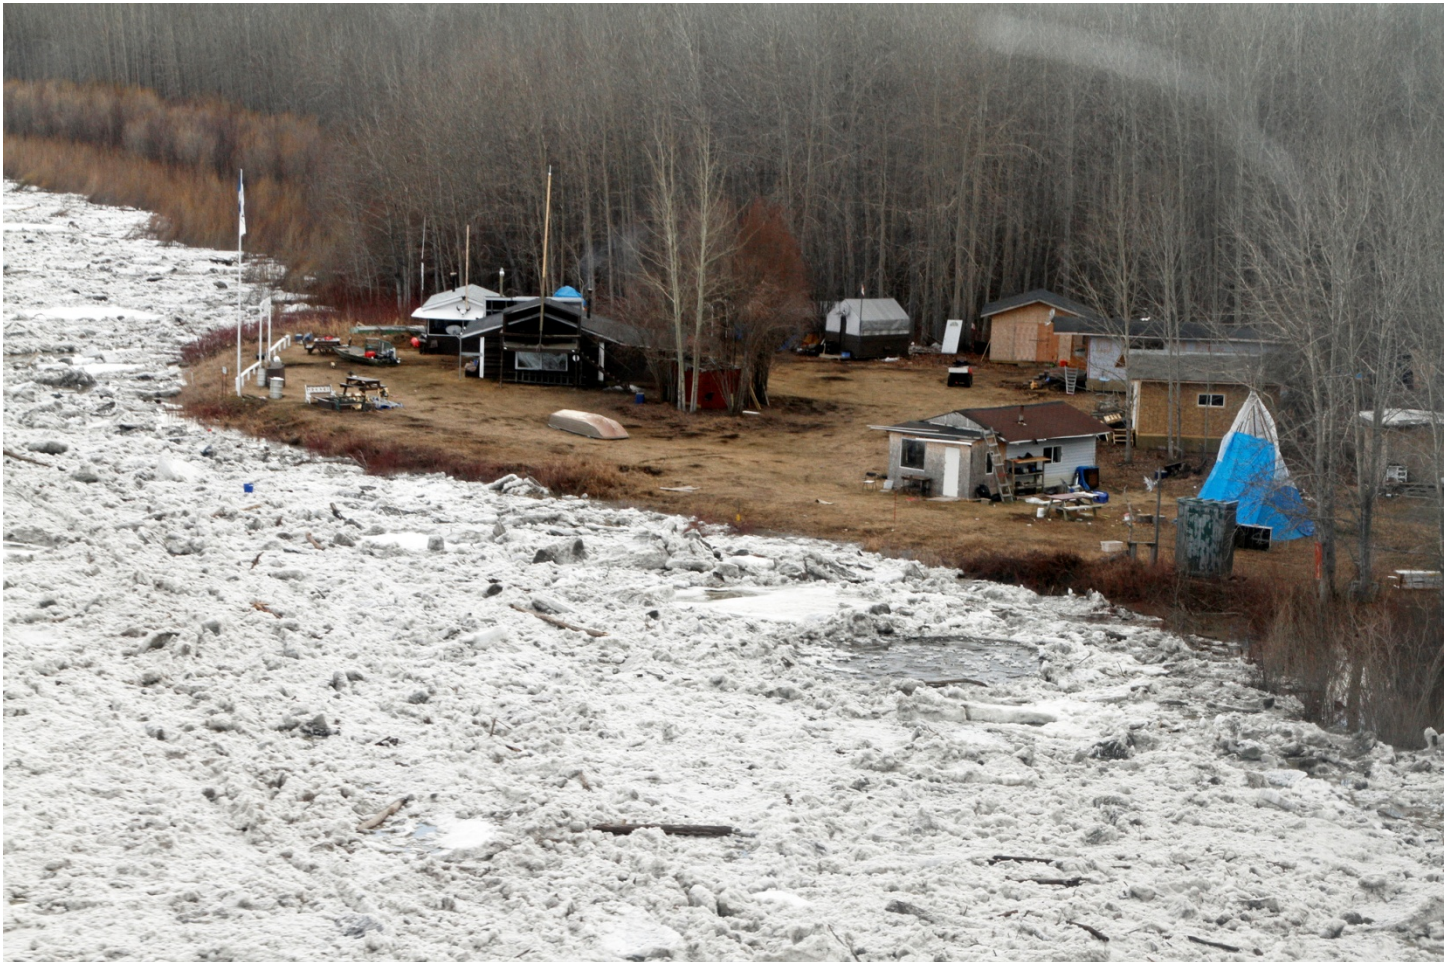
Cabins at Peace Point, Carlson's Landing, and Moose Island were not flooded, but water came within about 1 m of breaching the bank at Rocky Point (Figure 3), and reached some cabins downstream of Rocky Point.

Figure 3 - Water level approaching bank at Rocky Point (58.916183°N, -111.594057°W) on the Peace River (16:00 on May 6th, 2014).

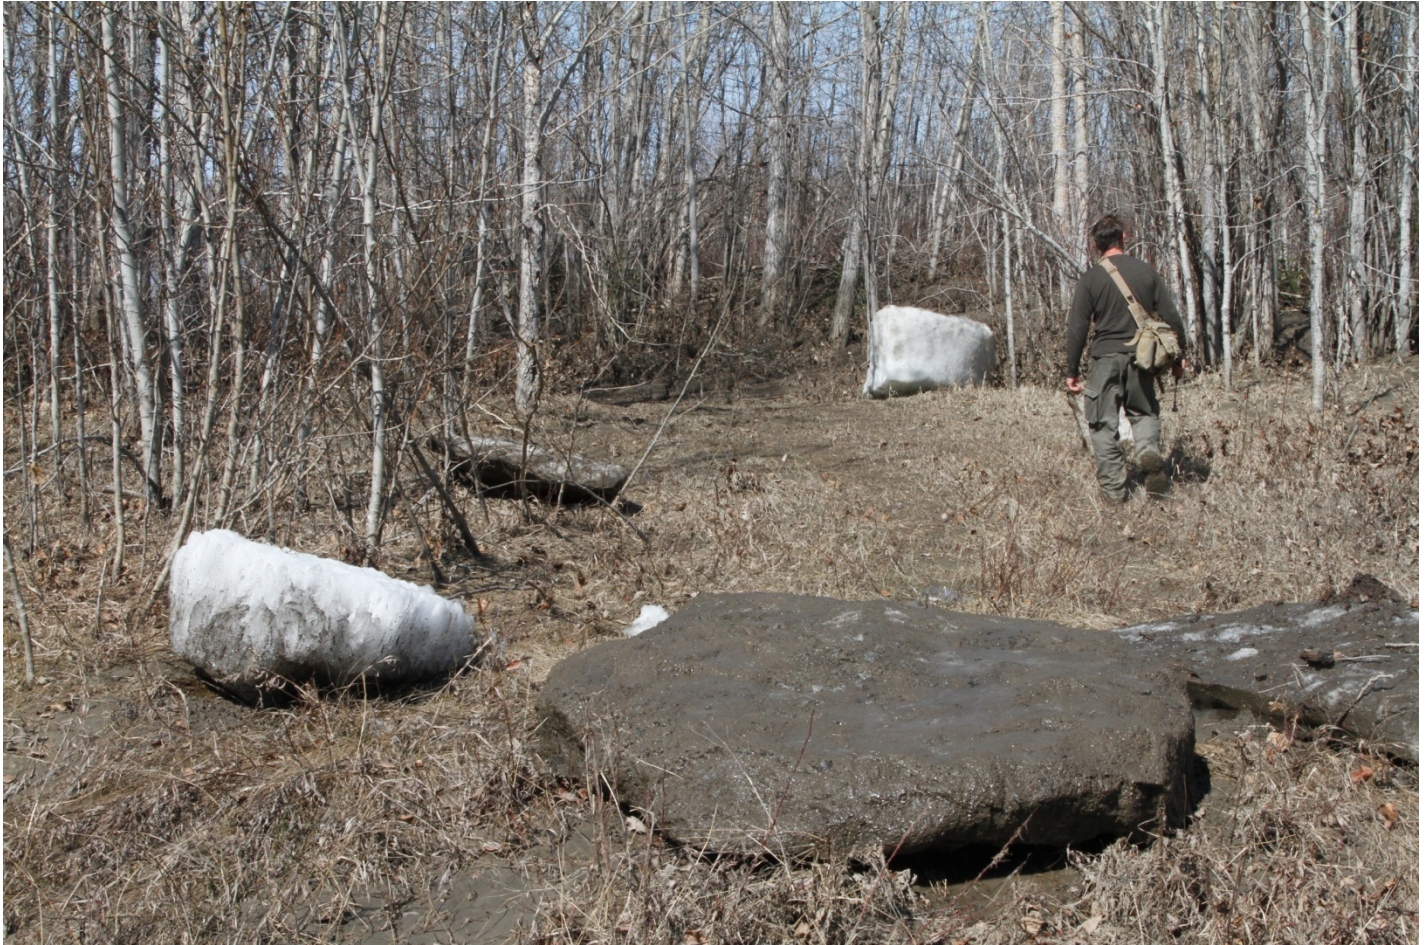
Water breached the north and south banks of the Peace River in several areas – particularly around Sweetgrass Landing (Figures 4-5).

Figure 4 – Ice and sediment deposited by overbank flooding at Sweetgrass Landing (photo taken post-flood: May 14, 2014).

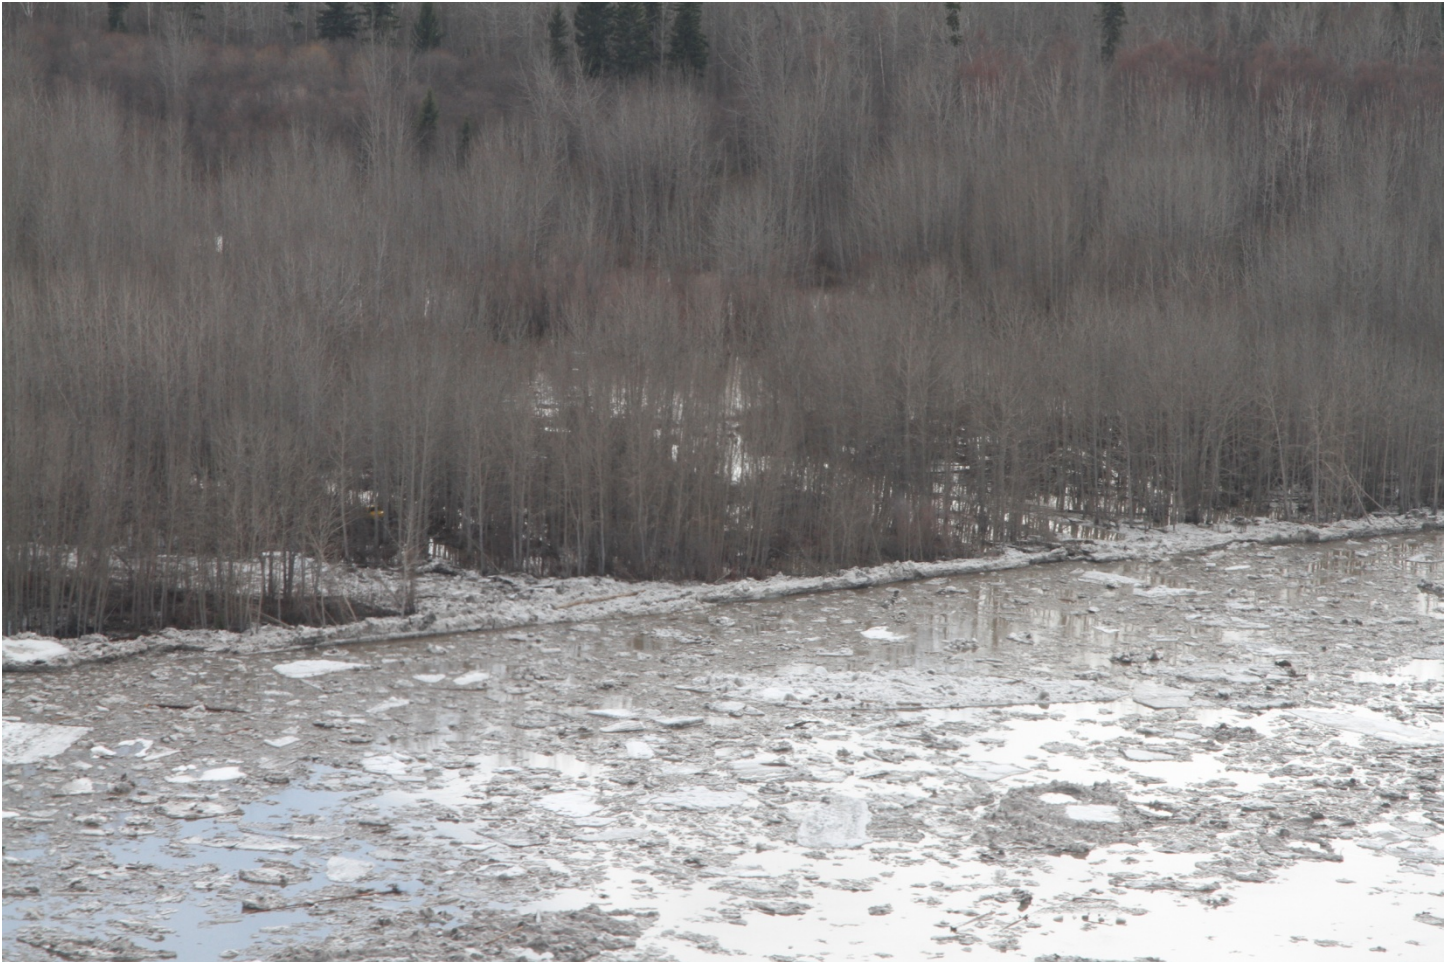
Figure 5 - Overbank flooding at Sweetgrass Landing (May 6, 2014)

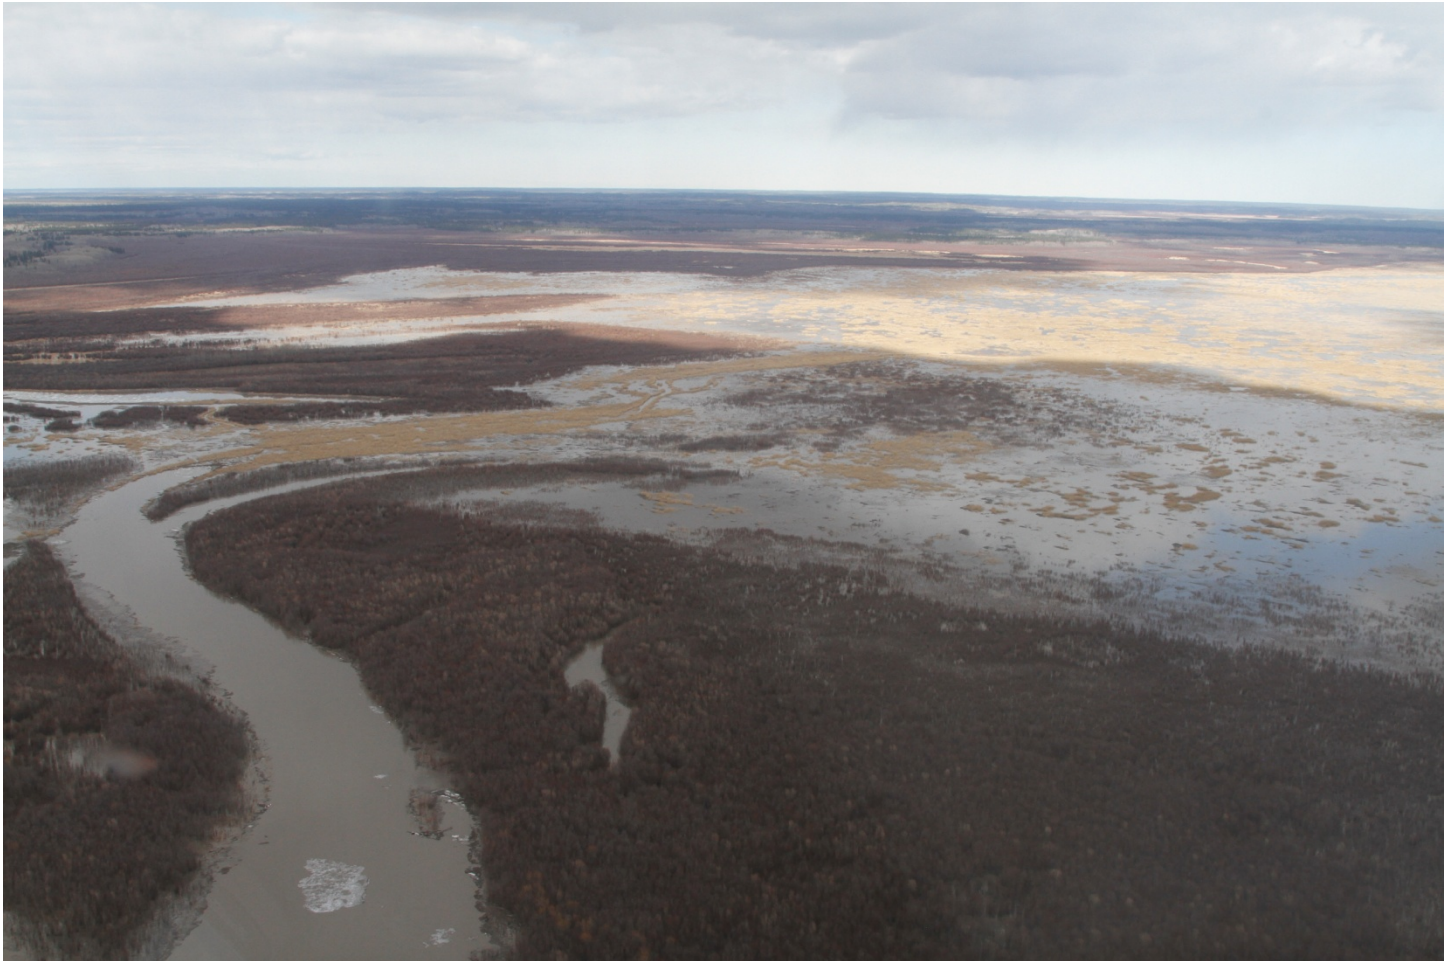
When the flood was at its peak, most of the major channels south of the Peace (Sweetgrass River, Claire River/Pine Channel, Baril River) began flowing rapidly, eventually carrying flood water as far as the north end of Lake Claire, Lake Mamawi, and Baril Lake (Figure 6).

Figure 6 - Flood waters from Peace River flowing into north end of Baril Lake (58.800464°N, -111.688498°W) via Baril River (May 6, 2014)

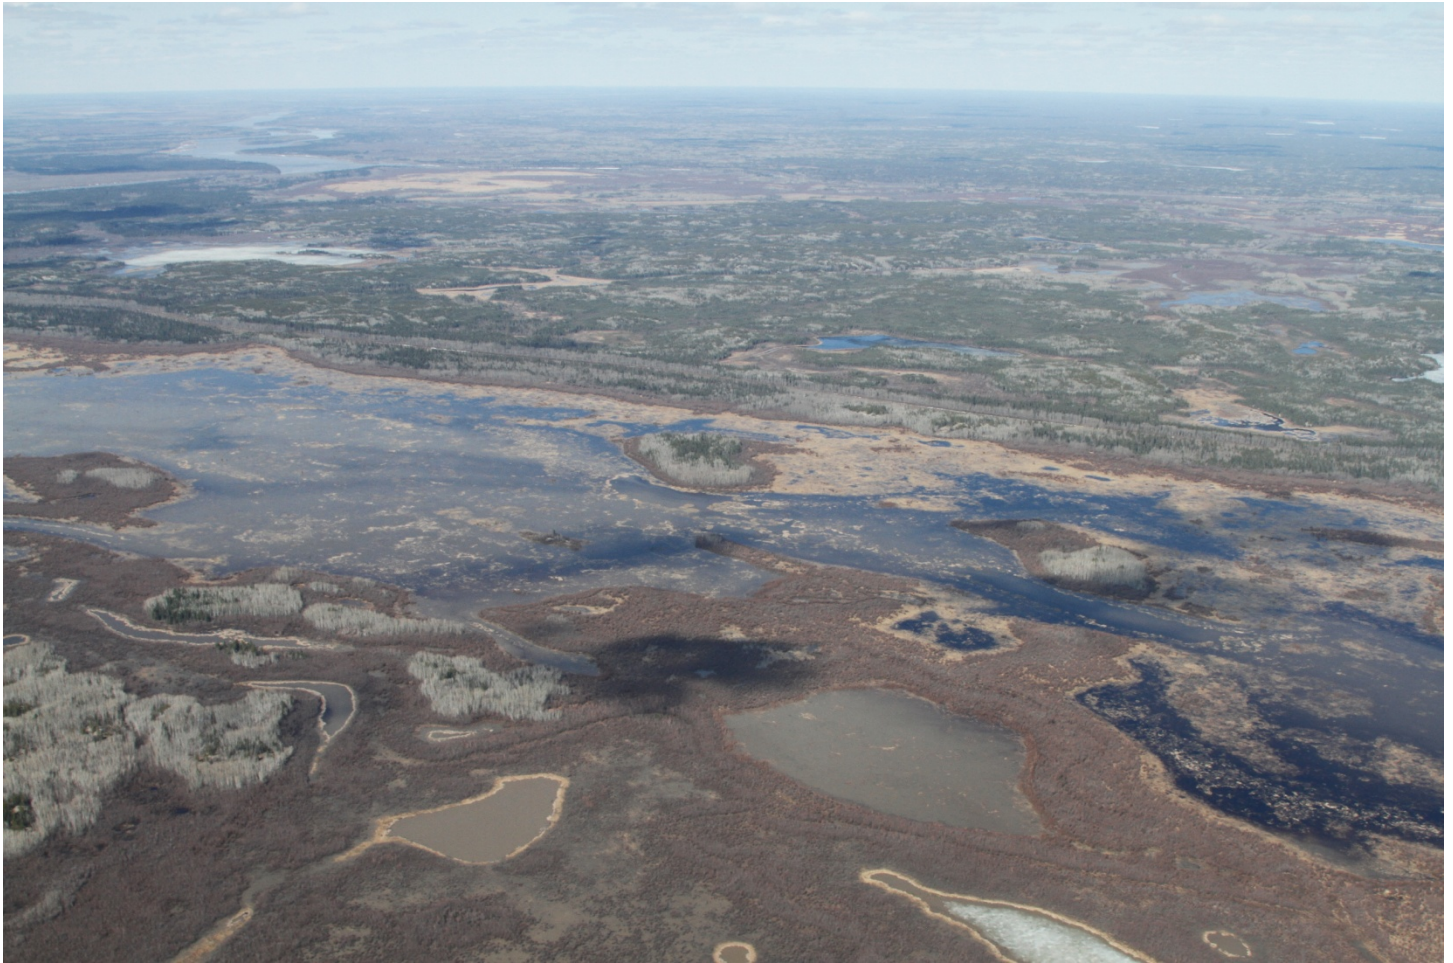
From about May 7-10 there was an ice jam on the Quatre Fourches channel, in the area west of Pushup Lake (see map - Appendix I. Head: 58.8424°N, -111.5761°W; Toe: 58.7925°N, -111.5314°W). This caused flooding of channels that feed a number of basins in the vicinity of Pushup Lake, and eventually Egg Lake (Figure 7).

Figure 7 – Flood water in Egg Lake (58.8963°N, -111.4228°W). Photo taken soon after flood (May 15, 2014).

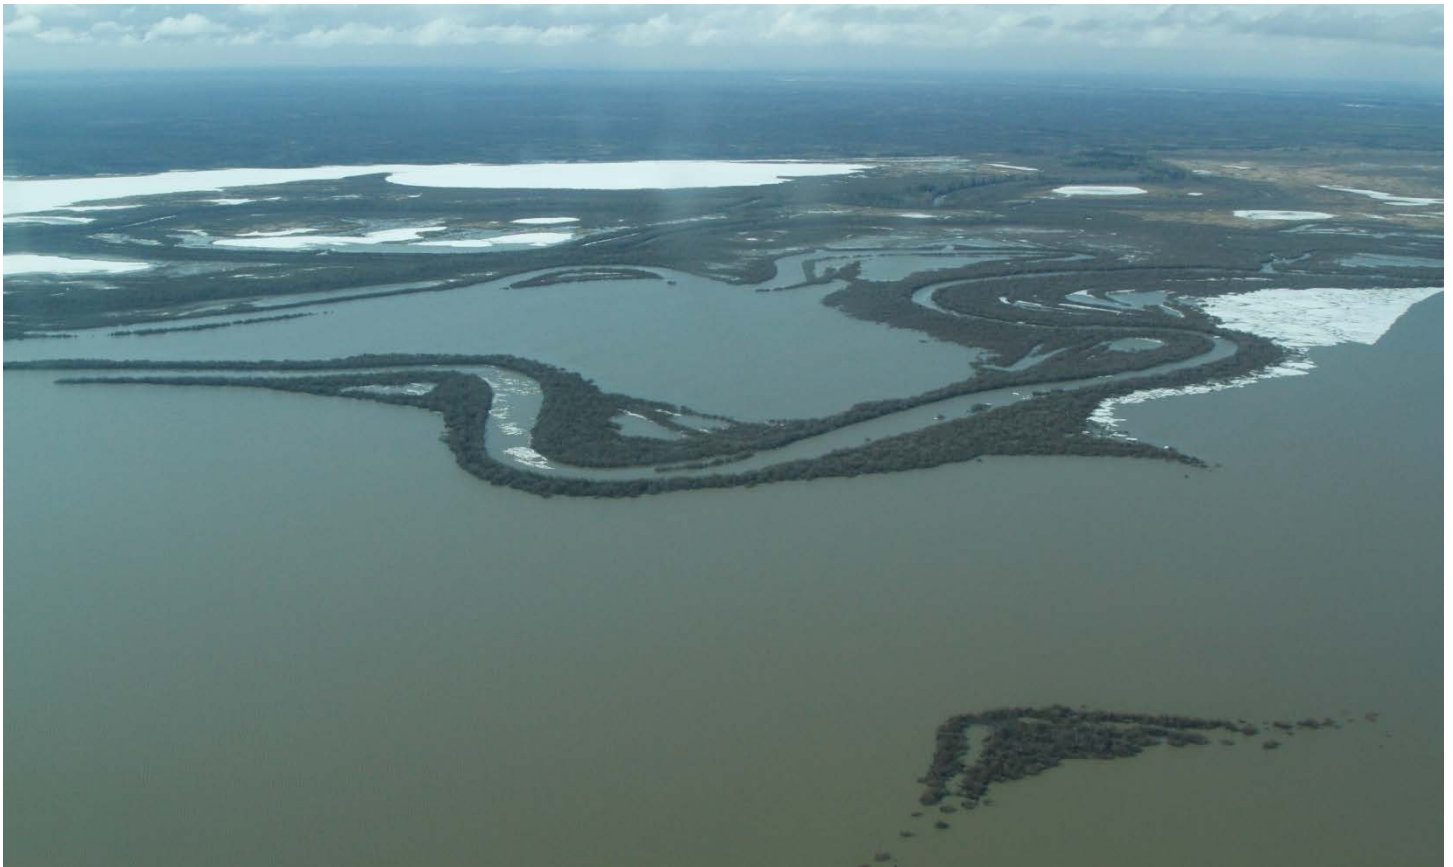
Flooding was observed south of the Athabasca River as far as Limon Lake (58.420934°N, -111.351317°W) and Blanche Lake (58.389088°N, -111.302747°W) (Figure 8).

Figure 8 – Flooding at Limon Lake, looking south from the Athabasca River (May 4, 2014).

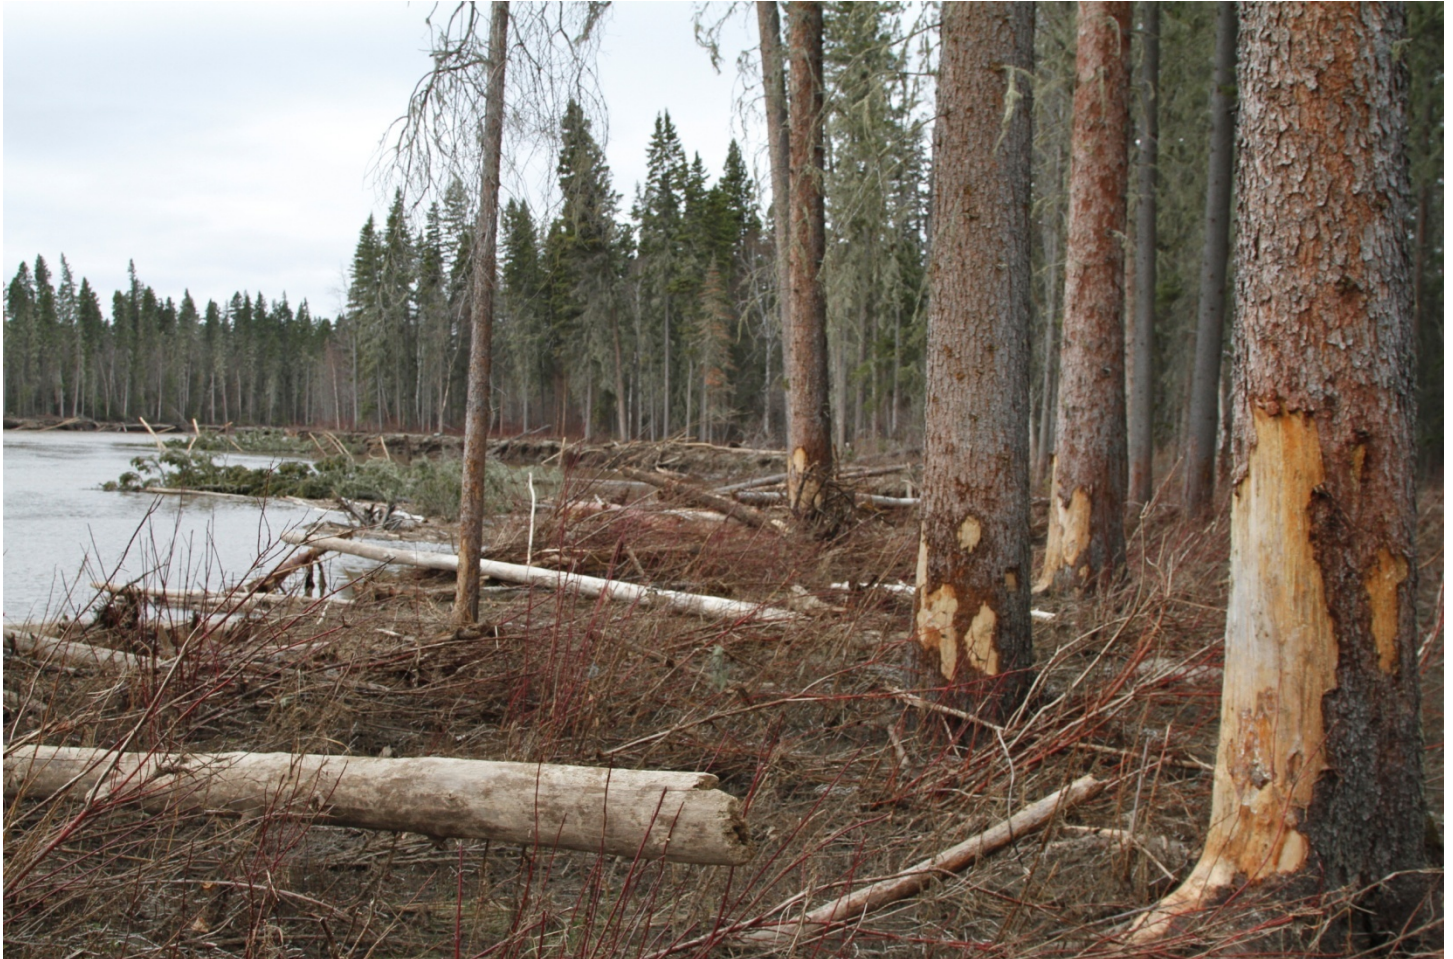
Water levels were high on the Embarras, and Mamawi Creek, perhaps rising as much as 3-4m. There was extensive erosion of the bank near the cut-off to Mamawi Creek and overbank flooding (Figure 9). A large amount of woody debris was carried to the mouth of Mamawi Creek at Lake Mamawi, which was the first area of the lake to have open water. Water levels were high along Mamawi Creek, causing flooding of channels and some overbank flooding and deposition of sediment into Johnny's Cabin Pond and Mamawi Creek Pond.

Figure 9 – Severe ice-scarring on mature spruce at the cutoff of Mamawi Creek from the Embarras. There was also extensive erosion and deposition of fresh sediment over this bank (east bank of Mamawi Creek)

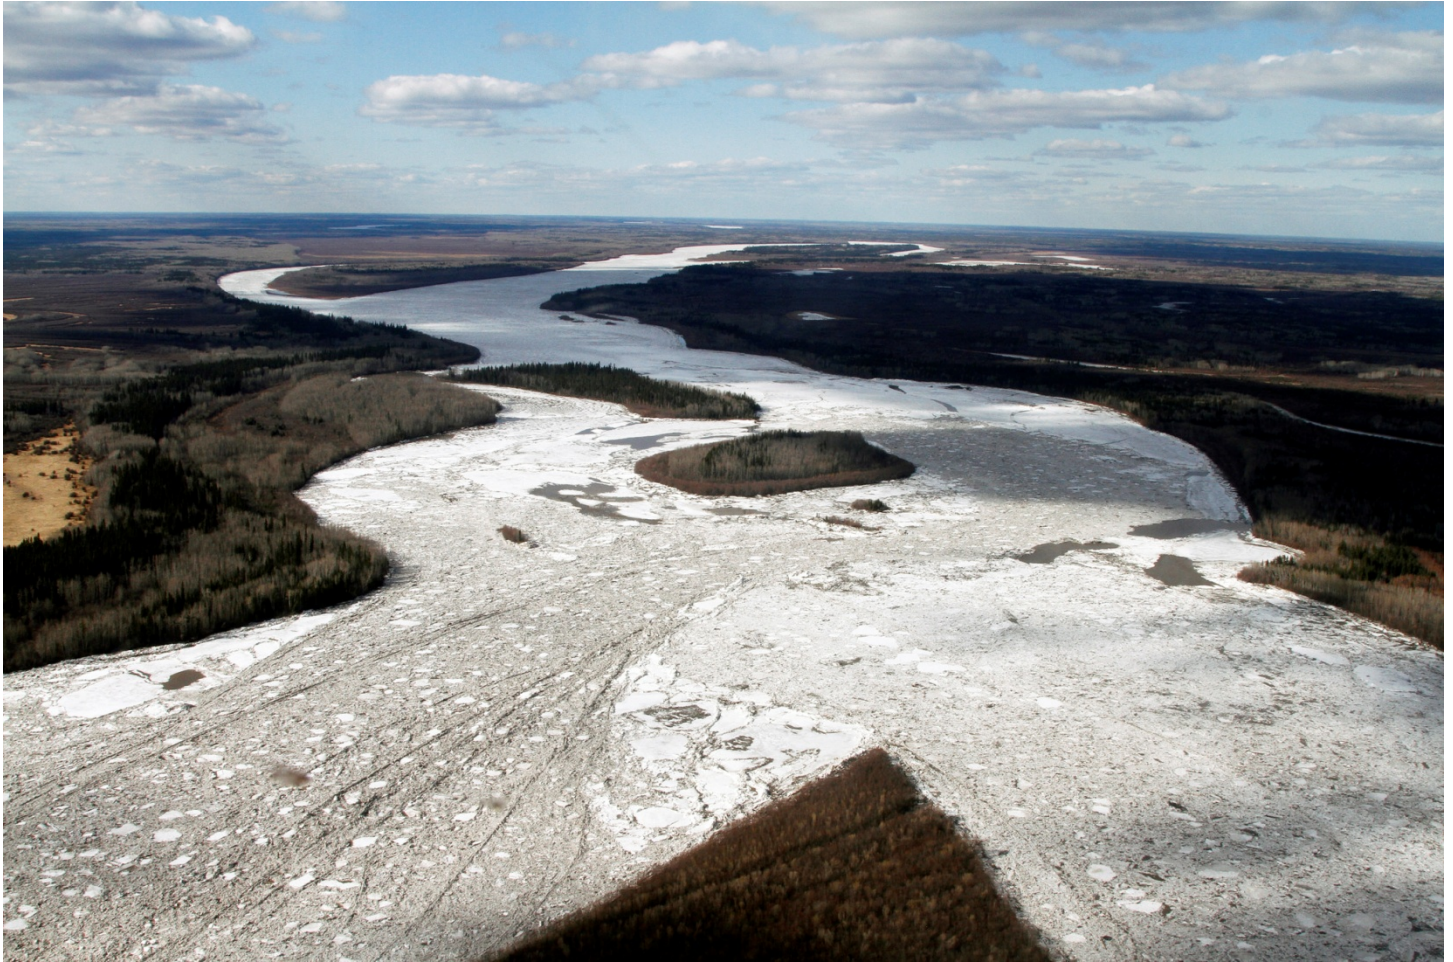
The main action on the Slave River was related to the toe of the large ice jam at 30th Baseline, and extending up the Peace (Figure 10).

Figure 10 - Toe of ice jam on Slave River (May 6, 2014). Sheet ice visible on either side of island.
