YORK FACTORY ARCHAEOLOGY:

INTERIM REPORT 1981-1982

by Gary Adams

1985

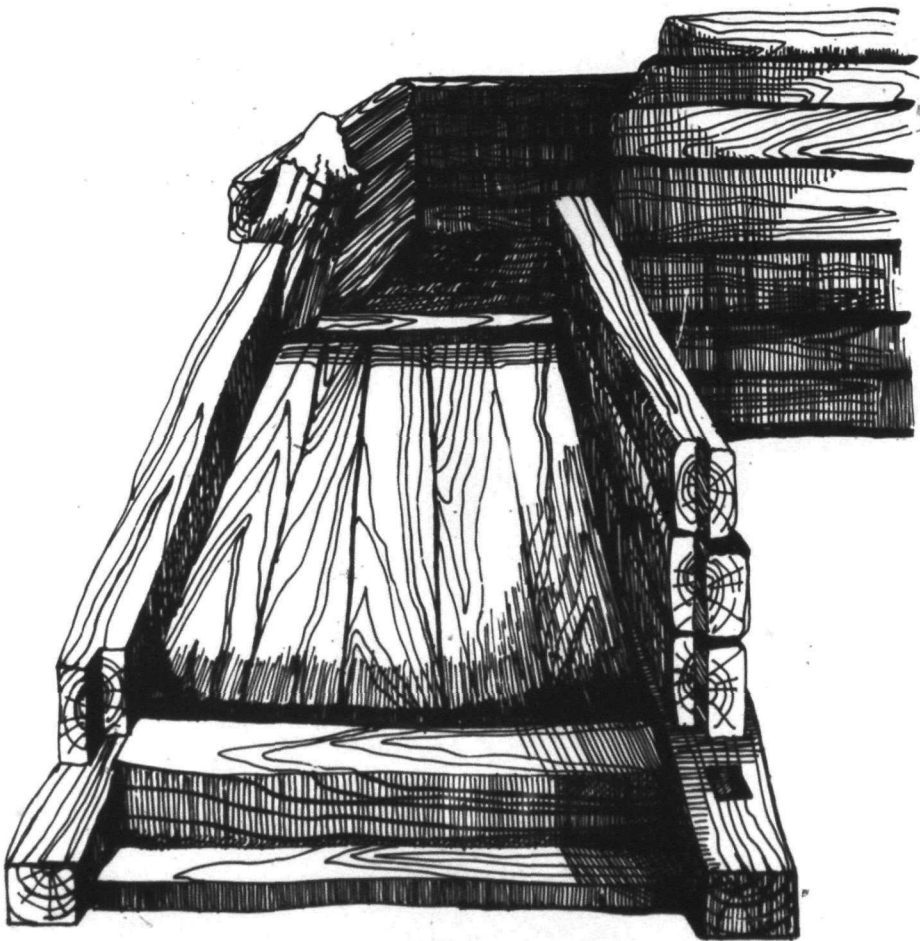
Figure 5. Artists impression of passageway remains looking towards interior of Ice House (L. Lynde, artist).

Further excavation in the area of the door in the north-west corner of the Ice House has confirmed the existence of an entrance passageway and outer door (Figure 5). The passageway was 0.96 m in width, 3.02 m in length and was elevated 17 cm above the interior floor. There were north and south walls of post-on-sill construction. These walls consisted of hand hewn, squared logs 12 cm wide by 18 cm to 21 cm thick notched at both west and east ends. Fitting against the notched ends were upright, frame posts, at one

The door frame was most evident at the interior (east) side of the entrance where there were two upright posts - one on each side of the doorsill. The south door post was roughly squared and measured 21 cm north-south by 14 cm east-west by 50 cm in height. The post was notched on the south side to fit against the north end of the interior west wall and was attached with wire nails. It was set on the interior west wall sill which was a squared log 16 cm wide by 10 cm thick. The north door post was a squared log 18 cm by 18 cm and 93 cm in height. It fit into the west end notch of the interior north wall and rested on the second

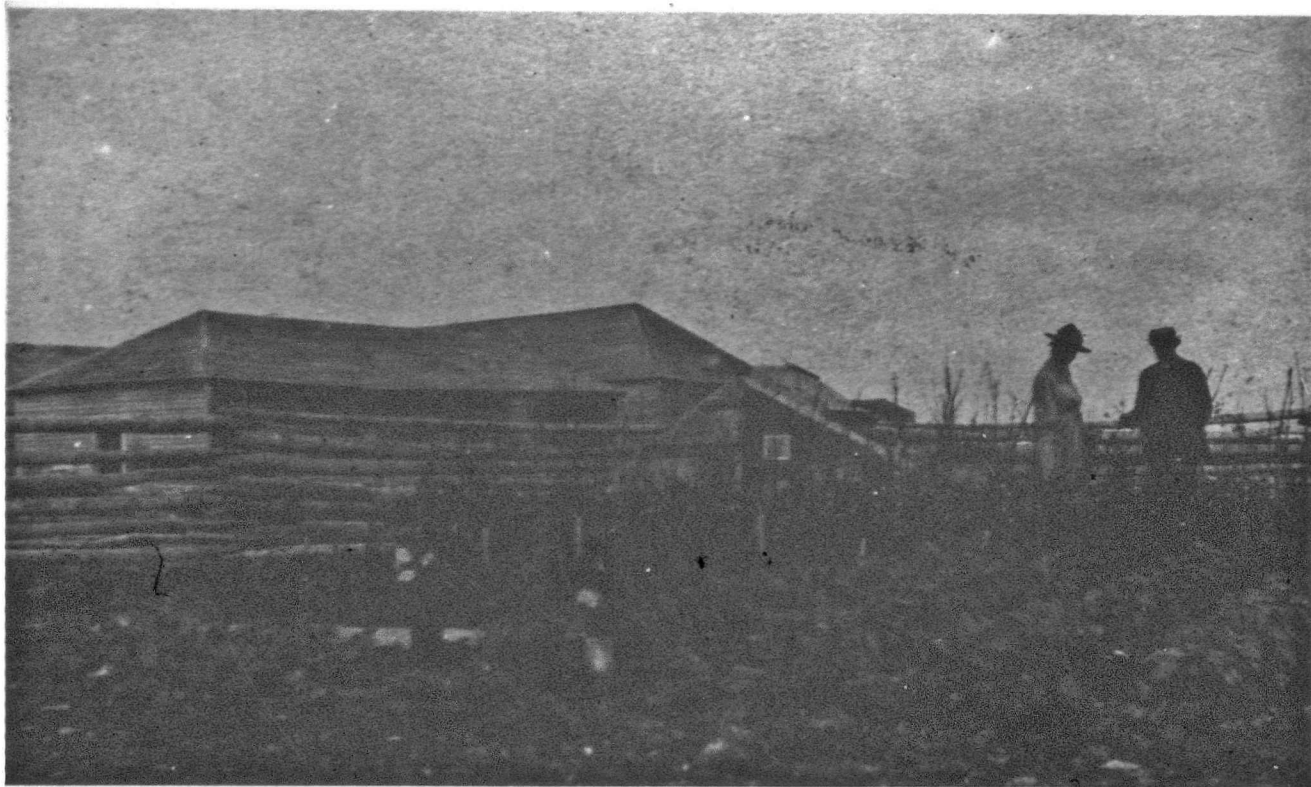
Figure 15. In 1910 Photograph the South Fur Store is tall structure in centre background. (Public Archives of Manitoba, A.V. Thomas, 97.)

The third fur warehouse, just completed, was alternately called the "New Fur Store or Back Fur Store" but has been termed the South Fur Store in this report (Figure 15). It was described in 1889 as being a 63 by 30 frame structure, ceiled and covered with a clapboard roof (HBCA B.239/e/12 fo.4a, YF Post Inspections Report.. J. McDougal, 6-15 August 1889). In 1895 it was described as 64 by 32 feet, one-and-a-half storeys and lined (HBCA, B.239/e/17, fo.2a, YFReport 1895-1897, F. Matheson).

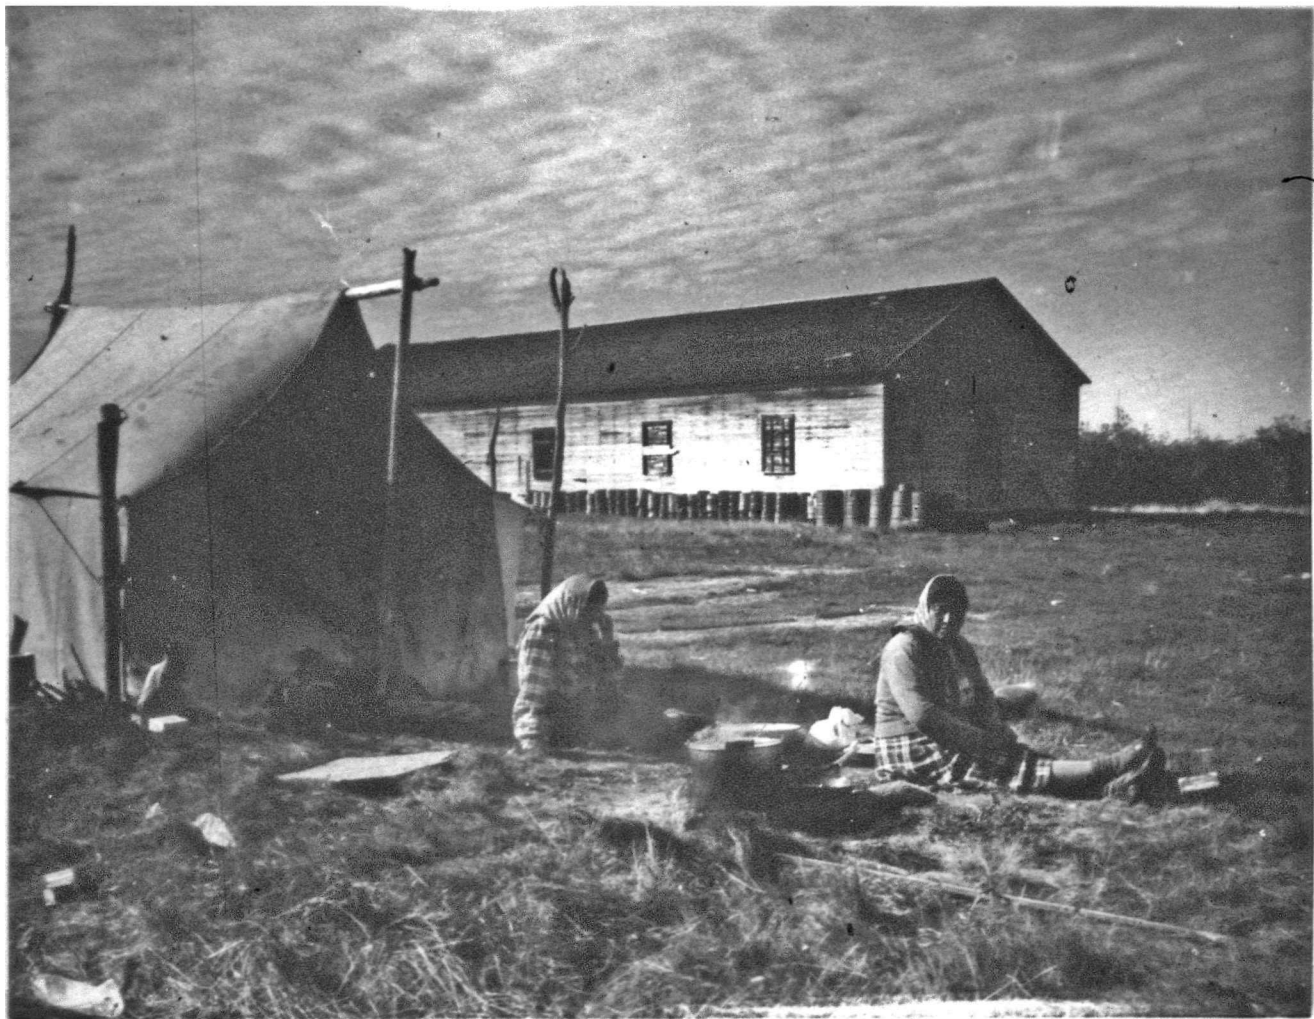
Figure 22. 1957 photo of 1916 Boat Builder's House. (Photo courtesy of A.B. McIvor, Hudson's Bay Company collection Y-110.)

storey structure of frame construction with planking inside and out. The roof and the exterior were covered in tarpaper. Photographs of the building indicated that it had one central door on the east side, flanked by two barn doors. The south side had four windows and a wide drop style door (Figure 22).

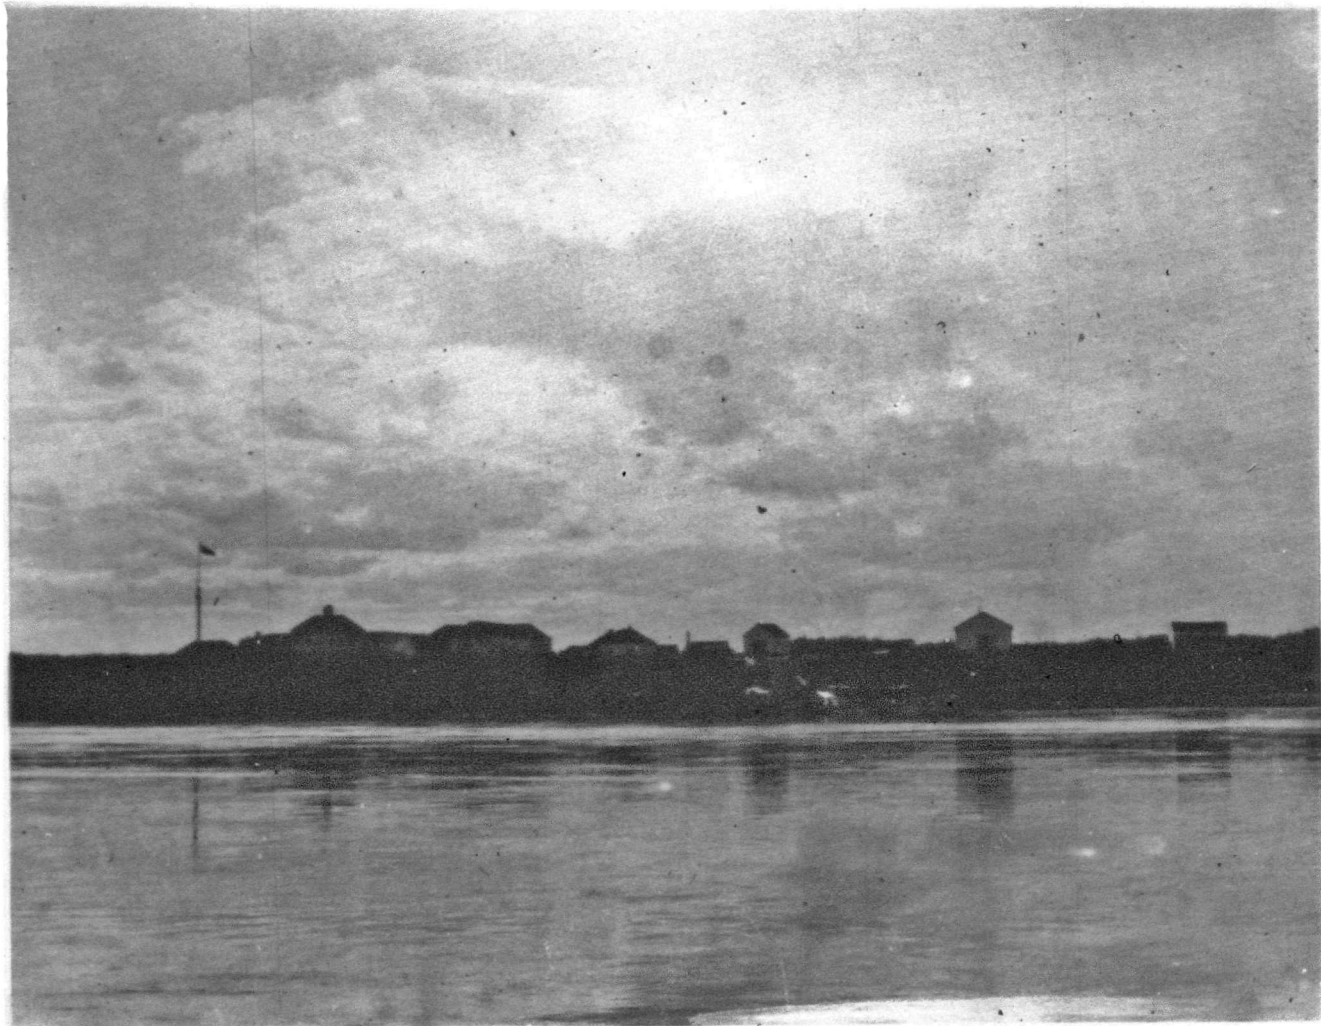
Figure 23. View of lower pier area in 1934. Canoe shed is structure directly behind pier, 1916 Boat Builders House is to its right and Inland Cargo House is to the left. (Photo courtesy of Hudson's Bay Company 80/144.)

The second Boat Builder's House was constructed to the north of the 1840 version, while to its south was an additional building, usually referred to as the Canoe Shed as its original function was to provide storage for small boats and canoes. Framing for the Canoe Shed began in May, 1845 followed by foundations and the frame erection in June. It was completed by July 12, 1845 (HBCA, B.239/a/161,f.46d YFJ, 12 July 1845). This building was a single storey frame structure measuring 40 feet (12.2 m) in length and 16 feet to 18 feet (4.9 m to 5.5 m) in width, weatherboarded and covered with a clapboard roof. Photographs indicate that it had a double door on the east end, two windows on either long side and a gable window on the west end (Figure 23).
