*BRUCE F. DONALDSON'S REPORT ON  
THE YORK FACTORY "DEPOT" WAREHOUSE:  
A STRUCTURAL AND USE HISTORY, 1830-1981  
MARCH 1982*

This study traces the structural and use history of the extant "Depot" warehouse building at York Factory, Manitoba, which was built by the Hudson's Bay Company between the years 1831 and 1838. The initial chapter deals with this construction process, as well as room use and layout during the period prior to 1870 when the building was utilized to its maximum capacity. The second chapter compares and contrasts the building's structural and stylistic details with those of other warehouses that were constructed by the Company at York and elsewhere during the 50 years postdating the merger with the North West Company in 1821. Section three chronicles the various structural modifications and changes in room use that occurred after York began to decline in importance as a result of the introduction of new transportation technology in western Canada during the 1860's and 1870's. This culminated with the consolidation of most activities within this building by the early years of the 20th century. The last chapter deals with the 11 years that elapsed between the Com

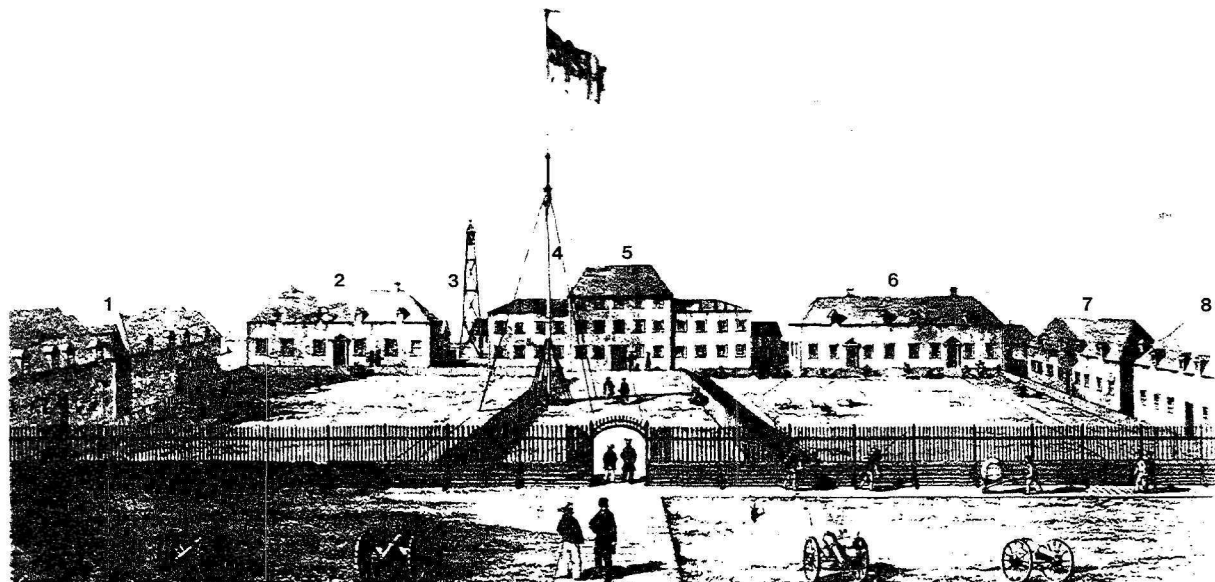
Fig. 4 "1st & 2nd Floor, Floor Plans." "As Found -  
York Factory," Report (1971), No. 9.

Compare this with the floor plan illustrated  
in Figure 39. Also see Figures 10, 14, & 18.

Note the presence of the original partitions in  
rooms 1, 3, and 7 (Figure 4). Also note the  
absence of interior entrances to room 8, and  
exterior entrances to rooms 3b and 5.

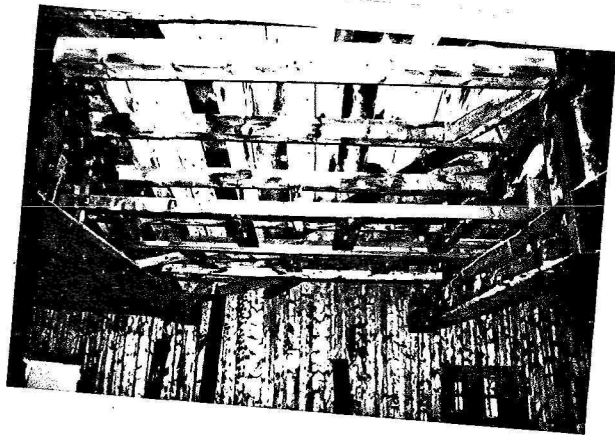
Fig. 22 Ceiling beams, room 10, Bruce F. Donaldson,  
August 1981.

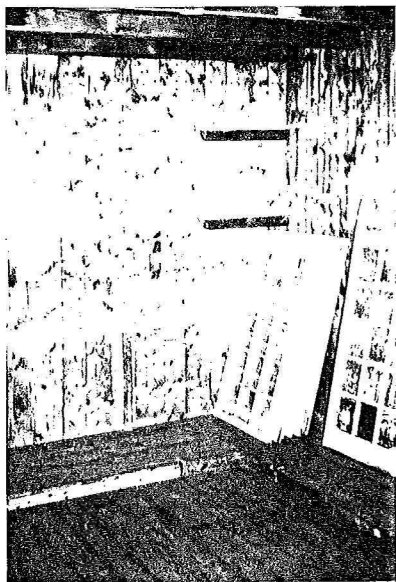
Fig. 25 Ceiling detail, room 12, Bruce F. Donaldson,  
August 1981.

Note the horizontal "knee" above the courtyard  
window and support pieces attached to the roof  
trusses and purlins.

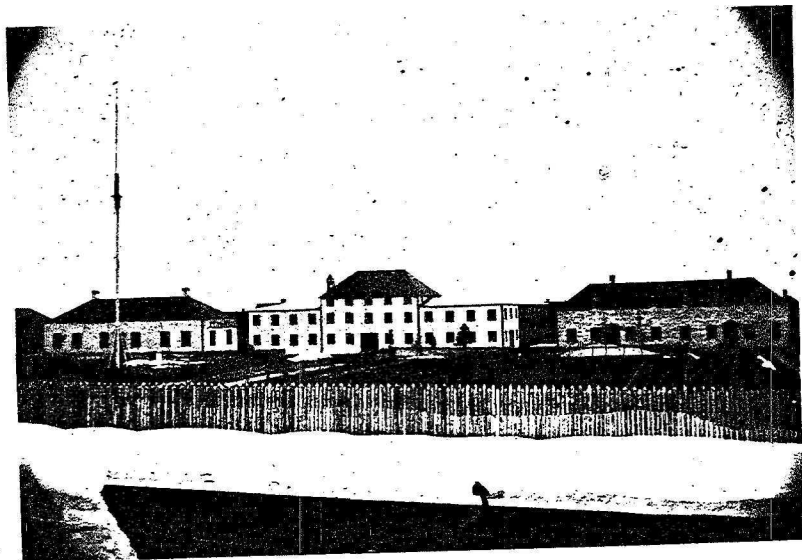
Fig. 37 York Factory in the 1870's (looking south),  
Hudson's Bay Company, No. 58A-128.

The rear portion of the "Depot" is clearly  
painted a dark colour. The trim appears to  
be white.

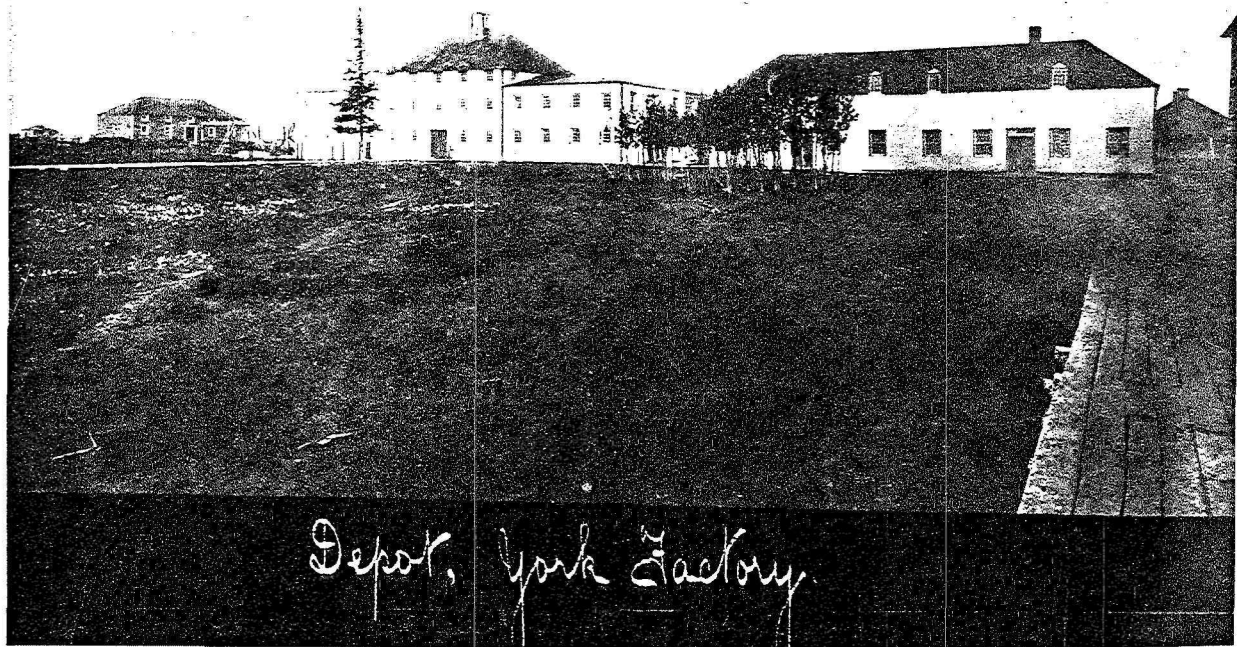
Fig. 44 "Main H. B. Company buildings York Factory, Man.,  
1915," P.A.23099, Public Archives of Canada.

Note the presence of the chimney for the heating  
stove in the saleshop in room 3b-c. The structure  
to the left of the "Depot" was the Nelson River  
District office.

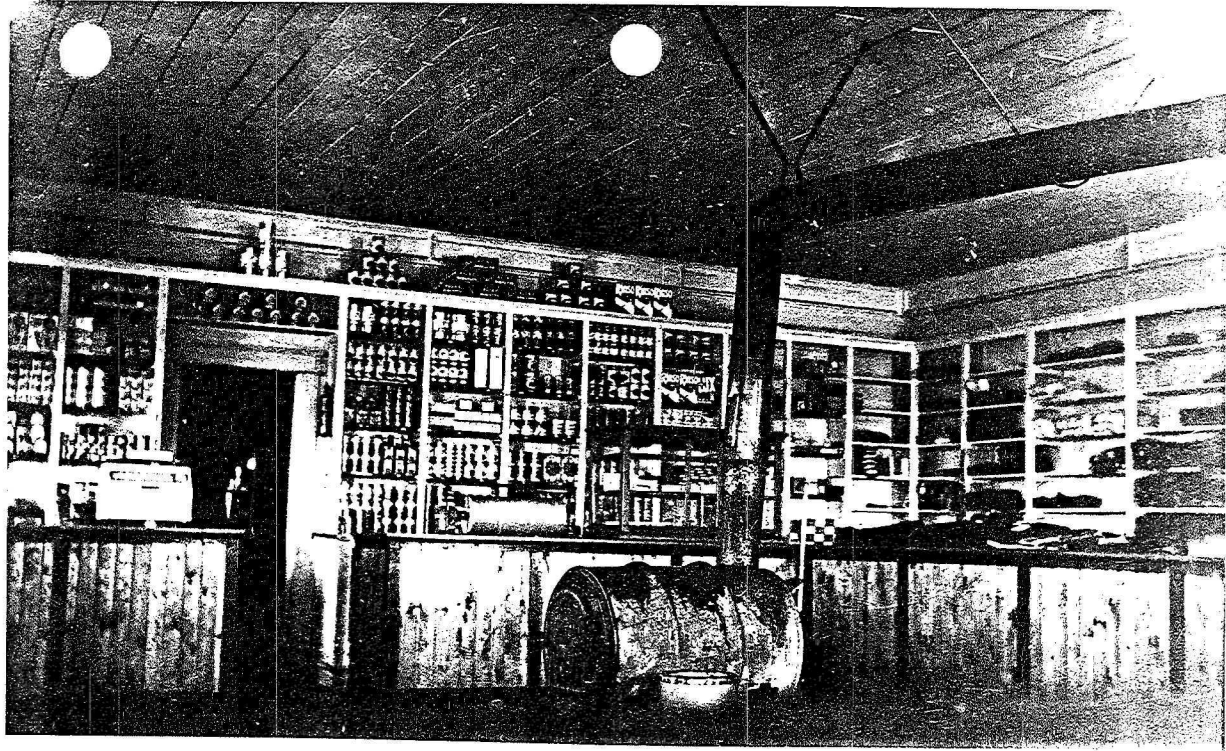
Fig. 53 "Interior of store at York Factory," 1956, No.  
McI-17, Hudson's Bay Company.

This photograph shows merchandise along the  
north and east wall of the saleshop in room  
5. The vertical boards in the counters were  
varnished.

District Manager G. A. Beare (1954+) suggests that the ceiling was raised to "provide a more modern (at the time) concept of merchandise display - i.e. higher shelves, etc."<sup>98</sup> In any case, the layout was similar to that of the previous retail store, with merchandise being placed on shelves and in cupboards located behind the counters. This layout and shelf and cupboard details are clearly visible in Figures 53 - 56.

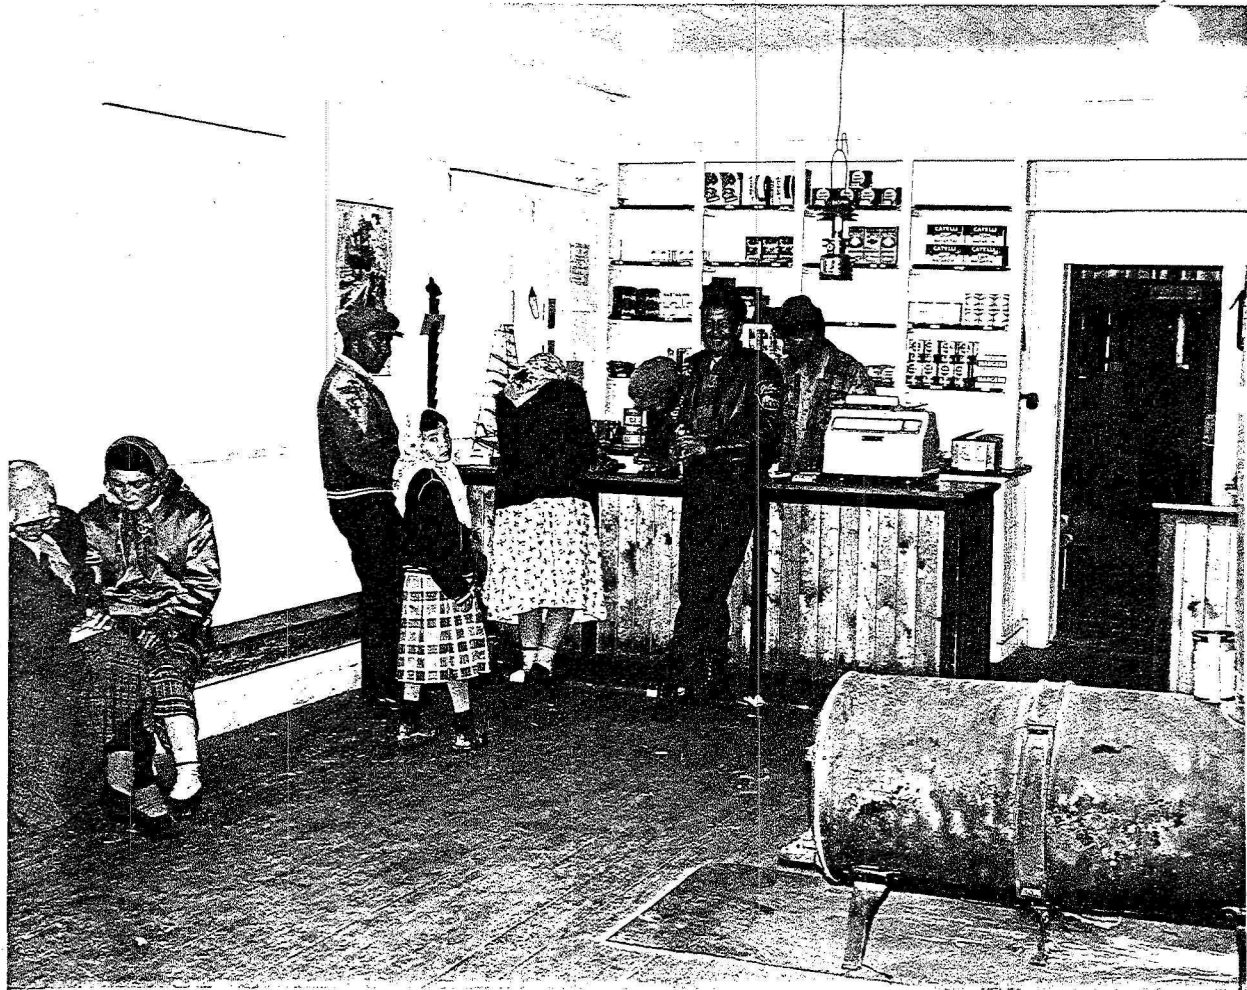
Fig. 54 "Modern Indians trading at the little store in the HBC depot building at York Factory, June 1957," No. McI-7, A. B. McIvor for the Hudson's Bay Company.

This photograph shows the north and west walls in the saleshop area. Note that the heating stove is different from that pictured in the previous photograph.

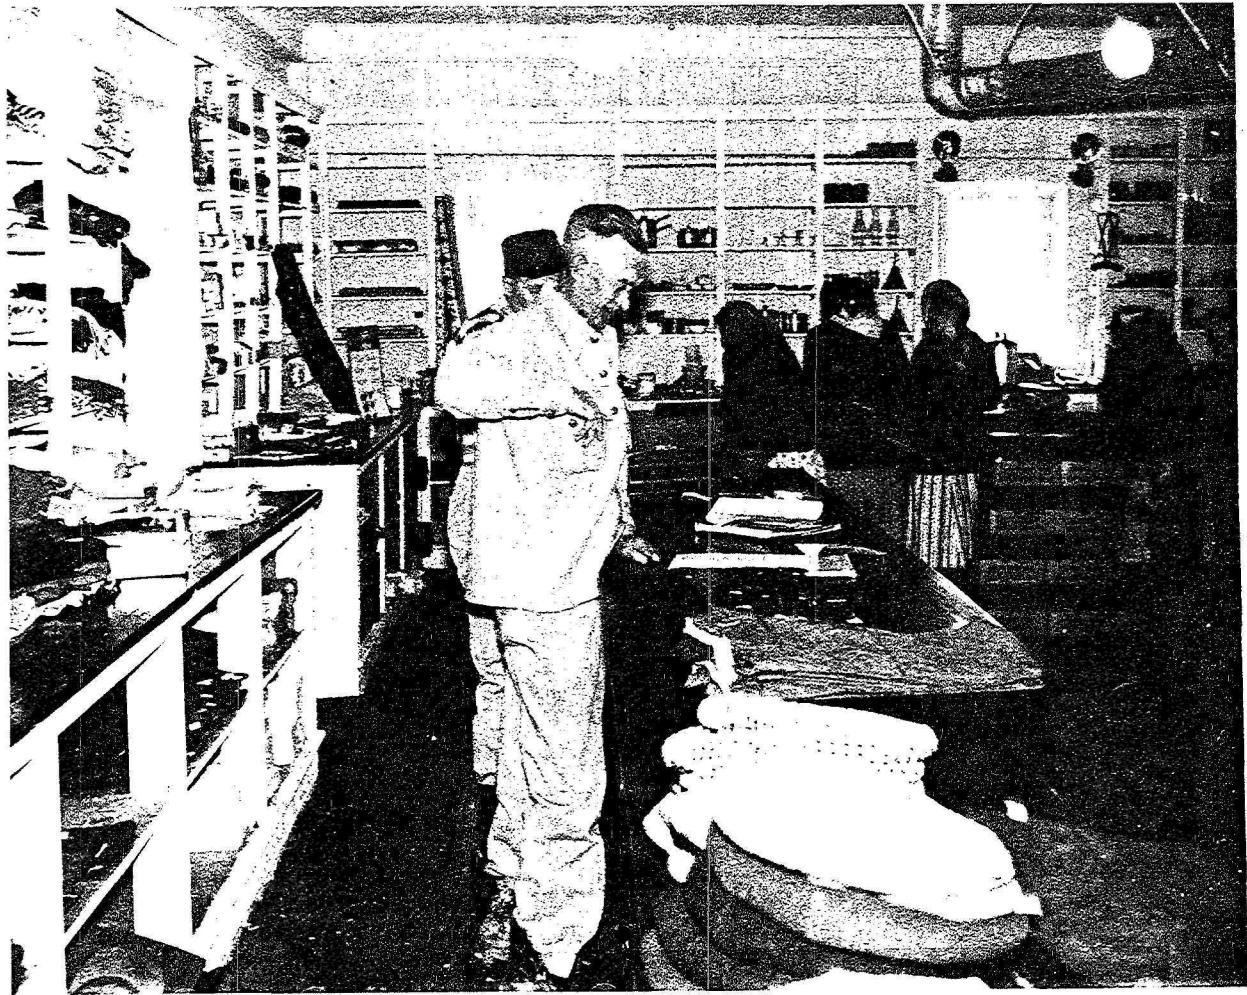
Fig. 55 "Mr. Frank Hughes, Superintendent, Indian agency,  
in HBC store, York Factory, 1957," No. 82-277A,  
A. B. McIvor for the Hudson's Bay Company.

This photograph shows the east and south walls in  
the saleshop area.

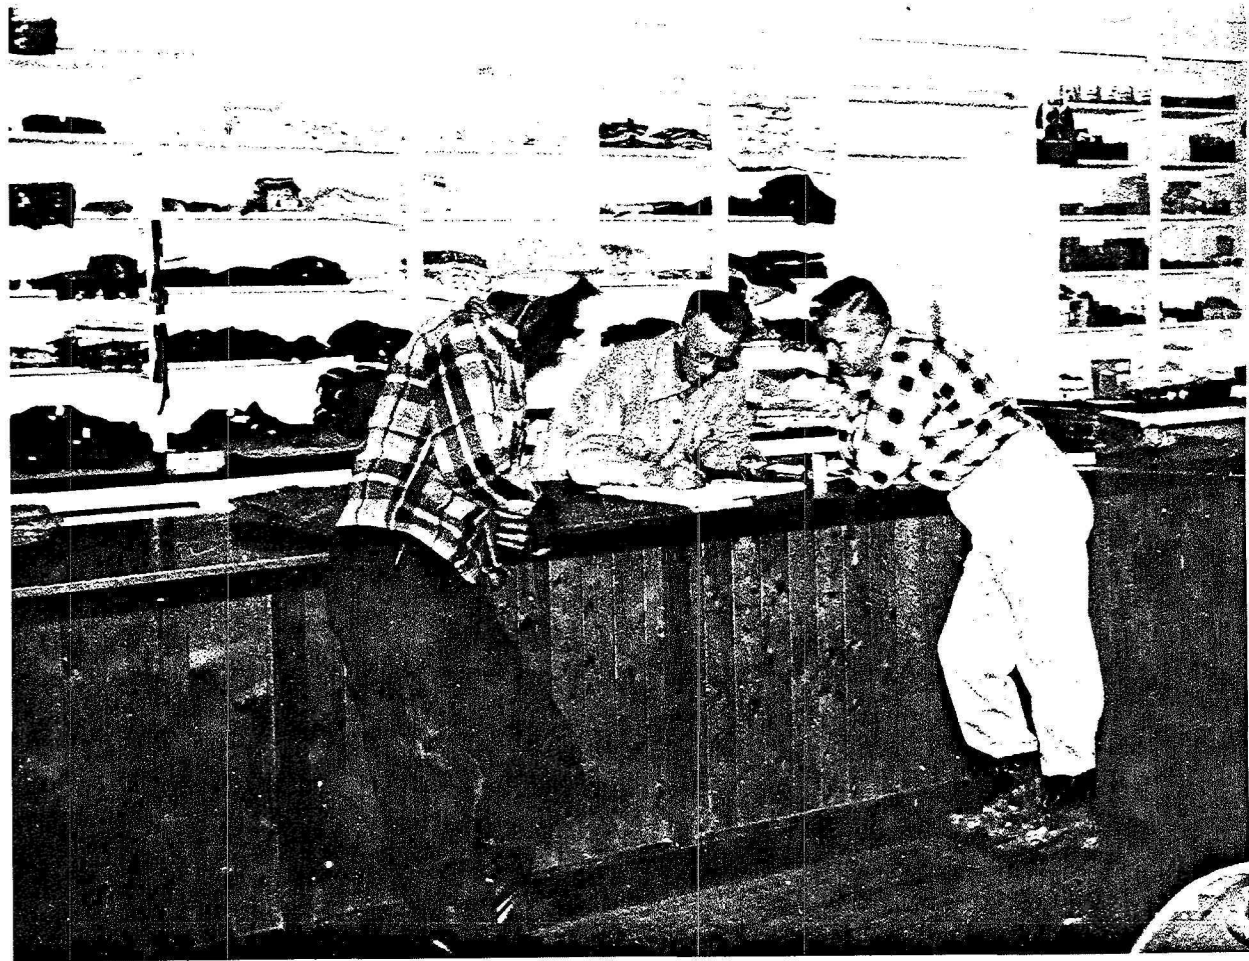
Fig. 56 "Department of Indian Affairs officials making arrangements for moving Indians from York Factory, in HBC store. (L to R) John Beardy, Councillor - Acting Chief, Mr. Frank Hughes, Superintendent of Indian agency; Mr. P. Fisek, Clerk, Indian agency," 1957, No. 82-277B, Hudson's Bay Company.

Once again, the east wall of room 5 is shown, as well as the entrance to room 4.
