# RESEARCH BULLETIN

No. 178

Archaeological Investigations at Cape Merry Battery,  
Manitoba, 1980.

Linda Sears, Prairie Region, Winnipeg.

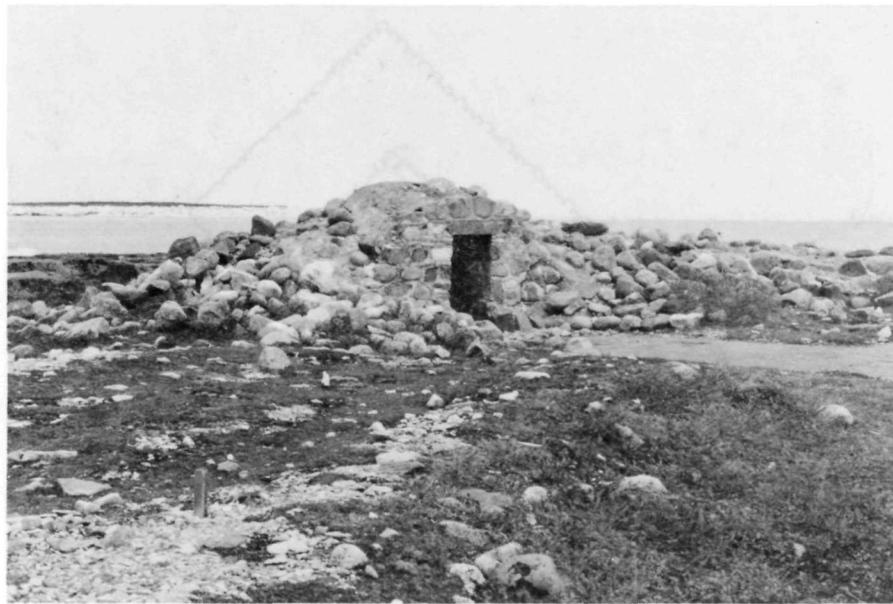
Figure 2. Cape Merry Battery I ruins, 1980. West parapet remains are in left foreground (photo 17K-9M).

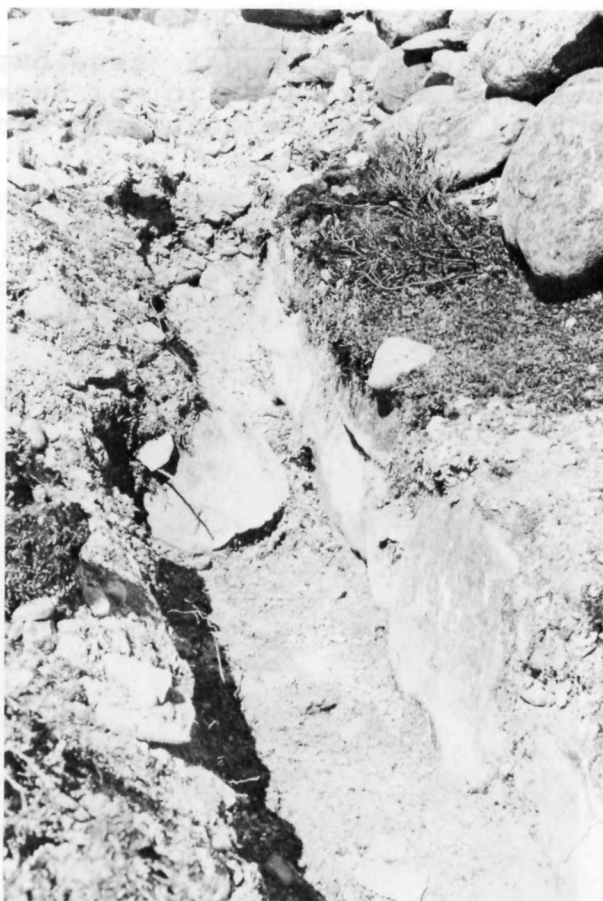
Figure 4. West parapet, exterior parapet line, showing mortared foundation stones. Facing north-northeast. (Photo 17K-33M)

The west parapet was 2 m wide at ground surface and measured 20 m from corner to corner along the face. The southern flank, not as essential for defense, was 1 m wide and 9 m long. The northern end of the parapet, closest to the magazine, was the most intact portion remaining. Nine metres south of the magazine it abutted a bedrock outcropping, continued over the bedrock, then extended east at a right angle to form a flank along the edge of the outcropping. Although masonry was extant in places, along the greater portion of the parapet there were only loose boulders and concentrations of loose gravel and mortar to indicate the original location. Dimensions and extent were determined by excavation along the lines of the face and interior of the parapet. Excavation to a depth of 1 m on the face uncovered a portion of a masonry foundation of mortar and partially-dressed stones (Figure 4). Where the face angled to join the magazine, the cornerstone was a large, dressed fieldstone. With the exposed foundation as an alignment, the southern end of the face was estimated over the bedrock outcrop. On the latter, mortar stains have leached down over the surface, thereby partially obliterating the original mortar (parapet) line. The outside corner was located south of the outcrop where fieldstones retaining traces of mortar were situated.

The interior line of the parapet was represented in part by heavily mortared foundation stones abutting the north side of the bedrock outcrop. Excavations between that area and the magazine revealed foundation stones surrounded by soil and small amounts of sand. These lower courses were apparently not mortared. The southern flank was evident from partially collapsed masonry. At the inside corner a post approximately 16 cm in diameter and well preserved by mortar was found (Figures 3b, 5). Still *in situ* atop the post were wood fragments representing "shims". This substantial post had apparently provided support for the platform at the inside corner.

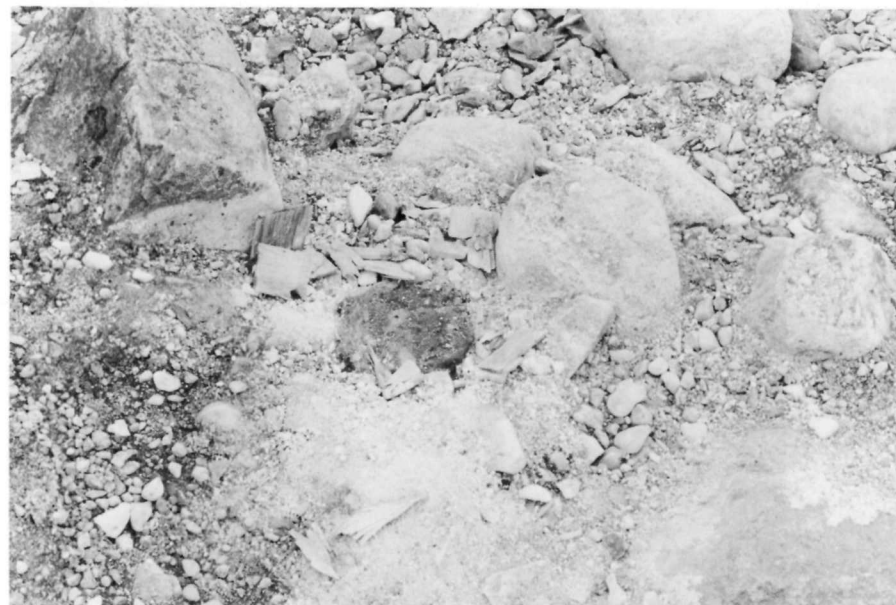
Figure 5. Corner post inside west parapet (refer to Figure 3b). (Photo 17K-43M).

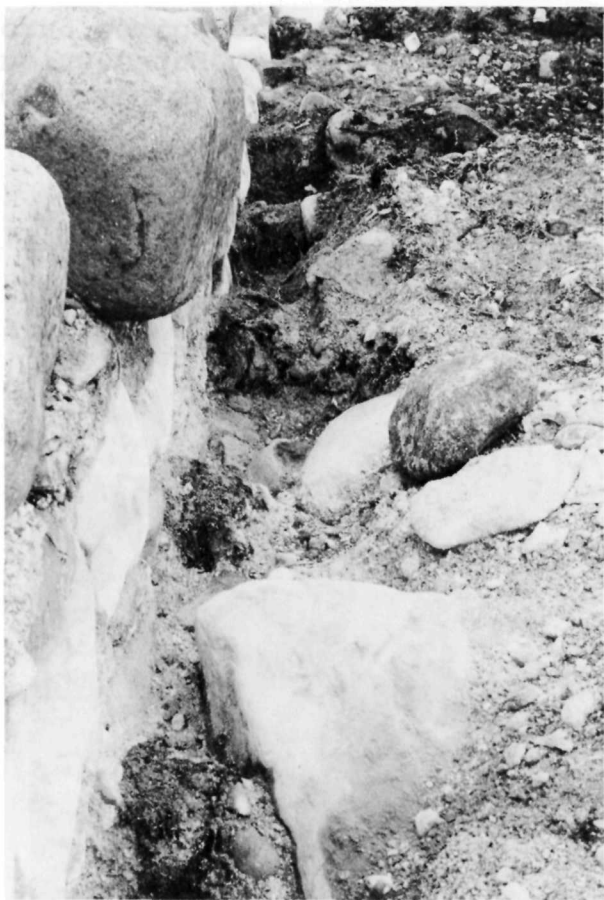
Figure 6. Interior of north parapet, showing row of well-preserved posts. Facing east. (Photo 17K-24M).

The north parapet measured 19.3 by 2 m; the flank was 2.2 m by 6.2 m. Structural remains inside the parapet indicated the former existence of a wooden gun support platform which extended from the flank to within 5 m of the magazine. Compared to the west parapet, a greater portion of the north parapet was extant adjacent to the magazine. In addition, rock, gravel and mortar debris on the surface provided a clear demarcation of dimensions and location. Unlike the relatively flat bedrock area inside the west parapet, bedrock here ranged from surface level to a point 0.4 m lower, with sharp rises, slopes and level areas. Hence, support post patterning was less consistent.

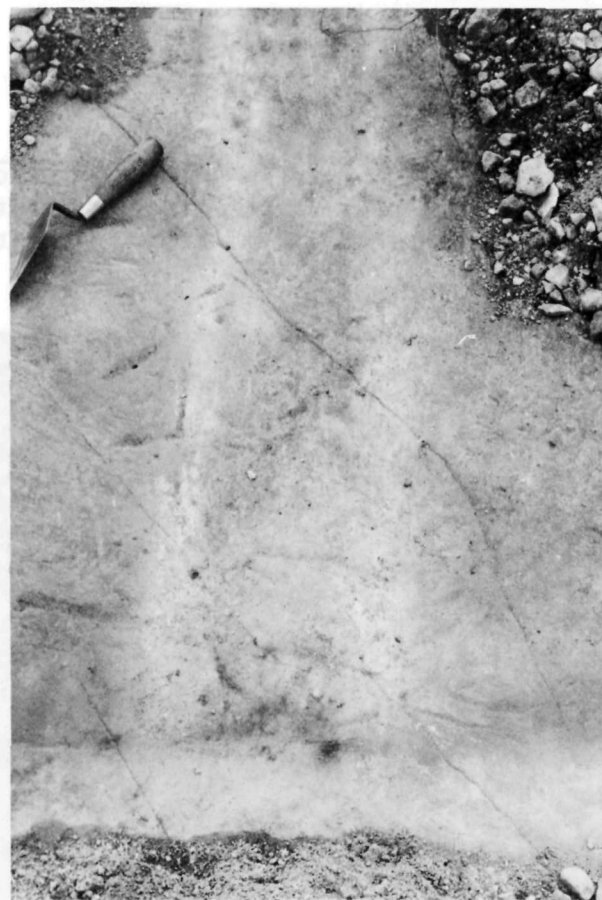
Figure 7. Mortar stains on bedrock, extending onto gravel (refer to Figure 3f). Facing south (Photo 17K-28M).

Clearing of surface debris on the largest bedrock outcrop revealed two mortar stains averaging 4 cm in width and spaced approximately 10 cm apart, at right angles to the parapet (Figures 3f, 7). Clearing in a straight line back from the parapet exposed a continuation of the lines in the form of compacted sand on the gravel surface atop bedrock. The lines continued for 4.5 m, then converged. They appear to provide a clear outline of a plank used in the platform floor, the sand and stains having resulted from fallout of debris between floorboards.
