RESEARCH BULLETIN

No. 184

The York Factory "Depot" Warehouse - Style and Construction

Bruce F. Donaldson

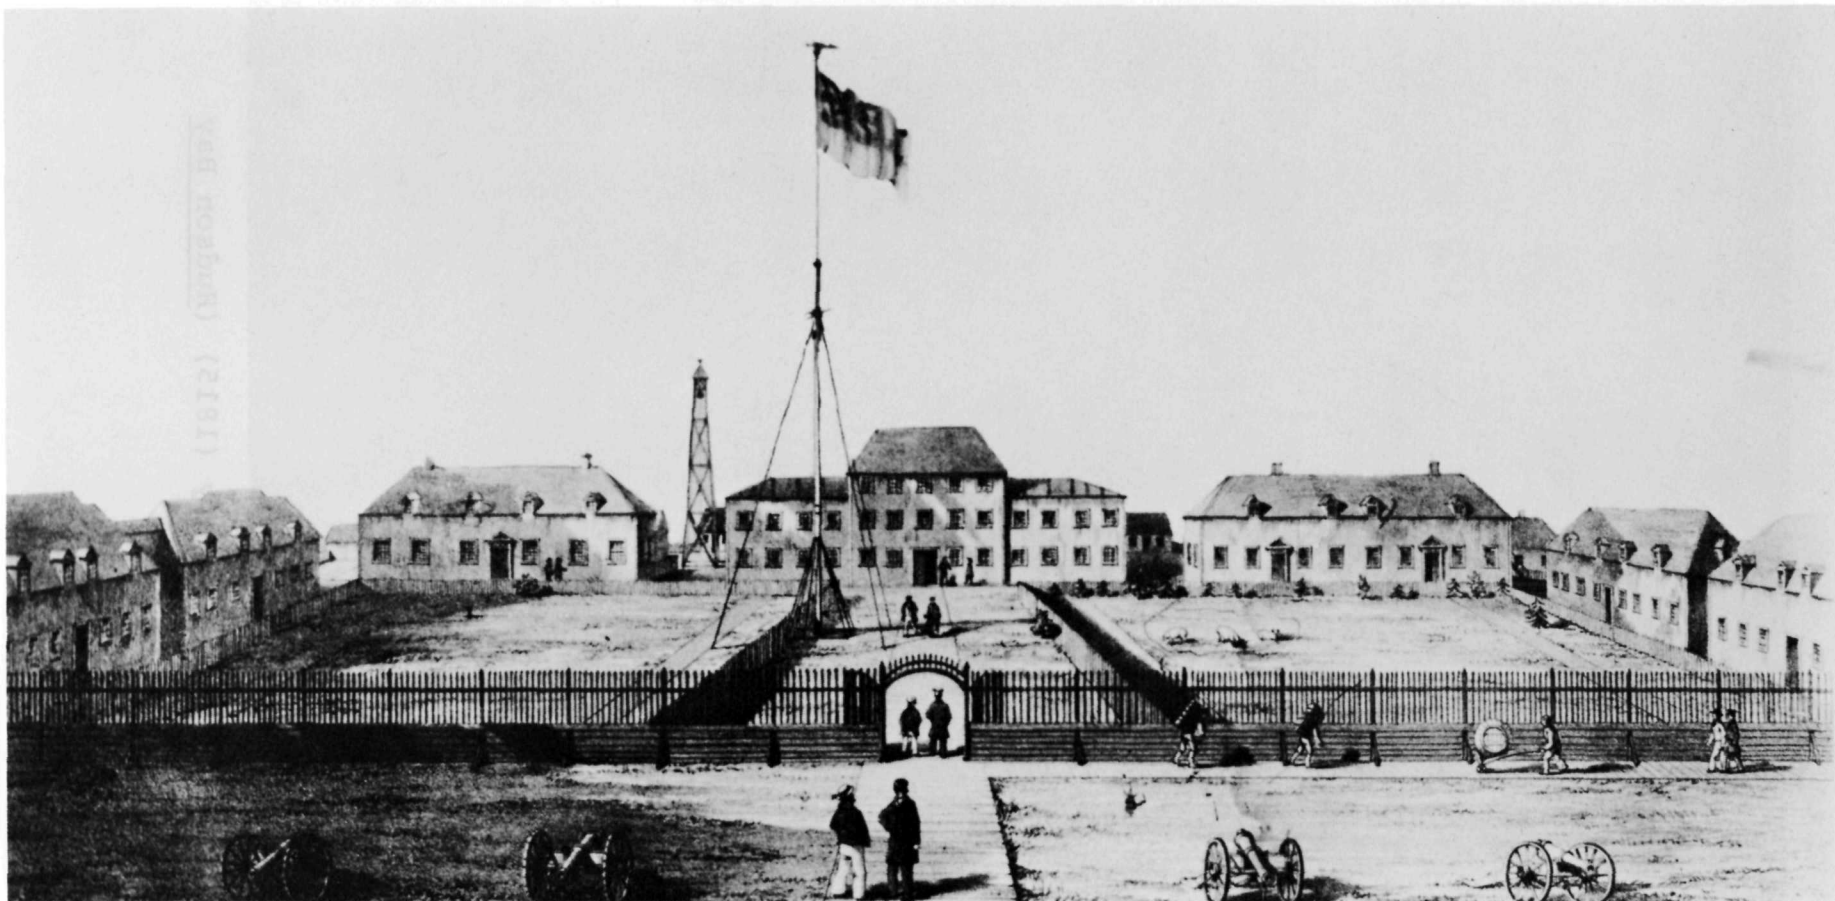
Figure 2. York Factory. From left to right: fur warehouse nos. 1 and 2; summer mess house; "Depot" warehouse; inland officers' residence; saleshops, "inland cargo" warehouse (used for Red River settlement goods at this time). (Manitoba Archives)

In 1821, after the decision had been made to abandon the North West Company's Canadian supply route and, hence, their former depot at Fort William, the immediate problem was the provision of sufficient space for the large increase in fur returns passing through York. A new, 22 by 80 foot, fur warehouse was built on the upstream side of the "Octagon" in 1821-1822 (Figure 2).⁵ This one and one-half story structure was very similar to the "Pack Store" at Fort William, an understandable coincidence given the fact that the new Chief Factor at York, John George McTavish, was a former North West Company wintering partner.⁶ The only major difference was the employment of a steeply pitched hipped roof, rather than the French Canadian, gable style that was typical at Fort William.⁷ An interesting feature of this building, as well as a second fur warehouse (1825),⁸ the inland cargo warehouse (1825),⁹ and the saleshop building (1826-1827),¹⁰ was the use of gabled dormers (as at Fort William) for lighting the second floor garrets (Figure 2).

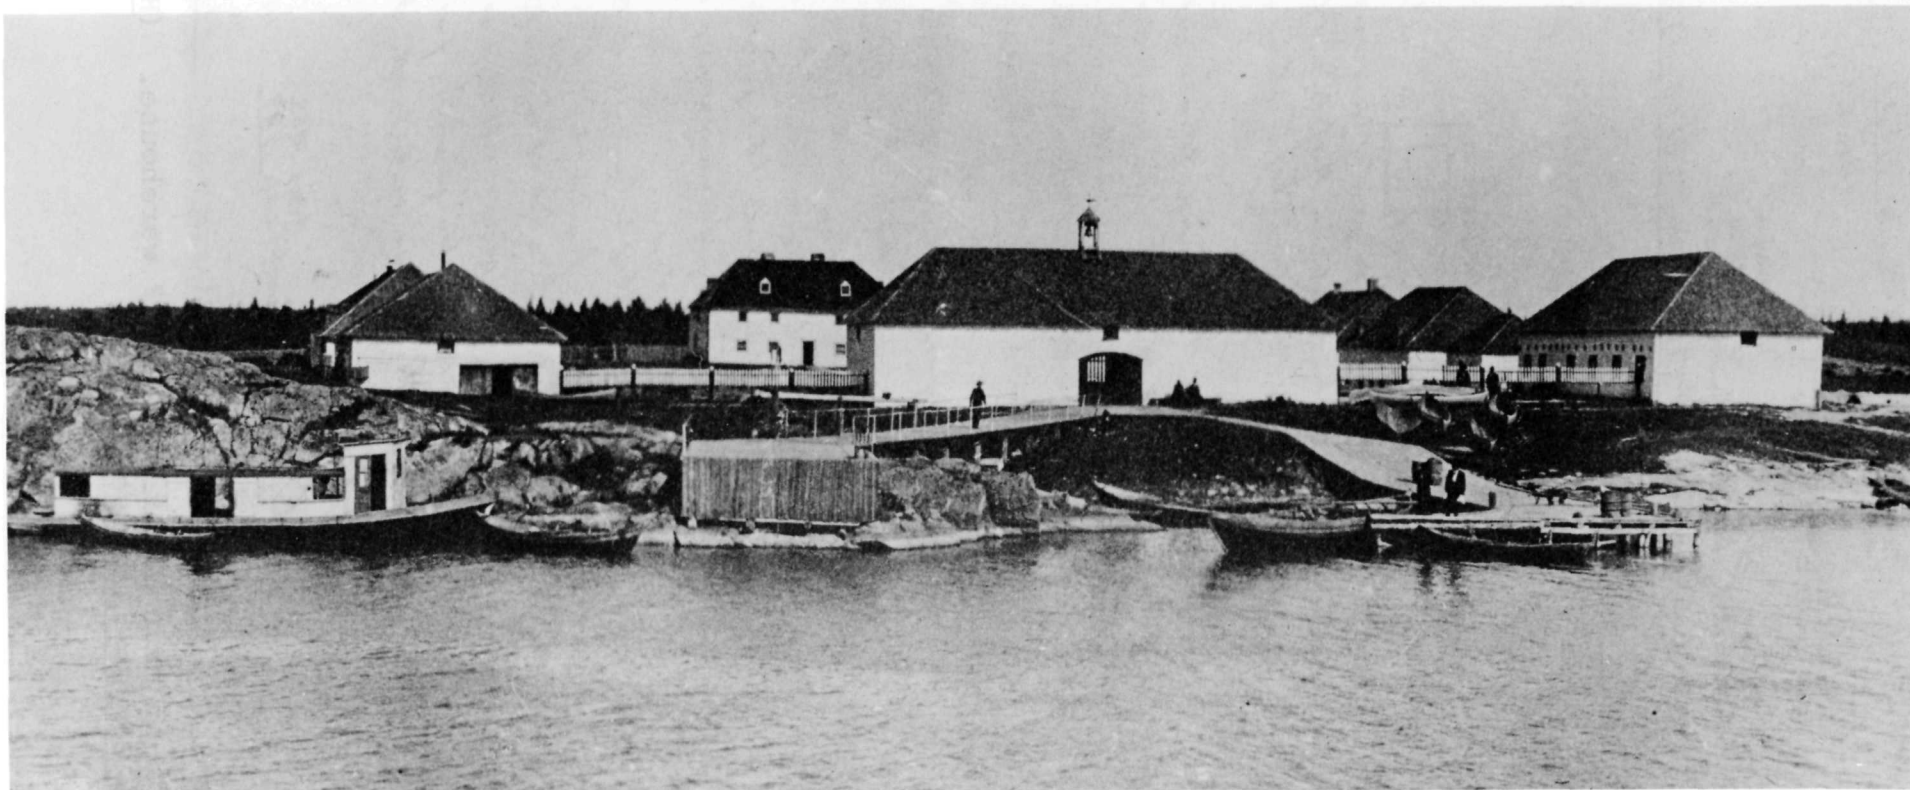
Figure 4. Pier and "Archway" warehouse at Norway House. (Hudson Bay Company Archives)

selection, sorting, and packaging of goods and furs for trans-shipment was not a priority, such as the "Archway" warehouse at Norway House (Figure 4), contained a minimal number of windows.²⁶
