RESEARCH BULLETIN

No. 191

Archaeological Investigations at Batoche National Historic Site, 1982

Archaeology, Parks Canada, Prairie Region

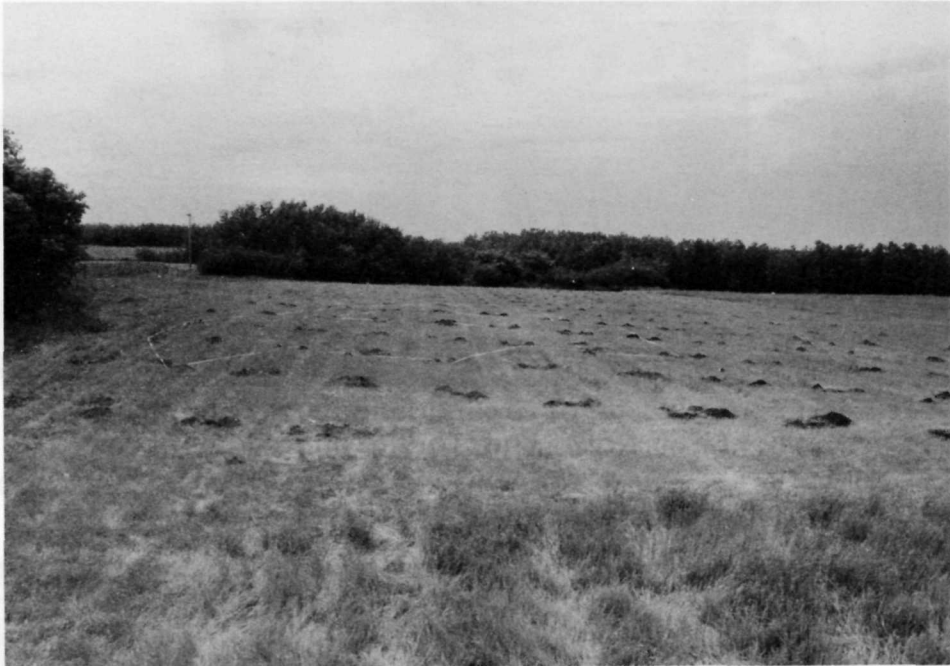
View looking south, of field west of rectory showing layout of systematic sample using post hole auger. Area outlined in white is where plaster/mortar layer was concentrated, indicating school location. (Photo by D. Grainger.)

Archaeological excavations related to landscape restoration focused on two areas, the environs of the rectory, and the zareba which commonly refers to the protective earthworks formed by General Middleton. In the area around the rectory, information was sought concerning the nature and location of the remains of the school, the barn and the well, all of which dated to the late 19th century. The school was known to have been located west of the rectory in a field which has since been extensively plowed. There were no surface indications of its location or of the barn which was thought to be somewhere near the south end of the same field. In order to try to locate any remains of either of these two buildings as quickly as possible, a systematic testing program was designed to examine the whole area. A grid was laid out over an area 37.5 m wide (east-west) and 95 m long (north-south) with its points being located at 2.5 m intervals east-west and 5 m intervals north-south. A mechanical post hole auger was used to dig a 30 cm diameter, 60 cm deep hole at each grid point. The earth removed was examined for artifacts and the holes were profiled and then backfilled. Although few artifacts were recovered which could be definitely linked to the school, its location was indicated by the presence of a disturbed soil layer containing varying amounts of mortar and plaster which extended over an area approximately 26 m long (north-south) and 20 m wide (east-west), with a heavy concentration over an area 4 m (north-south) by 7.5 m (east-west) in the approximate centre of the scatter. No further excavation was considered necessary in this area, since it was assumed that no more concrete evidence was likely to be found.

culturally deposited or disturbed soil layers. Thus, the systematic sampling strategy using the mechanical post hole auger saved a considerable amount of time, since the whole field was gridded off, tested, recorded and backfilled in about a week. The site caretaker, Emile Parenteau, who, as a life-long resident of the Batoche area, has considerable knowledge of the site's history, suggested another possible barn location near the modern garage and log shed northwest of the rectory. A test trench 1.0 m wide (north-south) and 8 m long (east-west), running from the back of the modern garage to the line of trees which runs parallel to the west side of the rectory behind the modern garage, revealed numerous artifacts and a thick layer of manure. Some of these artifacts were scattered, collapsed building components. Unfortunately, the area is quite disturbed, having been heavily used in the 1950s and many of the artifacts appear to date from the early to mid-20th century.

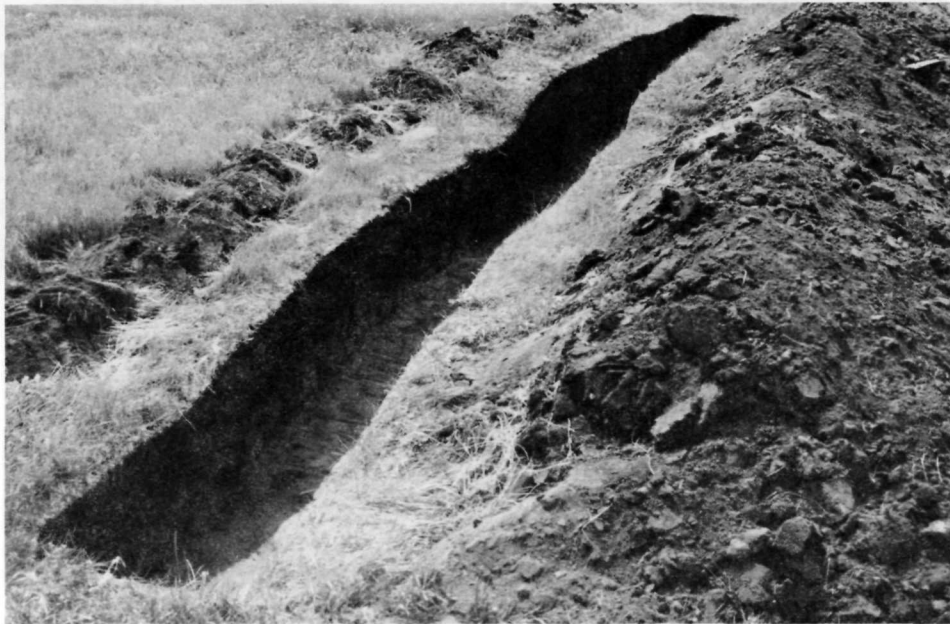
2. Test trench across missing south flank of zareba, looking south. (Photo by E. Lee.)

Archaeological investigation of the zareba in 1982 focused on searching for evidence of the missing south flank and southwest corner of the military earthworks constructed by Middleton's forces during the battle in May 1885. A map dated to 1950 (for which no historical documentation can be found) shows a dotted line indicating the missing southwest corner of the zareba underneath a barn associated with the Caron Sr. house. However, examination of a 1959 aerial photograph of this area shows that the barn would have been situated somewhat south of the corner and that a small structure, whose remains consist of a 1.4 m by 1.6 m cement slab, was located where the corner of the zareba appears to have been. In an attempt to determine whether any remains of the corner of the zareba earthworks could be found in this area, test trenches were laid out along the east and south sides of the cement slab. Neither the 13 m long north-south trench nor the 5 m long east-west trench provided any conclusive evidence of earthworks. The bottoms of several fence posts were found, as well as some small patches of manure. It is difficult to conclude whether the lack of evidence of earthworks indicates that there were none there, since the ground appears to have suffered considerable disturbance as a result of the barn and animal compound having been in the area. More testing in this area is probably warranted, as it is entirely possible that by being a few feet out, we could have missed subsurface evidence of the earth-works which may still remain.

The southeast corner of the zareba fades very gently into a slight ridge which extends west about two-thirds of the way towards the southwest corner and then fades out. At a point about halfway between the west and east side of the zareba's earthworks, a 10 m long (north-south) 0.5 m wide (east-west) test trench was laid out across this ridge. While no conclusive evidence of earthworks could be found in the stratigraphy, the ridge is obviously formed by a slight mounding of the cultural layer. It is impossible to determine, however, whether the ridge can be attributed to the earlier presence of military earthworks, since the area has been cultivated in the recent past (Emile Parenteau: pers. comm.). It is equally possible that

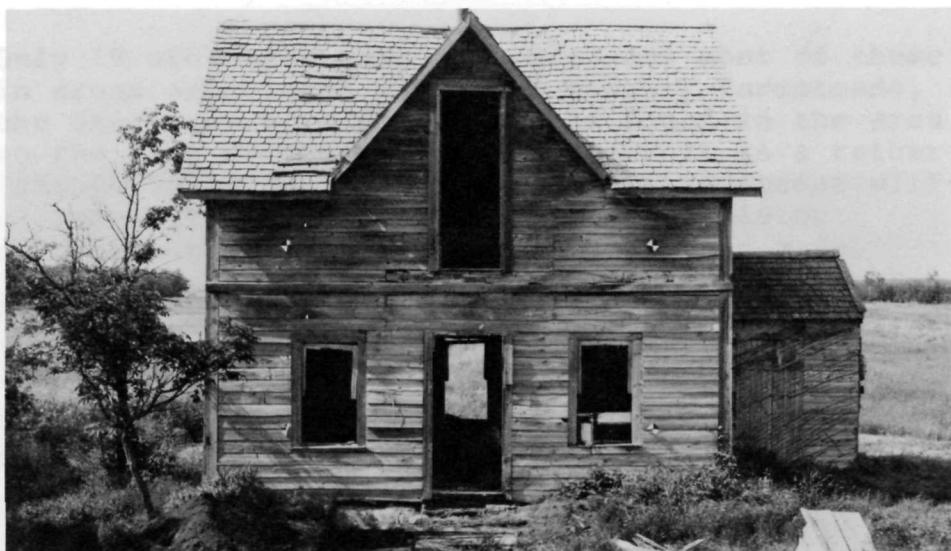
3. View of south side of Jean Caron Jr. house, looking north. Note the location of the test trench just to the left of the doorway. (Photo by E. Lee.)

Two test trenches were excavated close to the house, one on the north side and one on the south side. The north trench was 0.75 m wide (east-west) and 2 m long (north-south) and was situated 0.75 m east of the north-west corner of the house. It cut across a shallow ditch which runs parallel to the north wall of the house at a distance of approximately 90 cm from the wall. This ditch appears to be a borrow trench from which dirt was taken to bank up against the base of the north wall which faces into the prevailing wind. The weatherboards and logs covered by the earth bank are quite rotten. The log wall rests on a foundation consisting of one course of heavily mortared fieldstone. The mortar appears to have been applied after the log wall was constructed but before the weatherboarding was attached since both the sill log and a vertical nailing strip which had the weatherboards fastened to it, were embedded in the mortar. The logs have hand-hewn sides but still retain bark on their tops and bottoms, and a stiff, heavy clay has been used to chink the gaps between the logs.

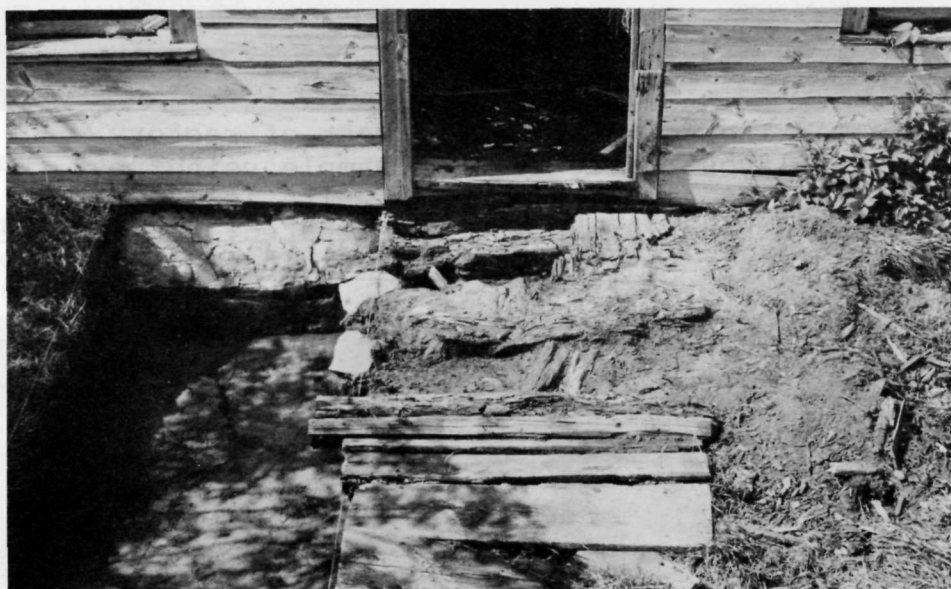
4. Test trench adjacent to west side of doorstep in front of central door on south side of Jean Caron Jr. house, looking north. (Photo by E. Lee.)

The south trench was 1 m wide (east-west) and 3 m long (north-south) and was located just on the west side of the doorstep and doorway centred in the south wall of the house. A considerable amount of window glass was recovered from this trench, undoubtedly as a result of its being situated just to the east of a window. One unusual feature of this house is that while this south wall had a second floor balcony which extended across its entire width, supported by vertical posts, the doorstep in front of the door beneath this balcony did not run the entire width of the building, but was only slightly wider than the door.
