RESEARCH BULLETIN

No. 192

Herschel Island: Heritage in the Face of Adversity

Archaeology, Parks Canada, Klondike National Historic Sites

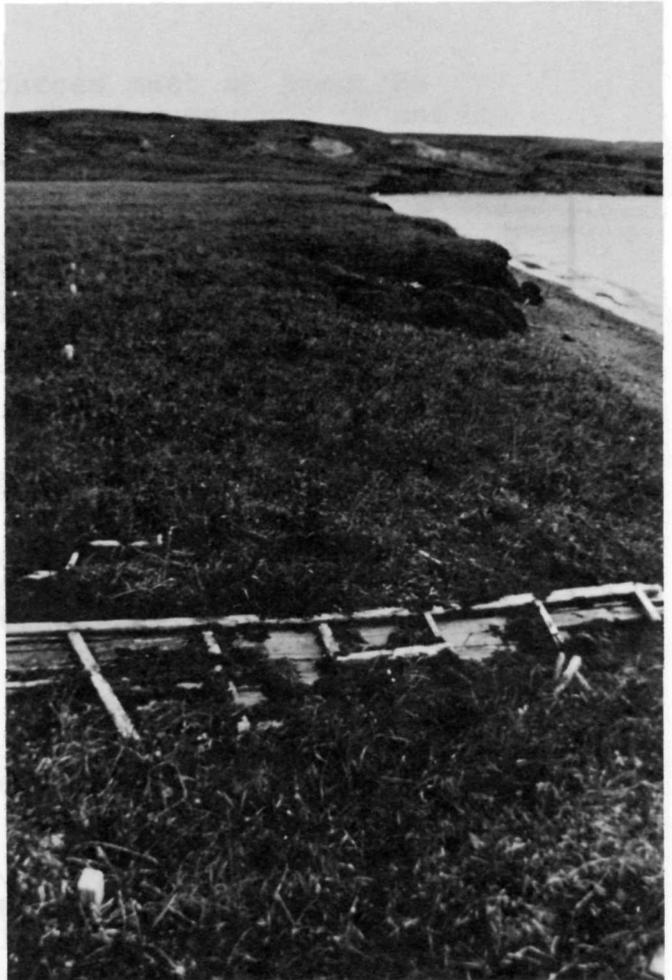
While prehistoric sites are known to be located on Herschel Island at Osborne Point and Lopez Point (Synergy 1974: 16), as well as at Avadlek Spit and Pauline Cove (Yorga 1980: 3), only the site at Pauline Cove, the "Wash-Out" site (NjVi-2), was visited. This site, located on the bank facing MacKenzie Bay, is known to have consisted of at least six house ruins containing Thule type artifacts. However, wave erosion has apparently destroyed most, if not all, of the site (Yorga 1980: 42; Hett 1978: 17). In 1978, the archaeologists excavating the Wash-Out site established a line of wooden stakes along the bank to measure bank erosion (Fig. 2). This summer, the stakes were less than 2 meters from the beach and probing of the bank revealed no evidence of structural remains or artifacts. Similarly, surface survey for artifacts washed up on the immediate beach area revealed nothing. It is quite possible that wave erosion is posing a similar threat to the other prehistoric sites on the island, since these too are located on banks, sand spits and barrier beaches.

Figure 2. Area of the Wash Out site (NjVi-2), showing line of wooden stakes and bank erosion. (Photo by B. Ross.)

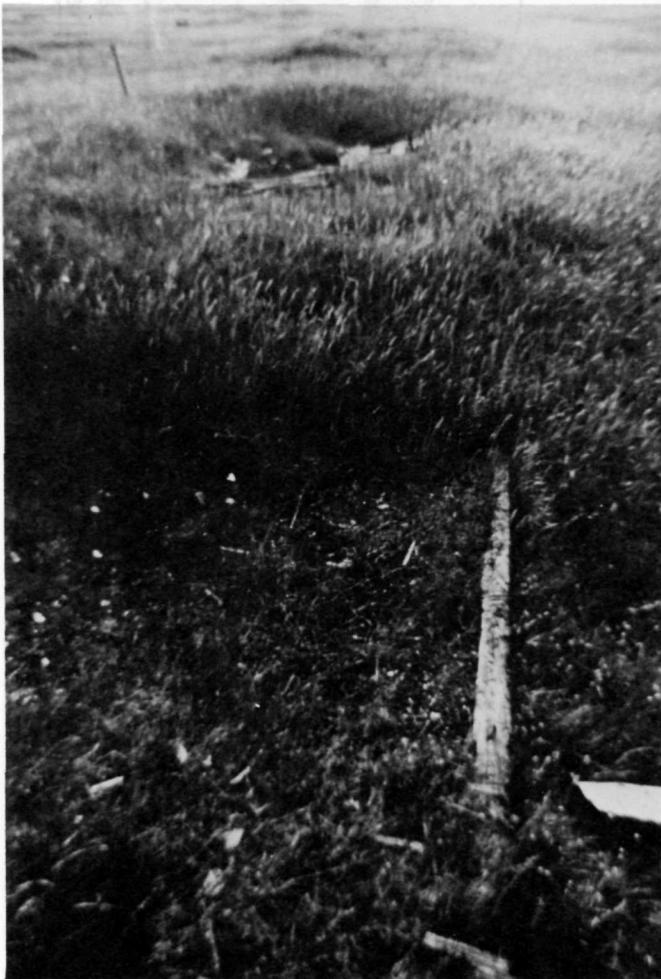
The historic community, situated on the spit of land separating Pauline Cove from MacKenzie Bay, consists of 14 extant structures and 40 readily observable structural features. These latter non-extant features are identified by the presence of foundation posts/piles, floor members and/or mounded depressions (Fig. 3). These depressions are square, rectangular or ovoid in shape and all have had soil mounded around their perimeters, likely for insulation. Some of the depressions are small and may be indicative of sheds, caches or even cellars, while others indicate quite substantial structures. All features conform to the general east-west orientation of the community. There are also a number of curiously uniform knolls which may indicate structures or middens.

Figure 3. Structural depressions and mounded depressions between the extant settlement and the Anglican Mission (in background). (Photo by B. Ross.)

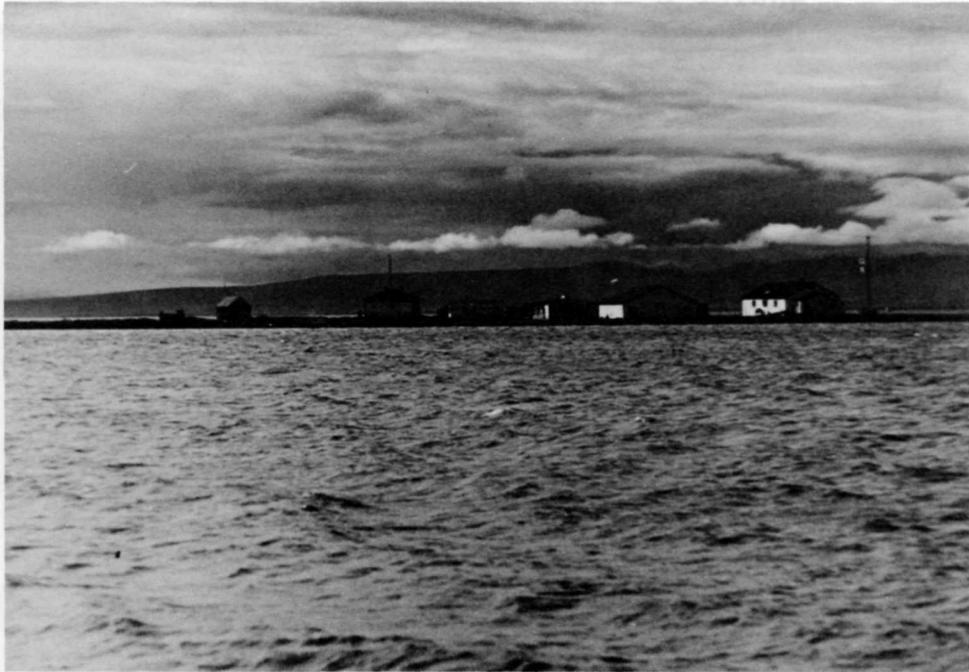
The 14 extant structures consist primarily of warehouses, residential shacks and sheds (Fig. 4). Thirteen of these buildings date from the historic period, including the Northern Whaling and Trading Company warehouses, one of which has its roof constructed from the ribs and keel of a boat; the Anglican Mission, originally a whaling warehouse; and the N.W.M.P. detachment building. This last structure being built in 1893 by the Pacific Steam Whaling Company, is of particular interest since it represents the earliest frame structure and the first prefabricated structure built in the Territory.

Figure 4. View of extant settlement from across Pauline Cove. (Photo by B. Ross.)

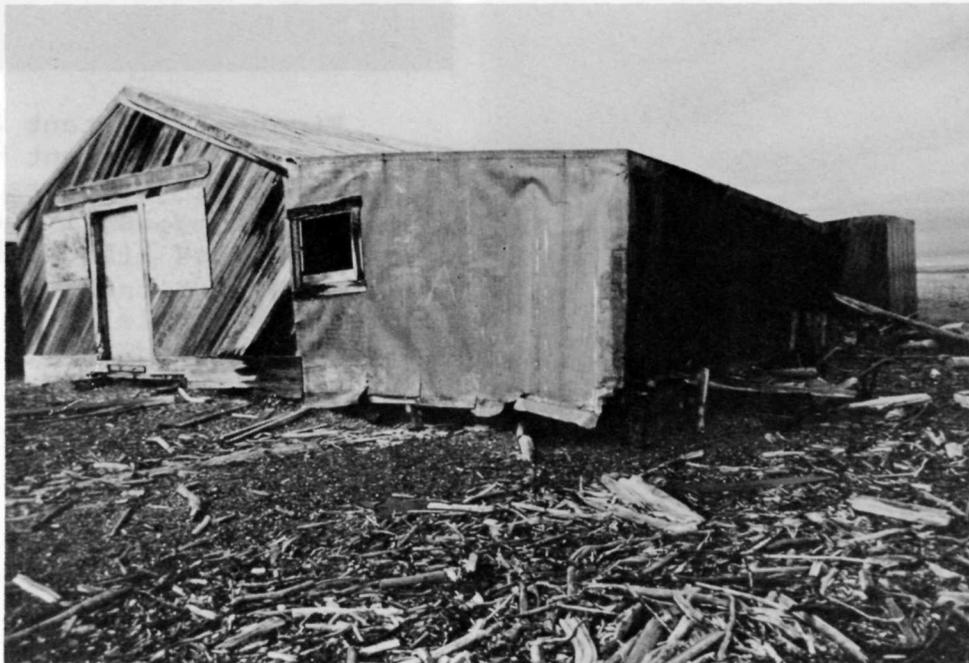
While the overall condition of these structures is still reasonably good, they are nonetheless subject to a number of threats. One such threat is pack ice which can be forced up and over the low beach surrounding the community. Indeed, the westerly wall of the Northern Whaling and Trading Company's tin clad warehouse has been gouged wide open by pack ice (Fig. 5). Unmonitored site visitations have also resulted in the damage and destruction of much of the historic resources at Herschel Island. Arson is believed to have destroyed one of the historic tin clad warehouses in 1973 (Synergy 1974: 28). The indiscriminate looting of artifacts over the years has now completely removed all surface artifacts dating to the historic period from the community.

Figure 5. West wall of Northern Whaling and Trading Co. warehouse damaged by pack ice. (Photo by B. Ross.)

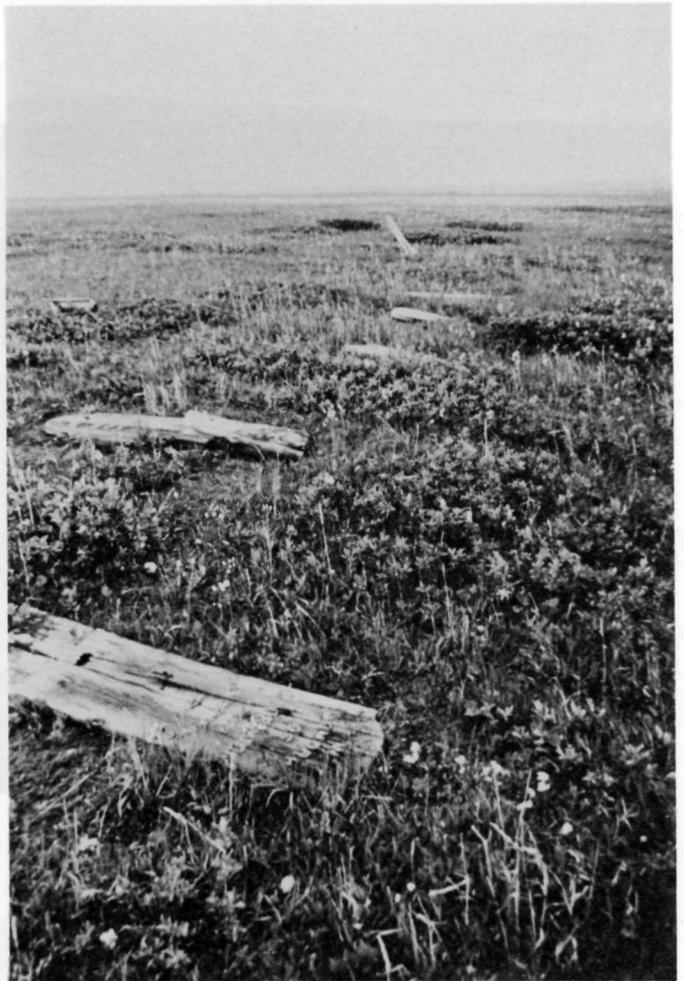
To the northwest of the whaler's Cemetery, the inhabitants of the Herschel Island community blasted a number of subterranean icehouses out of the permafrost at the foot of hills. Constructed in the early years of the settlement to provide the community with ice for fresh water during the short summer months, as well as providing cold storage for perishables, these houses consist of small log vestibules leading down by steep stairways into full log-walled cellars. The structures have been heaped over with soil. By as late as 1974, eight such ice houses were reported as being extant (Synergy 1974: 29). However, only two now remain intact and the remains of only two others are obvious (Fig. 7). Solifluction accounts for the decimation of this resource. The hillsides are in an active state of erosion evidenced by heaps of soil piling up on the flats below and around the two remaining ice houses. Indeed, the Historic Sites and Monuments Board's commemorative plaque for the island, erected in the same general vicinity, is presently leaning at a precarious angle and is in danger of toppling.

Figure 7. Extant and non-extant ice houses in area of solifluction. (Photo by B. Ross.)

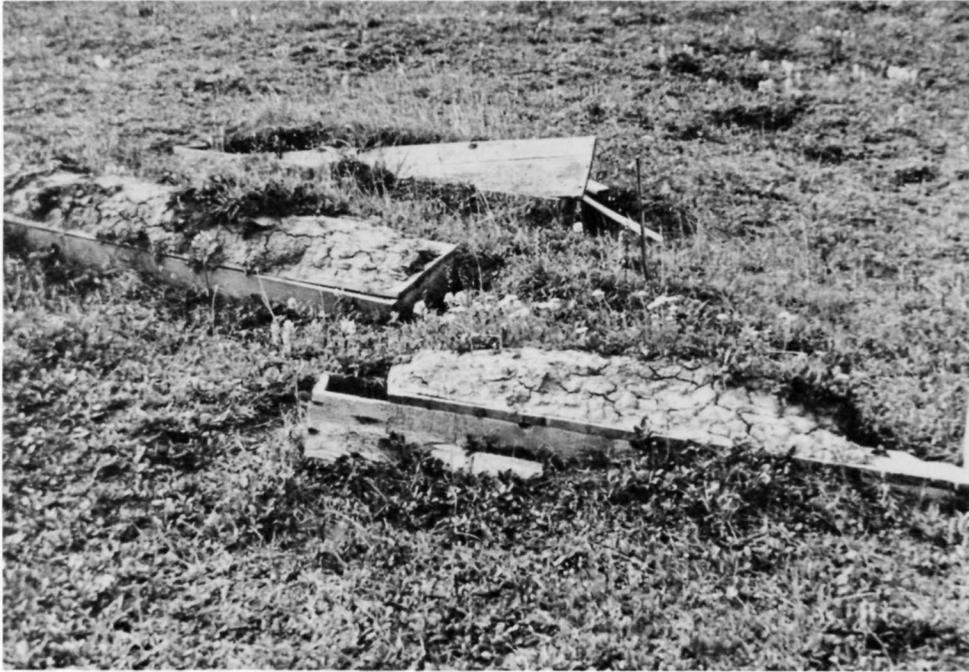
Solifluction is also posing an acute threat to approximately 100 historic Inuit graves located east of the ice houses. This cemetery is also located below the hills to the north and thus many graves are in danger of being completely buried by the collapsing hillsides. The cemetery is characterized by wooden grave fences and a wide variety of tooled and untooled wooden grave markers. Unfortunately, almost all of the inscriptions on these markers have weathered into illegibility. In addition, frost heaving is causing a number of grave fences to contort and a combination of frost heaving and wind erosion have exposed six coffins (Fig. 8). The tops on most of these coffins have become partially detached from and/or caved into the caskets, in turn exposing the human osteological

remains within. The remains themselves appear to have been disturbed in that the bones do not conform to any expected or uniform deposition. This may very likely be due to small animals now being able to get inside the coffins.

Figure 8. Exposed coffins in large historic Inuit cemetery.
(Photo by B. Ross.)

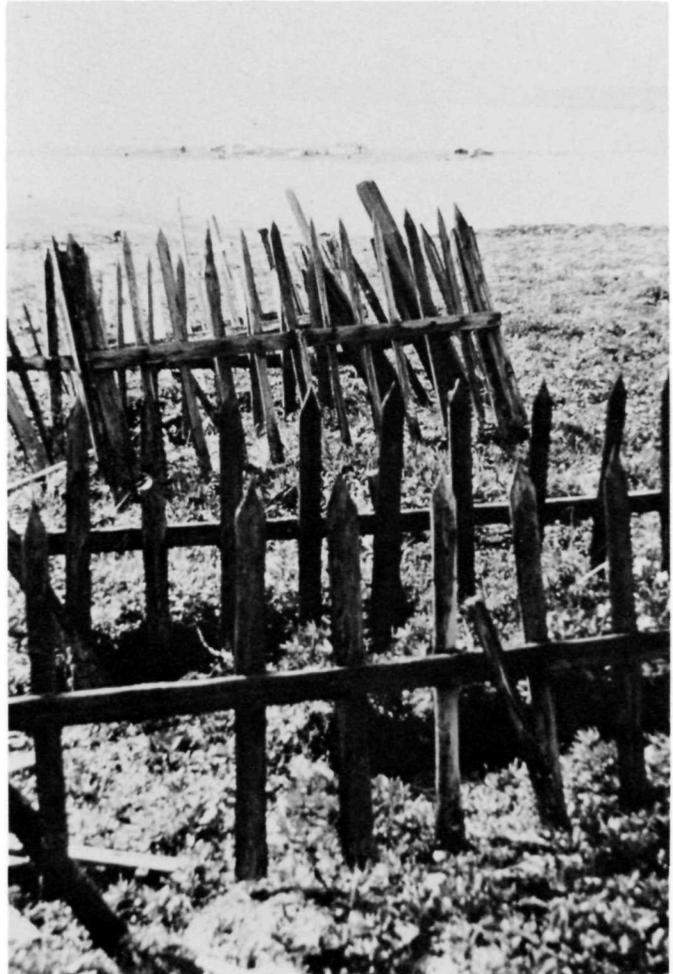
Further up the hill and to the west, a second historic Inuit cemetery is located (Fig. 9). It consists of approximately 10 graves characterized, as in the first Inuit cemetery, by badly weathered wooden grave fences and markers. The majority of these graves appear to date from the 1910-1930s period. Also, the most contemporary grave associated with the community is found at this cemetery, dating to 1956. As with the first Inuit cemetery, frost heaving and wind erosion are in the process of toppling the fences and markers, weathering the inscriptions and exposing the coffins and their contents. Also, this cemetery is at the edge of active solifluction and is in danger of sliding down the hillside.

Figure 9. Wooden grave fences in second historic Inuit cemetery, overlooking Pauline Cove and the Herschel Island settlement.
(Photo by B. Ross.)
