RESEARCH BULLETIN

No. 194

UNDERWATER RESEARCH AT RED BAY, LABRADOR: A SUMMARY OF THE 1981 FIELD SEASON

Willis Stevens, Marine Excavation Unit, Parks Canada

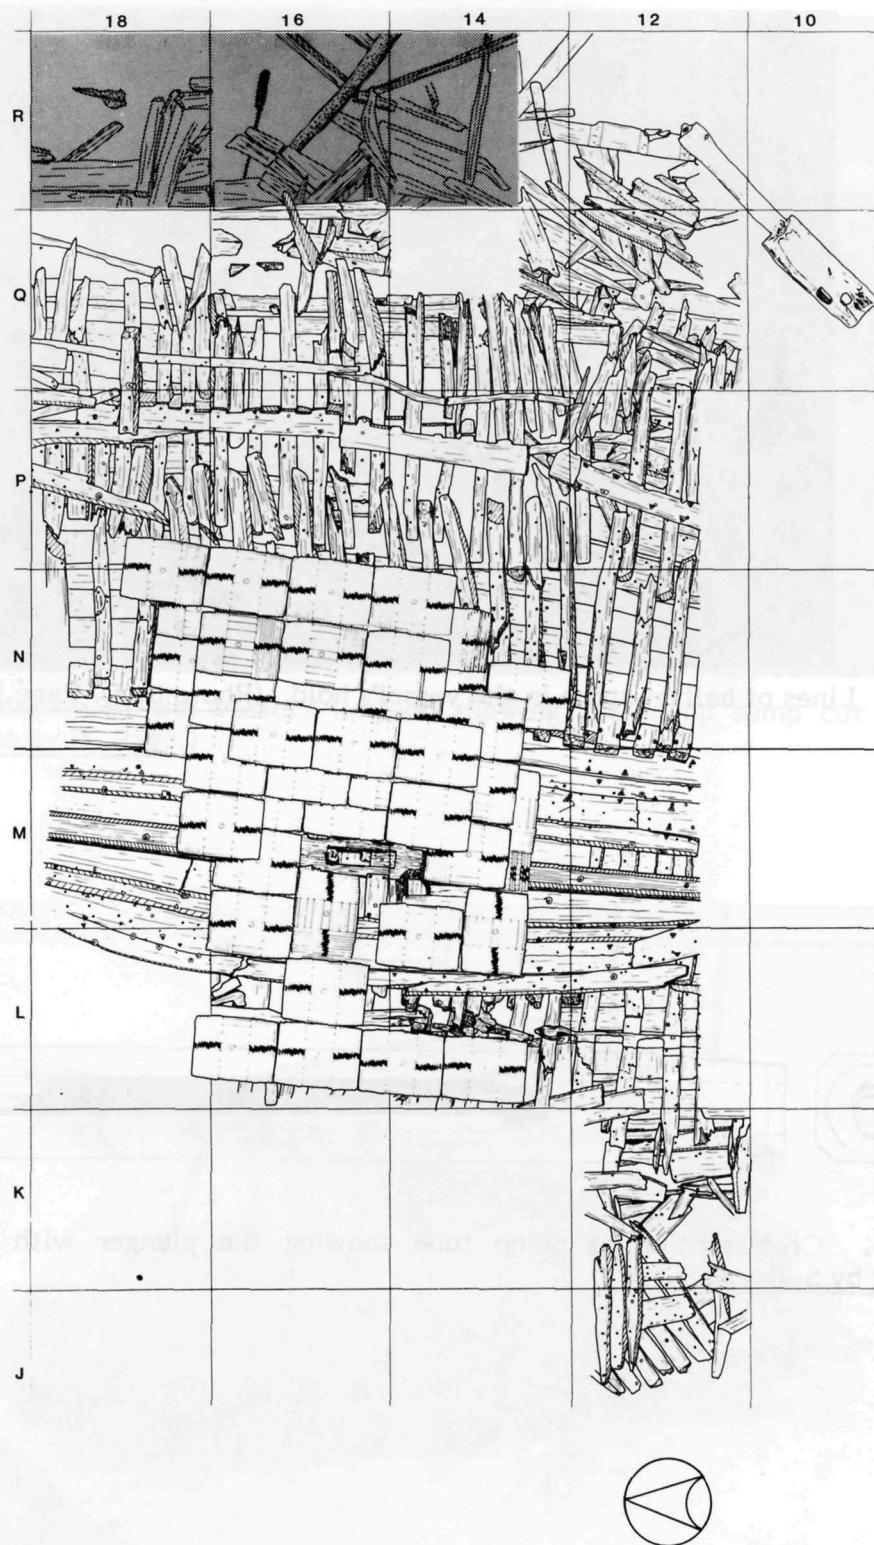
Figure 3. Plan view of reconstructed casks in the midship hold of the vessel.
(Drawing by S. Epps.)

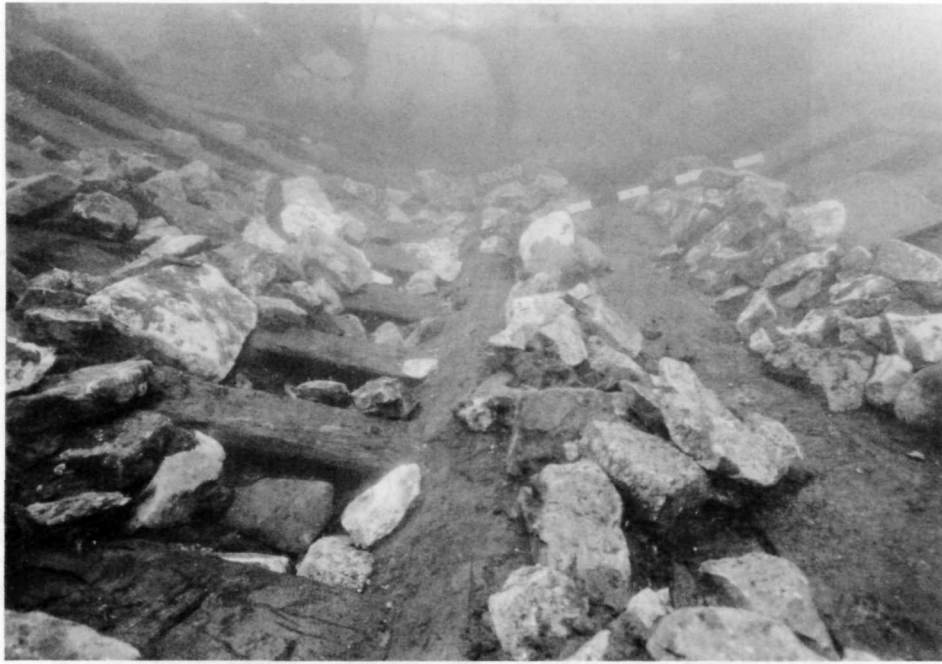
Figure 4. Lines of ballast stone in the vessel's hold. (Photo by D. Pagé.)

Ballast stones (Audy 1982). The casks were supported in a variety of ways through the use of billets, chocks, wedges and ballast stone. Ballast stone, which consisted primarily of limestone, was found throughout the entire central hull area. Its principal function was to act as support beds for the casks with the stones being packed on either side of casks to prevent movement from side to side. In the archaeological record these beds were revealed as long lines of ballast running longitudinally along the bottom of the vessel's hold (Fig. 4). This type of support was also used on the second tier of casks and possibly the third tier.

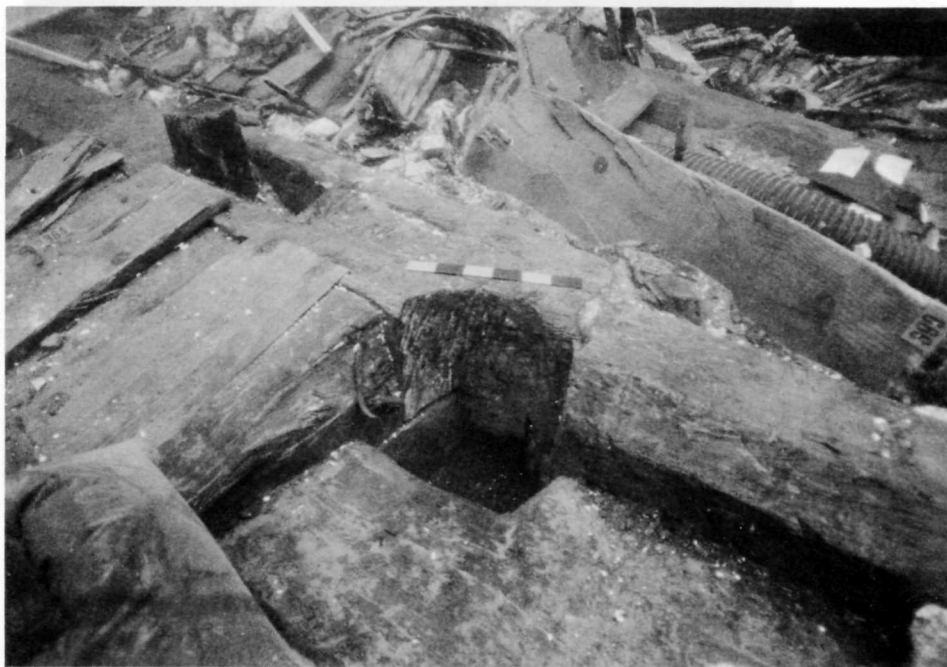
Figure 6. Close-up of the vessel's keelson showing the pump sump cut into the keelson. (Photo by D. Pagé.)

Pump Assembly (Waddell 1982). One of the major artifacts recovered in 1981 was a 2.39-m section of pump tube (Fig. 5). It was constructed from a single piece of beech which was subsequently squared and the corners bevelled. The outer diameter was 26 cm with an inner bore diameter of 12 cm. A plunger along with two wooden shafts, representing the pump's plunger spear and connecting spear, were found within the bore. The plunger consisted of 21 leather discs of varying diameters which were placed on the plunger spear in a bullet-like shape to facilitate the downward thrust in the tube bore and the passage of water around and above the discs. The base of the tube was located next to the pump sump, a circular hole cut into the port side of the keelson aft of the mast step (Fig. 6).

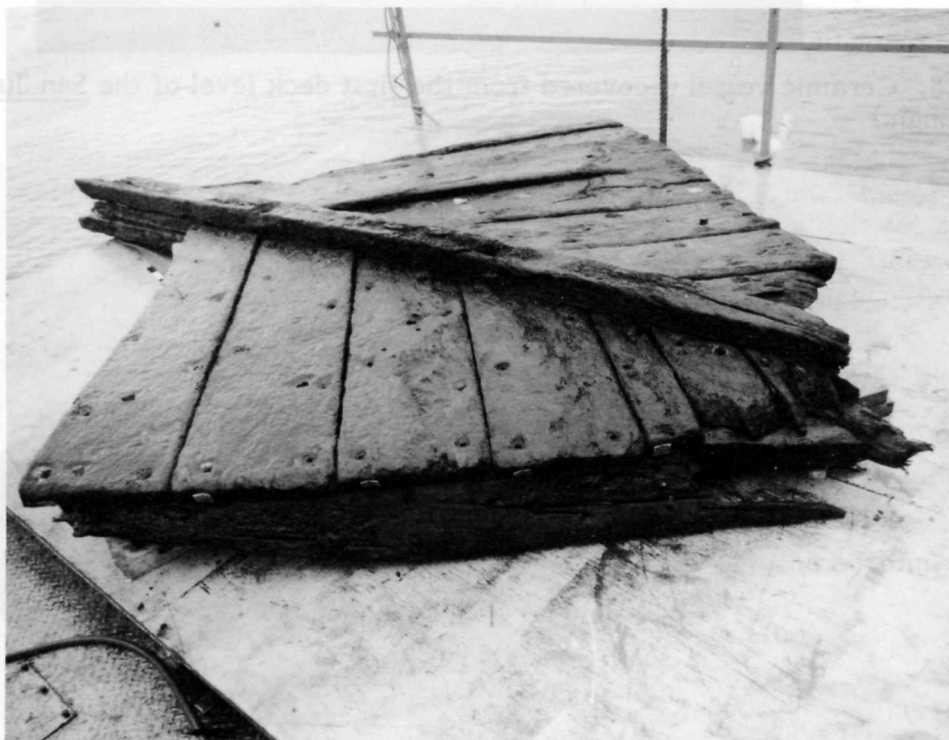
Figure 7. Reassembled transom on the deck of the research barge. (Photo by R. Grenier.)

The transom was lying flat on the harbour bottom located behind and below the broken end of the sternpost. It consisted of five transom beams rebated to fit over the inner face of the sternpost, as well as seven outside planks on the port side and five outside planks on the starboard side. These planks all fitted on the rabbet of the stern post in a v-shaped pattern. This design, sometimes called the "square-tuck," is typical of the sixteenth and early seventeenth centuries. The transom was disassembled following underwater recording and then brought to the surface where it was reassembled for drafting and photographic recording (Fig. 7).

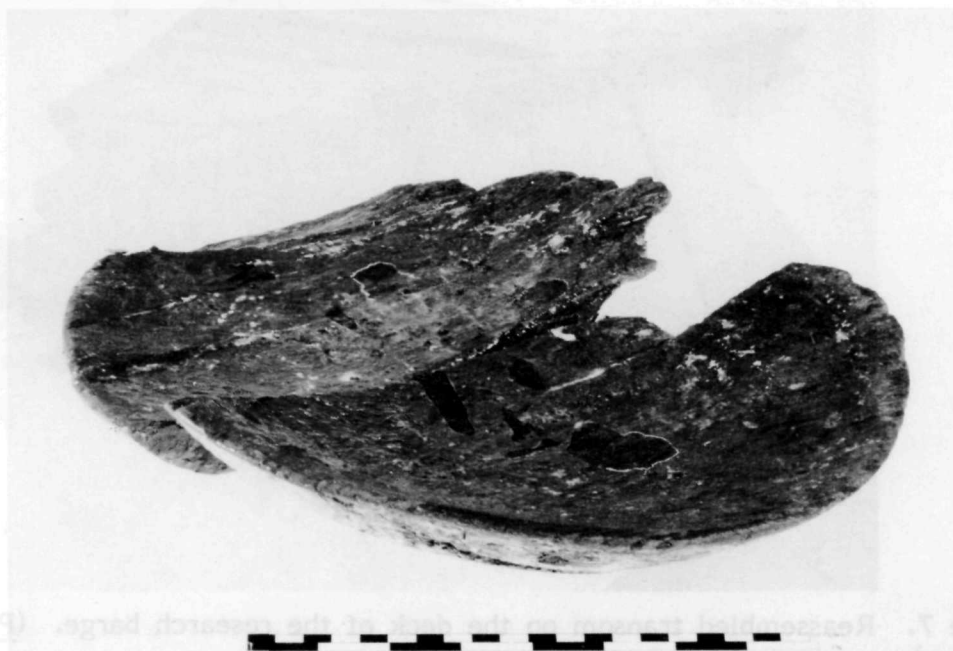
Figure 9. Wooden platter from the first deck level of the San Juan. (Photo by R. Chan.)

Treen. Seven wooden artifacts including two platters, one incomplete bowl, three small boxes of undetermined function and one small spatula-like artifact were recovered from the central hull area of the San Juan (Figs 9 & 10). There was also one incomplete bowl found outside of the wreck adjacent to the stern (Fig. 11). Of the seven artifacts found within the vessel, five were located above the first deck level in the midship area.

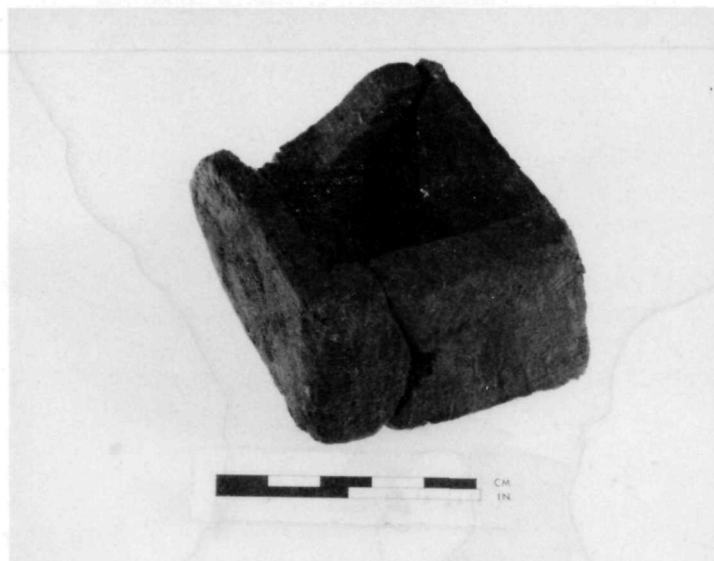
Figure 10. Unidentified wooden box from the first deck level of the San Juan. (Photo by R. Chan.)
