RESEARCH BULLETIN

No. 196

End of 1981 and 1982 Seasons: York Factory National Historic Site

Gary Adams

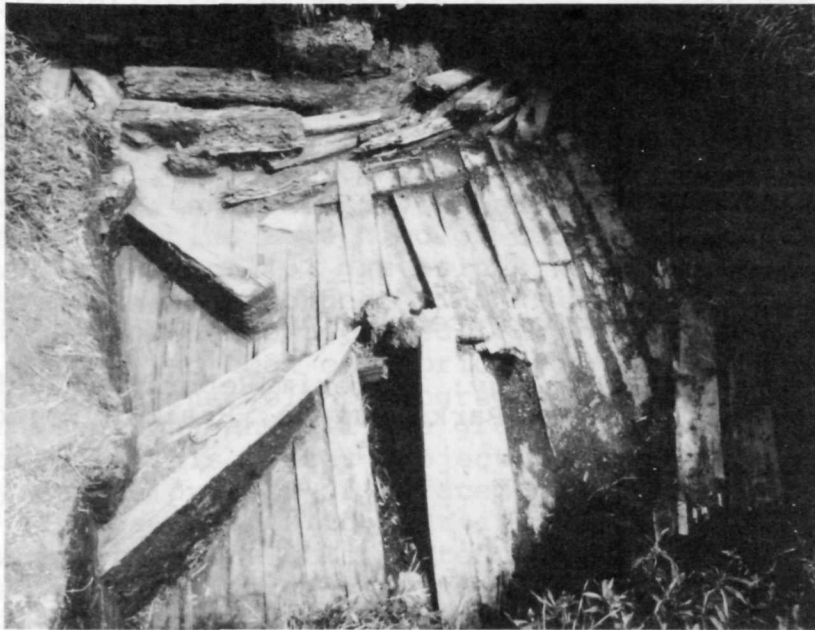
Figure 1. Interior of ice house looking north (photo by J. Hamilton).

The result of this confirmed much of the structural interpretation from the 1980 season (Adams and Burnip 1981). The structure itself had three major wall constructions. The innermost wall was square timbers with mortise and tenon corners; interior dimensions were 4.9 m north-south by 3.85 m east-west. The floor was built with 16 to 23 cm wide by 5 cm thick planks laying north-south on irregularly spaced joists. These were elevated almost a metre above the ground and the cavity had been filled with a layer of wood chips. In fact, one of the floor supports was the bottom of a very large oak barrel, filled with earth and woodchips (Fig. 1).

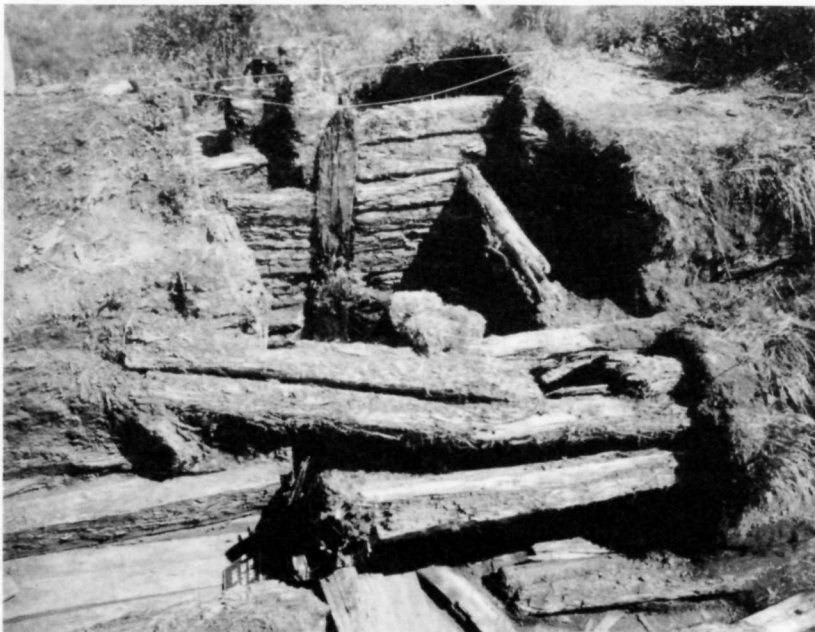
Figure 2. Section of north walls of icehouse (photo by J. Hamilton).

The middle wall was of post-on-sill construction and was spaced less than a metre from the inner wall (Fig. 2). It extended down to ground level and created a dead air space between the two walls from the ground to a height of about 1.5 m. Above this, in some areas there appeared to be a roof of longitudinally-placed timbers or logs and the upper section was apparently filled with rocks and earth.

The outer wall was 1.17 m away from the centre wall in the north side. It, too, was of post-on-sill construction that was held in place by spacers

connected to the middle wall. The intervening space was earth filled. Outside this wall, there was at least one layer of wood covering one of the earth embankment phases. It probably extended up to the height of the first floor of the ice house.

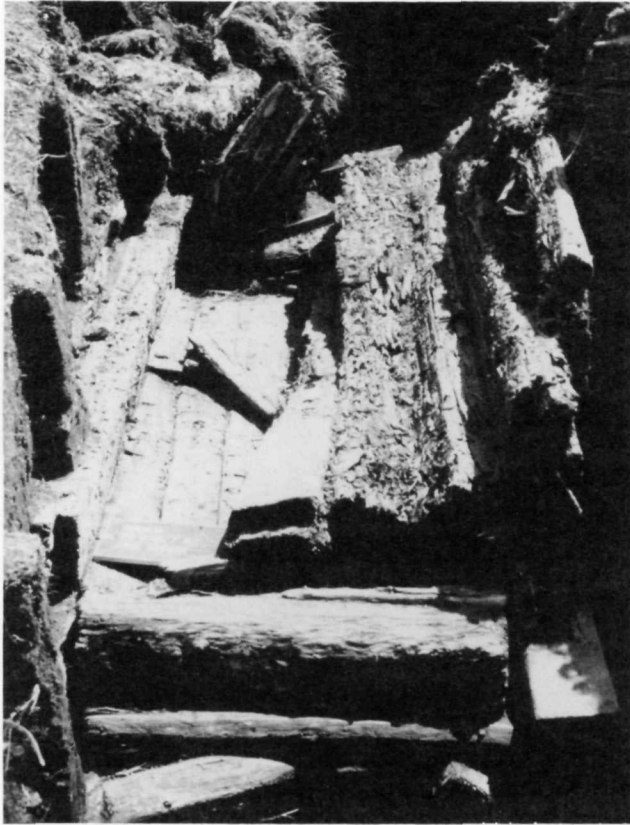
Figure 3. Entranceway to icehouse looking east towards interior (photo by J. Hamilton).

The doorway was located on the west wall, extending out from the inner north wall. It was of post-on-sill construction and consisted of a passageway 0.96 m wide and 2.7 m long. The floor was again planked, this time in an east-west orientation. It was slightly elevated over the interior floor so that there was a step at both ends (Fig. 3).

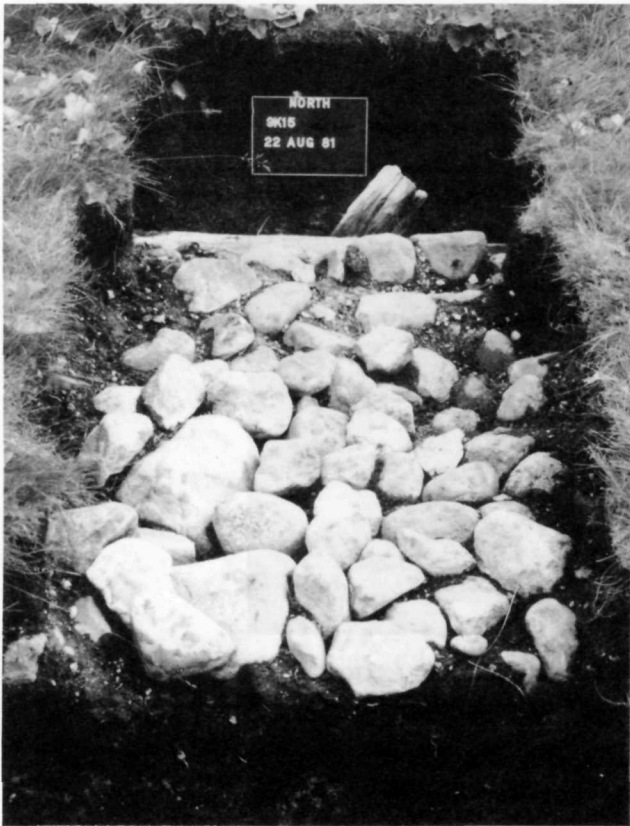
Figure 4. Rock filled drainage ditch for central garden (photo by G. Adams).

The first test was conducted in the form of two trenches, both oriented north-south and both extending out from the central garden feature. The south trench was 7 m long. At the north end a stone-filled ditch (Fig. 4) was uncovered which appeared to be a portion of a east-west oriented trench that served as part of the drainage system for the south perimeter of the central garden. This trench was approximately 1.2 m wide and of undetermined depth. It seemed to run from the back of the gardens to the front palisade area. Located 4.0 m to the south was a single east-west oriented log in a clay-filled footer trench that was judged at that time to be the north wall of the Eastern Fur Store.

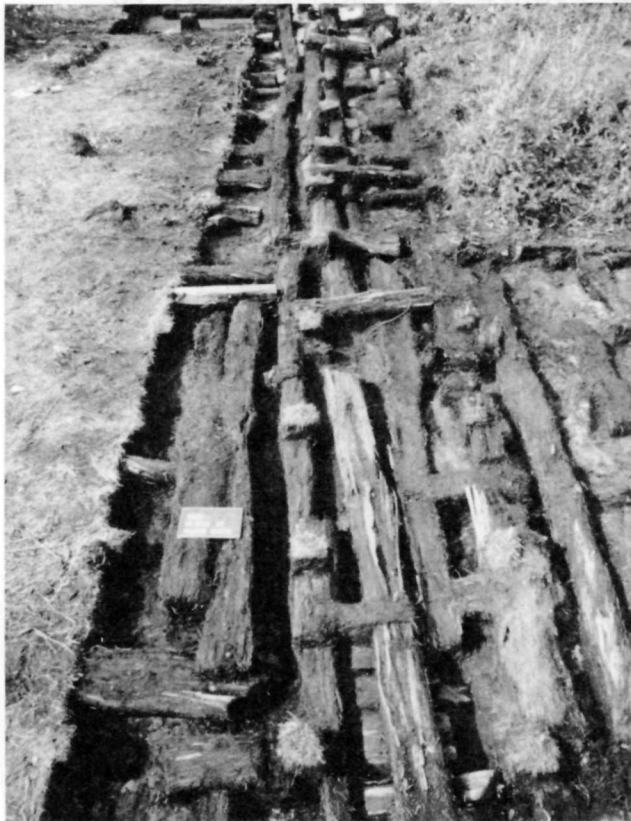
Figure 5. View along south wall of inland cargo house looking west. Structures to left are portions of boardwalk (photo by G. Adams).

The construction of the building, though not yet fully analysed, revealed yet another in a series of foundation styles and one more attempt to counteract the problems incurred by the permafrost. In this case, two long sills were laid parallel to the walls and set a little less than a metre apart. Sometimes there were sleepers below these sills but not usually. Above these, there appeared to be short lengths of squared timber that were laid across the parallel sills at irregular intervals about a half metre apart. Over these was laid a ladder-like frame that probably acted as the base of the walls per se, creating a structure that actually sat above the ground (Figs. 5 & 6). There were also sill beams from an apparently independent floor system and a few fragments of possible wall lining.

To the immediate south there was considerable structural evidence of a boardwalk that paralleled the long wall of the building. The basic structure appeared to be composed of short cross sills in shallow trenches overlaid by long timbers which would indicate that the actual planks walked on were laid parallel to the line of the walkway.

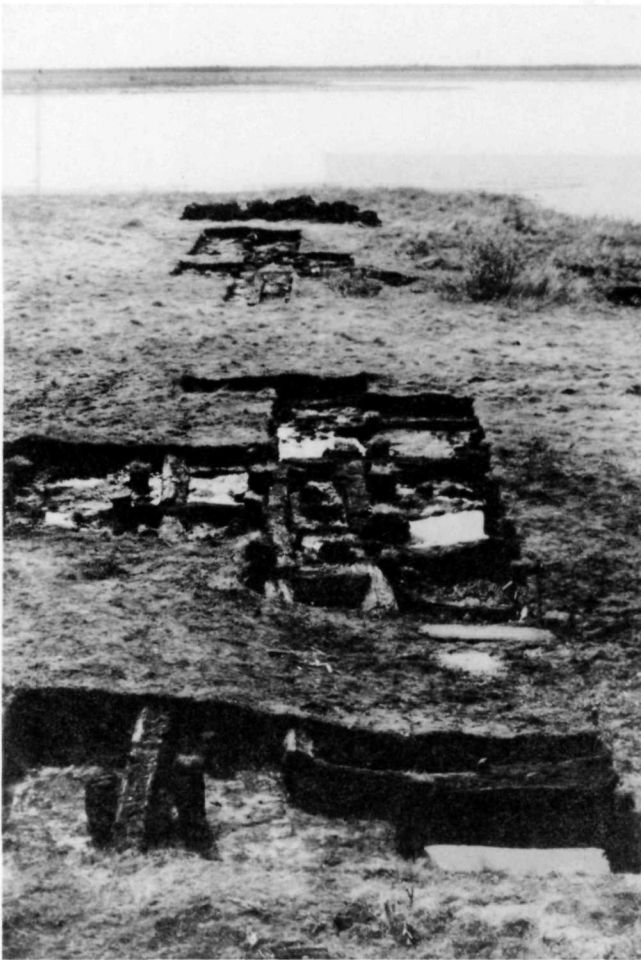
Figure 7. East Fur Store excavations looking east from west end of structure (photo by G. Adams).

The construction itself appeared to be very simple, though the remains were somewhat fragmentary. A set of mud sills were laid around the perimeter of the building and the frame was set on top. There was no evidence of sleepers or additional supports and no remains of the superstructure were recovered. A second set of mud sills were laid about a half metre inside the first set and floor sills were set about 1.5 m apart in a north-south orientation inside the inner sills (Figure 7). All of these foundation parts were probably the lower of a double silled construction. Though analysis has not yet been fully conducted, it is suspected that cross sills were laid over the two walls and a frame sill set over those, over or just inside the outer mud sill. Likewise, the floor would have required a double or triple set of sills and joists.

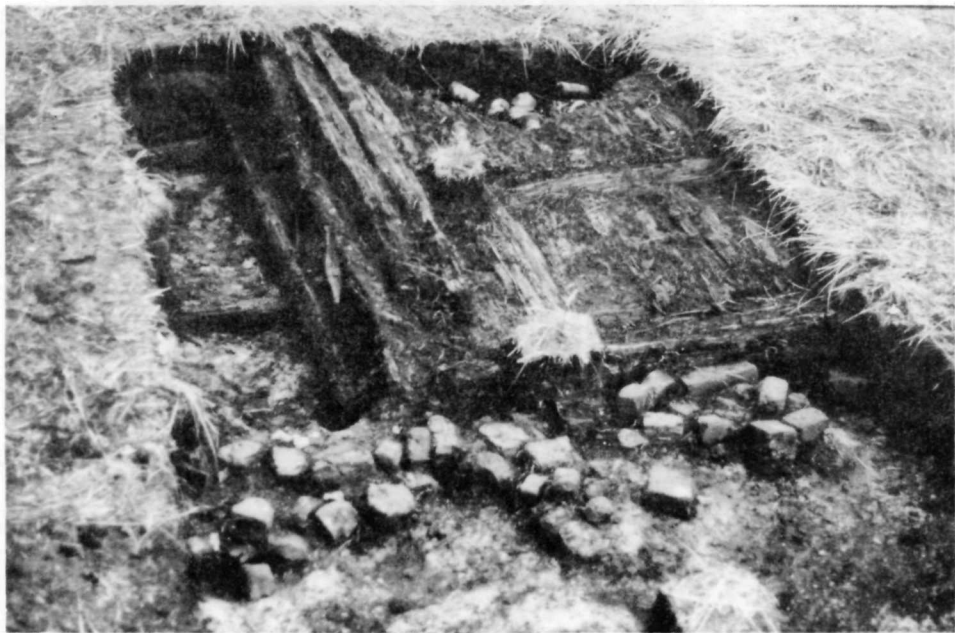
Figure 8. Southeast corner of Boat Builders Shop. Note intrusive garbage pit (Photo by G. Adams).

The 1840 Boat Builder's Shop was by far the best preserved, most complete set of foundations ever recovered at York Factory. This very fact led the crew to attempt to expose both the northeast and southeast corners of the building. An additional 24 m² were removed to locate and excavate the desired portions of this building and the foundation of a former firebox and boiler that formed part of a warping box. The actual foundation remains included mud sills and upper sills, portions of the frame for the superstructure and areas of intact flooring (Figure 8). It was the first structure where all the nails had not been removed.

In terms of construction, it appeared that a trench was dug to receive short half timbers which were used as sleepers. These were covered with three layers consisting of log sills, half timbers, square timbers and half timbers again. Over the uppermost layer was laid a square timber frame.

Two other features were found in direct association with the building. One was the aforementioned warping box and the other was a garbage pit dug right through the floorboards of the building sometime in the 1960s or 1970s.

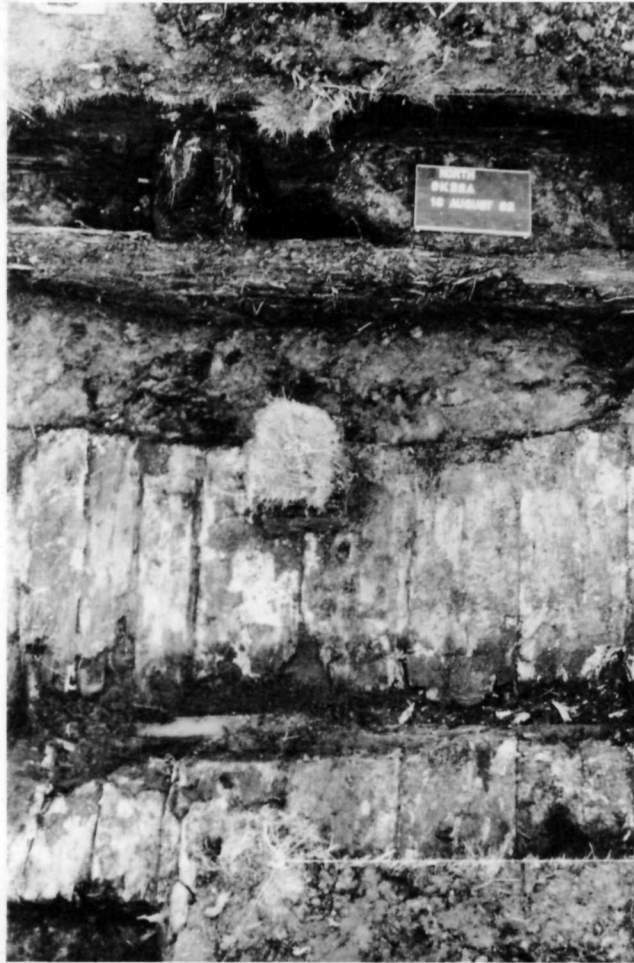
Figure 9. Planview of tongue-in-groove top of drainage ditch extending from the depot to the riverbank.

The fourth and fifth lines, as well as some of the subsequent pits revealed a series of poles. These were laid end to end to form lines about a metre apart and may have been part of a ground stabilization program. The sixth line exposed a miraculously well preserved drainage ditch. It may have been affiliated with the gardens which were now just a few metres west of the digs. The last line contained no features.
