# RESEARCH BULLETIN

No. 268

Kathleen Lake Day Use Redevelopment, Kluane National Park Reserve - Archaeological Assessment Re: Screening Report K85-06

Environment Canada-Parks, Archaeological Services, Prairie and Northern Region

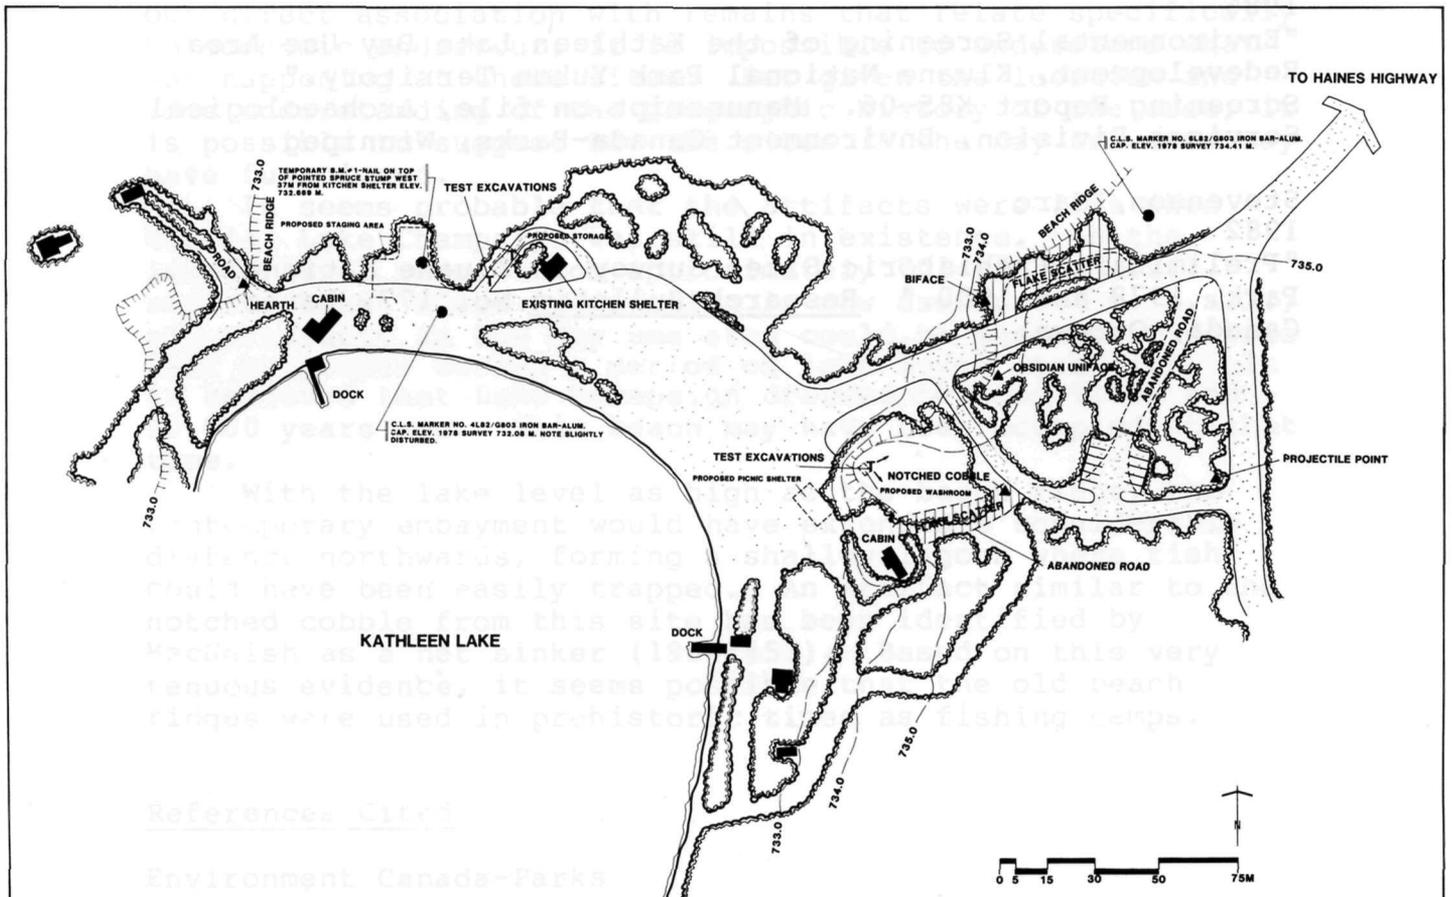
Figure 1: Kathleen Lake Day Use Area with archaeological sites indicated. Subsurface tests were conducted at the proposed site of the washroom, boat landing and storage shed (drawn by David Erick.) (1986)

Figure 1. Kathleen Lake day use area with archaeological recovery areas indicated. Subsurface tests were conducted in proposed site of the washroom, boat staging and storage shelter areas. (Drawn by David Elrick.)

An archaeological survey and collection program was conducted in the Kathleen Lake day use area in response to concerns expressed in the Environment Assessment and Review Process (EARP) screening report K85-06 regarding the possible impact on archaeological resources during lakeside redevelopment (see Figure 1)(Staley 1986:8-9; Environment Canada-Parks 1986:8-9, 15-16).

All lithic artifacts were recovered from the surface on or above the wave-cut cliff beach ridge. Figure 1 shows the distribution of lithic artifacts.

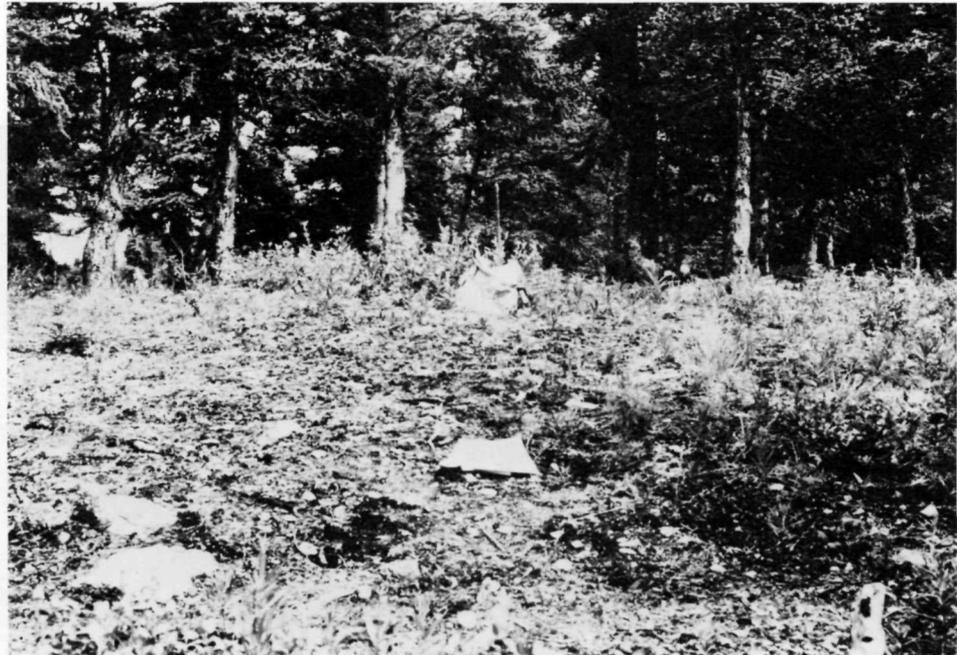
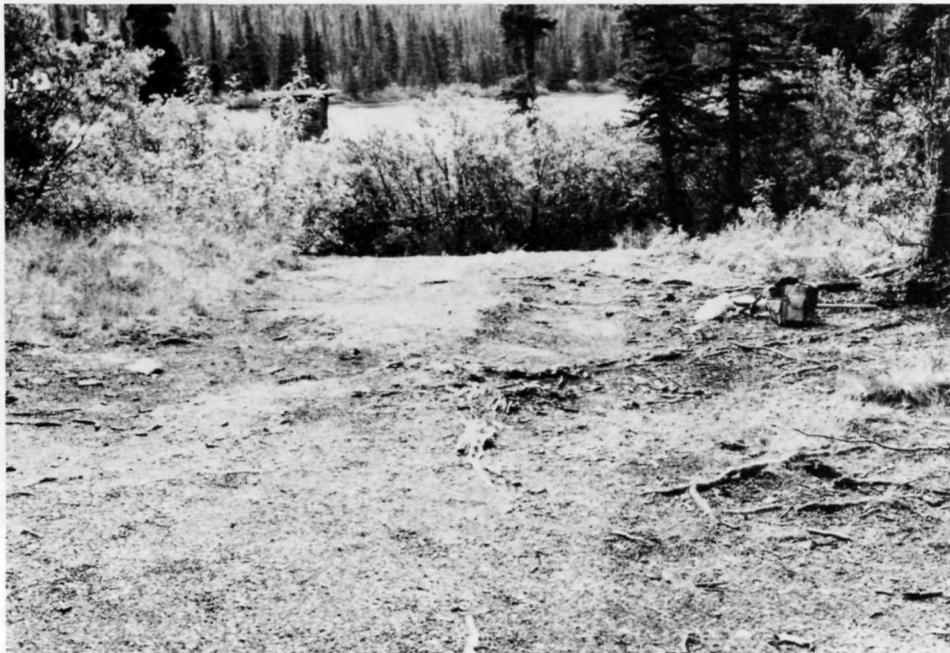
Figure 3. Test excavations located west of the present

Figure 3. Test excavations located west of the present kitchen shelter. (Photo by S.B. Ebell.)

In the storage shed and staging area, shovel tests were also placed at 5.0 m. intervals with reference to CLS marker 4L82/G803. Again no buried archaeological resources were found (Figure 3).

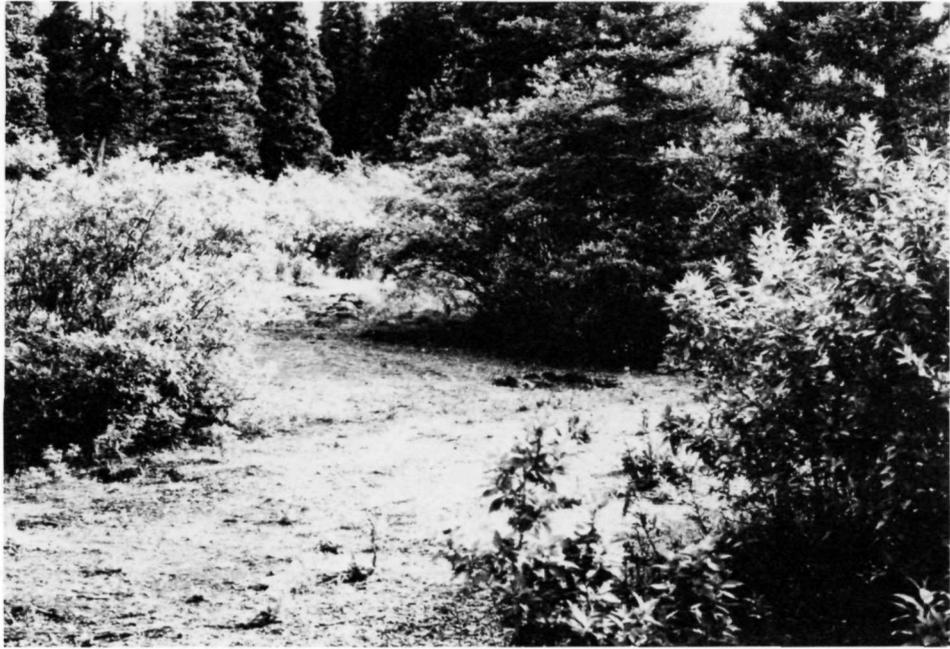
Figure 2. Test excavations in the area of the proposed washroom. The book in the middle foreground marks the location of Canada Lands Survey marker 2L82/G80. The kit bag and shovel behind it marks the location of test excavations. (Photo by S.B. Ebell.)

Shovel tests were placed at paced 5.0 m. intervals with reference to Canada Lands Survey marker 2L82/G80 (not shown on Figure 1). The shovel tests were about 20 cm.<sup>2</sup> and extended approximately 30 cm. deep (Figure 2). No buried archaeological resources were noted.

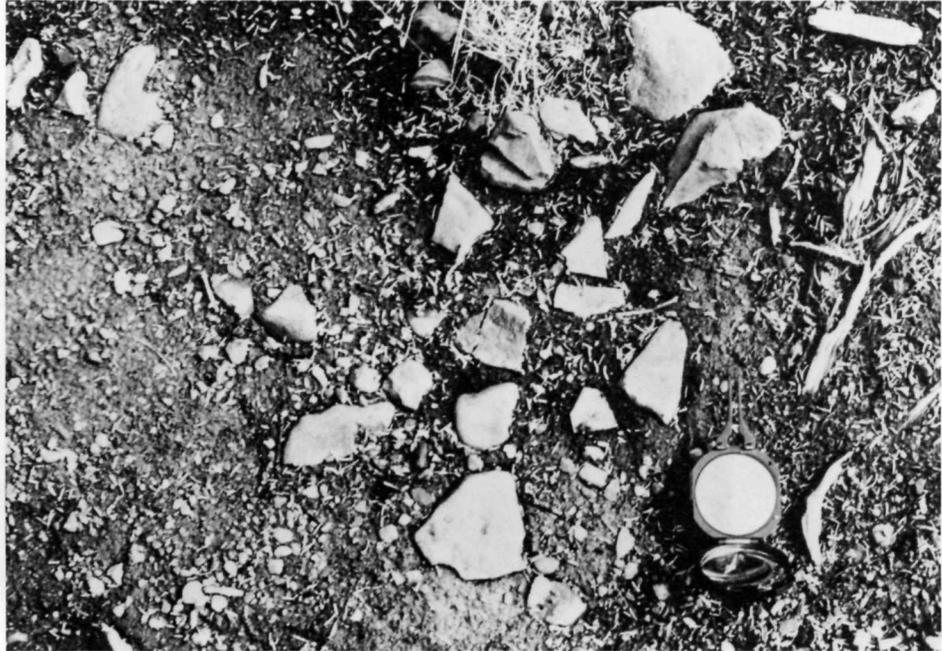
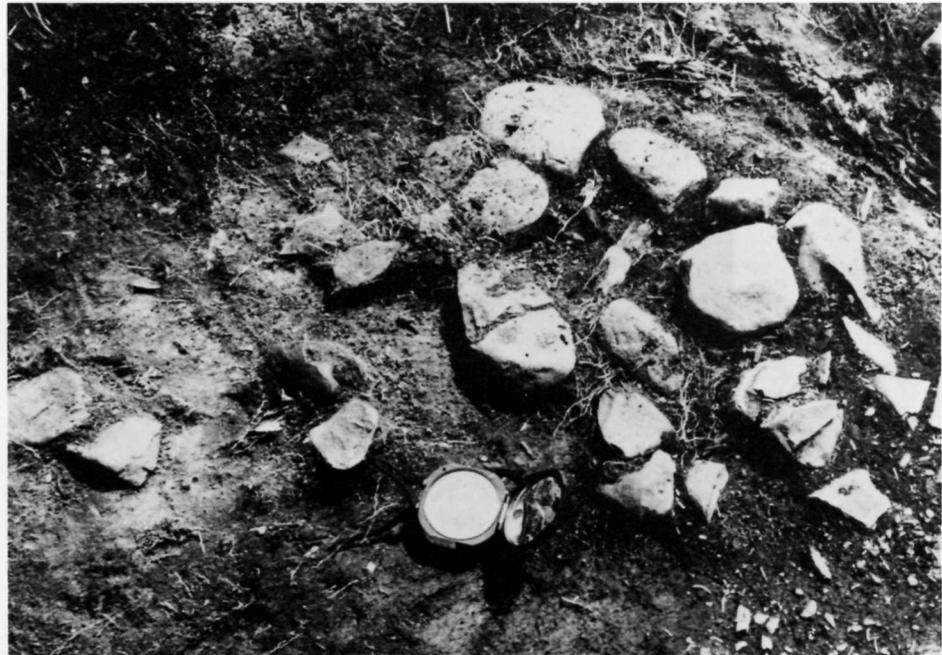
Figure 4. The fire hearth is located in the right wheel track directly beside the kit bag. Kathleen Lake is in the background. (Photo by S.B. Ebell.)

Figure 5. Fire hearth on the beach ridge. North is to the top:  
 a) vertical photo of fire hearth as found;  
 b) excavation in progress. Note location of bone in both photos.  
 (Photos by S.B. Ebell.)

One of these sites was an area of heat cracked rock and calcined bone exposed in the roadway behind the extant private cabin west of the staging area (Figures 1 and 4). Vehicle travel had eroded the ground surface away from the feature. Because the fire hearth was rapidly deteriorating from automobile traffic and natural erosion, the author excavated it to salvage what data there was. Using small hand tools, I cleared away the soil from around the feature, exposing an area about 1.0 m. in diameter. The various stages of the excavation were photographed (see Figure 5), but no artifacts were found. However, a small quantity of calcined and unburned bone was recovered, most from the west side of the rock feature where the clay had been reddened by the fire.

The hearth stones appeared to be resting on a level surface and the calcined bone was recovered from within and below the rock feature. The bone was well-preserved, suggesting that the feature was not very old. The acidic boreal forest floor will usually cause bone to disintegrate quickly.

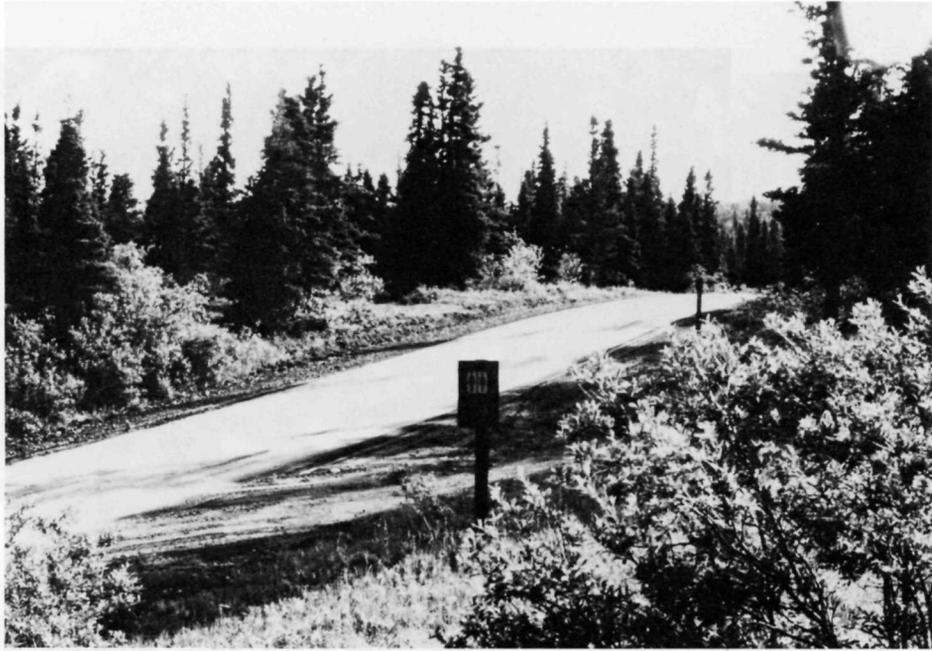
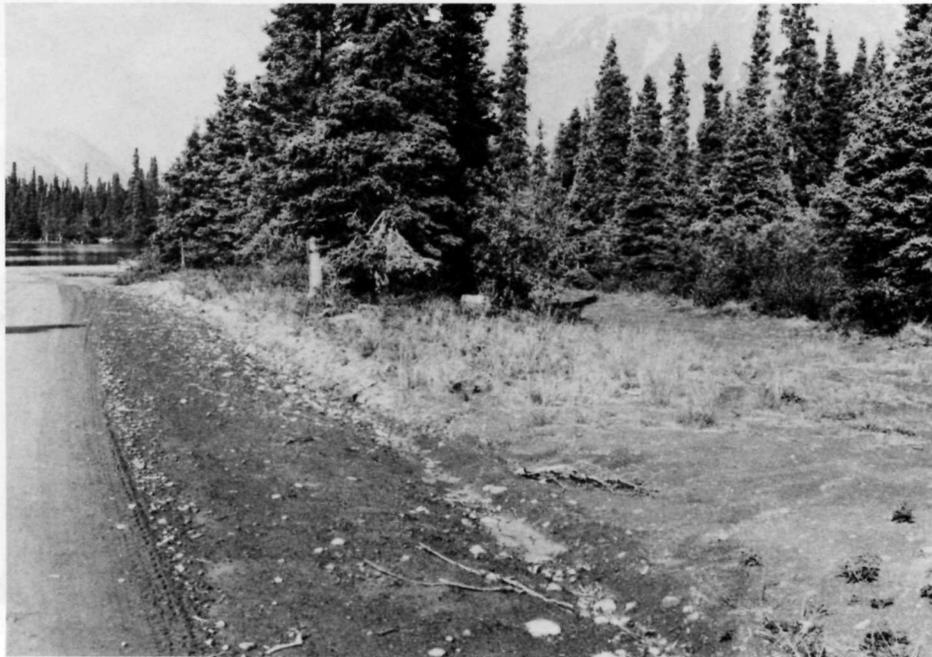
Figure 6. Surface site 32Y100. Note beach ridge:  
 a) looking north, 32Y100 is on the left side of  
 the road between the spruce trees;  
 b) looking south towards Kathleen Lake, 32Y100 is  
 located in the open space on the right.  
 (Photos by S.B. Ebell.)

Stevenson (1982:5) and French (1980) reported that obsidian and chert flakes were recovered from both sides of the access road. This site, 32Y100, contained two activity areas consisting of lithic scatters. The first was on the

Across the access road to the north in an area designated for scarification, 29 obsidian flakes, two quartzite flakes, one chert flake, one basalt flake, one small fragment of a biface of obsidian, and one complete hafted biface of obsidian were recovered (Figures 6 and 7). This site was noted by French to be located "to the north of the road, ca. 10 m. along the old creek bed" - the shore line of the abandoned embayment. Today the recovery area consists of three picnic sites and a currently unused roadway. Directly across the access road from this area, I recovered one thick obsidian flake that has some unifacial retouch along one edge (Figure 7c).

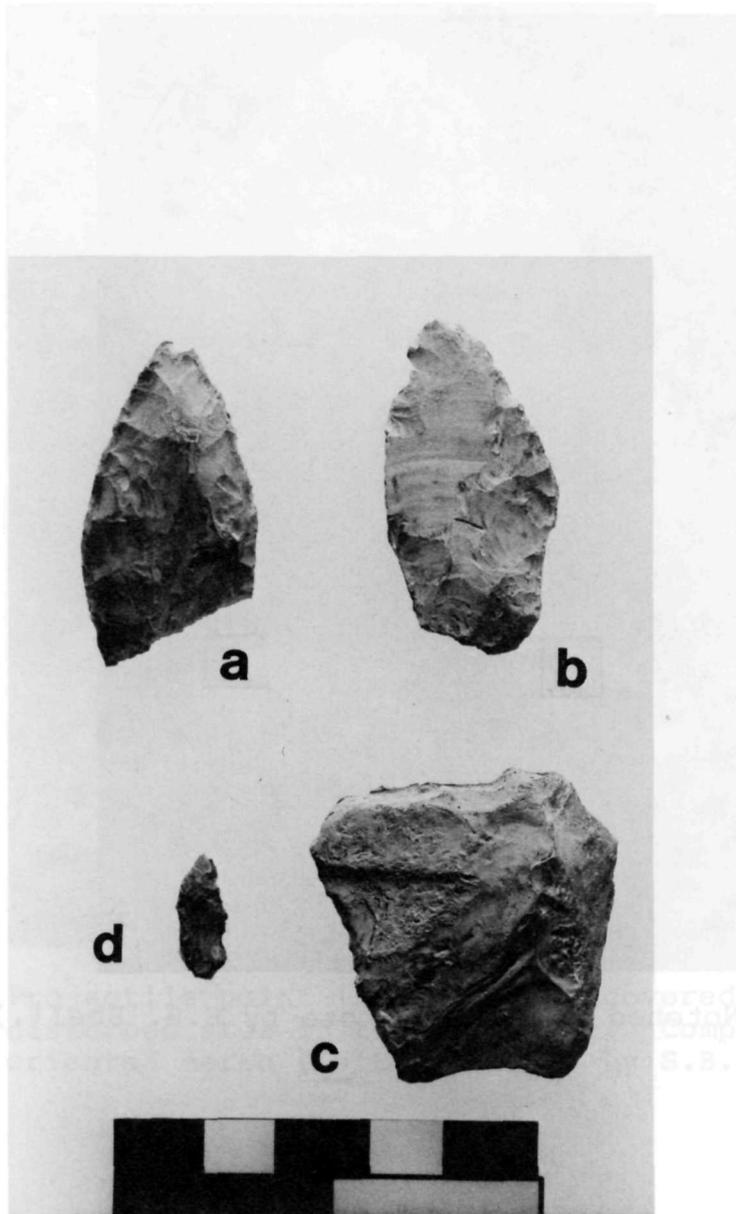
Figure 7. Artifacts recovered from the surface in the Kathleen Lake day use area: (a) lanceolate projectile point with base missing; (b) obsidian biface; (c) obsidian uniface; (d) obsidian biface fragment. (Photo by S.B. Ebell.)

The base has been snapped off, but it was originally lanceolate. It is made from dark green-grey fine grained rhyolite or chert. The flaking is well executed, although both surfaces retain remnants of the original flake from which the artifact was made. Because the base is missing its type can not be determined.

This artifact is made from a flake of dark green translucent obsidian. Both surfaces retain unflaked areas. One lateral edge is slightly shouldered and the blade is asymmetrical. The stem lateral edges and base are lightly ground. The flake blank percussion bulb is located at the basal end and numerous thick randomly directed flakes have for the most part removed it. The blade lateral edges show some evidence of wear.

A small fragment from the edge of a fine biface or projectile point is made from opaque Hoodoo Mountain obsidian.

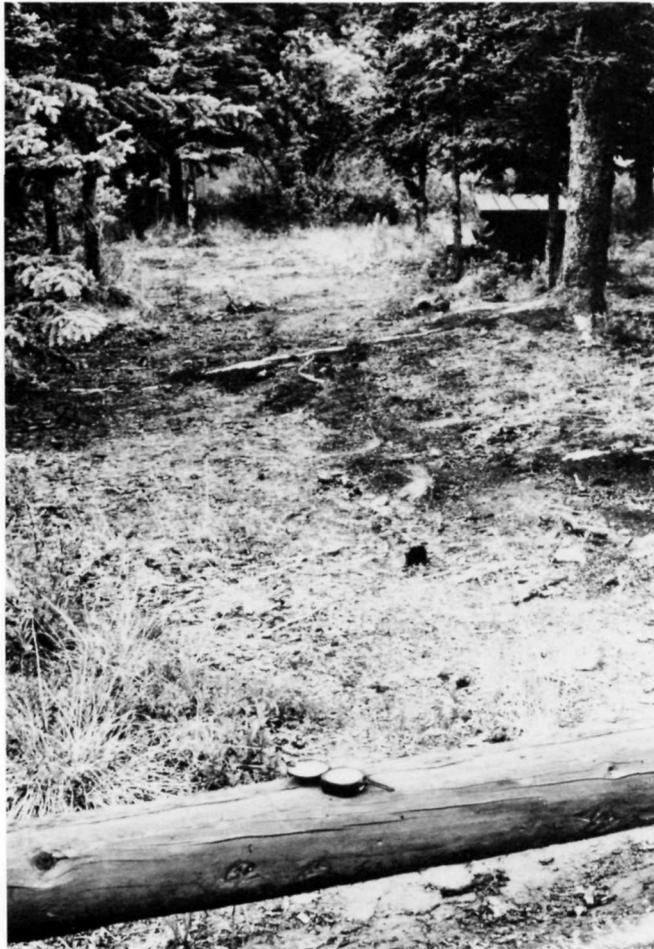
Figure 9. Projectile point (Figure 7a) recovered from disturbed area in front of root. Compass oriented north (left). (Photo by S.B. Ebell.)

An isolated projectile point was also recovered in the opposite corner of the day use area west of the road leading to the hiking trail and north of the road that circumscribes the southern boundary of the picnic area (Figure 7a and b).
