# RESEARCH BULLETIN DE RECHERCHES

No. 76

## Motherwell Homestead Archaeology Project

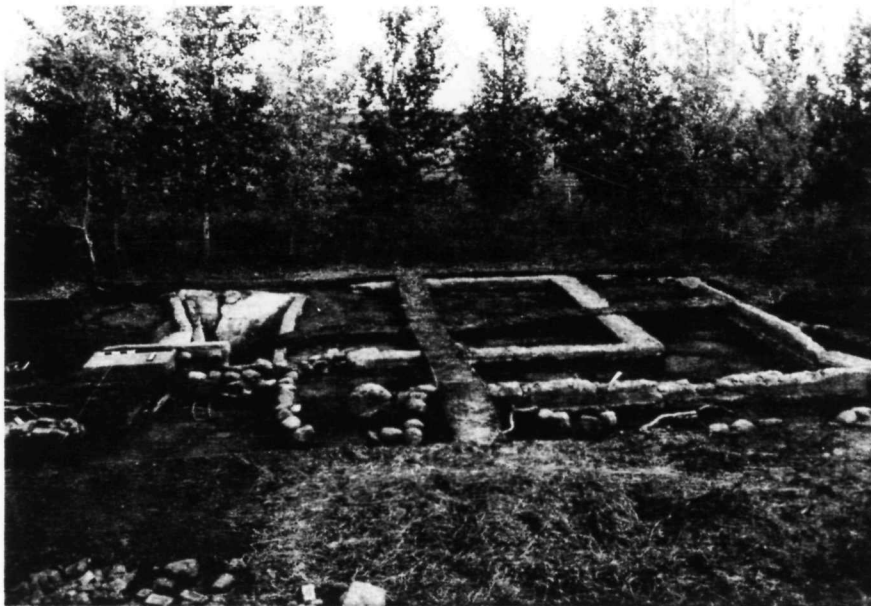
6 Excavation of men's cottage from the south. (Photo by G. Adams.)

The two largest excavation areas both occurred in the barn quadrant. Though the men's cottage had been moved to Abernethy in the late 1950's, the concrete foundation underwent extensive examination. The original 1908 foundation which measured 6.4 m north-south by 4.5 m east-west were excavated. To this, there was added a 2.6 m extension to the east and a 2.1 m extension to the south. A third extension consisted of a 6.2 m by 2.7 m basement, detached from the west wall by .8 m. This basement was 1.9 m deep and filled with discarded concrete and garbage. The front of the larger structure was to the south as indicated by a front doorstep and boardwalk south of the basement, a rock bordered garden along the south extension wall and ornamental shrub plantings along the garden border. A side door was located in the centre of the east

extension. There were no construction details except as indicated in the contours of the concrete. (Fig. 6.)

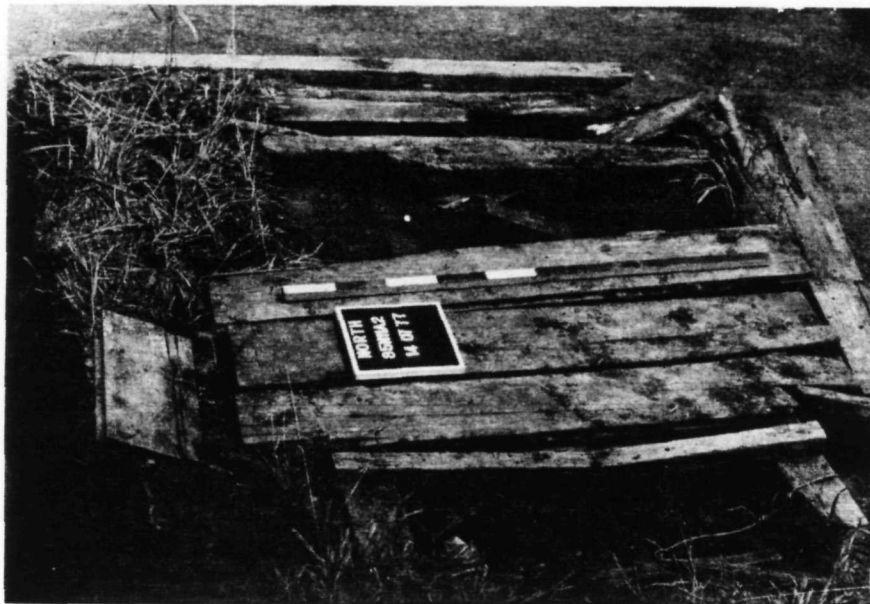
8 Excavation of dry privy floor. (Photo by G. Adams.)

A dry privy east of the barn caused considerable anxiety. Historical sources indicated that the privy had been located in the same spot for a considerable length of time. Though the superstructure had been knocked over a 1.5 by 1.2 m substructure on skids was found and excavated. However no evidence of a pit was found beneath it. Since extensive testing in the vicinity of the privy failed to reveal any indication of a former pit the tentative conclusion was drawn that the privy had internal containers that were emptied periodically. (Fig. 8.)
