WILDLIFE MANAGEMENT BULLETIN

OTTAWA
JUNE 1950

Limnological Investigation of
Fundy (New Brunswick) National Park,
1948.

Victor E.F. Solman.

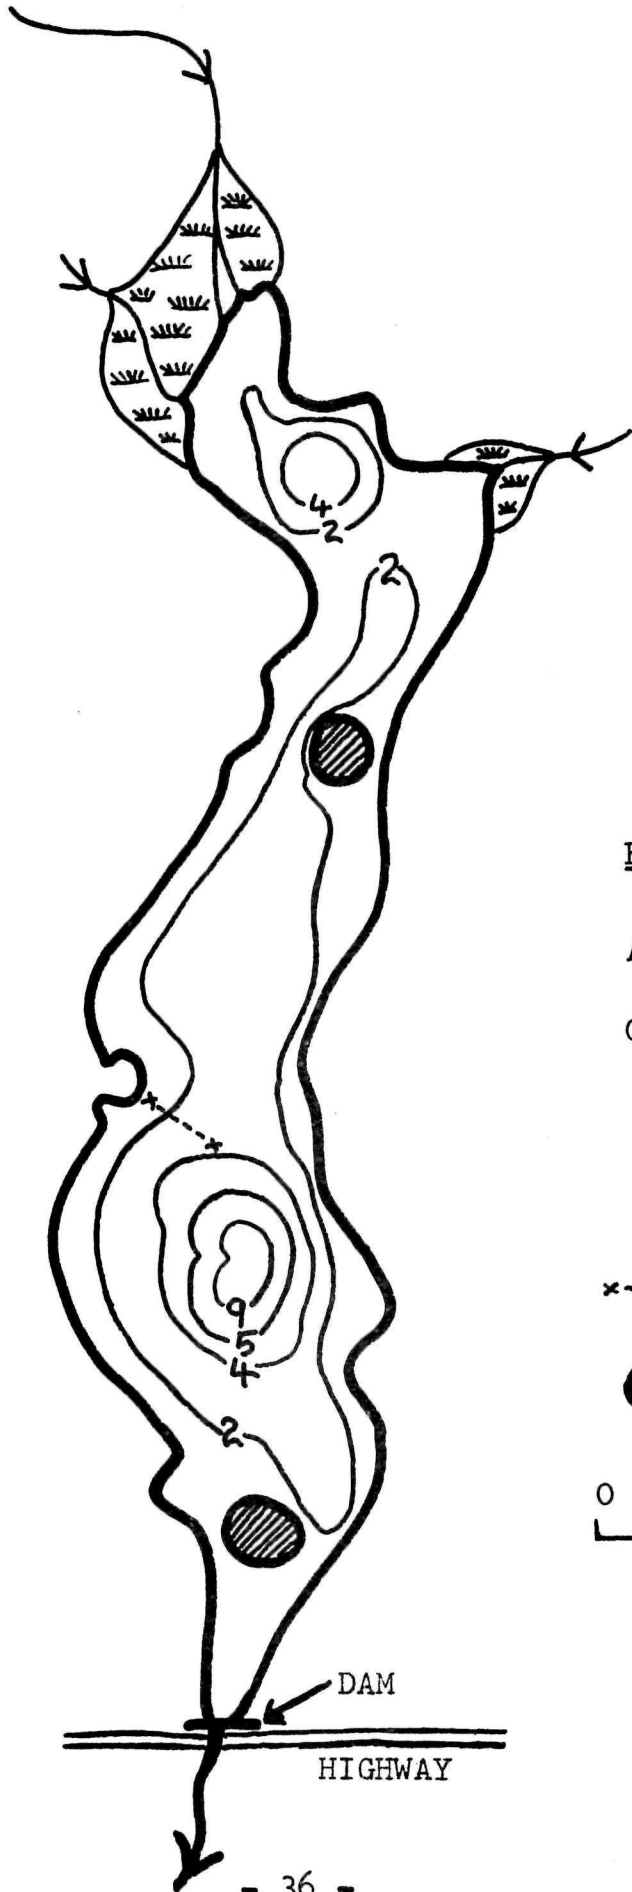
BENNETT LAKE

AREA == 48 ACRES

DAM

HIGHWAY

The lake was investigated on May 19 and 20. It was thoroughly sounded on May 19, and the contour map on page 36 was prepared on the basis of 61 soundings. It will be noted from the map that much of the lake is less than four metres deep and the maximum depth of over nine metres occupies only a very limited area. On page 39 are two photographs of the lake.

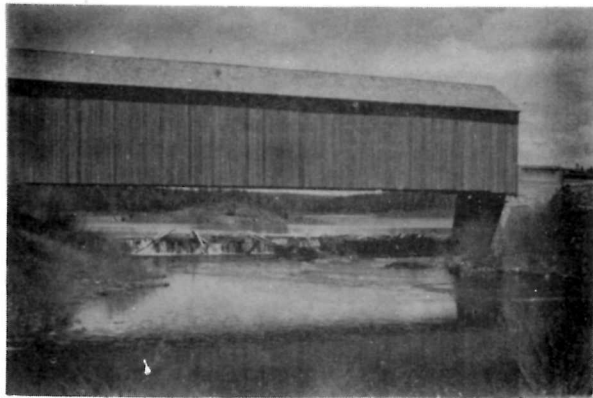
Bennett Lake looking north up outlet stream to show highway bridge, beaver dam and south end of lake. May 20, 1948.

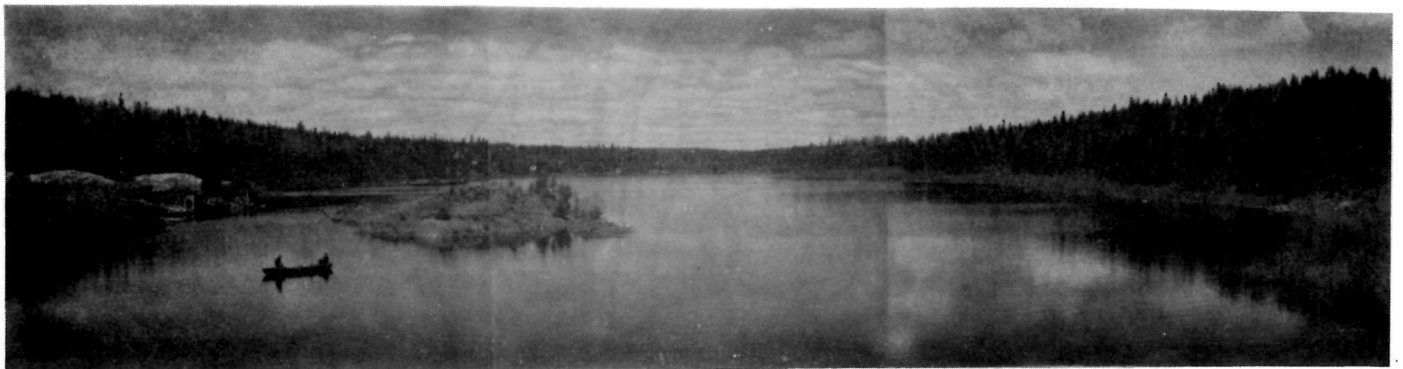
Bennett Lake looking north from highway bridge at outlet. Note sawdust pile and remains of sawmill on west shore and beaver house on east shore of island. May 20, 1948.

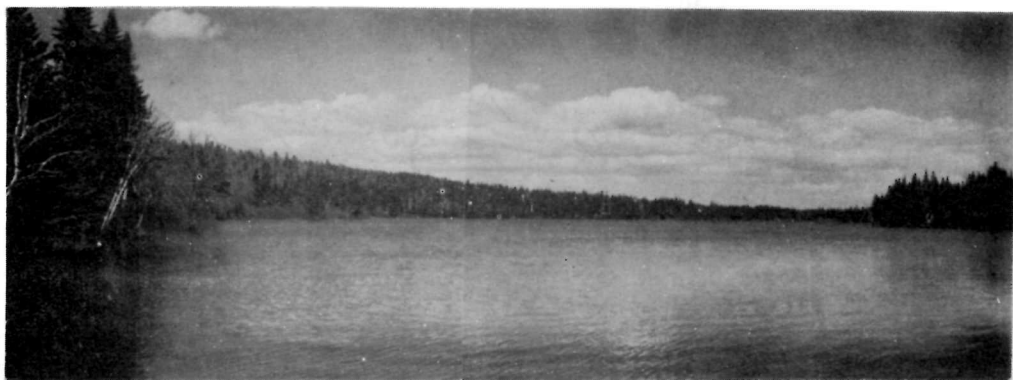
Lake View looking north from near south end. May 21, 1948.

cottages are to be found on its northwest shore. Several boats were present on the lake at the time of observation. These probably belonged, in at least some cases to the owners of the cottages. Photographs of the lake appear on pages 39 and 40.

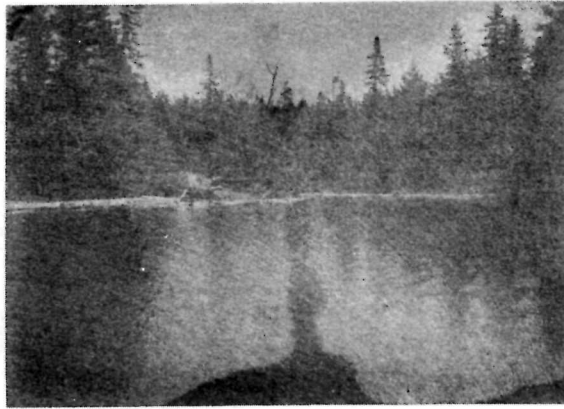
Earth dam and wooden control structure at south (outlet) end of Lake View, looking south. May 21, 1948.

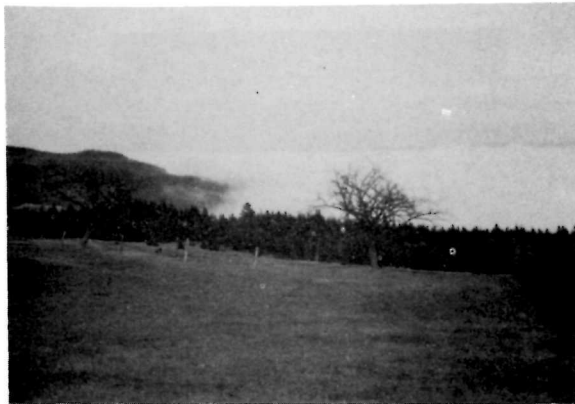
Looking west from a point on the park highway about 2 miles east of Alma at an altitude of 900 feet showing fog over Alma and vicinity approximately 600 feet thick. Most of the park area was free of fog at this time. May 26, 1948.

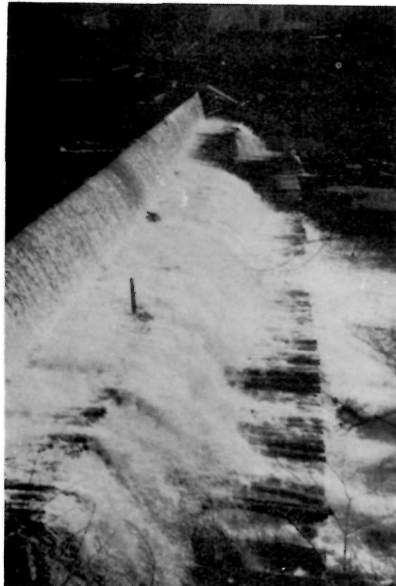
Dam on Upper Salmon River near Alma, looking east to show flow of water over entire face of dam. May 16, 1948.

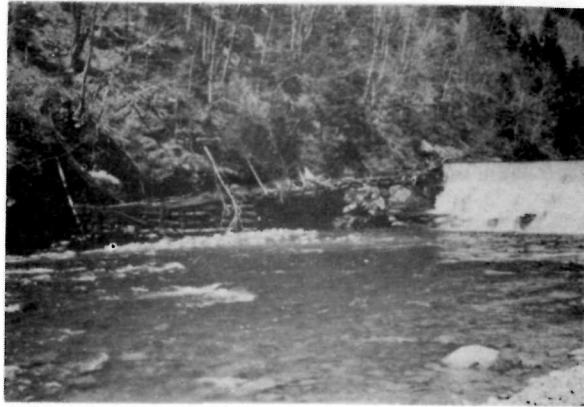
Unserviceable fishway at west end of dam on Upper Salmon River. May 16, 1948.

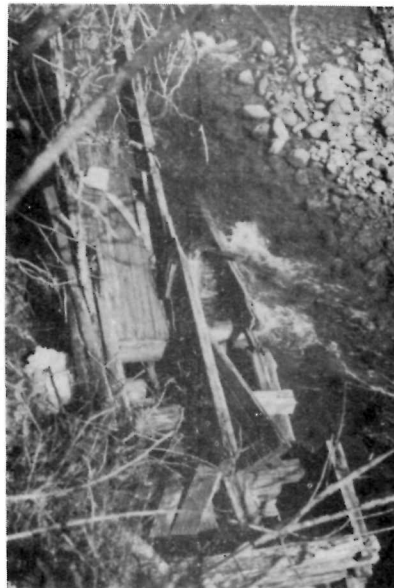
Unserviceable fishway at west end of dam on Upper Salmon River as seen from south end. May 16, 1948.

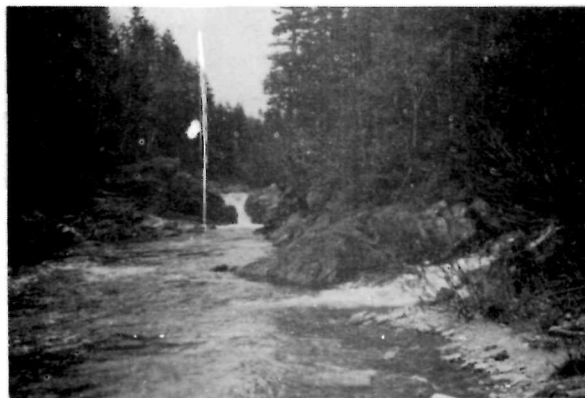
Looking east up Forty-five River showing falls on north branch in background and south branch entering main river in right foreground. May 25, 1948.

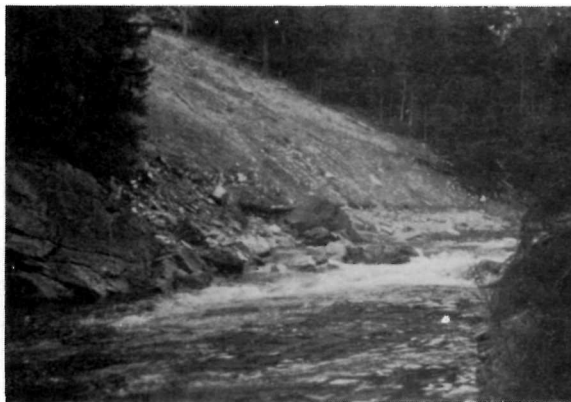
Pool on north branch of forty-five river. Vegetation has been removed from area in background by logs sliding down to river. May 25, 1948.

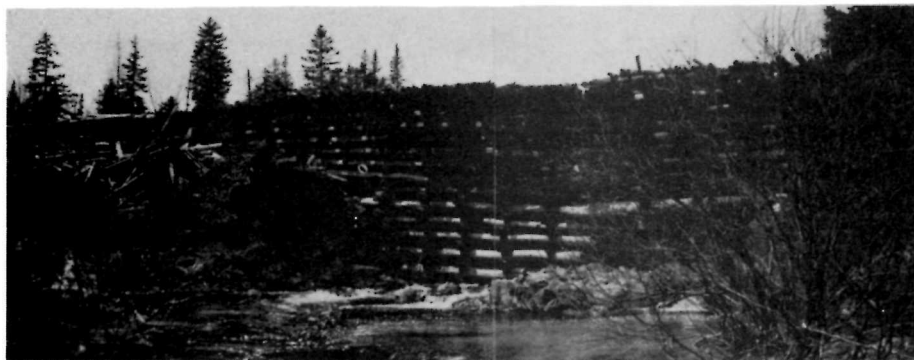
"Driving" dam on Drummond Stream one and a half miles south of Lake View as seen from downstream side. This dam is over 500 feet long and 20 feet high at midstream. May 24, 1948.

This stream, which drains Lake View and is a tributary of the Point Wolf River, has been used extensively during past years for the transport of logs cut in the area south of Lake View to the mill near the mouth of the Point Wolf River. In order to facilitate log-driving² a timber dam has been constructed at a point approximately $1\frac{1}{2}$ miles south of Lake View. The construction of this dam has created a pond area approximately $\frac{3}{4}$ mile long extending up-stream from the dam. The dam is approximately 500 feet long and 20 feet high at the centre and is well shown in the photographs on pages 44 and 45. The dam is fitted with large gates which may be opened quickly and which will permit the rapid flow of water required for log-driving in the lower reaches of the stream.

The stream was visited on May 24, which was approximately 10 days after the last log-driving operations had been conducted. The effects of the sudden release of a large volume of water for log-driving purposes were easily observed below the dam and the scouring action of

this rapid flow appeared to have been quite great. Twenty hand-sized stones which were examined in the stream bed below the dam and which would have been expected to be populated by insect larvae in fair numbers were completely bare as the result of the scouring action. The stream below the dam contained several deep pools and might be capable of supporting a moderate population of Eastern Brook Trout provided that the use of the dam for log driving is discontinued. The pond above the dam is largely filled with alders and since it is shallow over most of its area it would probably become too warm to be a suitable habitat for Eastern Brook Trout during the summer. At 3:00 p.m. on May 24 the surface temperature of the water in the pond was 9.°C and the pH was 6.0. The surface pH in Lake View on May 21 was 6.5. The lower value obtained in the pool on the Drummond Stream was considered to be due to the large mass of decaying wood in the pond.

Now that logging operations are terminated the dam will fall into disrepair and can be expected to collapse within a few years. After that time the stream will return to its original condition and since its flow is stabilized to some extent by Lake View it should provide a limited amount of good angling for Eastern Brook Trout in its numerous pools.

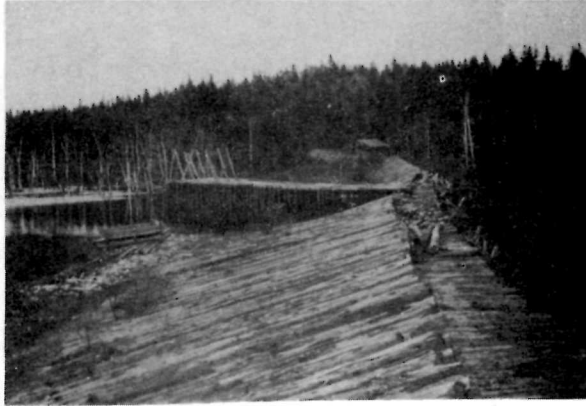
"Driving" dam on Drummond stream as seen from west end looking east. Structure to left of dam face in centre of dam is control for quick release of water for log driving. May 24, 1948.

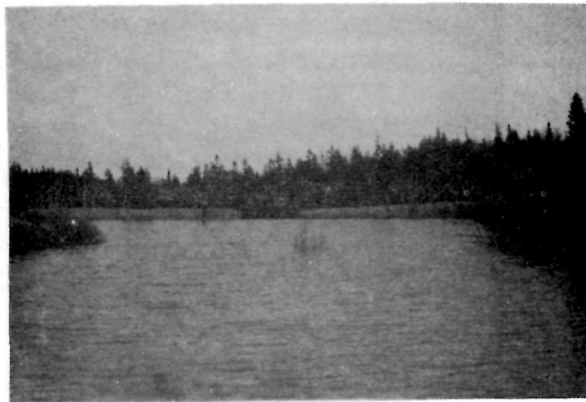
"Driving" dam on Drummond stream looking south from pond above dam. May 24, 1948.

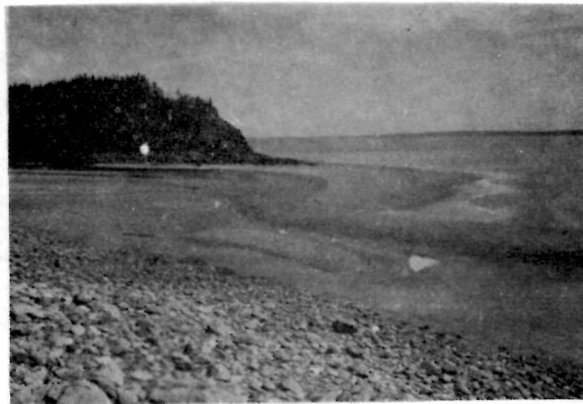
Mouth of Point Wolf River at low tide looking southeast. May 16, 1948.

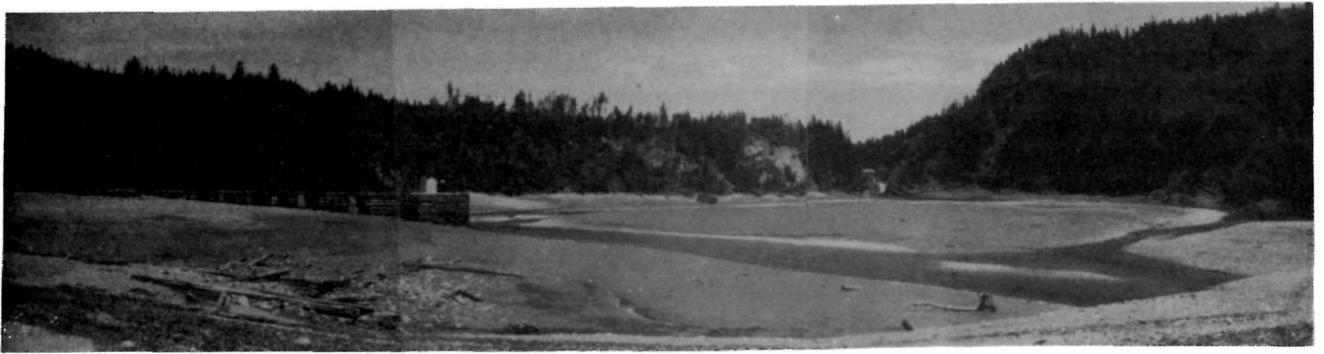
Looking upstream from mouth of Point Wolf River at low tide to show estuary and in right centre background the dam and bridge. May 16, 1948.

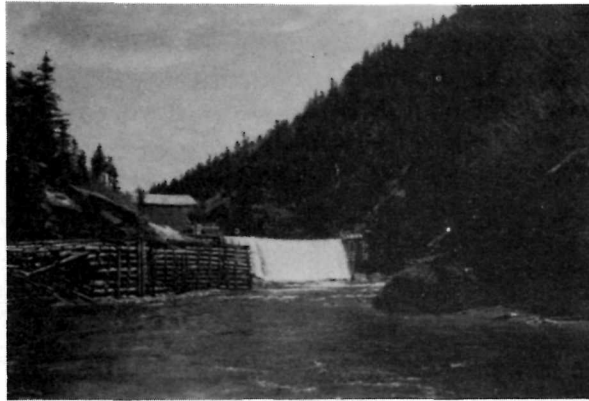
Dam and part of covered bridge over Point Wolf River, looking upstream at low tide. May 16, 1948.

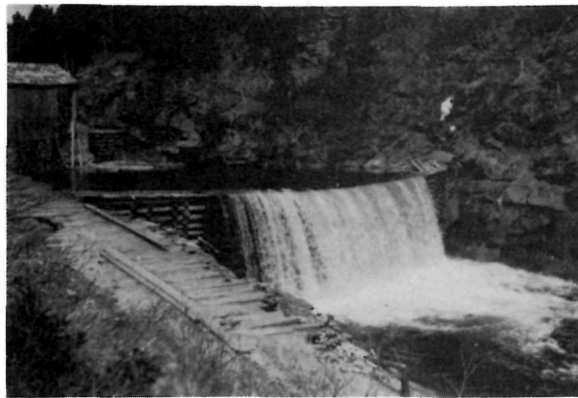
Dam on Point Wolf River showing absence of fishway. End of covered bridge and part of road appear in background. May 16, 1948.

If a suitable fishway was provided or if the dam was removed it is probable that an annual salmon run capable of providing angling in the lower reaches of the river would result. The dam at present is a picturesque addition to the river and if it is to be maintained in its present condition the construction of a suitable fishway would permit the up-stream migration of salmon. If routine maintenance of the dam is neglected for a few years the dam will be carried away and salmon migration will be possible. The dam could also be removed in the near future by explosives or other means if such a course is deemed desirable.

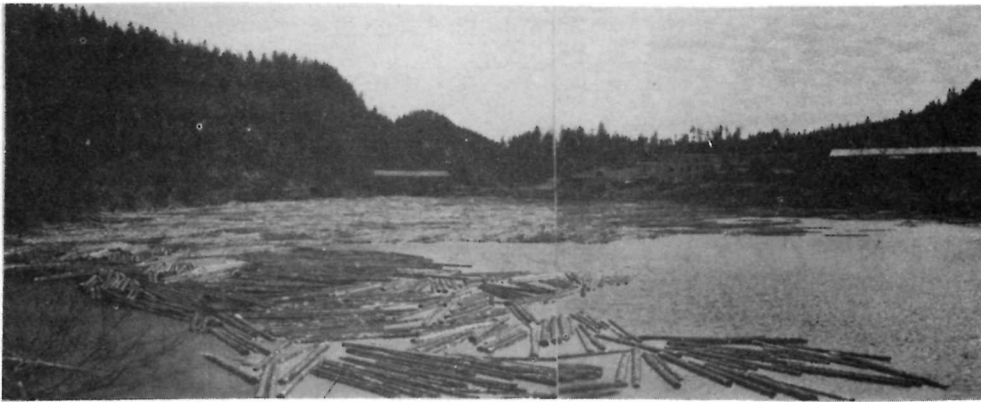
Log pond above dam on Point Wolf River looking downstream. Sawmill and living quarters for employees are visible at right centre. May 16, 1948.

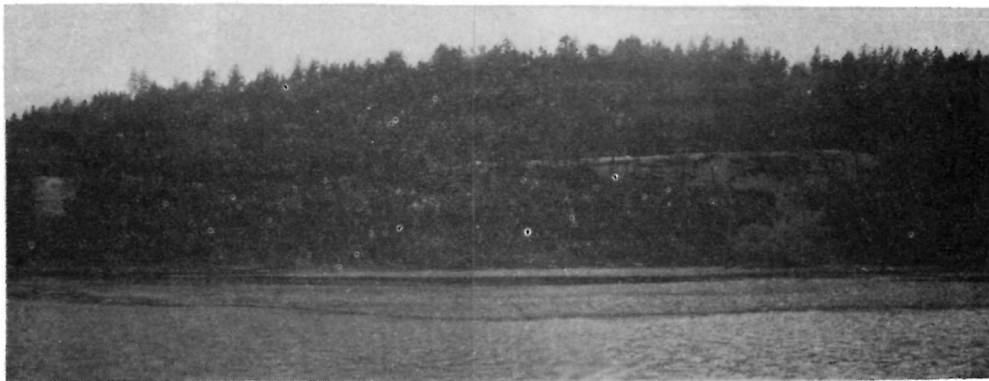
Large pile of sawdust extending upstream from sawmill along west bank of Point Wolf River as seen from east bank. May 16, 1948.

Large piles of sawdust, resulting from the operations of sawmills during many years, are present at many points in the park, as seen in the photographs on page 47. Fortunately, most of this sawdust has been piled on land and little damage to limnological interests has occurred.

The piles of sawdust present a considerable fire hazard, as well as detracting from the esthetic beauty of many parts of the park. The disposal of the sawdust will presumably be carried out as soon as possible, probably by burning or burying.

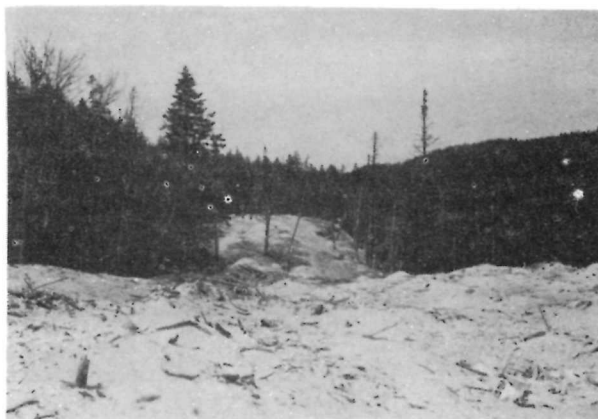
Looking north over sawdust pile behind sawmill on Point Wolf River. May 16, 1948.

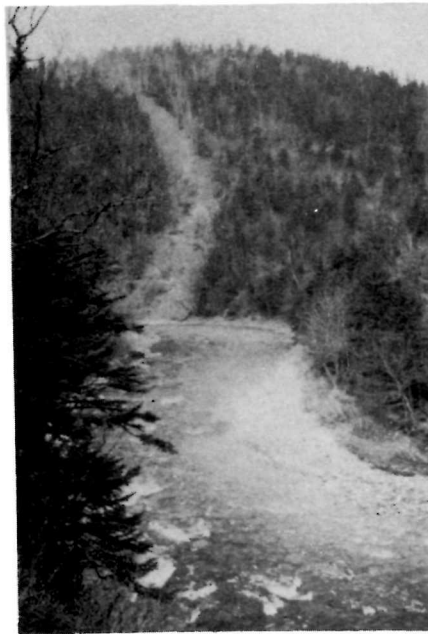
Point Wolf River looking downstream from point one mile above dam to show log slide down 500 foot bank. Note gravel bar in right foreground. May 26, 1948.
