# Delta Mill Conservation Report

## *DELTA MILL CONSERVATION REPORT*

*Prepared by:*  
*Andre Scheinman Heritage Preservation Consultant*  
*William Trick, Mechanical Engineer*  
*McNeely Engineering Consultants*  
*M.D. Smith*

*For: The Delta Mill Society (6/05/96)*

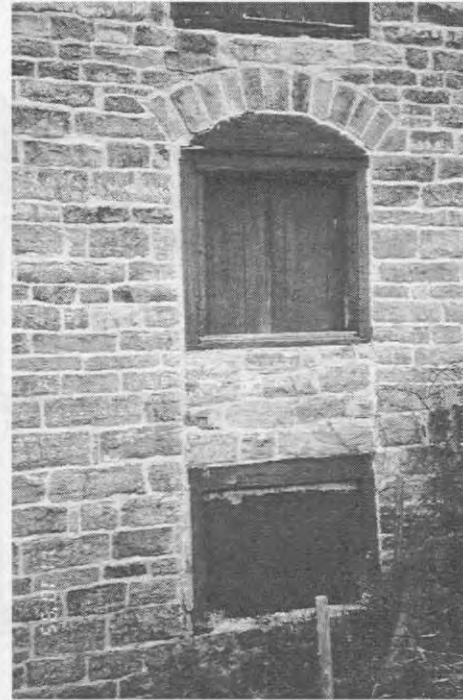
Fig.11 Former door opening

The south end was less consistent. It appears that the centre bay did originally consist of longer service door type openings, though historic photos show that at various times some were glazed as window units. There is evidence at both the interior and the exterior that the middle window of the ground storey was continuous as a door opening as the vertical joint is not 'broken' through all courses below the existing window.(Fig.11). Likewise it appears when viewed from the interior that the adjacent window over the tailrace arch may have actually been the 'waterhouse' door as pictured in Evans (Fig.12-13). Here however there has been a later attempt to tooth in the outer wythe of stone, though not successfully achieved. These doors would have required exterior stairs/landings to allow access.

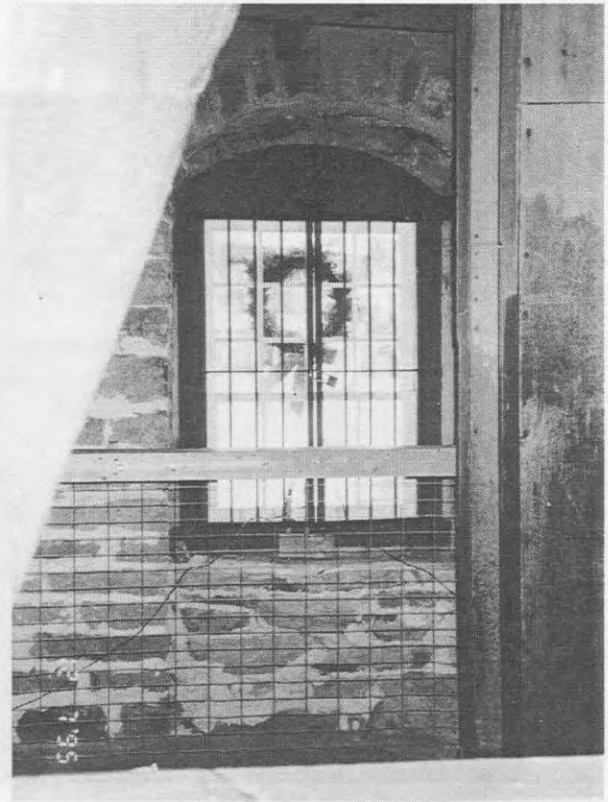
Fig.13 Former 'waterhouse' door

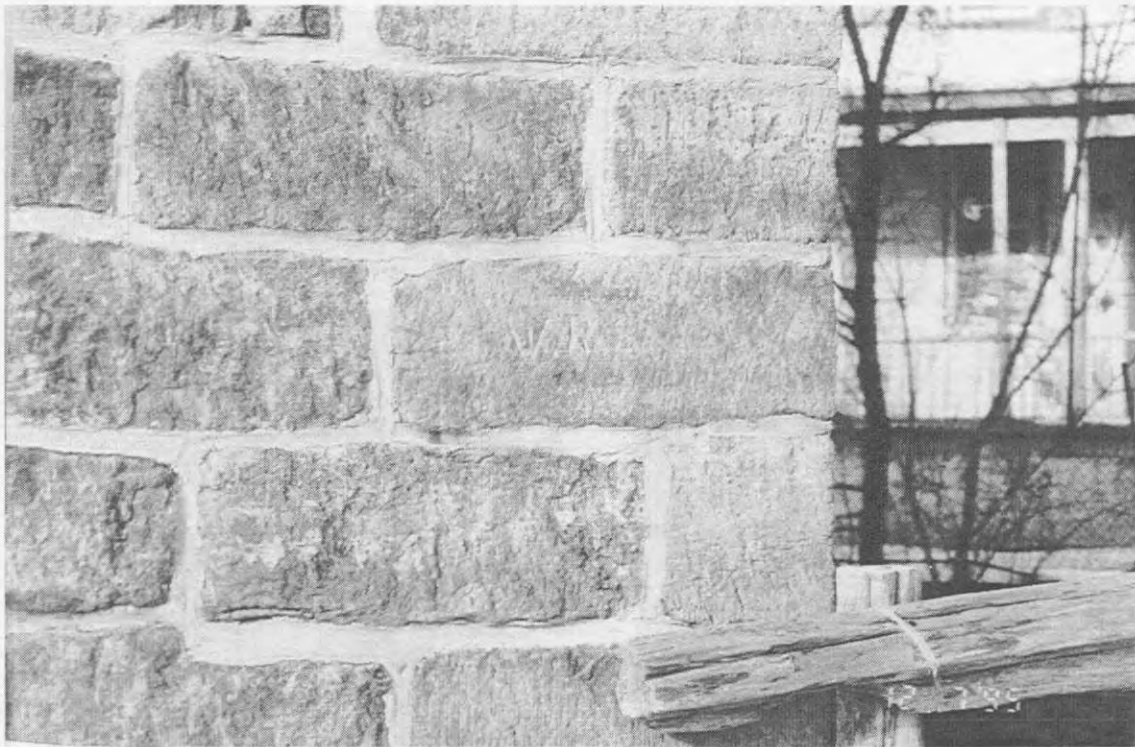
Fig.16 Incised initials

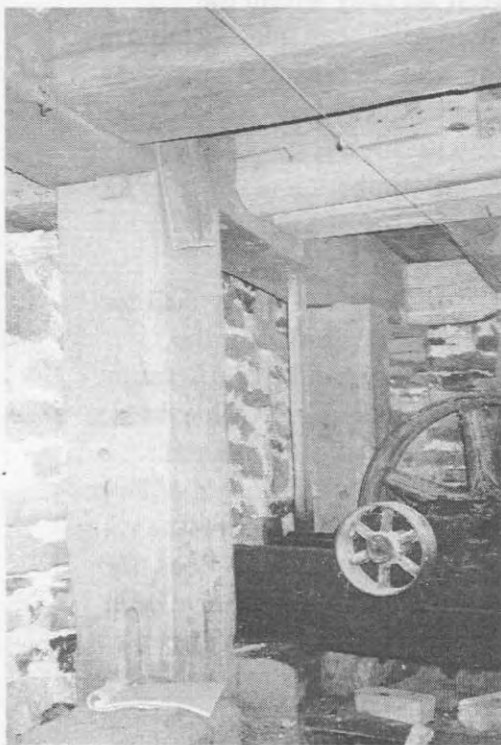
Fig.20 Husk

Thus it would appear that the waterwheel was set higher and extended higher than had been previously considered and that the husk was likewise set higher than its current location and to the east of the wheelpit allowing the wheel to extend uninhibited through the first storey within a 'waterhouse' (wheelroom) as shown in Evans (Fig.12). Indeed investigation has shown that the southwest window of the first storey was formerly a door, the door to the waterhouse as in Evans. Also a shoulder at the stone wall below typical second floor level is evident at the southwest (Fig.21), indicating the position of the ceiling/floor over the waterhouse which may have differed in elevation from that of the husk or the rest of the second floor as in the Evans prototype. The millstone and millstone support timbers at the west of the current husk are all relatively recent and would have replaced the original millstone supports. This supposition makes sense of the much older tentering post located in relation to the west millstone. The upper and lower husk beams originally framed into posts adjacent to the waterhouse wall at the west. The two western stones would have been the original set with room on the husk for a third stone which was added sometime later. The original vertical shaft extended up between the two western stones.

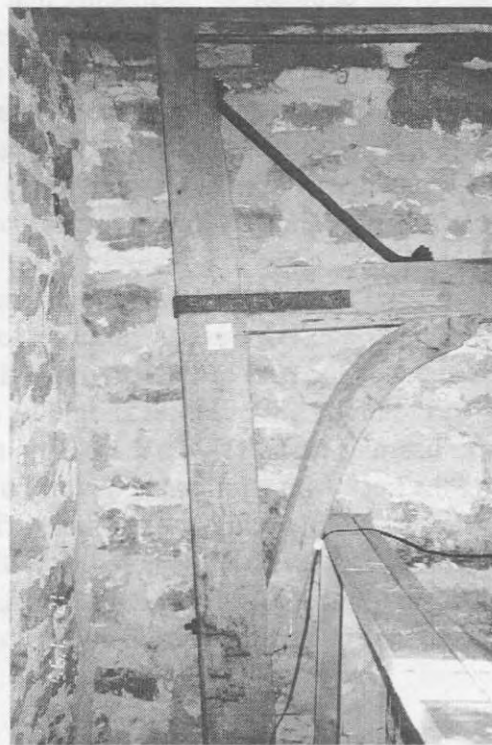
Fig.21 Waterhouse ceiling location

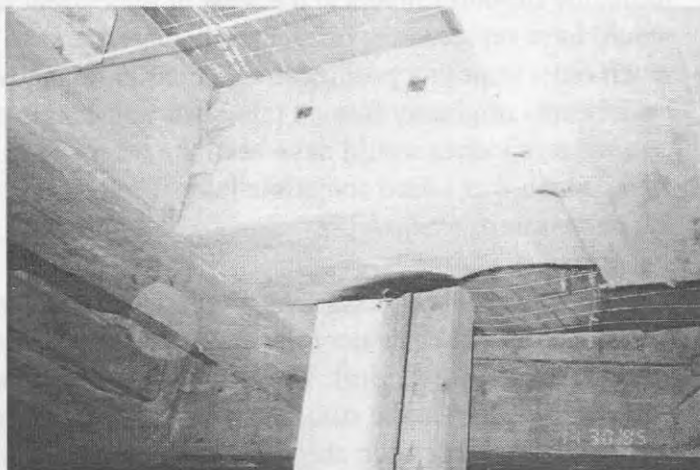
positions. The basement stair stinger is inscribed 1922. Likewise the husk timber which carries evidence of a vertical shaft is inscribed 'for vertical shaft' and dated 'April 8, 1922', signed 'Silva Slate' (Fig.23). It is likely that the husk was dropped or reassembled in the basement space at that time. Until then access may have well been simply a ladder type stair within the husk area. Following Ellicott's design in Evans there may well have been a stair to the millstone area of the husk from the main floor and a connecting short stair from there to the rest of the second floor (Fig.24).

Fig.23 Signed member '1922'

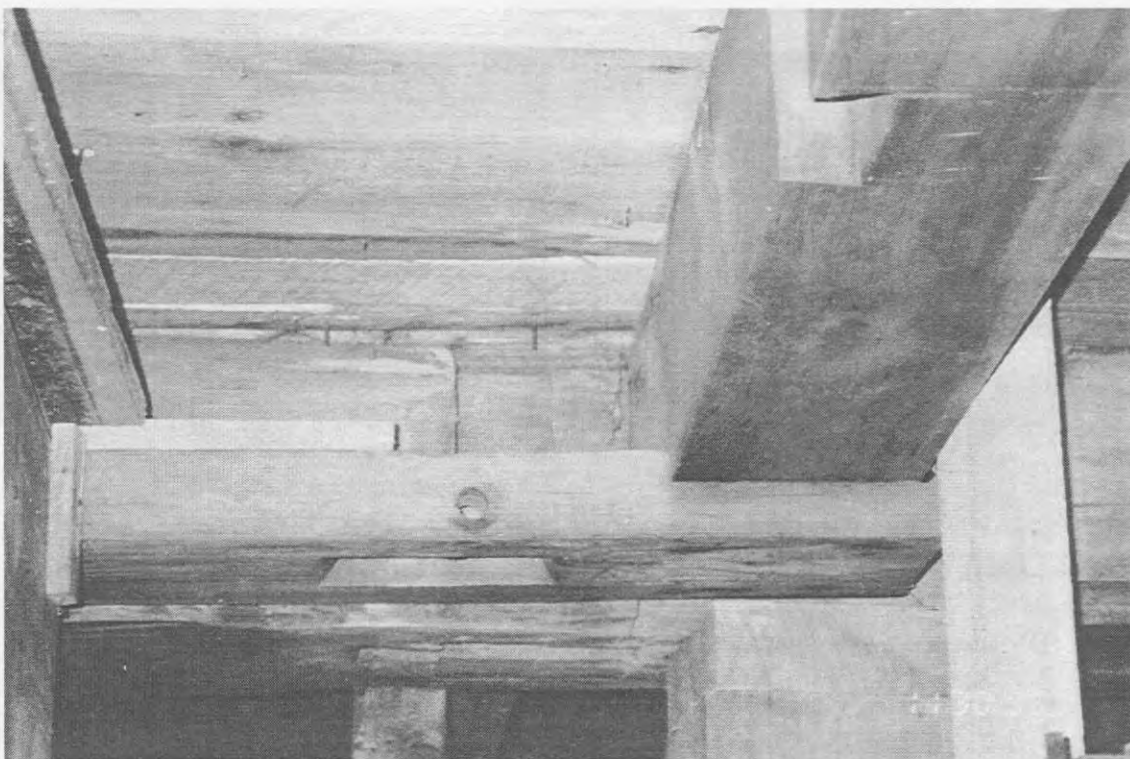
As stated above the existing beams which now carry evidence of the vertical shaft are of relatively recent origin. They are machine planed and the pegged jointing of these members actually remained common in mill (and barn) construction up until 1940. The beam at the basement has been inscribed as noted earlier and its equivalent at the second is clearly at least the third generation of member to occupy that space. It follows a much larger original beam (the mortise for which can still be identified in the transverse member in which it was joined) and the simple joist which replaced it and was notched into the original mortise. The current beam occupies part of the original mortise (Fig.25).

Fig.25 Earlier mortise

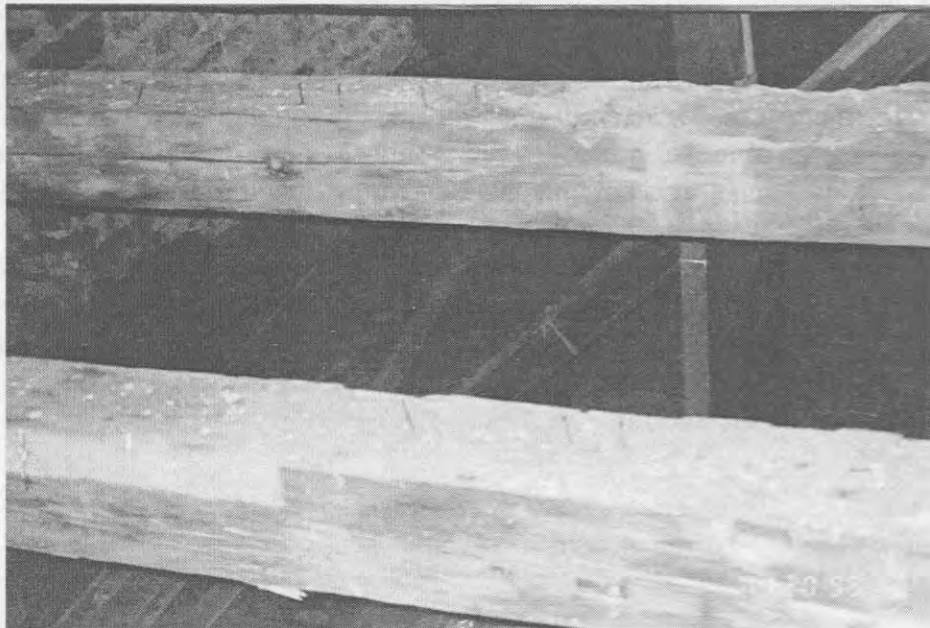
As noted earlier the attic had usable floor space of possibly two layers of full 1" planking as reflected in the rows of hand wrought nails which now line and 'stand proud' of the surviving beams (Fig.33). The northeast remnant ceiling is of very early date signified by the split accordion lath and hand wrought lathing nails (newer nails from renailing are also present) (Fig.34). The plaster ceiling may well have extended throughout the northern half of the structure as nailing from lath is evident on the underside of the beam at the north gable and there is a change in the degree of surface rendering still visible at the north which suggests this greater extent of original finish. It is possible that this section of the attic was used as a granary with the plaster acting not only as a 'higher' finish but also to further inhibit vermin. The northeast with its brick chimney built interior to the stone walling appears to have always been the location of the offices. At the Stone Mills this may have included a business office on the ground floor and a private Miller's office/'study' originally on the third floor. The business office seems to have been located in its current location as evidenced by the door opening and by being the only space within the mill where the window surrounds have a finished stool, composed of a single stone, one of which appears to have initials incised into it.

Fig.33 Nails

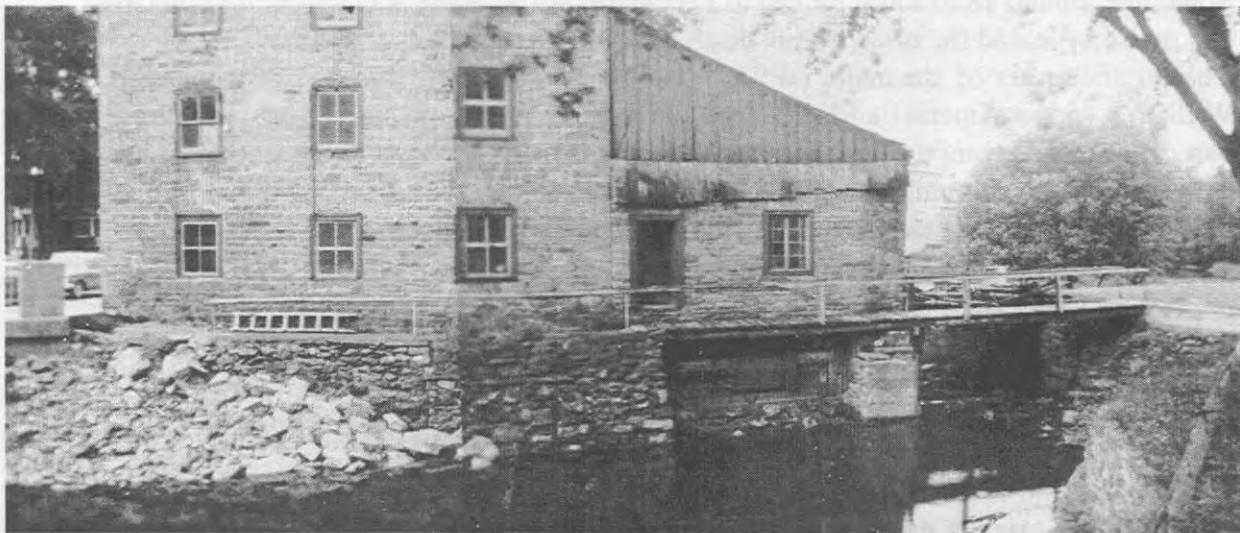
Fig.35 Dam and sawmill abutment 1960. (MNR)

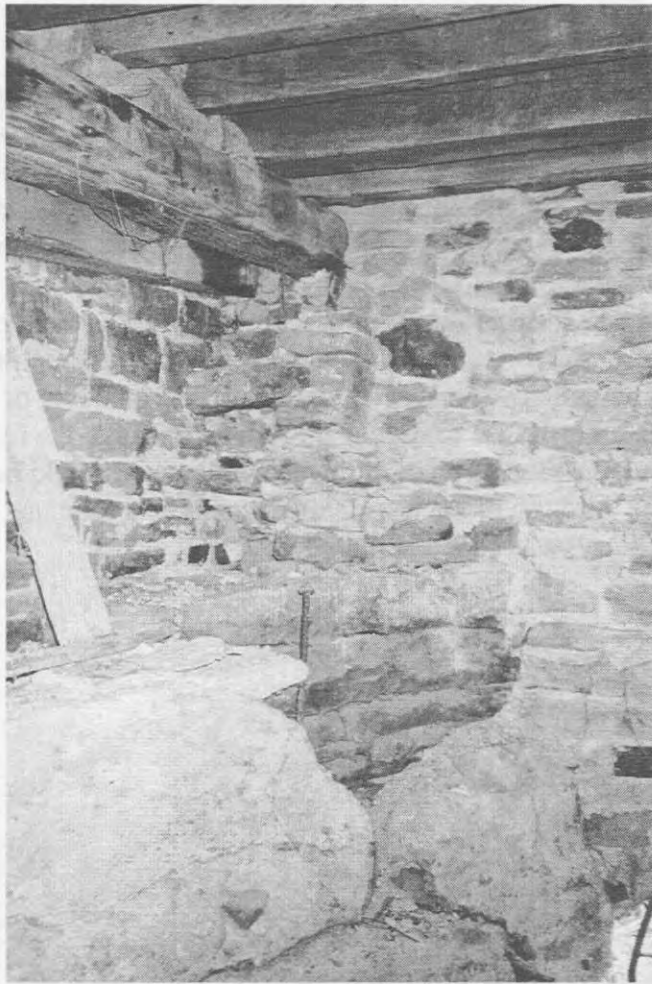
Fig.40 Turbine shed raceway, southeast corner

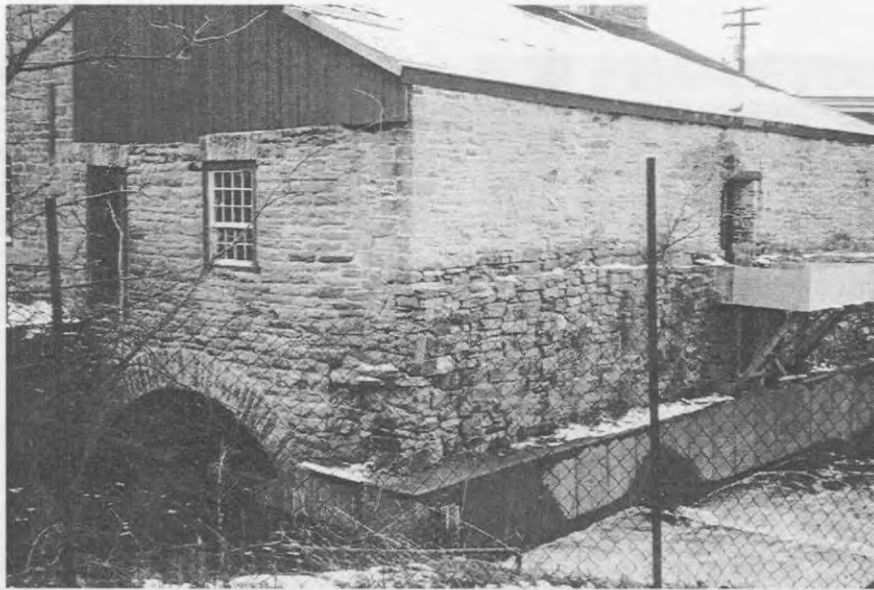
Fig.58

Joint deterioration was noted in the central upper portion of the wall and in the east corner. There is vertical cracking above and below the windows again as a result of water penetration at sill areas. On the north face of the turbine shed there is joint deterioration, major cracking and an unstable area at the arches over the doorway and window. Much of the deterioration in the upper portion of the turbine shed stone work can be attributed to the fact that the stone projects 100-150 mm beyond the vertical siding of the gable above and this allows water to readily penetrate the masonry below. This condition in turn seems to be the result of a discrepancy in planes between the west and north walls which relates to the original angled face at this corner at the conjunction of dam abutment, and sawmill framing.(Fig.58) In any case a ledge exists at the bottom corner and the masonry below is not coursed into the main walling. Between this area and the window a crack radiates. As well the lower portions of this wall experience severe exposure from water in the creek running immediately at the base of the wall. (Fig.57 )

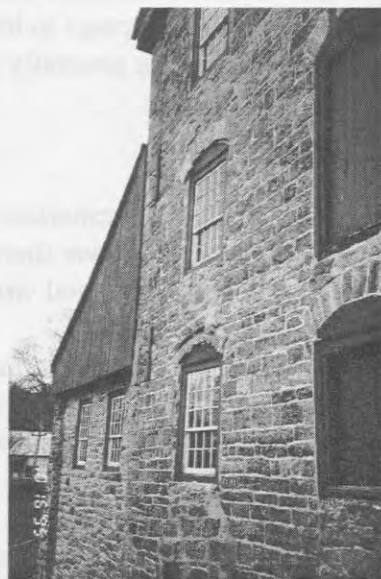
Fig.60

The most serious condition at the mill is the failure of the tailrace arch abutment ( 'arch failure' - see also above) reflected in the wide settlement cracks extending through the full height of the wall at the southwest corner and causing rotation away from the general wall plane. Early photos and layers of crack patching show that this has been a long-time condition. The failure of this arch seems due initially to the erosion of mortar at the west abutment caused by ongoing water action (with occasional surface frost) on, and eventually through the masonry. This corner, with the arch opening, the waterhouse door and windows above becomes essentially a tall stone column and at the same time is most

exposed to water action (both from inside and originally also from out) at the base and was thus inherently most susceptible to failure. Added to these factors is the significant vibration caused by the working waterwheel. (When building the turbine shed Denaut attempted to buttress the original abutment area thickening the masonry wall substantially in that location and there has been a more recent attempt to tie this corner back with steel rods.) Though the forces acting against the corner of the original mill have lessened i.e. no waterwheel, less water force, they are still present and the abutment failure has, as yet not been fully resolved e.g. mortar joints above and below the waterline remain open. This will be a significant challenge of the upcoming restoration program (Fig.59,60).

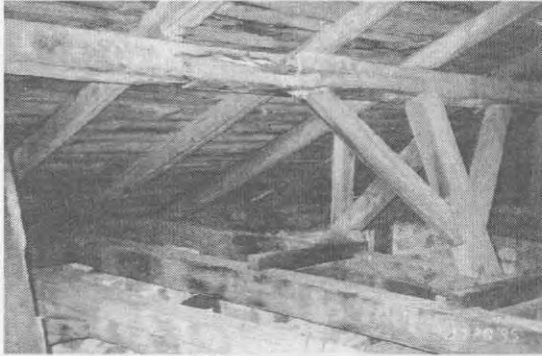
Fig.61

The purlins are generally sound except for a significant decayed and cracked area at the west purlin at the mortise for the south strut of the third brace from the south. Decay appears to be active. Of the two rafters bearing on this area one has been sistered and one has been replaced.(Fig.61)

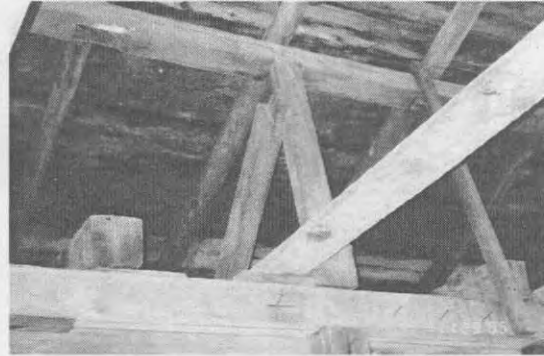
Fig.62

While purlin support braces remain in place a number have lost struts or have poor replacement components. The southeast brace is missing its rear strut; the second (from south) set of braces (both west and east) are missing their north diagonal struts; the third east brace has been reassembled without diagonal struts and the brace itself is of modern conventional lumber of smaller section with the rear strut affixed to the side.(Fig.62)

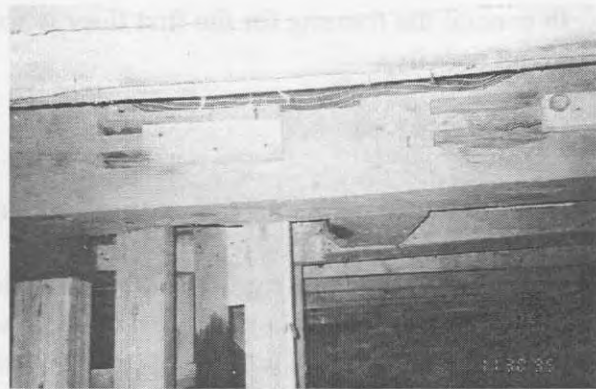
Fig.65

The upper husk shows many areas of insect activity particularly at the northern section. The empty mortises at both sides of 'E' and at 'F' have become the entry points for extensive insect infestation. (Fig.65). Much of member 'F' south of 'G' is just a shell. Both Carpenter Ant and Furniture Beetles seem to have been at work judging from the shape and size of flight holes and the fine dust like frass and the infestation appears to be active in certain areas.

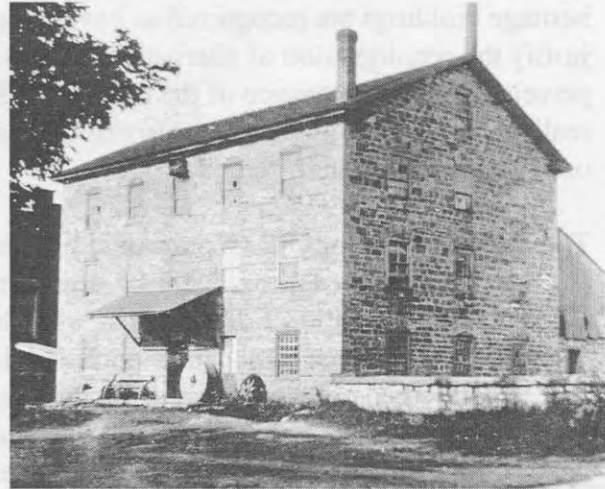
Fig.68

The importance of the main mill door has been discussed. While the historic door is itself remarkably sound, the base of the side jambs has decayed to a height of approx. 18" (Fig.67). The office door is not historically accurate (panel door was original Fig.68), the office area being generally 'fitted out' and finished to a higher degree than the industrial areas of the mill. The north door frame is badly decayed as is the base of the door itself. The west door, similarly, is decayed at the bottom.
