Parks Canada - Technical Reports in Ecosystem Science

Report No. 41

Fish passage and stream habitat restoration in Terra Nova National Park

highway culverts

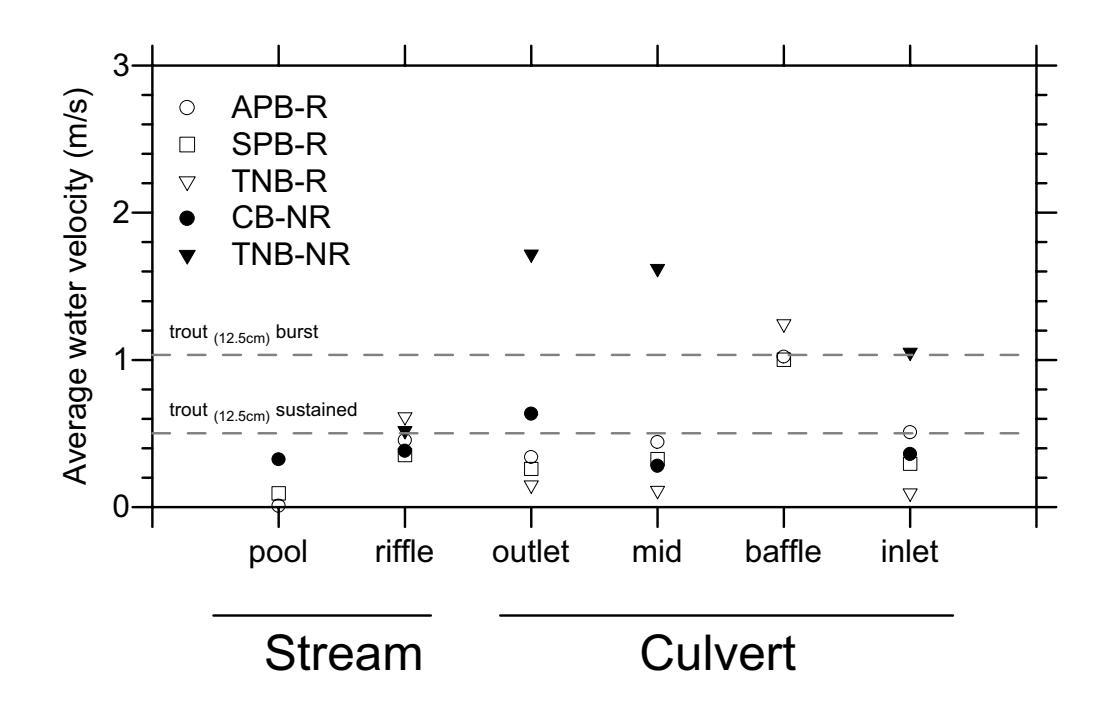
Water velocities within restored culverts were similar to those found within the natural reaches of the adjacent brooks except for the short distances where the flow poured over the scour baffles (Figure 4). In contrast, the relatively low gradient Terra Nova Brook culvert at the TCH, prior to restoration (1.4%; Appendix C), showed greatly elevated water velocity when compared to natural areas of the brook. Culvert velocities in the unrestored Charlottetown Brook did not appear to differ greatly from that of its natural reaches but the gradient of this culvert was relatively low (1%). Comparisons of culvert velocities to sustained and burst swimming speeds of trout and salmon (Peake et al. 1997) indicate that restored culverts appear to provide conditions suitable for fish passage for individuals larger than 12.5 cm. Within the Terra Nova Brook culvert, in its unrestored state, water velocities were only suitable for trout >24 cm.

Figure 4: Average water velocities during the study period of restored (open symbols) and unrestored (solid symbols) culverts and the adjacent natural reaches in Terra Nova National Park, 2002. Burst and sustained swimming speeds of a 12.5 cm brook trout (Peake et al. 1997) are represented by dashed lines APB-R: Arnold's Pond Brook – restored condition; SPB-R: Square Pond Brook – restored condition; TNB-R: Terra Nova Brook – restored condition; CB-NR: Charlottetown Brook - unrestored condition; TNB-NR: Terra Nova Brook – prior to restoration.

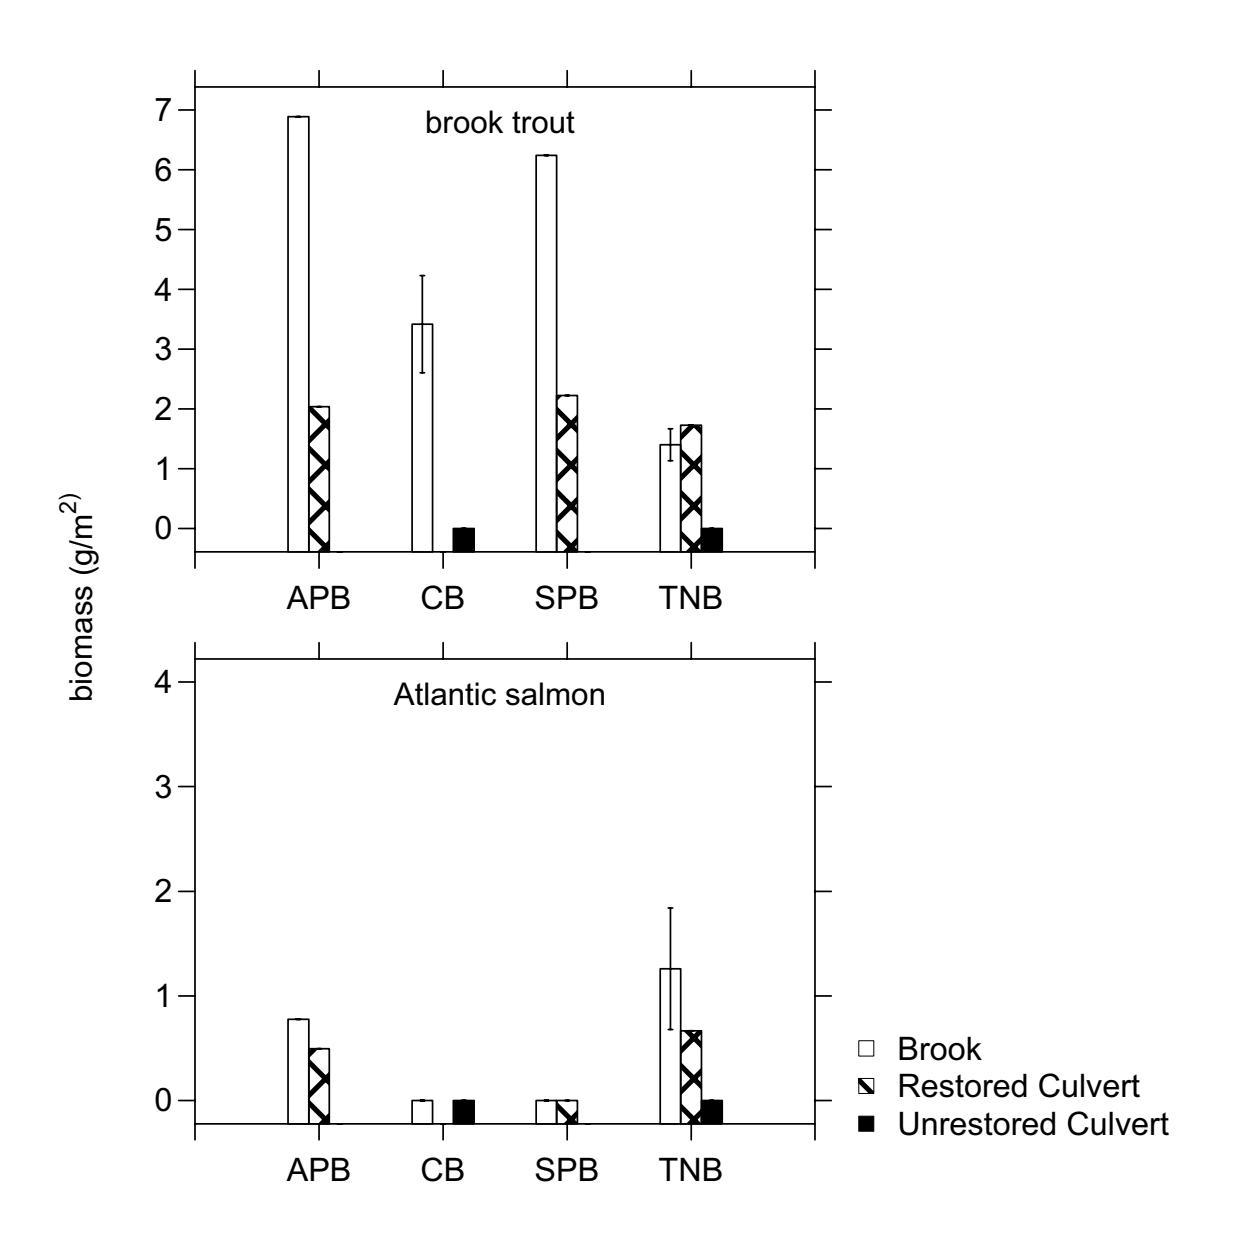
Figure 5: Salmonid biomass in natural stream reaches and in restored and unrestored culverts on the Trans-Canada Highway, Terra Nova National Park, 2002. APB: Arnold's Pond Brook (after restoration); CB: Charlottetown Brook (unrestored); SPB: Square Pond Brook (after restoration); TNB: Terra Nova Brook (before and after restoration). Errors bars represent the SE.

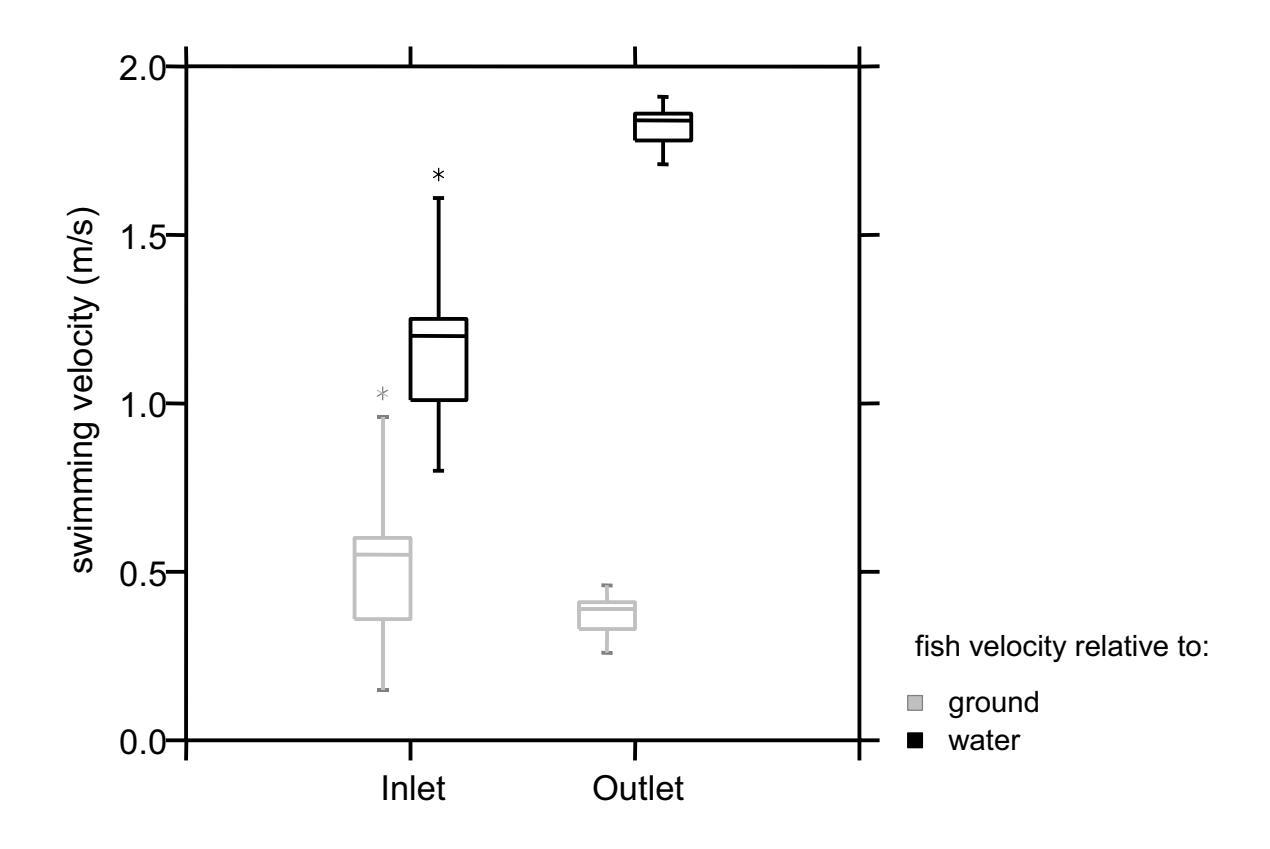
The Terra Nova Brook culvert, prior to restoration, was the only culvert in which migrating fish showed directed movements upstream. On 21 June, 5 fish successfully moved up through the culvert. The smallest was in the 12.5 - 17.5 cm size class, 3 were of the 17.5 - 22.5 cm class and 1 was of the 22.5 - 27.5 cm size class. Migrants maintained relatively constant ground swimming velocities under upstream and downstream cameras even though water velocities differed substantially (Figure 7). Swimming speeds of these individuals (1.8 - 1.9 m/s) exceeded those predicted by models of prolonged and burst swim speed (Peake et al. 1997).

Figure 7: Swimming velocity of salmonids observed swimming upstream through the unrestored Terra Nova Brook culvert on 21 June 2002. Boxes represent mid-quartile range, mid lines represent median swimming velocity and asterisks represent outside values (>1.5 interquartile ranges from the median).

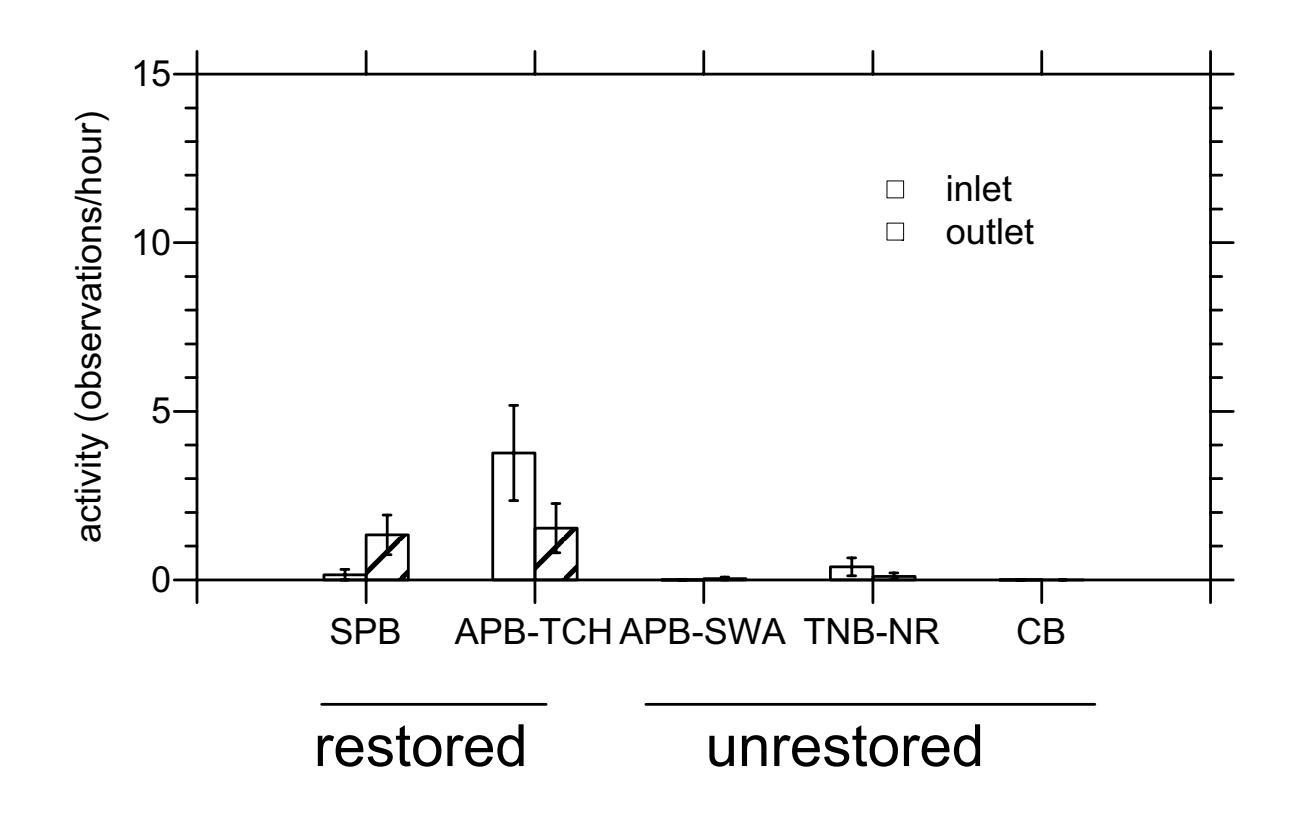
Activity in restored culverts was much greater than in unrestored culverts (Figure 8). Even in unrestored culverts (e.g. Charlottetown Brook) with low gradients, observations of fish were few. The inlet of Terra Nova Brook (TCH) was the exception as it had higher activity than the inlet in Square Pond Brook. Diel patterns in activity were variable as Terra Nova Brook and Arnold's Pond Brook had diurnal activity rates more than double the nocturnal activity. In Square Pond Brook, nocturnal activity was slightly greater than the daytime. The size distribution of fish in restored culverts, based on camera observations, included smaller size classes and were more representative of the adjacent stream than in the one unrestored culvert with fish observations (Terra Nova Brook) (Figure 9). The size range of active individuals in Terra Nova Brook ranged from 12.6 to > 27.5 cm while in the restored culverts the largest fish were in the 17.5 – 22.5 cm size-class and length modes were in the 7.5 – 12.4 cm class for Square Pond Brook and 12.5 - 17.4 cm class for Arnold's Pond Brook. Fish smaller than 12.6 cm were not observed in Terra Nova Brook culvert despite being common in the natural stream reaches.

Figure 8: Activity of salmonids within restored and unrestored culverts in Terra Nova National Park, 2002. SPB: Square Pond Brook; APB-TCH: Arnold's Pond Brook at the TCH; APB-SWA: Arnold's Pond Brook at Southwest Arm Day Use Area; TNB-NR: Terra Nova Brook in its unrestored condition; and CB: Charlottetown Brook. Error bars represent SE.

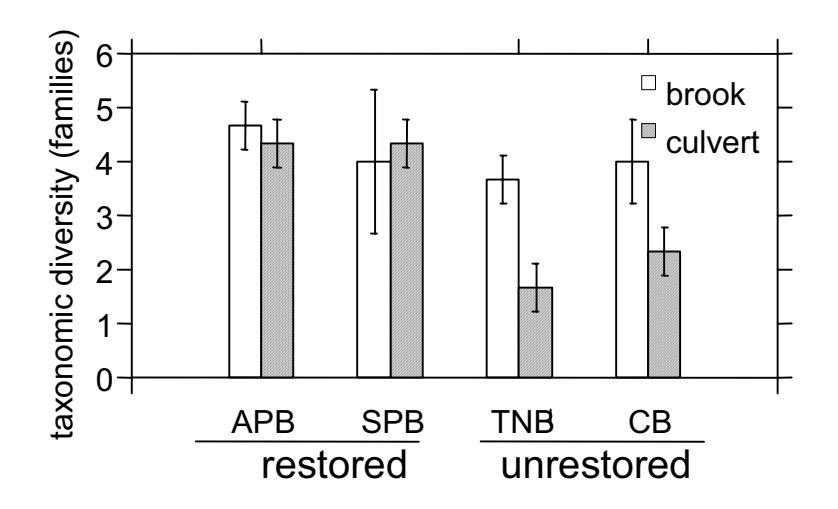
Taxonomic diversity of stream invertebrates in restored culverts was similar to that found in the natural stream reaches (Figure 10; Square Pond Brook: $t_{d.f.=4} = 0.32$, p = 0.77; Arnold's Pond Brook: $t_{d.f.=4} = 0.71$; p 0.52). In unrestored culverts, family diversity was approximately half found in natural riffles though it was only statistically significant in Terra Nova Brook (Terra Nova Brook: $t_{d.f.=4} = 2.5$, p= 0.013; Charlottetown Brook: $t_{d.f.}=4 = 4.2$, p = 0.082). Due to small sample sizes, statistical power was quite low. Unrestored culverts were dominated by dipterans (e.g. Simulids) whereas natural reaches and restored culverts had relatively high numbers of Trichoptera, Plecoptera, Ephemeroptera and chironomids.

Figure 10: Taxonomic diversity of stream invertebrates within restored and unrestored culverts and natural reaches of brooks. APB: Arnold's Pond Brook; SPB: Square Pond Brook; TNB: Terra Nova Brook; CB: Charlottetown Brook. Error bars represent SE.
