HAWTHORNE COTTAGE RESTORATION

BRIGUS, NL.

PROJECT NO. 16-1475 - ISSUED FOR TENDER - 2018/01/31

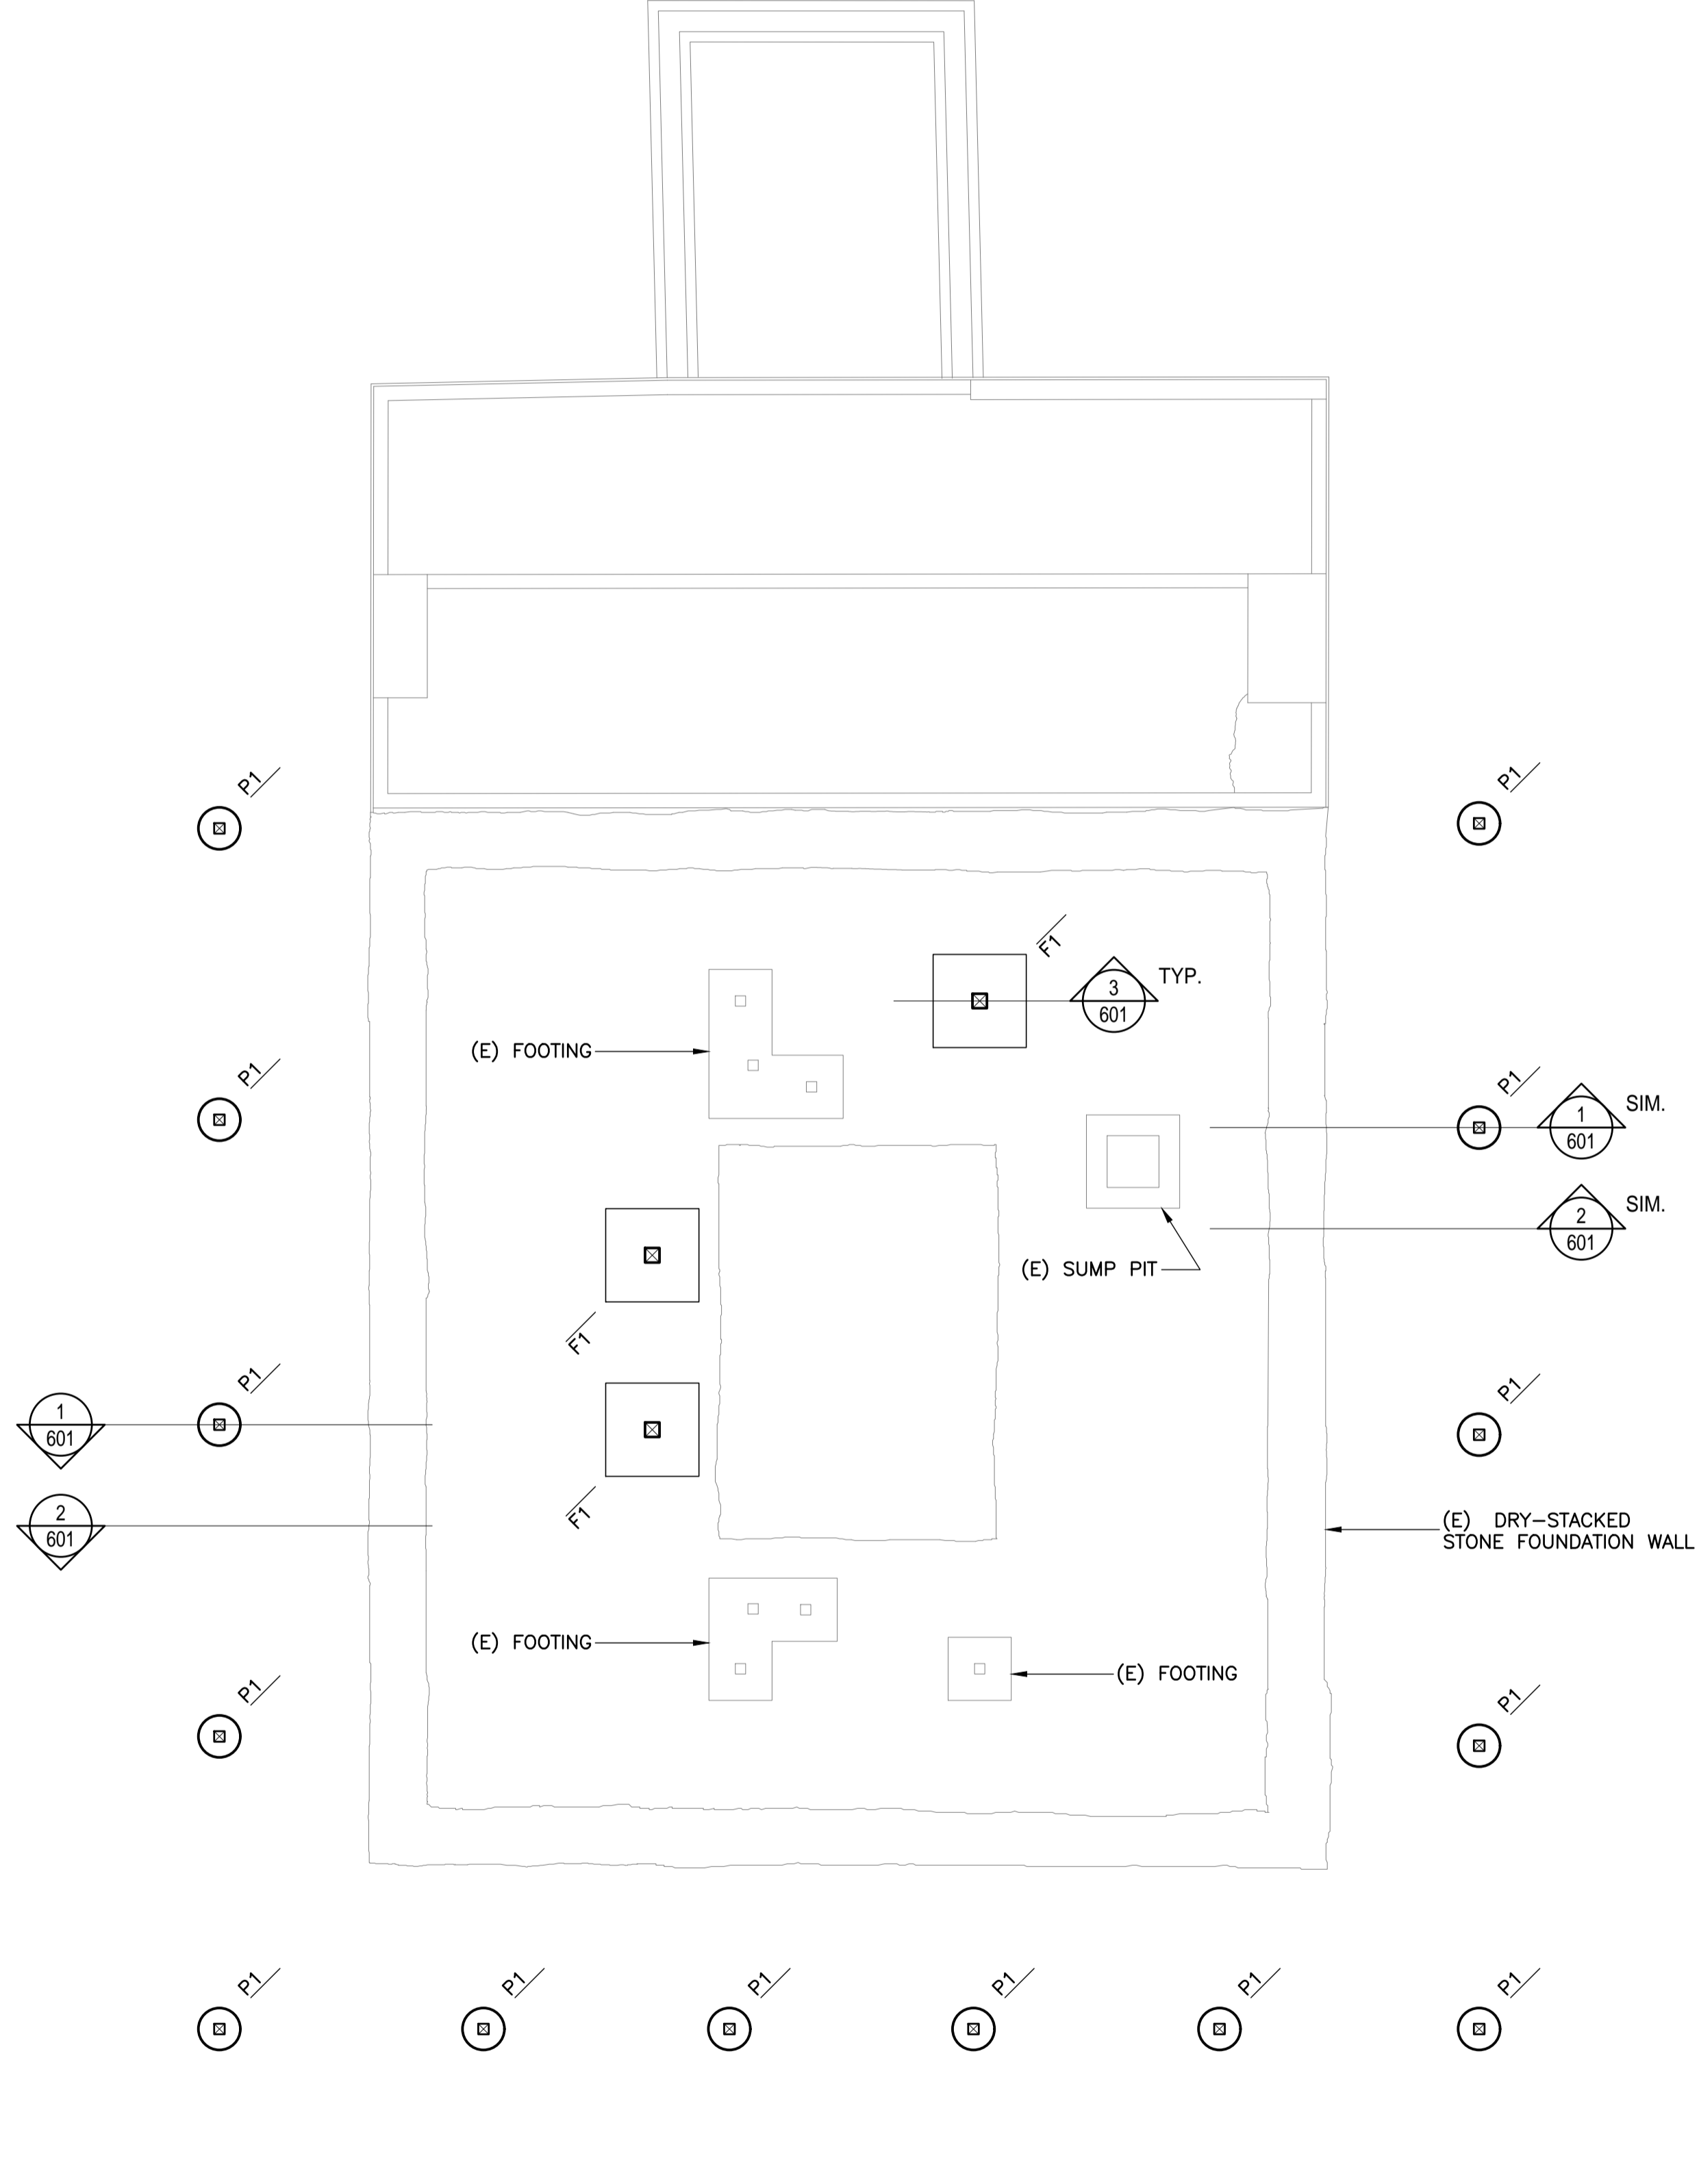
FOUNDATION PLAN
 SCALE - 1 : 50

- NOTES:**
- P1 - SEE 1/601 FOR DETAILS

FOOTING MARK	FOOTING		
	SIZE	DEPTH	REINFORCING
F1	900x900	300	15M @ 150 o.c. BOT.
