A SUMMARY OF MARINE ARCHAEOLOGICAL RESEARCH  
CONDUCTED AT RED BAY, LABRADOR:  
THE 1984 FIELD SEASON.

James Ringer  
Parks Canada

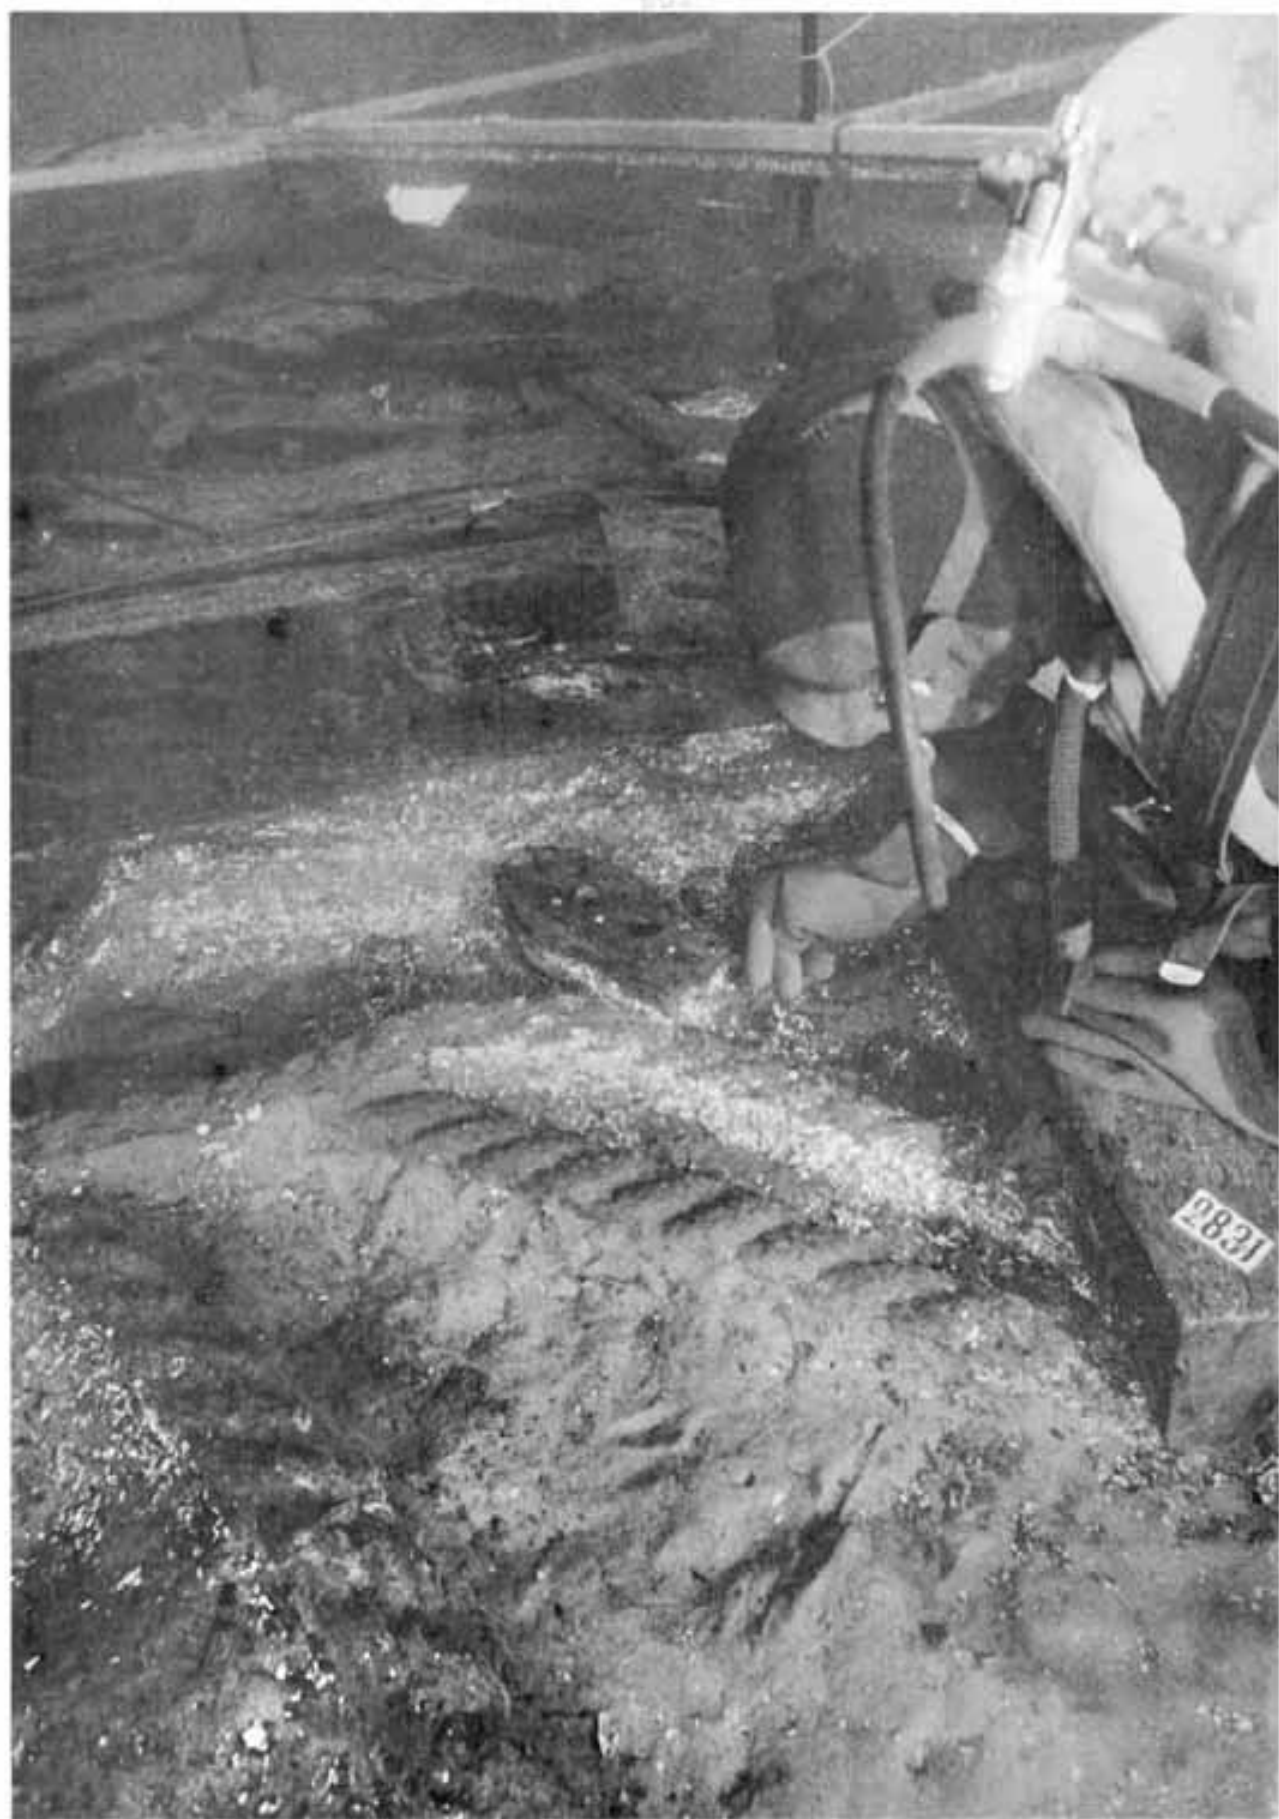
FIGURE 3

Large diameter rope and a single-sheaved block found beneath the bow of the ship. (Photo by: D. Page).

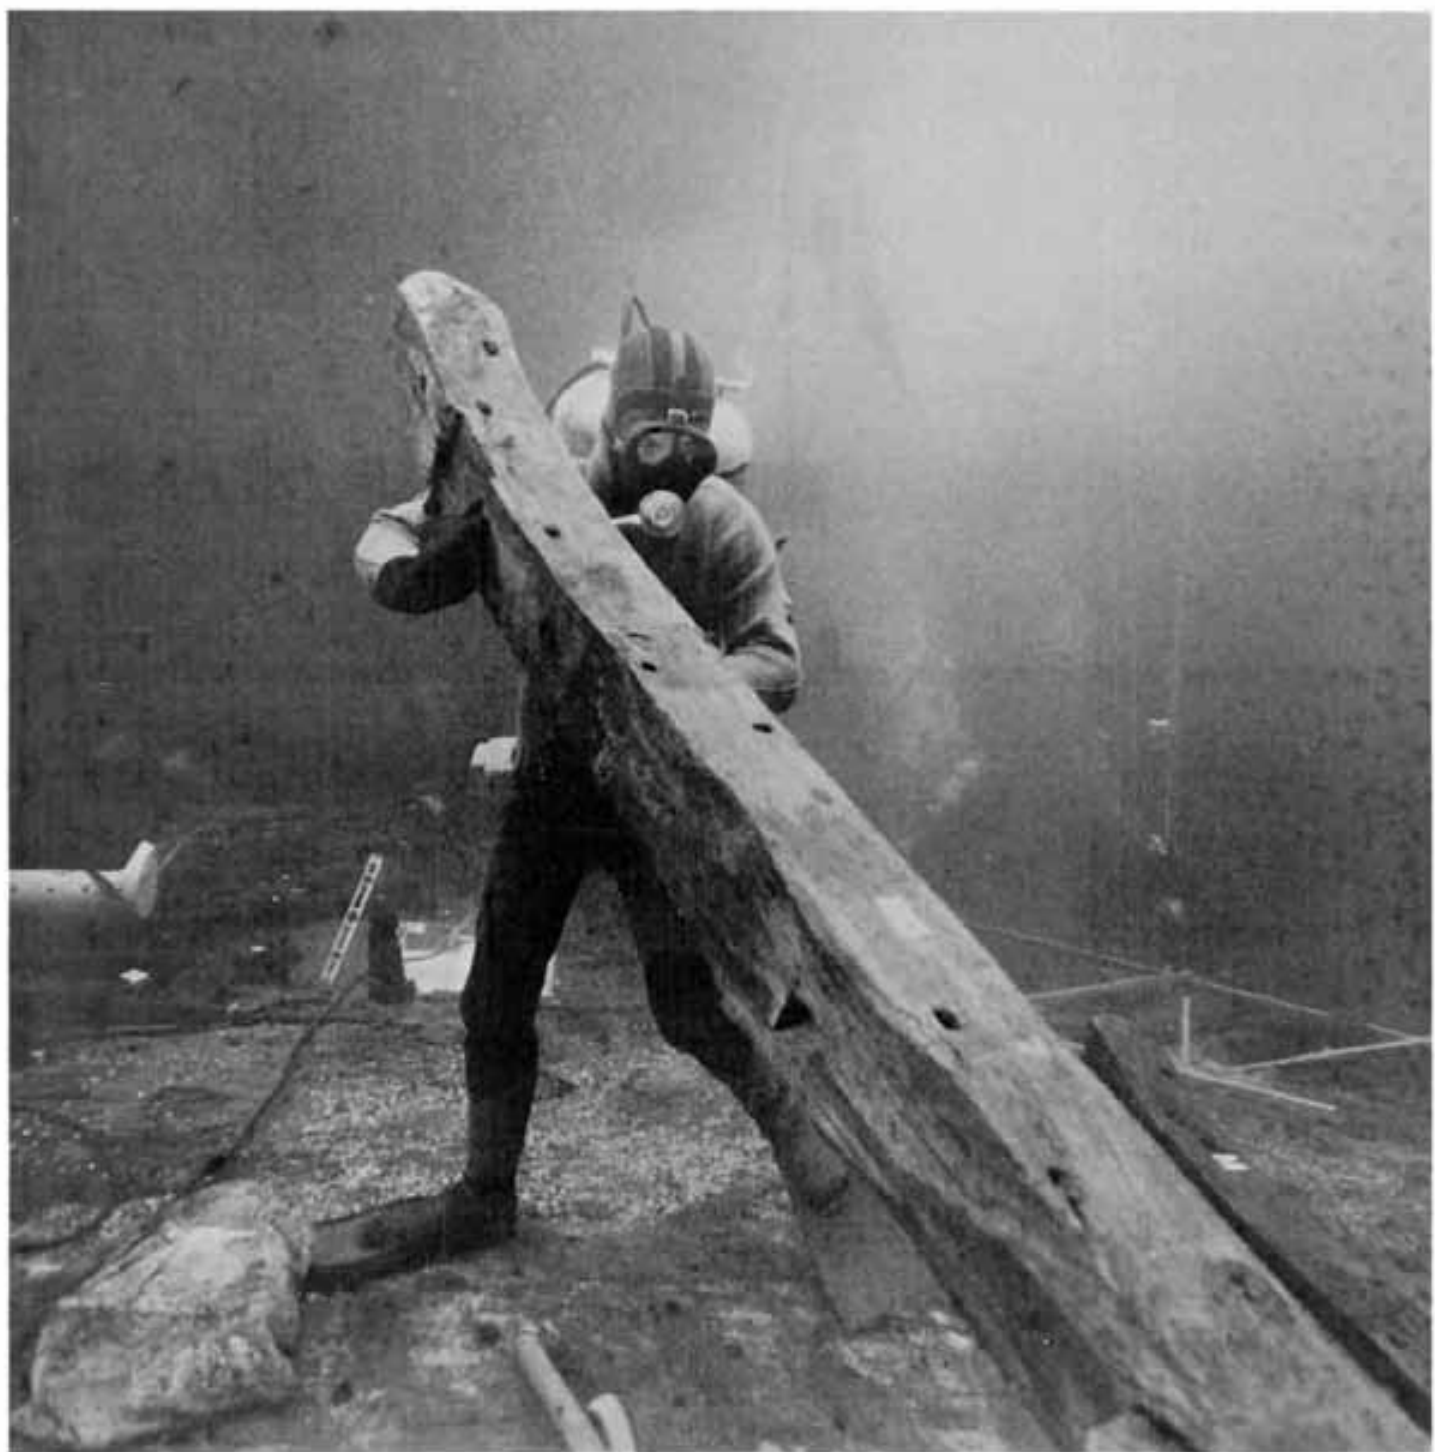
Figure 5

Excavator disassembling a floor timber from the hull. (Photo by: D. Page).

Because excavation proceeded more rapidly in the prime areas than expected it was resolved to disassemble the remaining port side structure and excavate below the hull (Figure 5). This decision was prompted by the rich finds below the starboard side. Equally productive results were gained here.

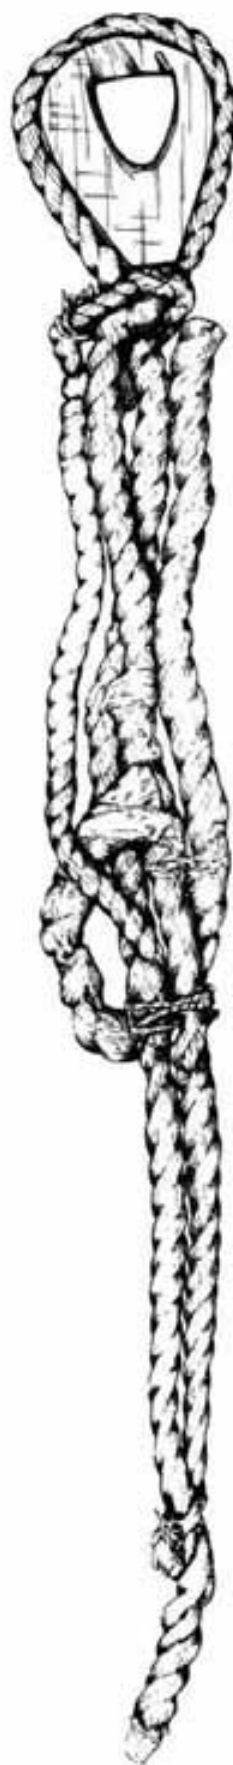
Figure 6

Heart block with an attached portion of the rope shroud. (Drawn by: C. Piper)

abundant. Here, twelve heart blocks, both with iron and rope stropping, were unearthed. The rope-bound hearts proved extremely informative as preserved with them were portions of the stropplings, shrouds and rat lines (Figure 6). These finds are providing the first information on shroud sizes, lashings and knots used.

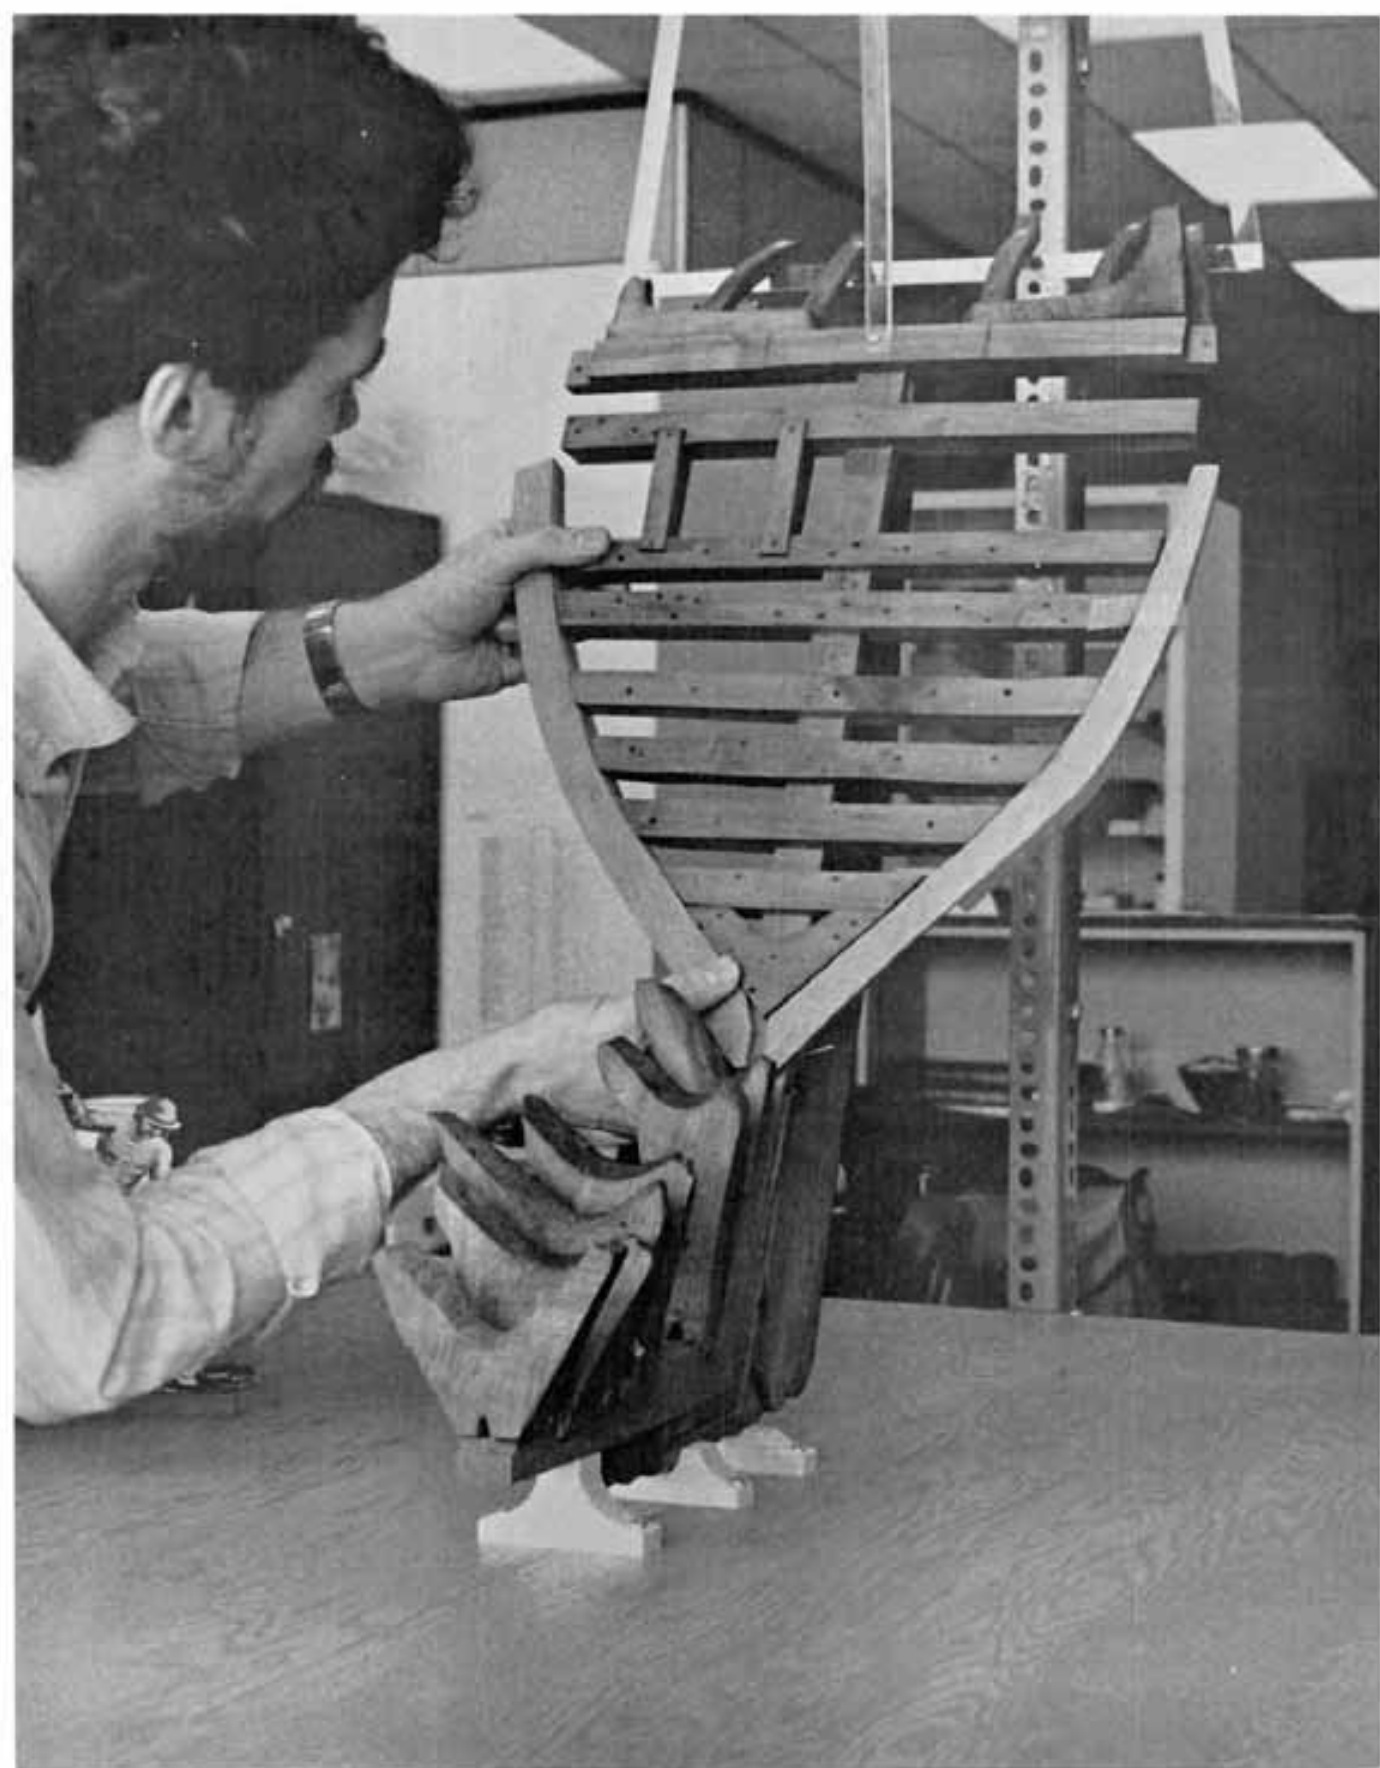
Figure 10

Modelled reconstruction of the stern and transom. (Photo by: D. Page).

in situ timbers, timbers found on the sea-bed surface and the sea-bottom topography. The other model, and probably the more important of the two, is a 1:10 scale reconstruction of the ship. A total reconstruction will not be attempted. Rather, enough will be done including most of the starboard side and stern, the lines of the vessel, to illustrate important structural details, and to see how significant assemblages of pieces fit together (e.g. the transom) (Figure 10). The modelling program will principally be a learning process for the archaeologists on sixteenth-century Spanish naval architecture, and an instructional device for associated researchers and seasonal diving staff.

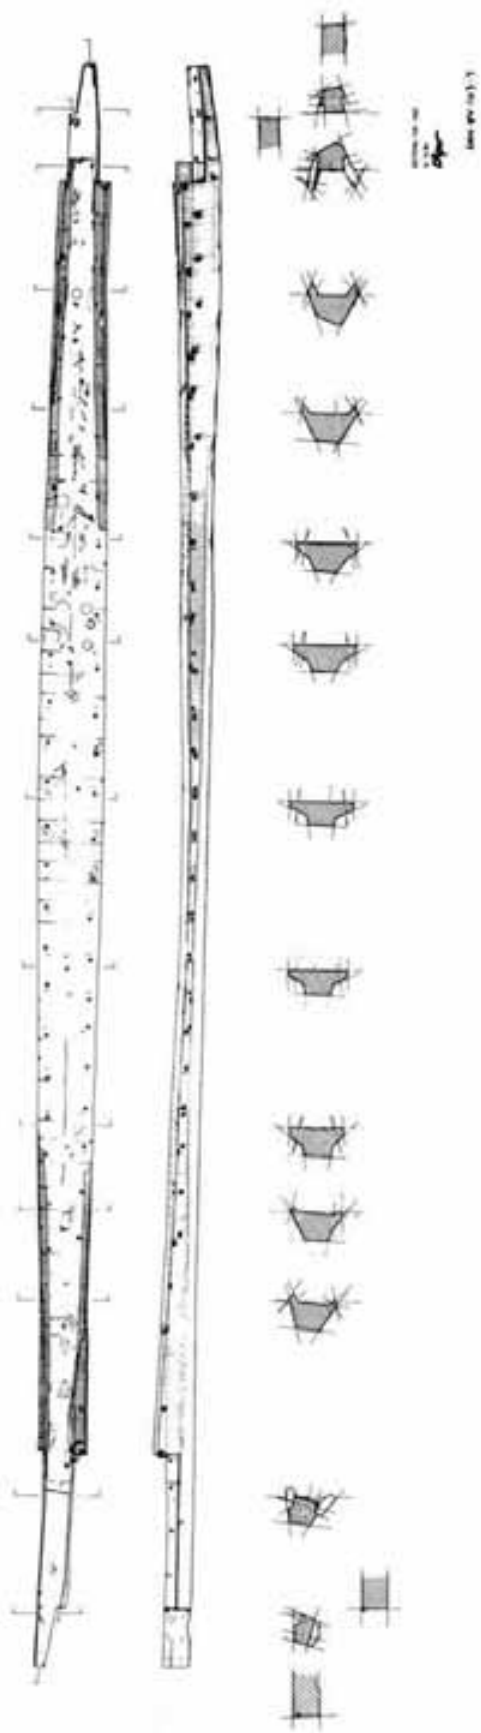
Figure 11

Drawing of the keel. (Drawing by: C. Piper).

Another significant piece recorded this year was the keel. The keel was a massive piece of beech 14.3 m long, 58 cm wide and 45 cm deep (Figure 11). More remarkable than its size, however, was its shape. At the middle the keel was roughly T-shaped in cross-section. The projections were shaped more and more upwards towards the bow and stern so that the keel was U-shaped at either end. The ends appear to have been manufactured much in the way a dug-out canoe might have been made. In effect the projections formed the garboard strakes on either side of the keel.
