Parks Canada John Cabot Building P.O. Box 1268 St. John's, NL A1C 5M9

Stantec Consulting Ltd. 845 Prospect Street Fredericton, NB E3B 2T7

Project No. 121812230 July 12, 2016

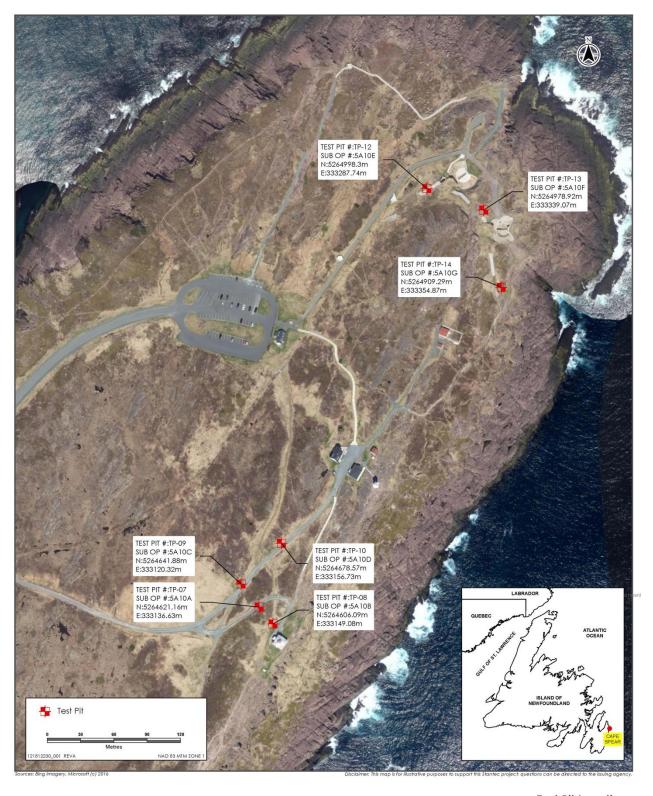
Figure 1

**Test Pit Locations**

The broader Study Area consists of Cape Spear NHS. More specifically, the work was focused on seven geotechnical test pits (Figure 1). Four of these (Test Pits 7, 8, 9 and 10) were situated adjacent to the access roads around the original (1835) lighthouse, while Test Pits 12, 13, and 14 were located within the Fort Cape Spear battery complex.

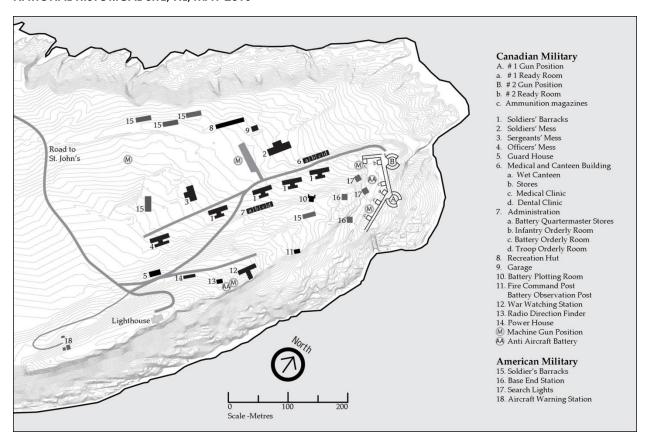
Figure 1 Plan of Military and Other Historic Features at Cape Spear NHS (Courtesy Parks Canada)

In 1941, during the Second World War, Fort Cape Spear was constructed as part of the Allied defence system to provide protection for Allied marine convoys from German submarines. The fortification consisted of a battery complex, barracks, administrative buildings and other structures located at the base of the ridge, and utility lines and roads that connected the various facilities. With the exception of the batteries, most of the buildings were of temporary construction but evidence of the temporary structures still exists. Other evidence of Fort Cape Spear includes a memorial cross located near the tip of the peninsula (Figure 2).

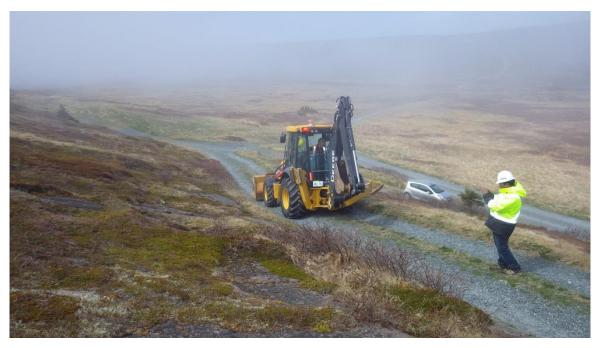
Photo 1 Location and context of Test Pit 7 (Suboperation 5A10A) prior to excavation.

Test Pit 7 (Suboperation 5A10A) was situated in proximity to the 1835 Cape Spear lighthouse, and had potential to contain evidence of the construction and/or occupation of the lighthouse (Photo 1). Excavation revealed 5-7 cm of sod/rootmat with loose, black-brown silty sand with gravel, and alder roots present in the top of the layer (Photo 2). This shallow topsoil was underlain by bedrock. No cultural features or artifacts were identified.

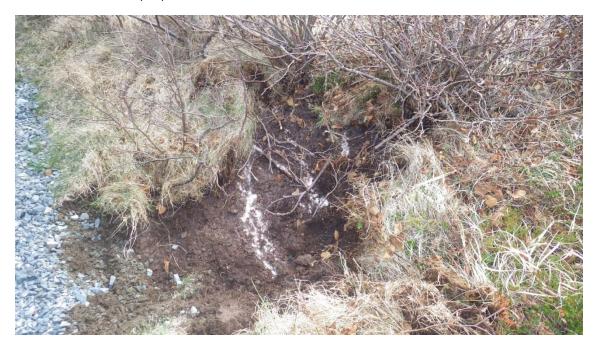
Photo 2 Test Pit 7 (Suboperation 5A10A) after excavation.

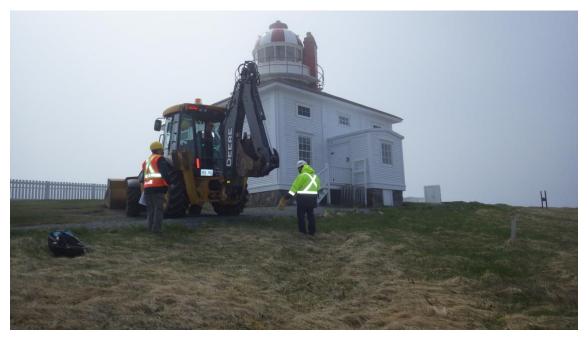
Photo 3 Location and context of Test Pit 8 (Suboperation 5A10B) prior to excavation.

Test pit 8 (Suboperation 5A10B) was also situated near the 1835 lighthouse, beside the pathway leading to the structure (Photo 3). Excavation below the sod/rootmat revealed 10 cm of crushed stone underlain by 20 cm of gravelly brown silty sand fill (Photo 4). Beneath this lay a black organic buried sod or peat 15-17 cm thick resting on bedrock. This buried sod layer yielded two small (thumbnail-sized) brick fragments. No other cultural features or artifacts were identified.

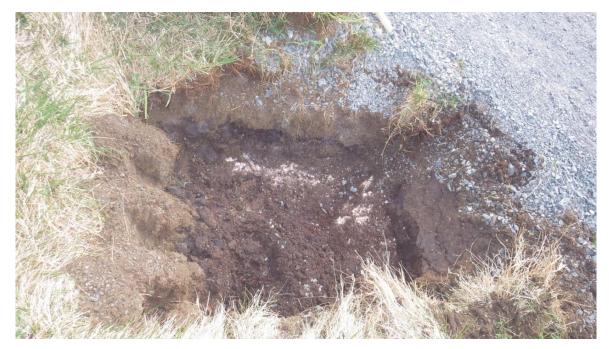
Photo 4 Test Pit 8 (Suboperation 5A10B) after excavation.

Test pit 8, situated near the original 1835 lighthouse, contained two small fragments of brick. These are interpreted to pertain to the additions and ancillary structures to the 1835 lighthouse, and thus to be historic resources of (at most) "Other" significance. These items were noted only and not collected.

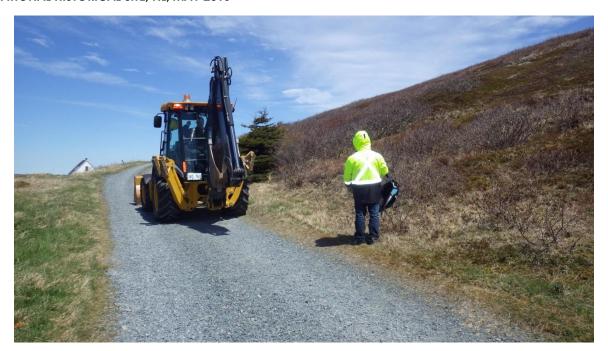
Photo 5 Location and context of Test Pit 9 (Suboperation 5A10C) prior to excavation.

Test Pit 9 (Suboperation 5A10C) was situated east of the road to the lighthouse, in proximity to a former guardhouse (Photo 5). Excavation revealed some 15 cm of sod/rootmat, underlain by 20 cm of loose brown sand with silt, gravel and cobbles, and then by bedrock (Photo 6).

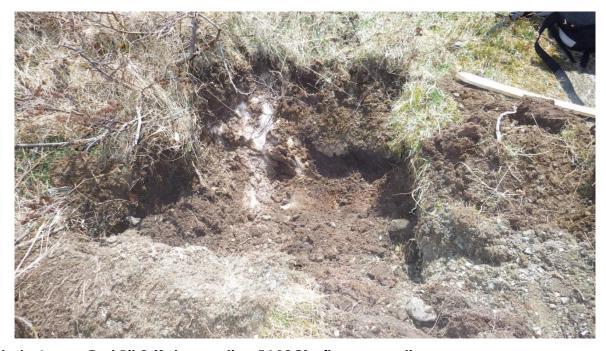
Photo 6 Test Pit 9 (Suboperation 5A10C) after excavation.

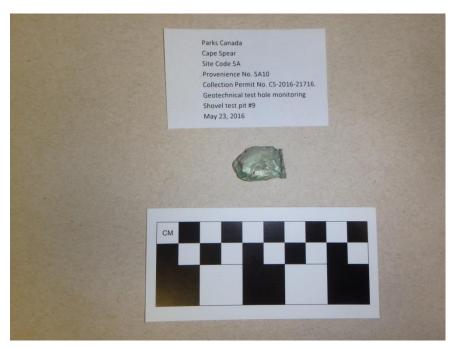
Photo 7 Sherd of container glass from Test Pit 9 (Suboperation 5A10C).

One small sherd of clear container glass (Photo 7) and a palm-sized piece of roofing felt (Photo 8) were recovered from the loose silty sand, along with a piece initially believed to be corroded iron but subsequently identified as conglomerate rock. The glass and roofing material both appear to be of 20<sup>th</sup> Century date and most likely pertain to the construction and occupation of the guardhouse.

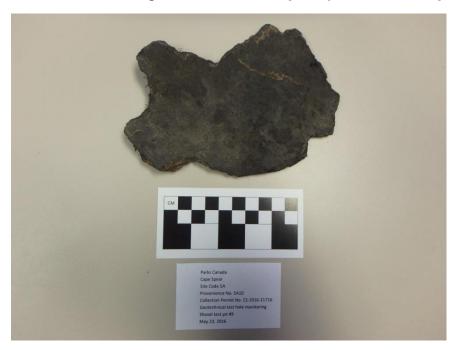
Photo 8 Roofing felt from Test pit 9 (Suboperation 5A10C).

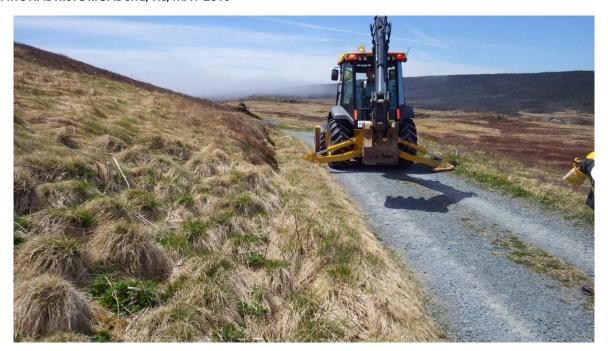
Photo 9 Location and context of Test Pit 10 (Suboperation 5A10D) prior to excavation.

Excavation of Test Pit 10 (Suboperation 5A10D), also situated in proximity to the former guardhouse (Photo 9), revealed 15 cm of sod/root mat, underlain by 45 cm of silty sand and gravel, likely deposited as road fill (Photo 10). Bedrock was encountered 60 cm below surface. No cultural features or artifacts were identified.

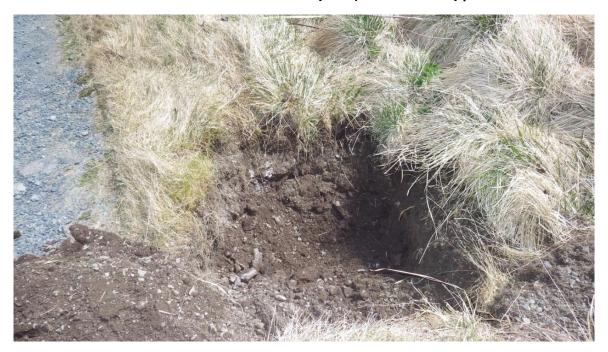
Photo 10 Test Pit 10 (Suboperation 5A10D) after excavation.

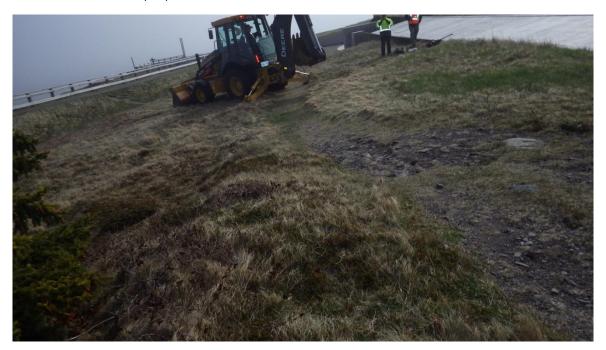
Photo 11 Location and context of Test Pit 12 (Suboperation 5A10E) prior to excavation.

Test Pit 12 (Suboperation 5A10E) (Photo 11) was excavated alongside the tunnel leading to the bunker at #2 Gun Position. Excavation revealed 20-25 cm of brown/black silty sand with cobbles beneath the 8 cm thick sod/rootmat (Photo 12). Below that was a brown silty sand with cobbles to the bedrock layer. Bedrock or concrete was encountered 1 m below the surface. No cultural features or artifacts were identified in the soil.

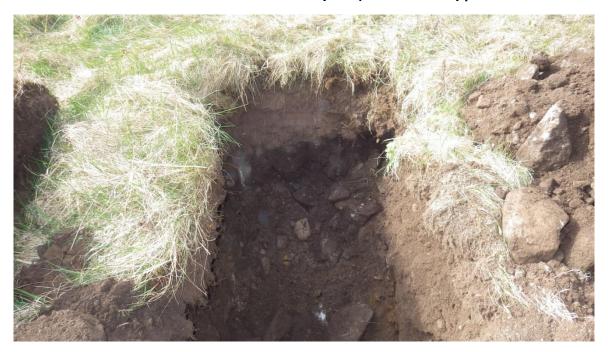
Photo 12 Test Pit 12 (Suboperation 5A10E) after excavation.

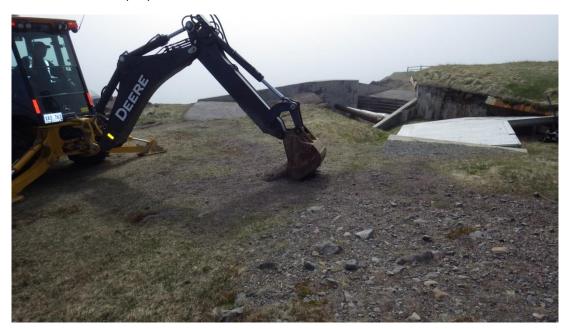
Photo 13 Location and context of Test Pit 13 (Suboperation 5A10F) prior to excavation.

Test Pit 13 (Suboperation 5A10F) (Photo 13) was excavated near the former ammunition magazine alongside the tunnel between #1 and #2 Gun Position. . Stratigraphy consisted of 1-2 cm of loose, grey gravel fill overlying a loose to compact brown silty sand with cobbles and some boulders extending down to bedrock at a depth of 1.75 m below the surface (Photo 14). No cultural features or artifacts were identified.

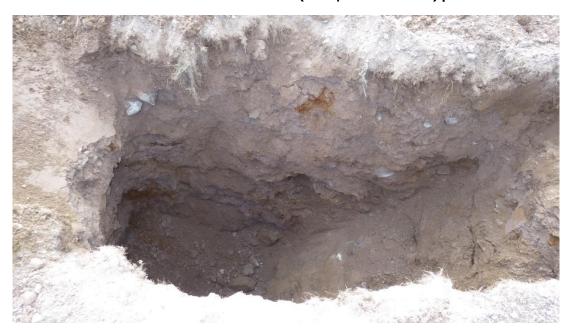
Photo 14 Test Pit 13 (Suboperation 5A10F) after excavation.

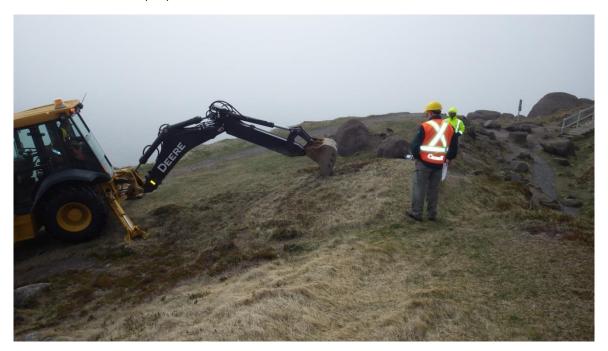
Photo 15 Location and context of Test Pit 14 (Suboperation 5A10G) prior to excavation.

Excavation of Test Pit 14 (Suboperation 5A10G) (Photo 15),, alongside the tunnel wall near the southernmost former ammunition magazine south of #1 Gun Position revealed an extremely thick (40 cm) sod/root mat layer. This was underlain by 40 cm of thick reddish sandy soil. Approximately 80 cm below the surface lay a 10-15 cm thick black, weathered, buried sod. This was underlain by 20 cm of reddish sand, which in turn was underlain by bedrock (Photo 16). No cultural features or artifacts were identified.

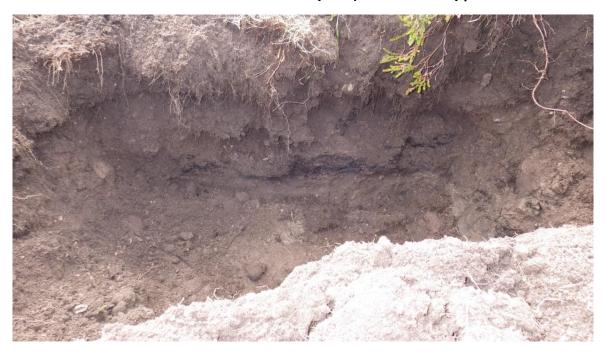
Photo 16 Test Pit 14 (Suboperation 5A10G) after excavation.
