PARKS CANADA AGENCY (PCA)

## TRANS CANADA HIGHWAY (TCH) KM 81+300 TO 85+500 ANIMAL UNDERPASS STRUCTURES GEOTECHNICAL SERVICES

### REPORT

AUGUST 2011  
ISSUED FOR REVIEW  
EBA FILE: V33101067

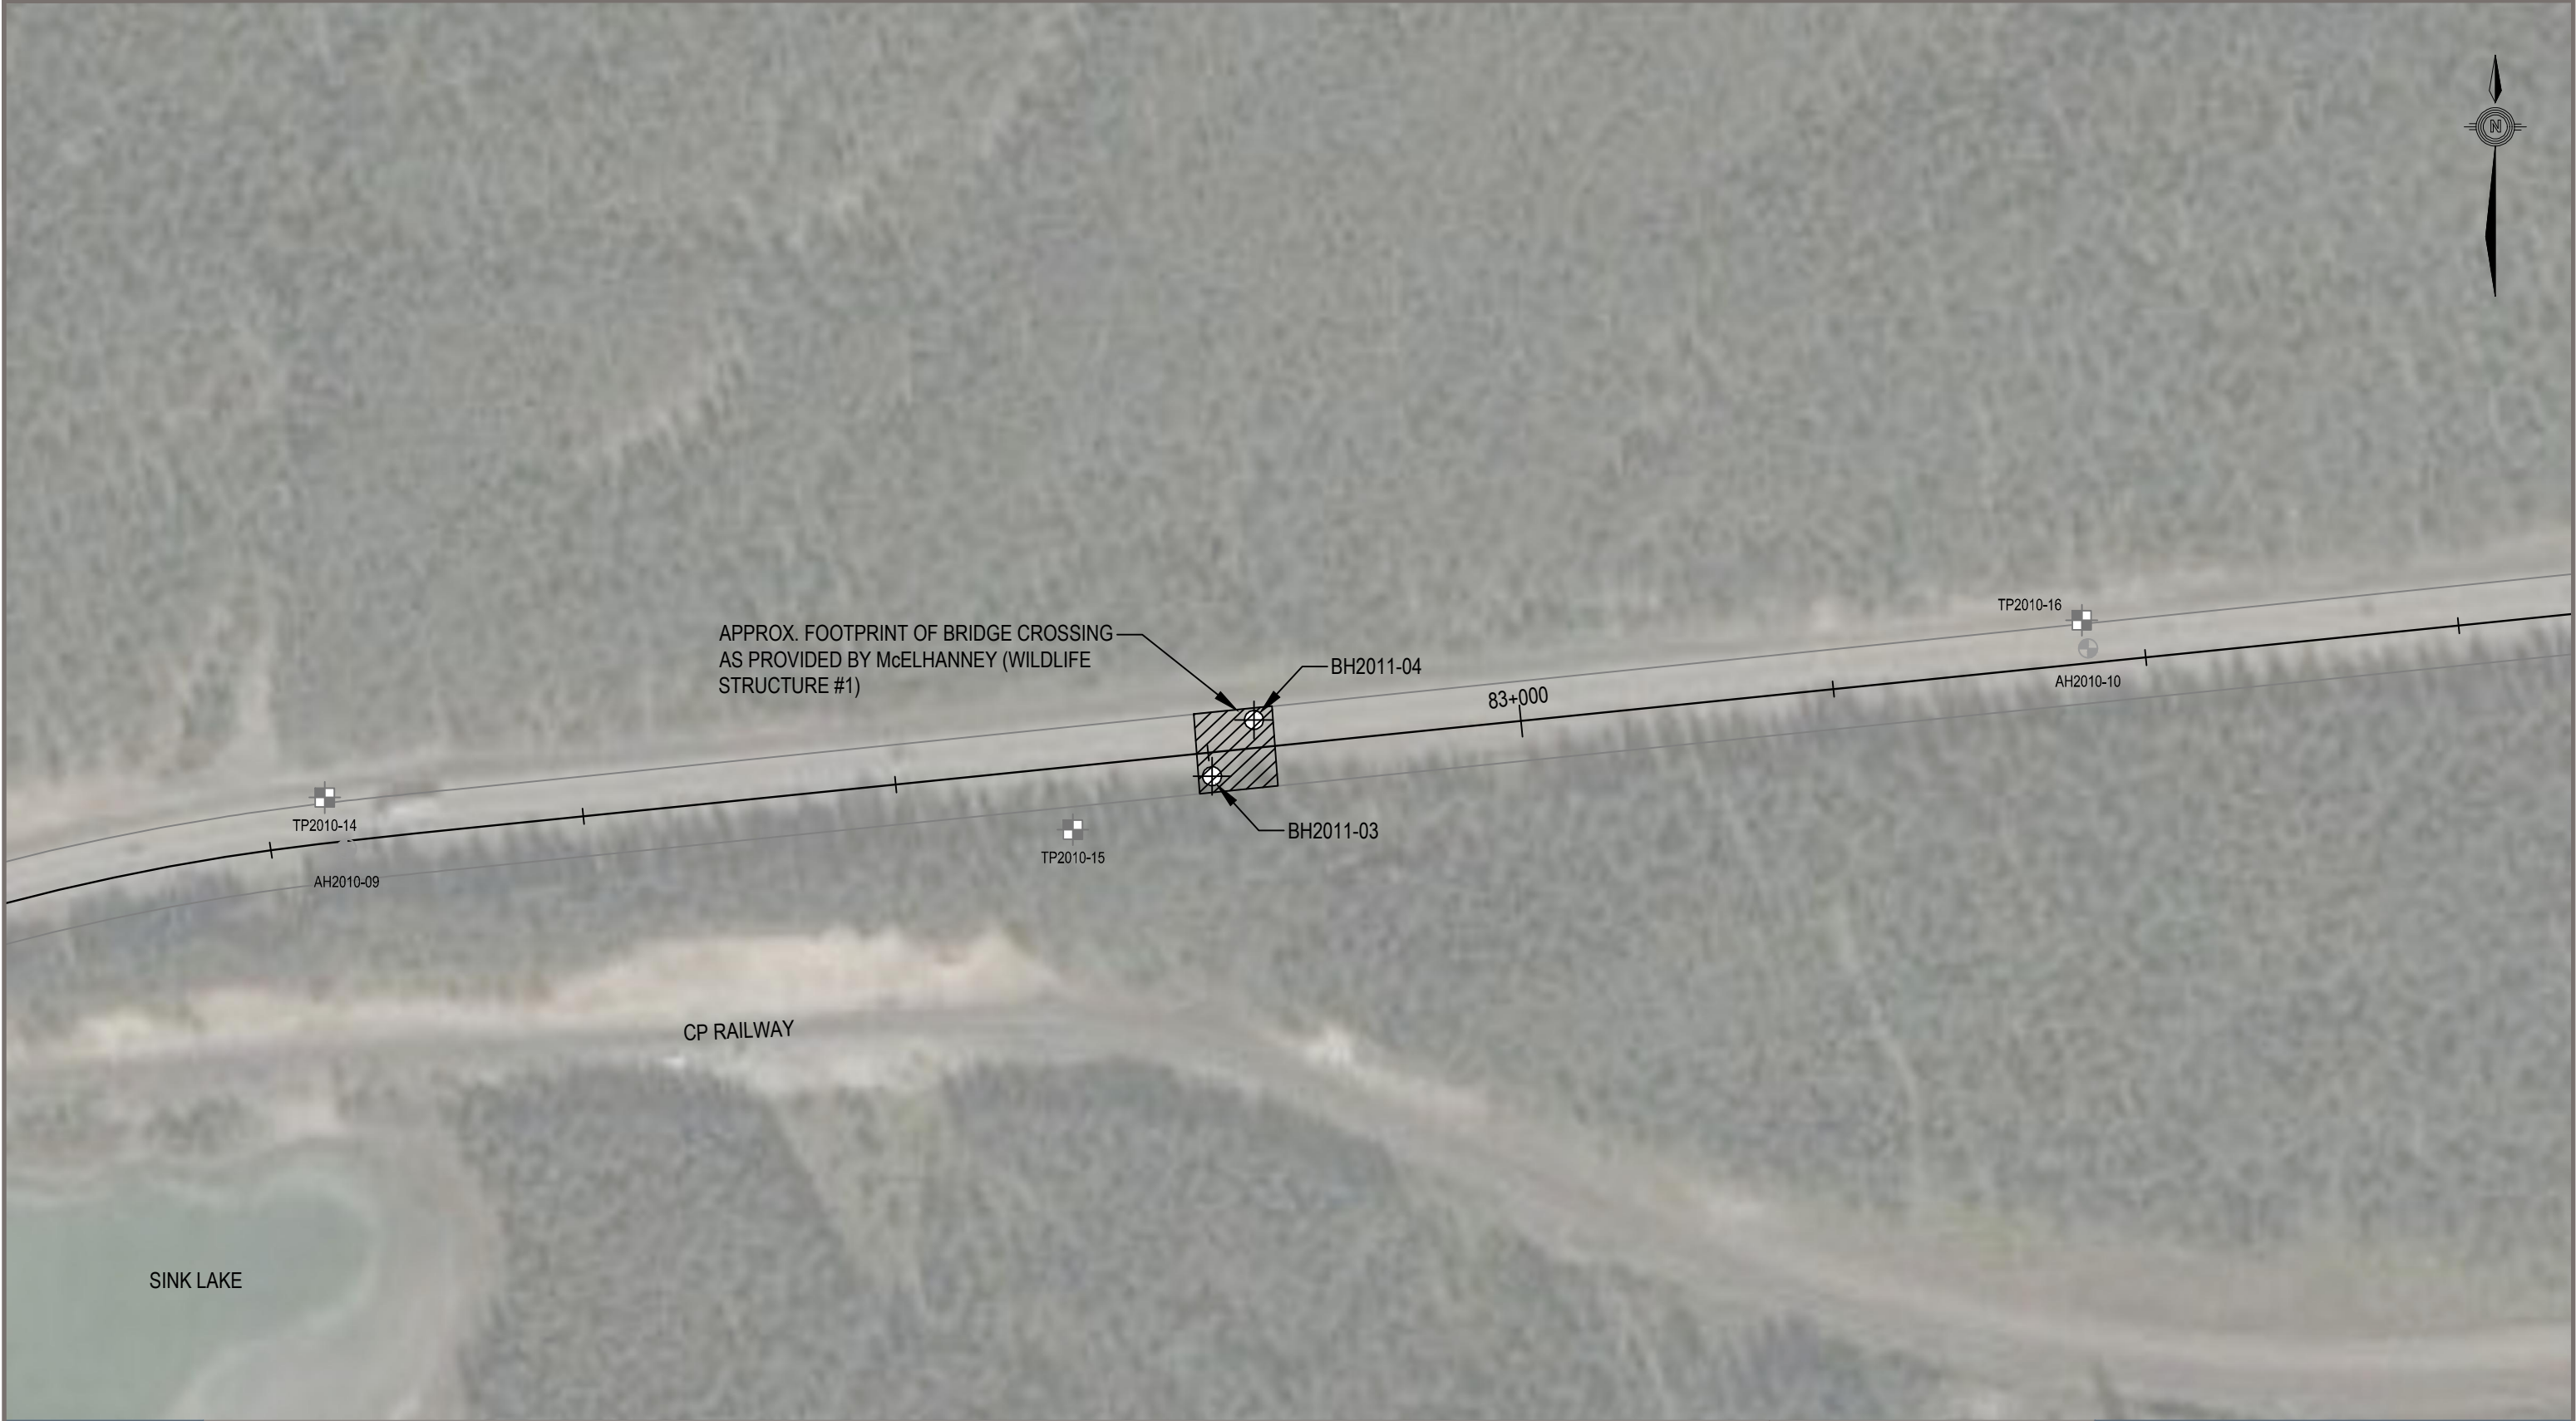
PROJECT NO. V33101067	DWN AD	CKD RB	REV 0	FIGURE 3
OFFICE VANC	DATE August 2011

BRIDGE AT KM 83+090

Borehole locations were determined based on the drawings provided by MCS which show the proposed structures footprints (Appendix B). Boreholes were advanced on the shoulder or outer lane of the TCH on each side of the proposed crossings. Figures 2 through 4 show the drilled borehole locations which were surveyed by MCS.

Boreholes BH2011-03 and BH2011-04 were drilled by EBA in 2011 near the east and west abutments of the proposed bridge at Km 84+920. Borehole BH2011-03 is located near the west abutment on the south side of the existing TCH eastbound lane, and borehole BH2011-04 is located near the east abutment on the north side of the existing TCH westbound lane. Borehole locations are shown in Figure 3.

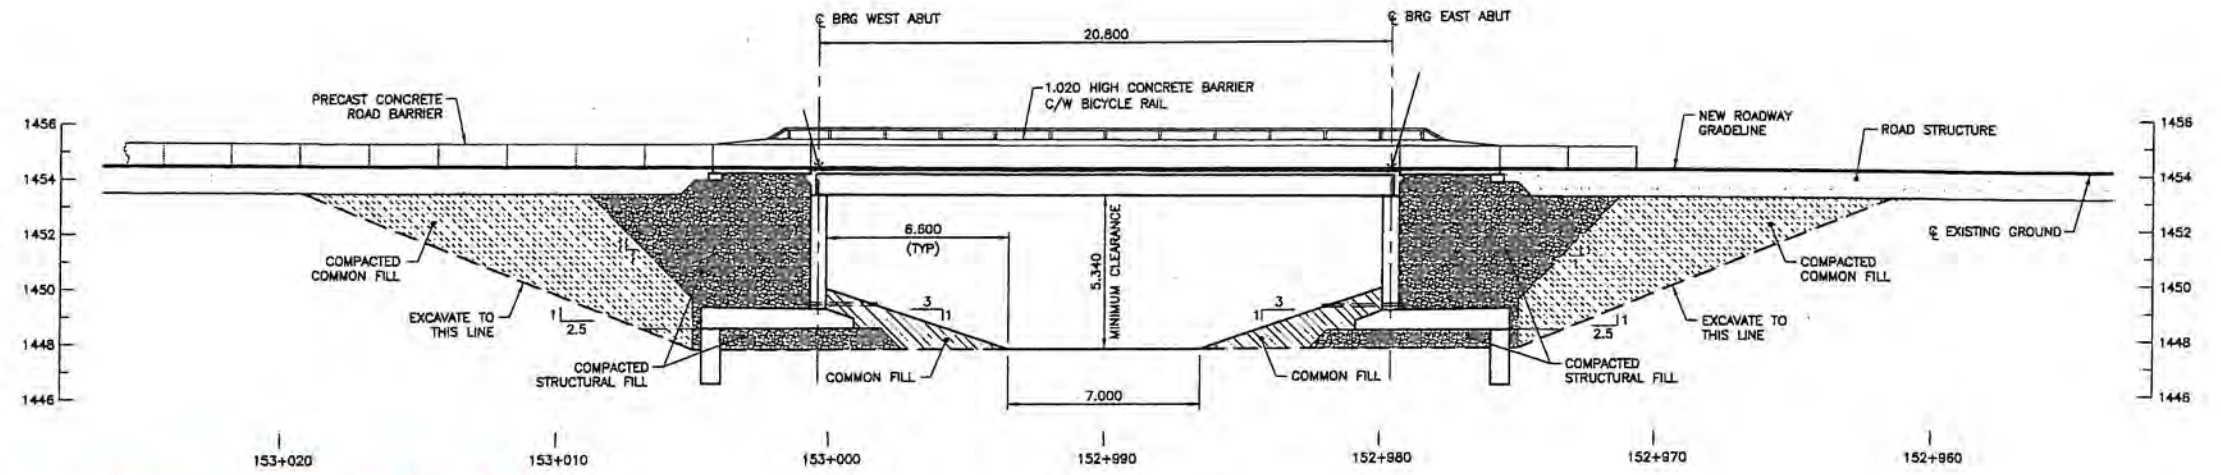
WILDLIFE STRUCTURE #1

**BRIDGE ELEVATION**  
1:125  
LOOKING NORTH

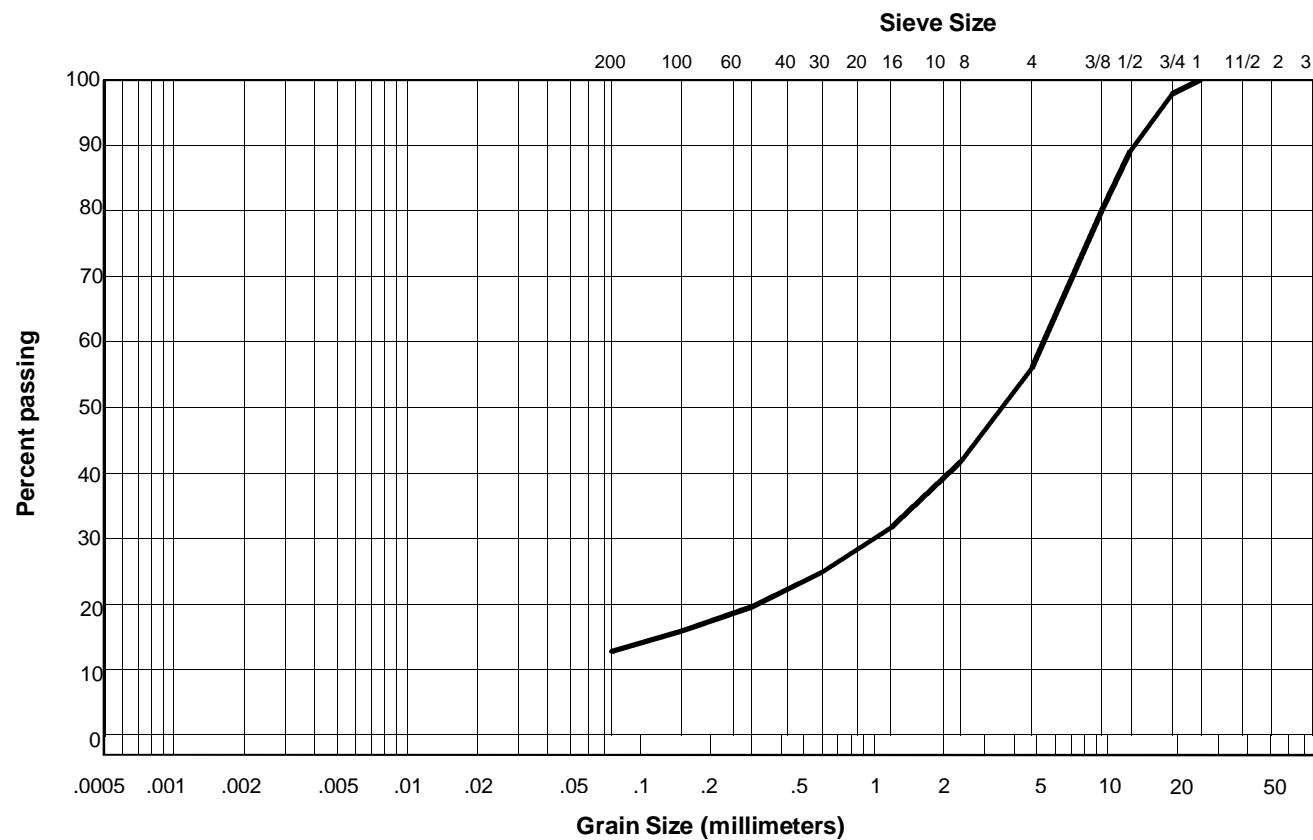
Sieve Size (mm)	Percent Passing
25.000	100
19.000	98
12.500	89
9.500	80
4.750	56
2.360	42
1.180	32
0.600	25
0.300	20
0.150	16
0.075	12.8

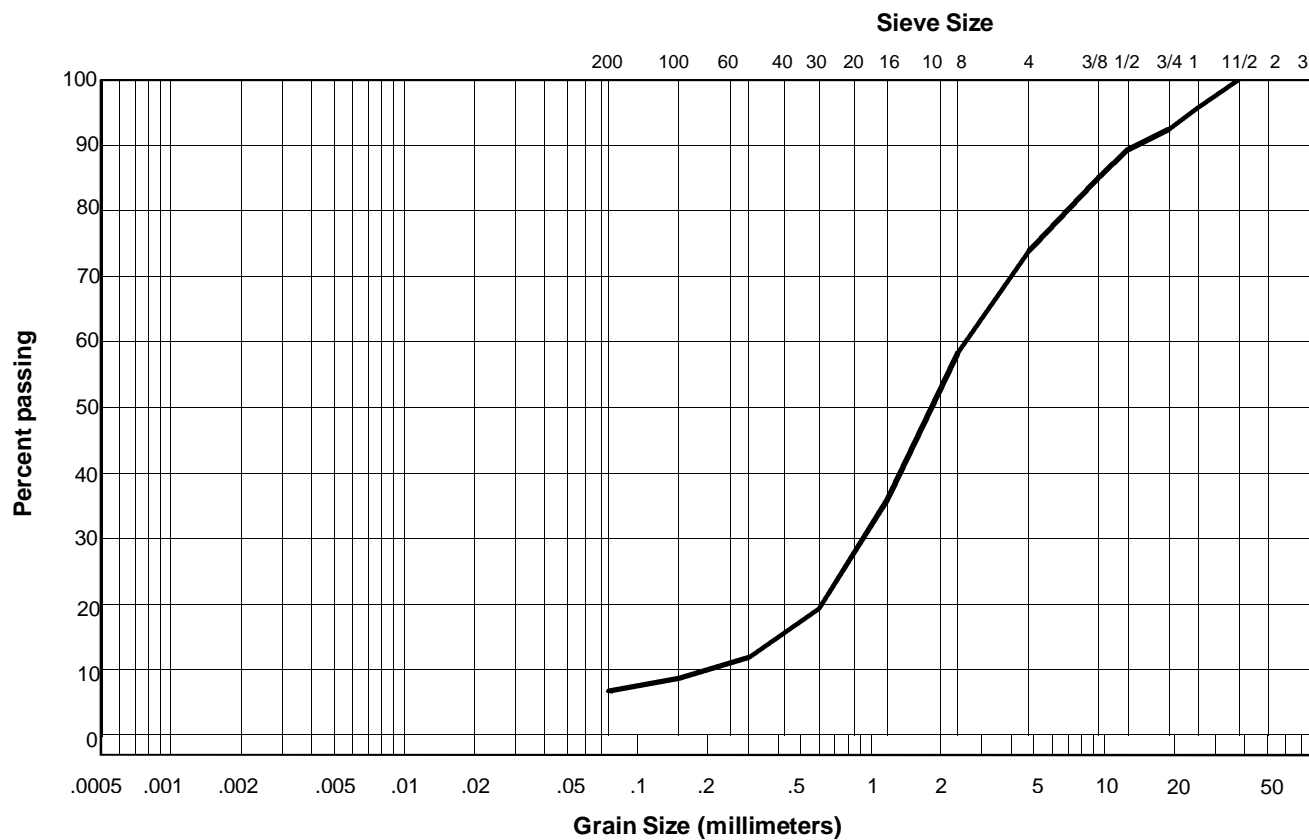
Sieve Size (mm)	Percent Passing
37.500	100
25.000	96
19.000	92
12.500	89
9.500	85
4.750	74
2.360	58
1.180	36
0.600	19
0.300	12
0.150	9
0.075	6.7

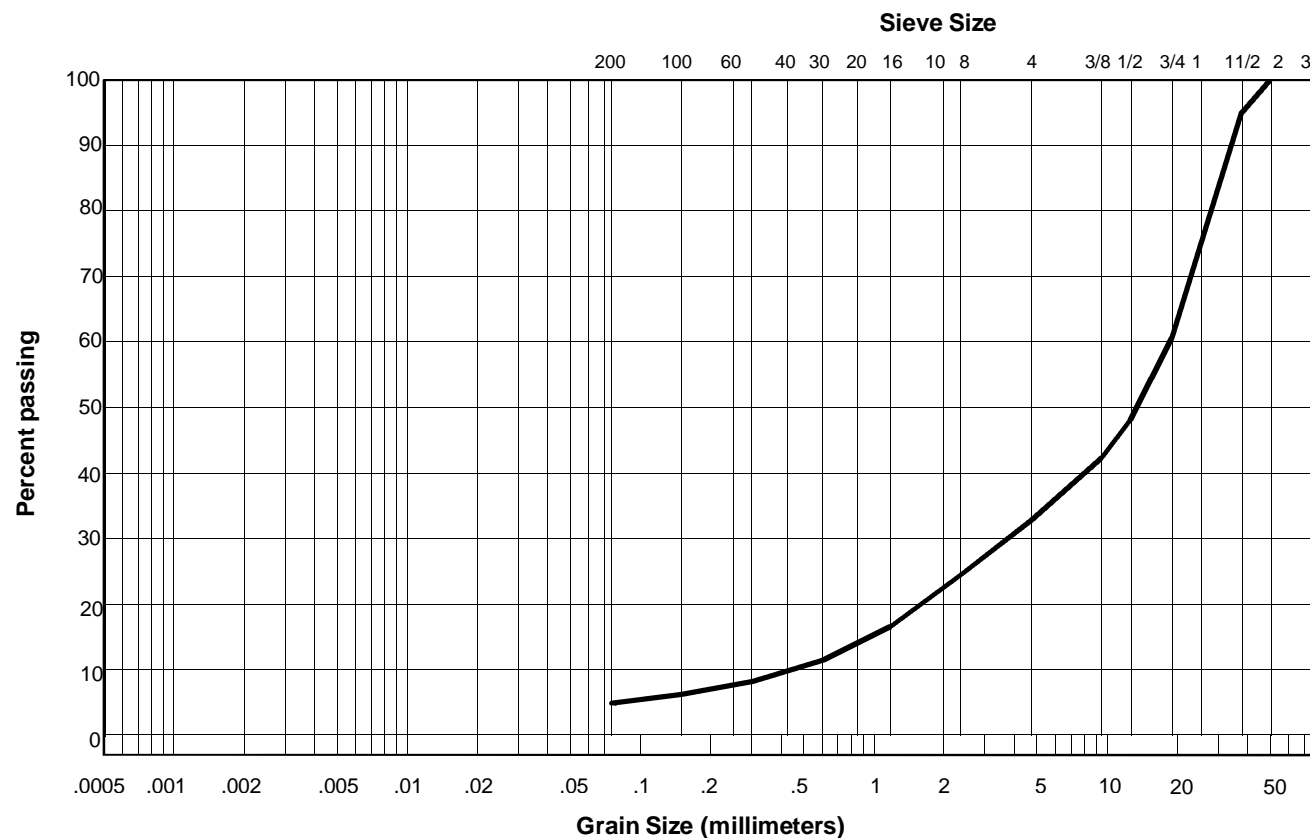
Sieve Size (mm)	Percent Passing
50.000	100
37.500	95
25.000	75
19.000	61
12.500	48
9.500	42
4.750	33
2.360	24
1.180	17
0.600	11
0.300	8
0.150	6
0.075	4.9

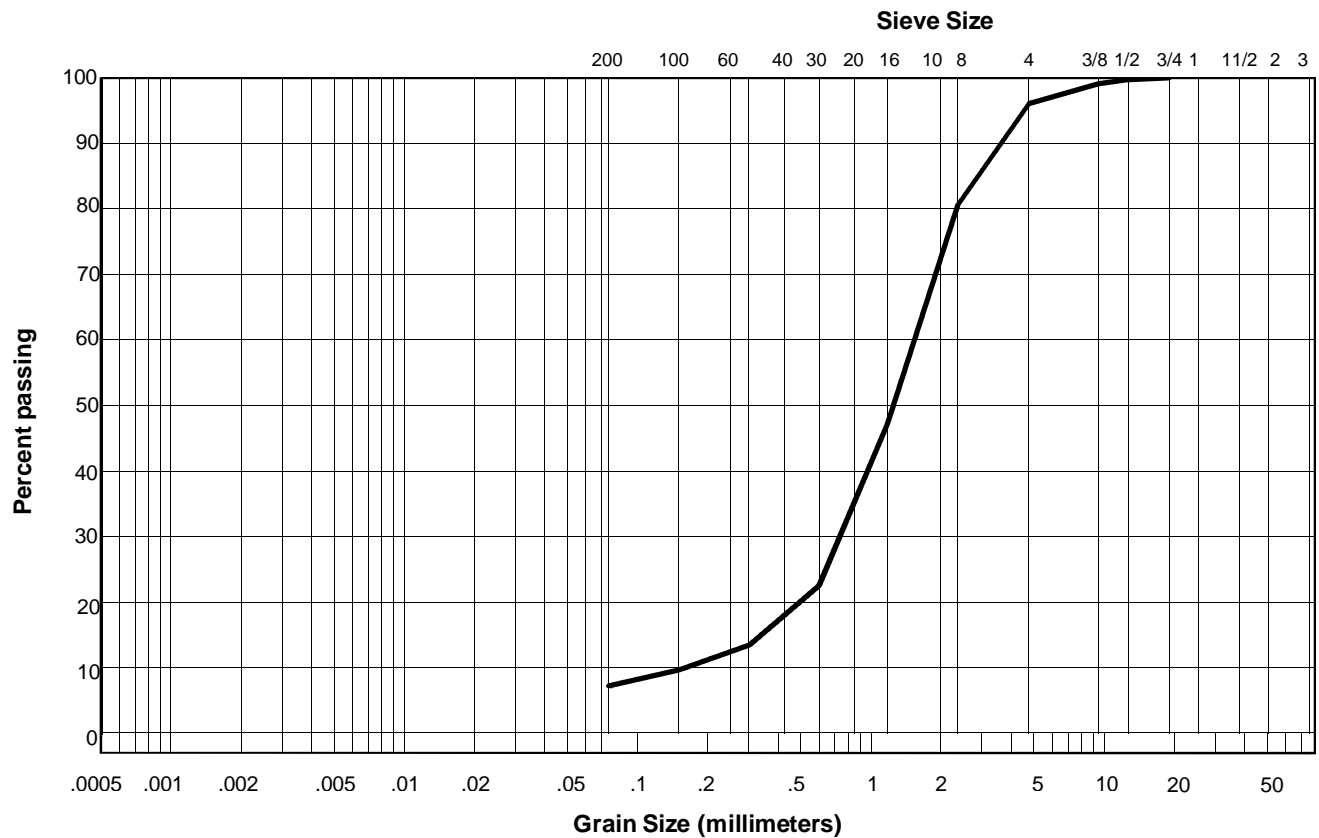
Sieve Size	Percent Passing
19.000	100
12.500	100
9.500	99
4.750	96
2.360	81
1.180	47
0.600	22
0.300	13
0.150	10
0.075	7.3

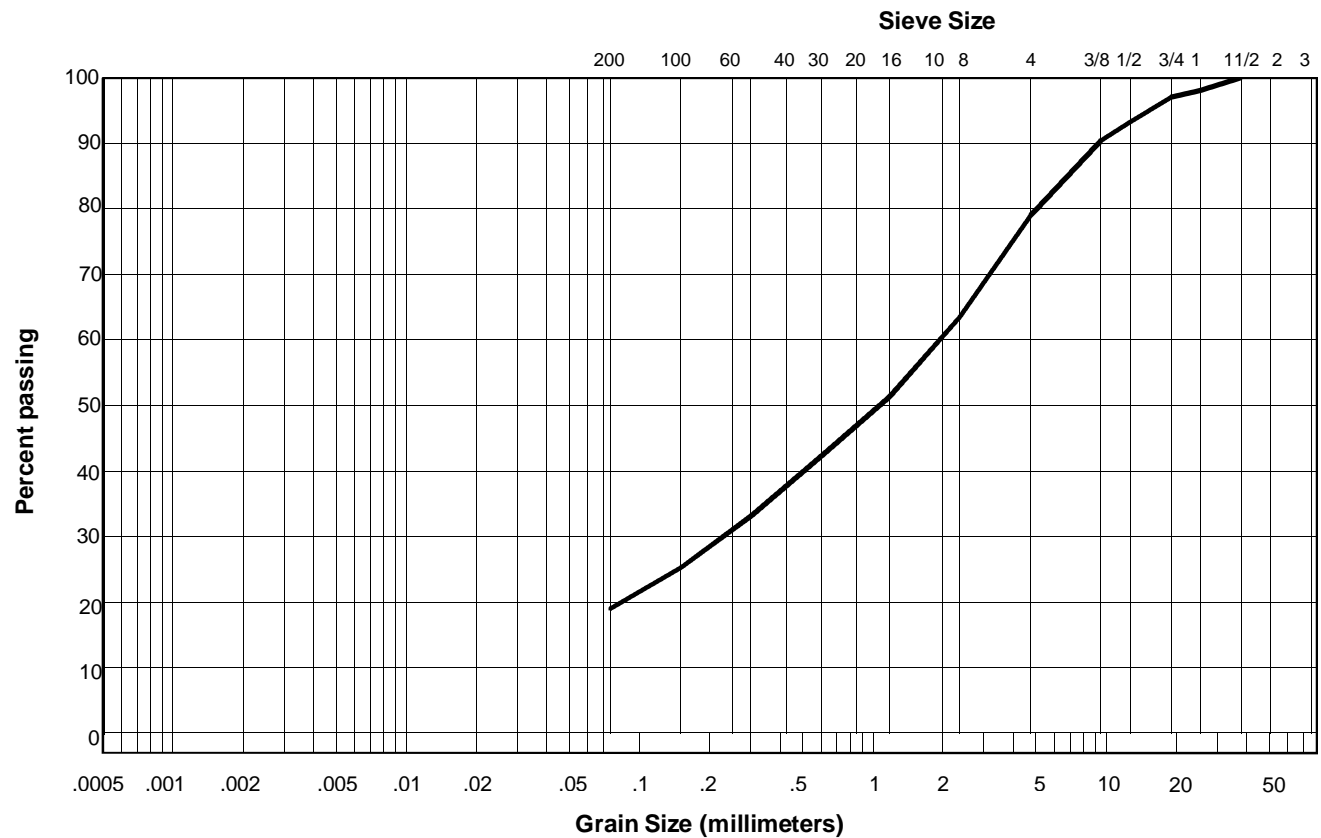
Sieve Size (mm)	Percent Passing
37.500	100
25.000	98
19.000	97
12.500	93
9.500	90
4.750	79
2.360	64
1.180	51
0.600	42
0.300	33
0.150	25
0.075	19.0

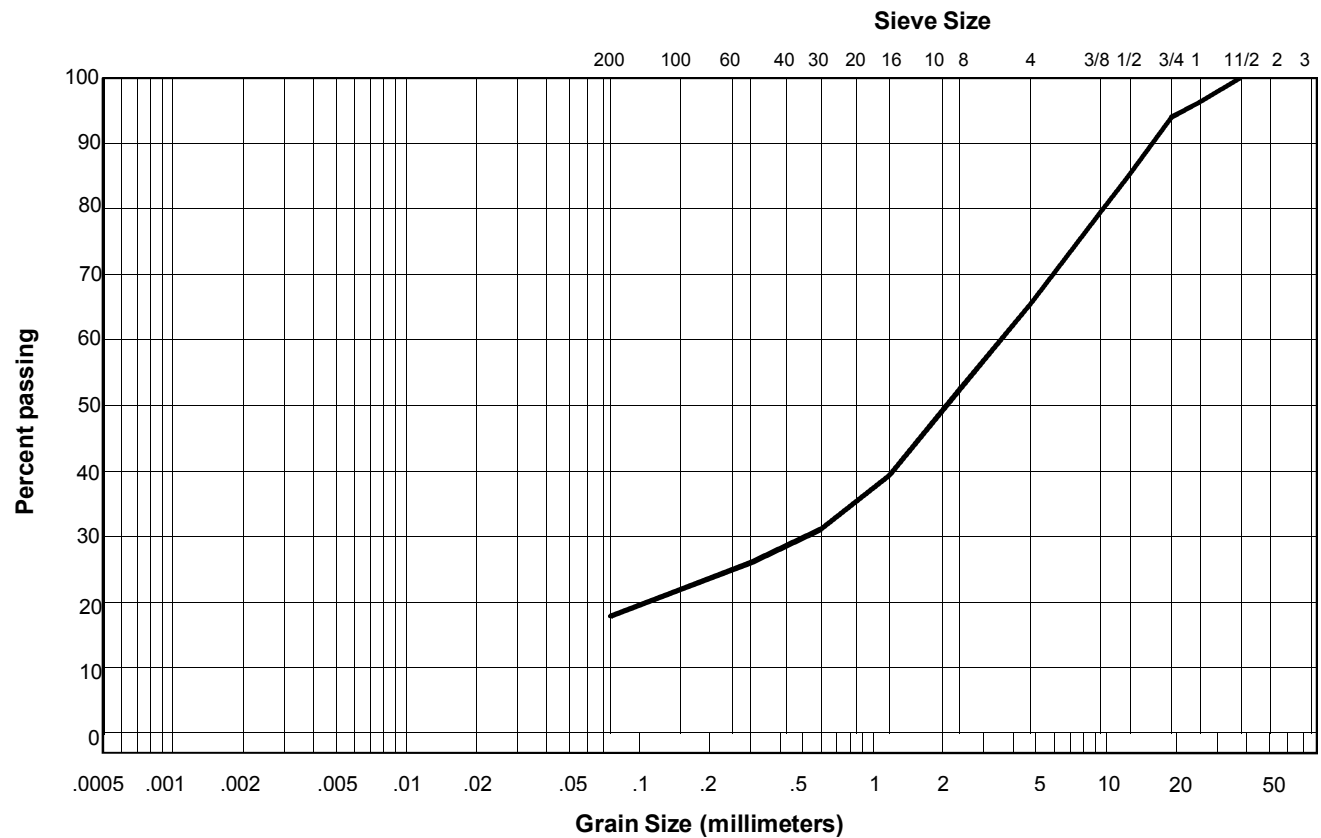
Sieve Size (mm)	Percent Passing
37.500	100
25.000	96
19.000	94
12.500	85
9.500	80
4.750	66
2.360	52
1.180	39
0.600	31
0.300	26
0.150	22
0.075	17.9
