NATIONAL HISTORIC PARKS
AND SITES BRANCH

MANUSCRIPT REPORT NUMBER
TRAVAIL INÉDIT NUMÉRO **133**

1967 SALVAGE EXCAVATION AT
FORT LENNOX, ILE-AUX NOIX

SALVAGE EXCAVATIONS AT
MONTMORENCY PARK, QUEBEC CITY: 1967-1968

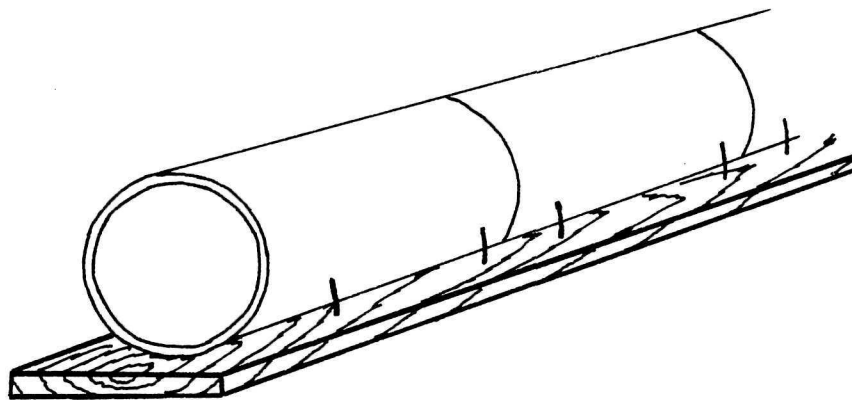
Figure 1. View of modern drain as found on wood planks with nails used as supports.

The agricultural tile drain extended between the N.W. and S.W. catchbasins and was constructed of 1' lengths, held in place by nails driven through wood planks. (Fig. 1). The top of this drain was located 2.7' B.S.

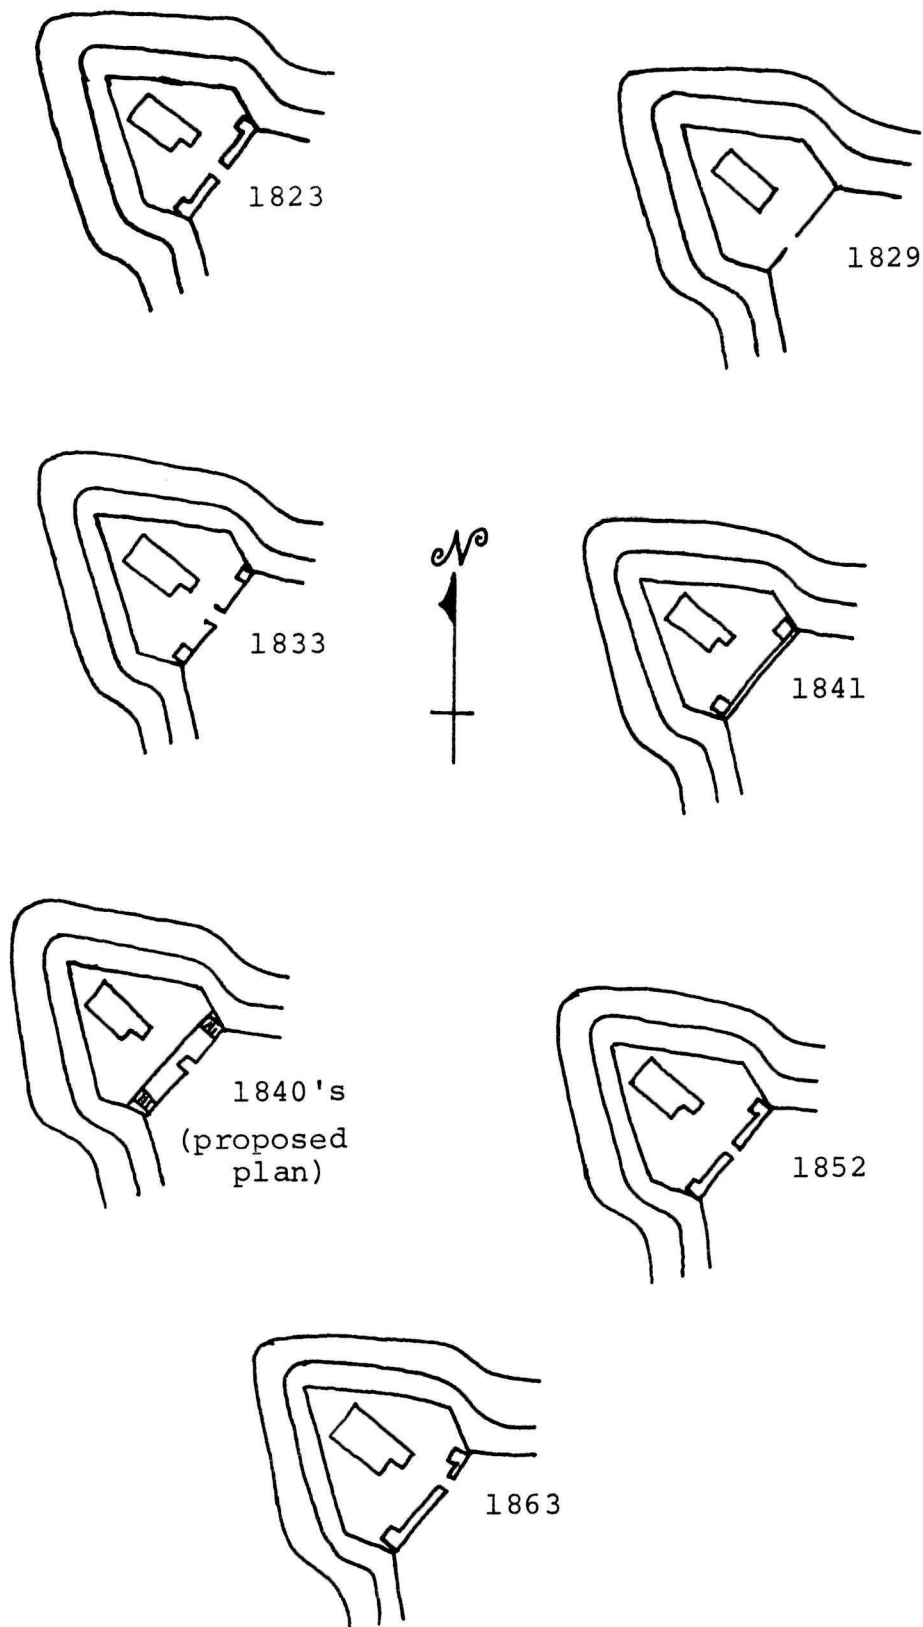
Figure 2. View of various defence walls used and proposed in front of the Powder Magazine.

This stone structure would appear to be the foundation remains of a wall which existed in front of the Powder Magazine. Historical records indicate the presence of such a wall, although these vary as to its actual structure. The earliest map (1823) shows the wall as having a doorway in the centre with a shifting room at each end of the wall. An 1829 map indicates only a thin straight wall across the entrance of the bastion with

a central entrance, and an 1863 version indicates the wall having an entrance just left of the centre of the wall, with shifting rooms at the ends. The 1841 map shows no entrance at all and the others (1833 and 1852) indicate the entrance at the centre of the wall. A map with a plan of alterations shows the wall to have even a different shape from the others, but this plan was apparently never carried out, (Fig. 2) By 1939 no wall is shown at all on the map dated at that time, however one of the attendants at Fort Lennox, Mr. A. Longois, recalls such a wall in existence in the 1930's. From his description of the wall, it very closely resembles the one shown on a painting of the area (Appendix I-h).

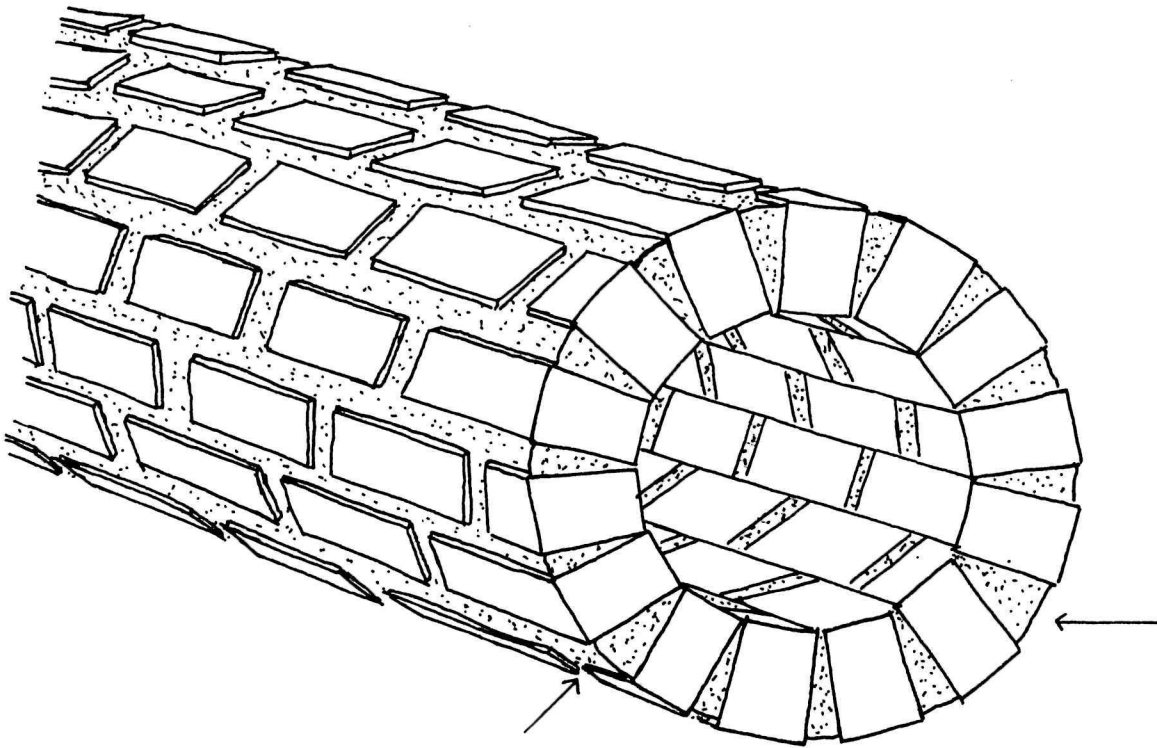
Figure 3. View of brick drain structure. Arrows indicate a widening of mortar joint.

The structure of the bottom half of the drain differs somewhat from that of the top in that there is a sudden widening of space between the bricks along the exterior wall on the bottom half, (Fig. 3). This compression of the bricks forces the bottom of the drain to be flatter than the rest of the structure.

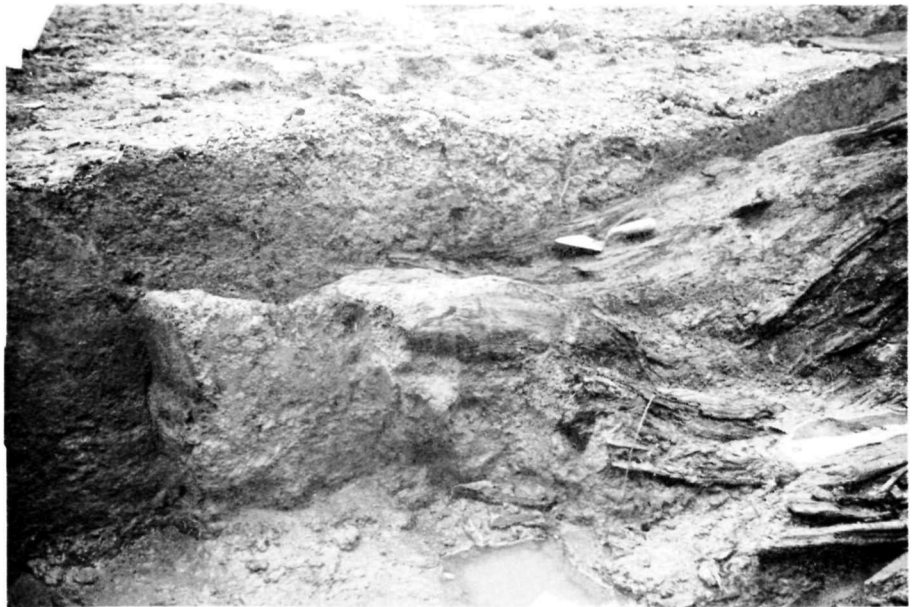
Appendix I - a. View of collapsed wood structure in the North ravelin. 5G-43-M

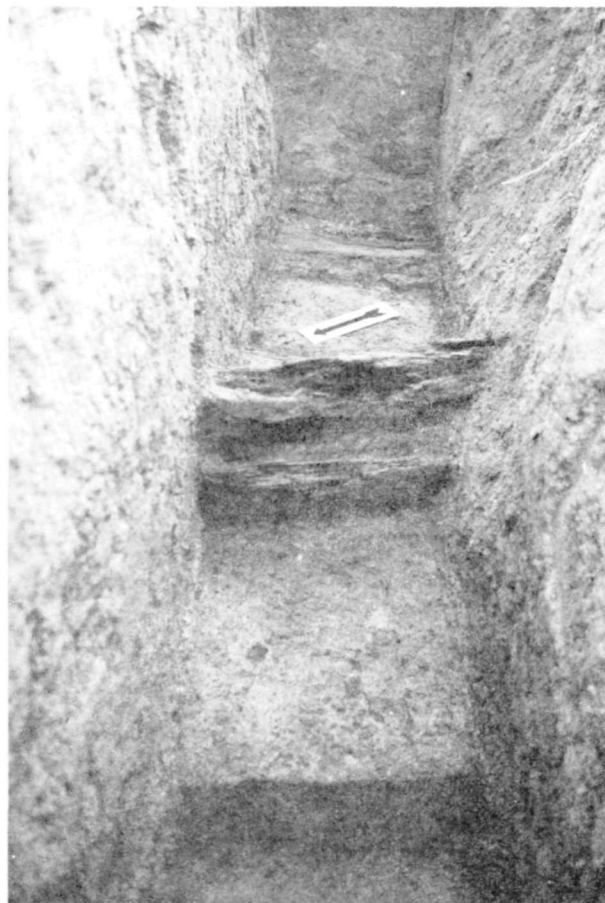
Appendix I - b. View of two beams on top of one another in test trench south of the sally port. Note wood chips in front and wood logs behind this structure. 5G-50-M

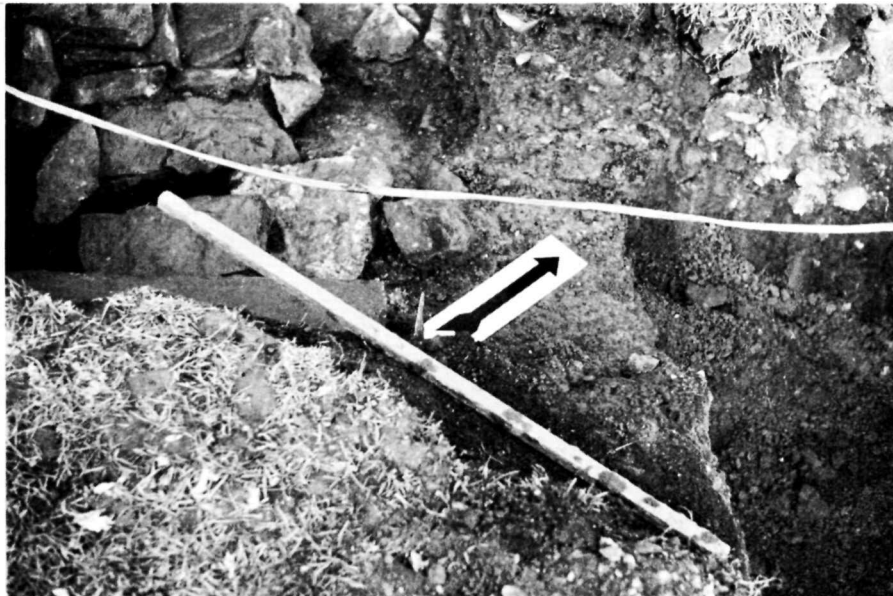
Appendix I - e. View of iron rod which was found near the East end of the stone drain in the Parade Ground. Damaged drain seen at top left corner. **5G-67-M**

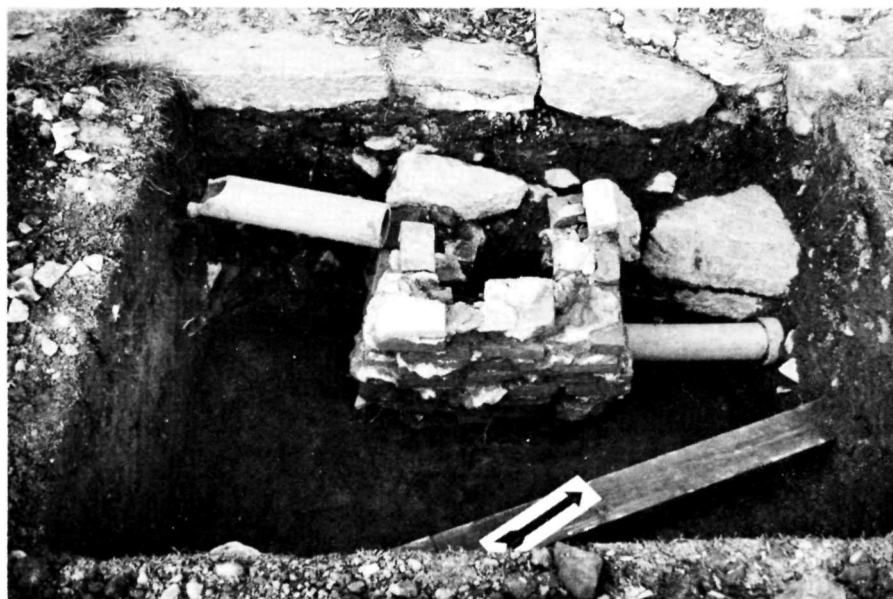
Appendix I - f. View of North east catch basin after excavation, showing two modern pipe inlets plus wood plank covering electric wiring. Surface runoff drain is seen at top of photograph. **5G-92-M**

These planks may have covered electrical wiring, as no drain or nails were found which would indicate a structure similar to the drain found west of the Barracks.

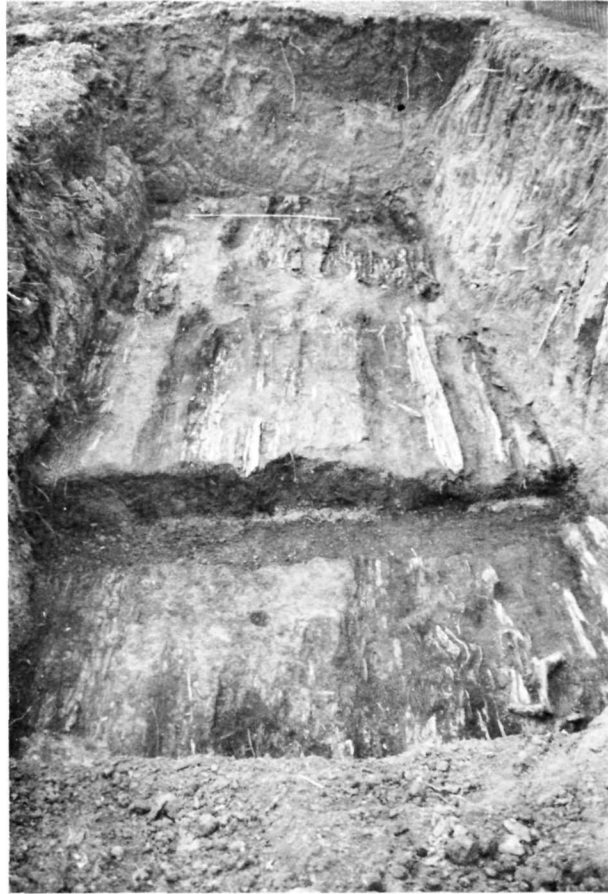
Appendix I - c. View of continuous wood feature found parallel to the moat, west of the north ravelin. Slope goes down to the moat. **5G-8-M**

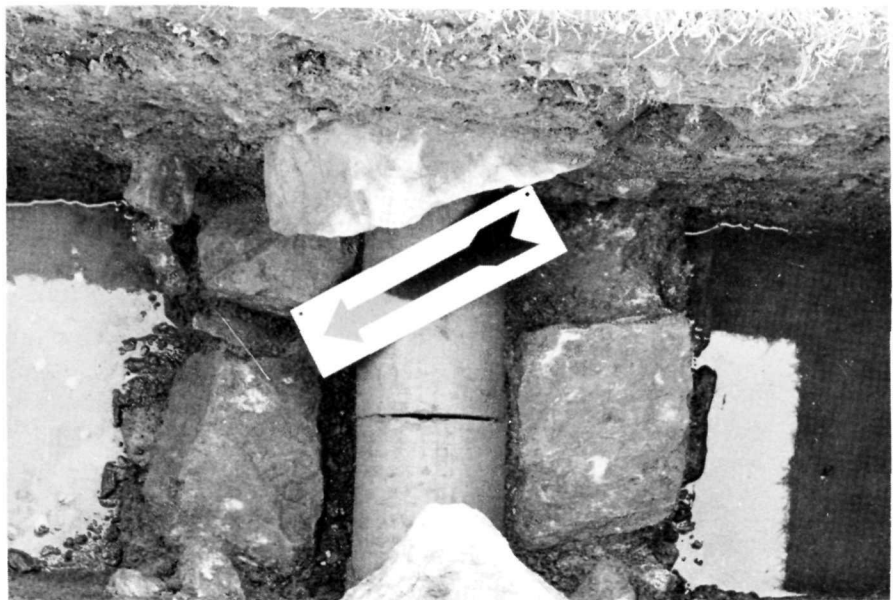
Appendix I - d. View of modern agricultural tile drain inside old British stone drain, with stones covering the drain protruding from both trench walls. **5G-63-M**

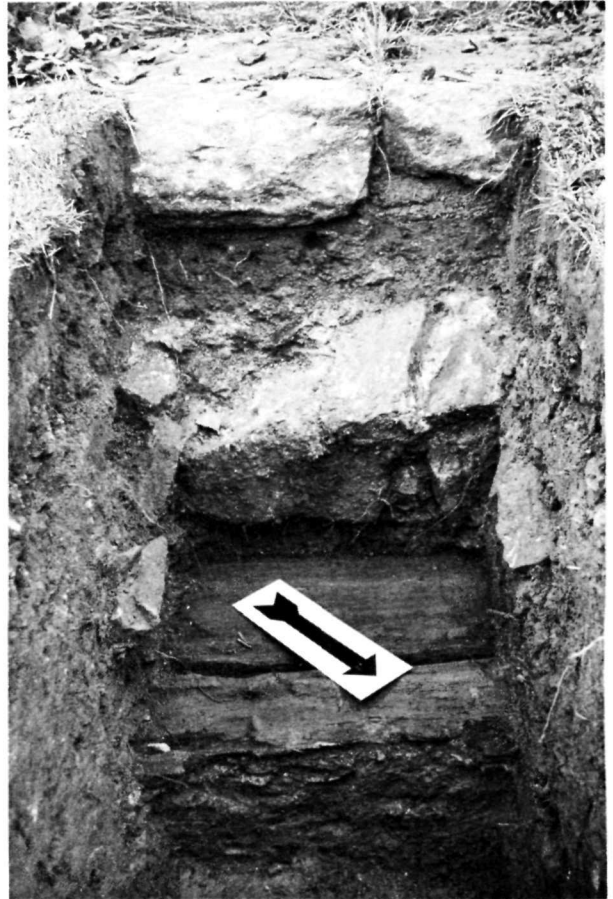
Appendix I - g. View of two wood planks
north of stones forming exterior
support for the foundation of the Men's
Barracks. **5G-83-M**

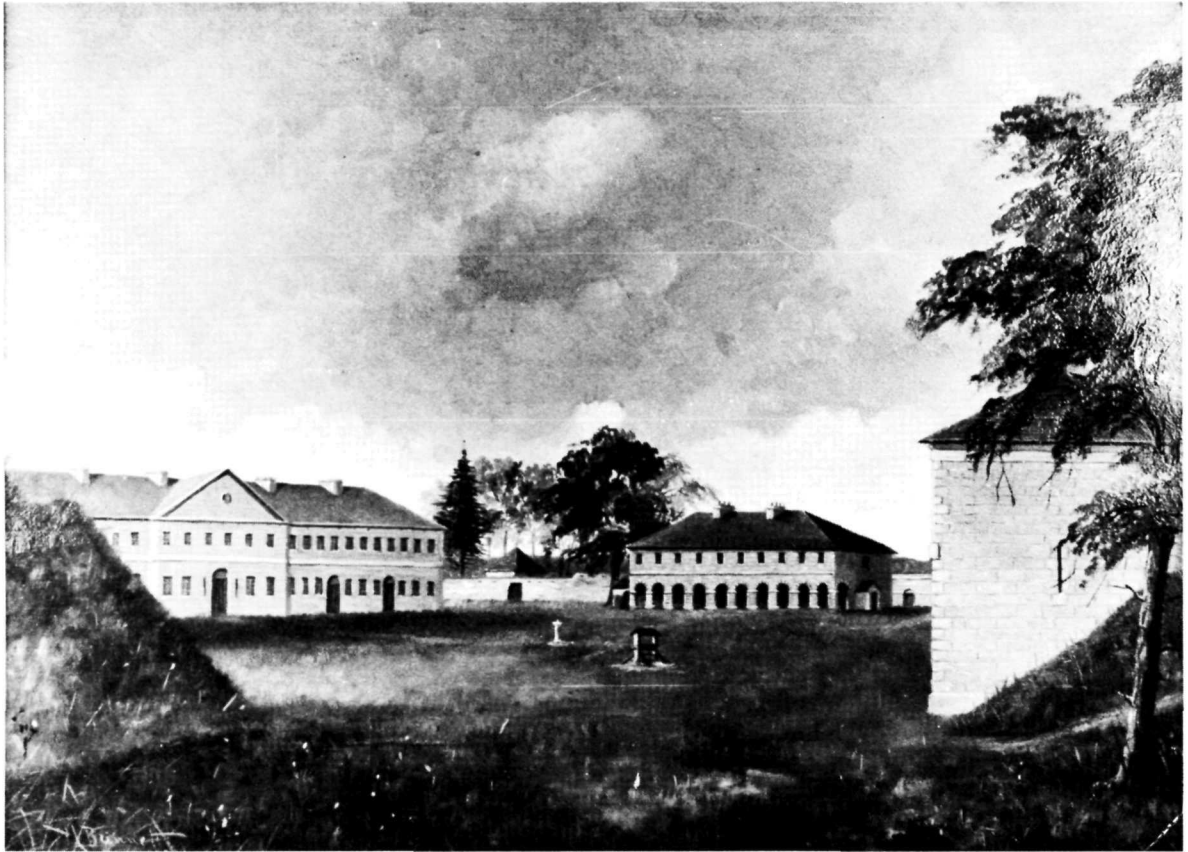
Appendix I - h. Photograph of a painting by Bunnet, ca. 1880's, showing the magazine defense wall between the Men's Barracks and Officers' Quarters. (Original at McGill University, 872.)

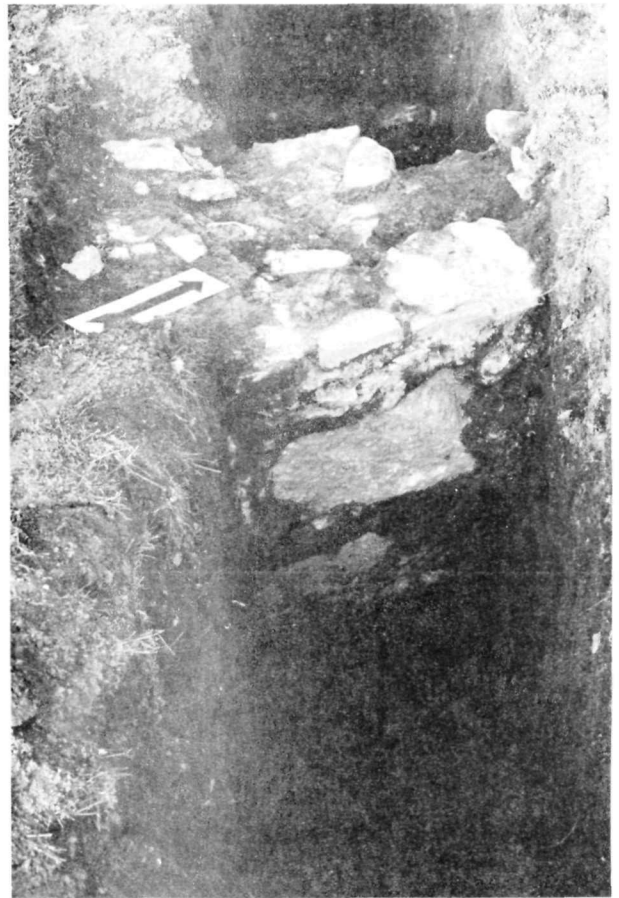
Appendix I - k. View of
the brick drain between
the Powder Magazine and
the Men's Barracks.
5G-111-M

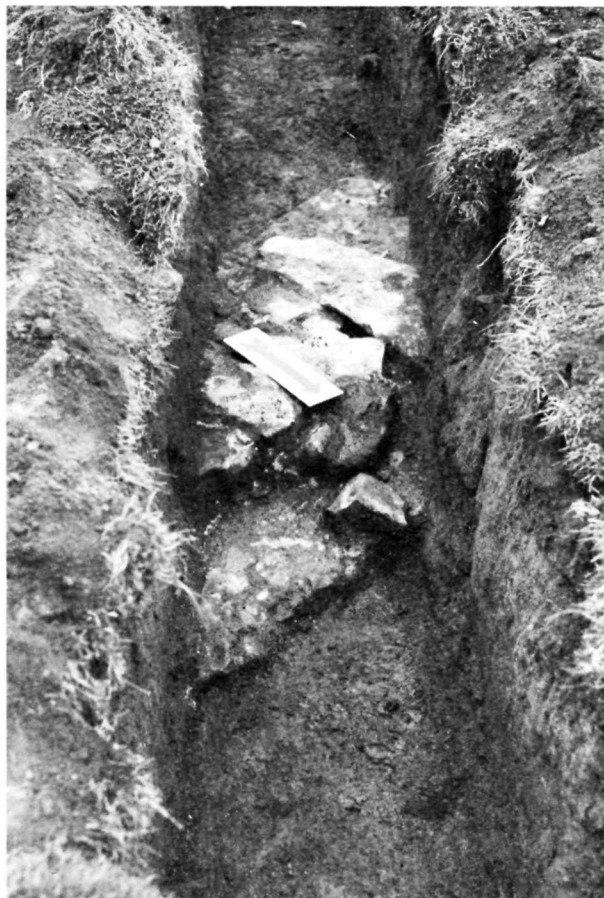
Appendix I - l. View of stone drain
between Officer's Quarters and Men's
Barrack. 5G-133-M

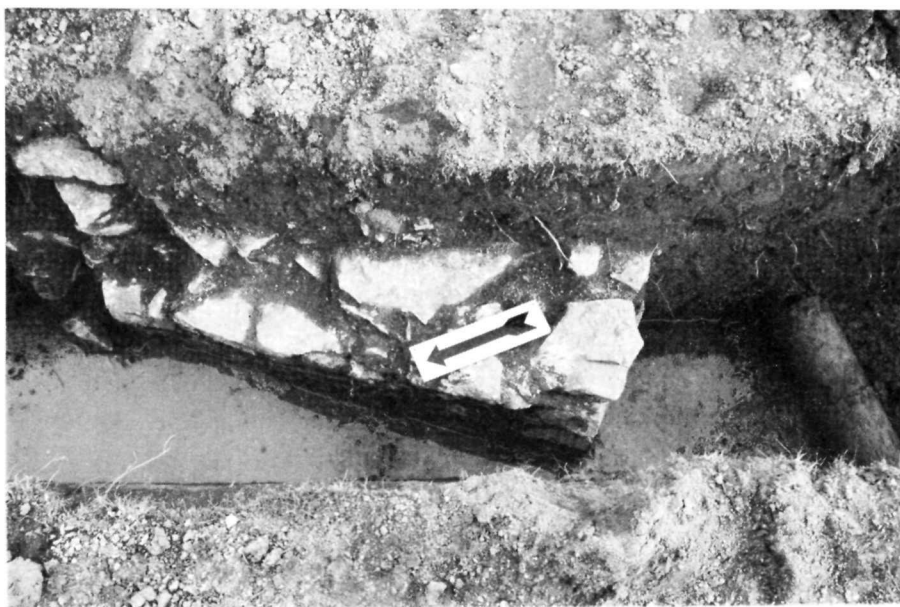
Appendix I - m. View of stone feature between the Powder
Magazine and Men's Barracks, with a modern drain on the
right. 5G-116-M

found 1.5' B.S. This particular structure is unique from all the others as a corner is exposed, (Appendix I-m). This structure was severely damaged by the backhoe and hence the actual top of the structure could possibly be located around 0.5 or 0.7' B.S. The bottom depth of this structure was not excavated, as water began to pour into the trench from the stone structure as soon as a level of 3.2' B.S. was reached. A particular feature of this structure was the tendency for course overlap (Appendix II-h). Although this may have been the result of deterioration, the mortar is rather firm and the stones do appear to jut out purposely near the base.

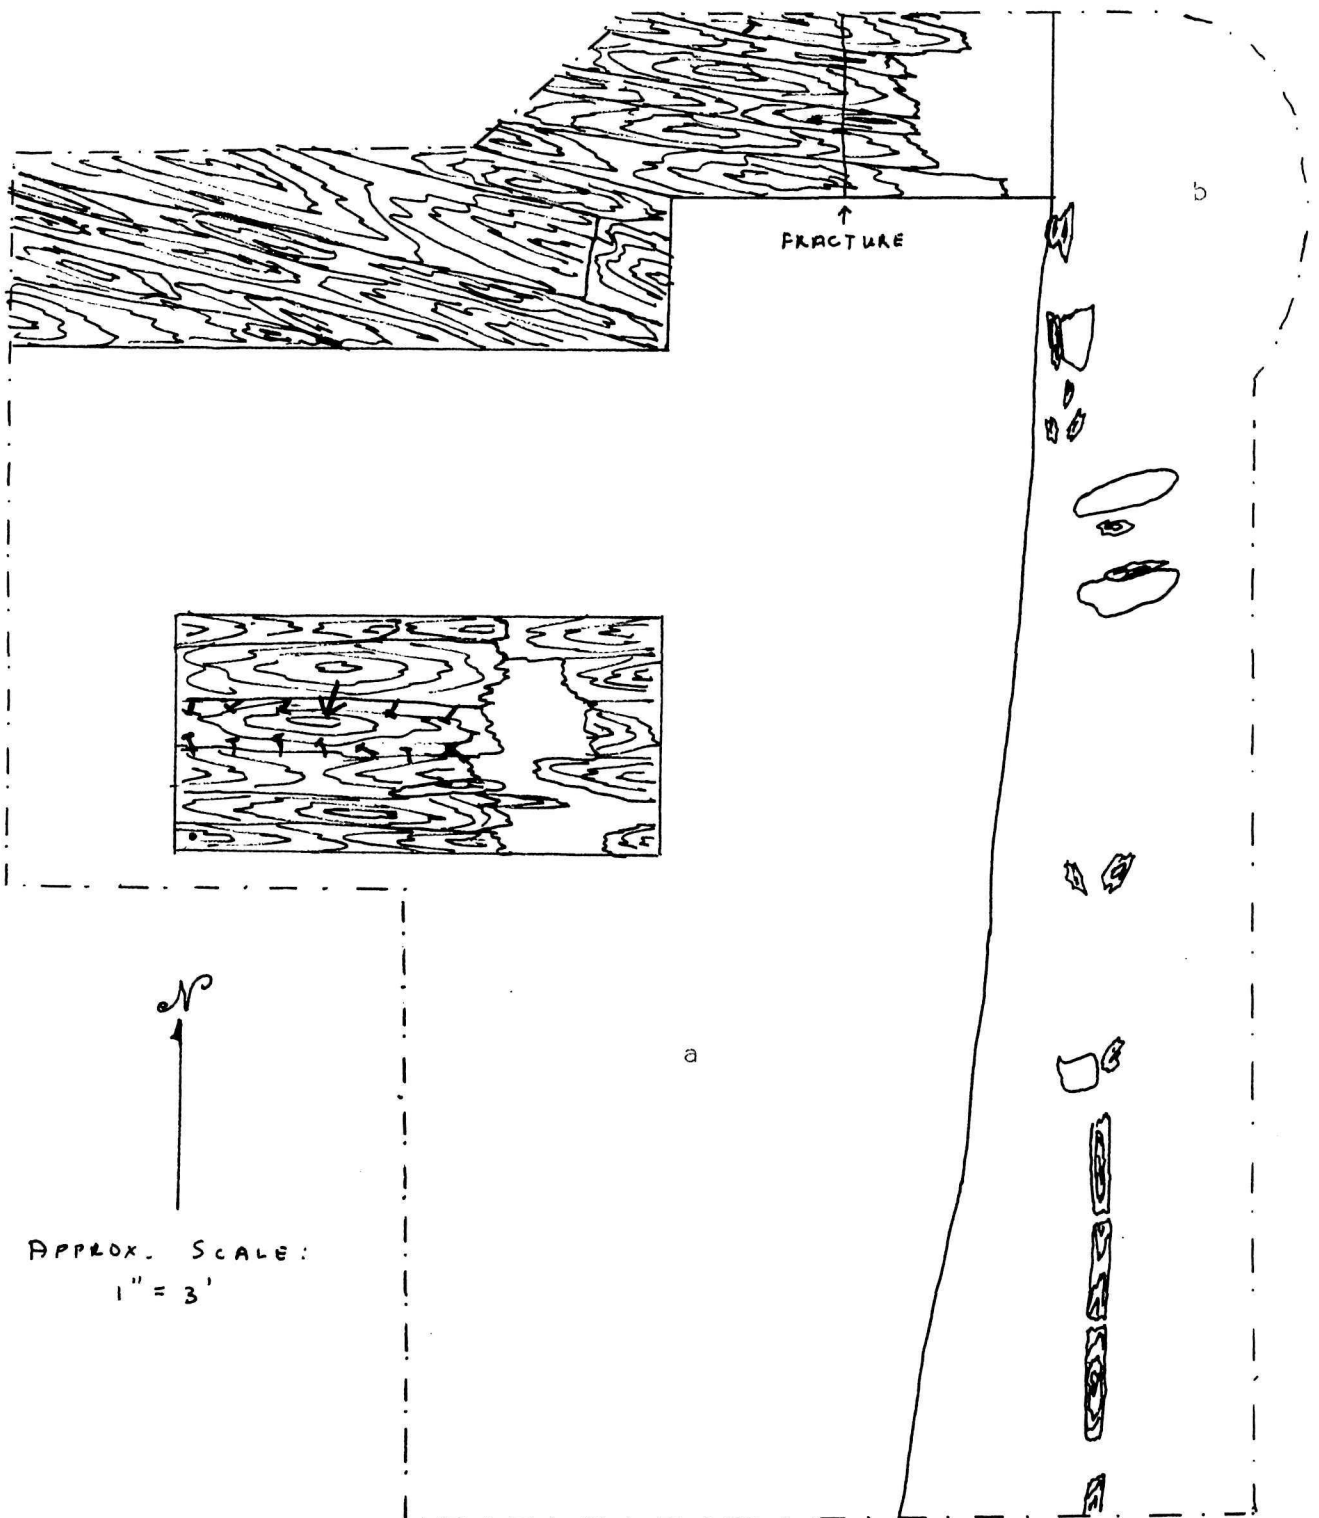
Appendix II - a & b. View of wood structure(s) found in the north ravelin. Note spikes in small trench of section "a". Wood in section "b" is at a higher level.

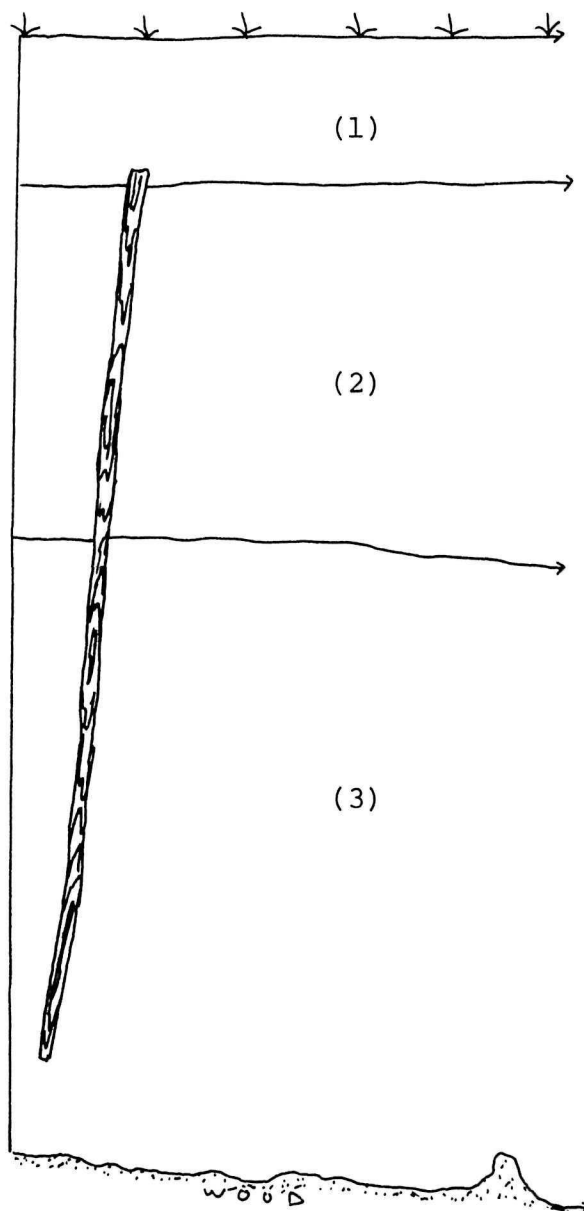
- (1) Very dark greyish brown loam (10 YR, 3/2)
- (2) Very dark greyish brown loam (2.5 Y, 3/2)
- (3) Olive brown loamy clay (2.5 Y, 4/4)

Appendix II - b. View of wood post found in south wall of 5G60B.

Figure 2 also gives an indication of the stratigraphy of this trench, which runs uniform throughout the trench. This would not only indicate that the structure was in existence before the ravelin was erected, since no disturbance can be detected; but also that the post was most likely inserted after the ravelin was constructed and may possibly have protruded above the soil.

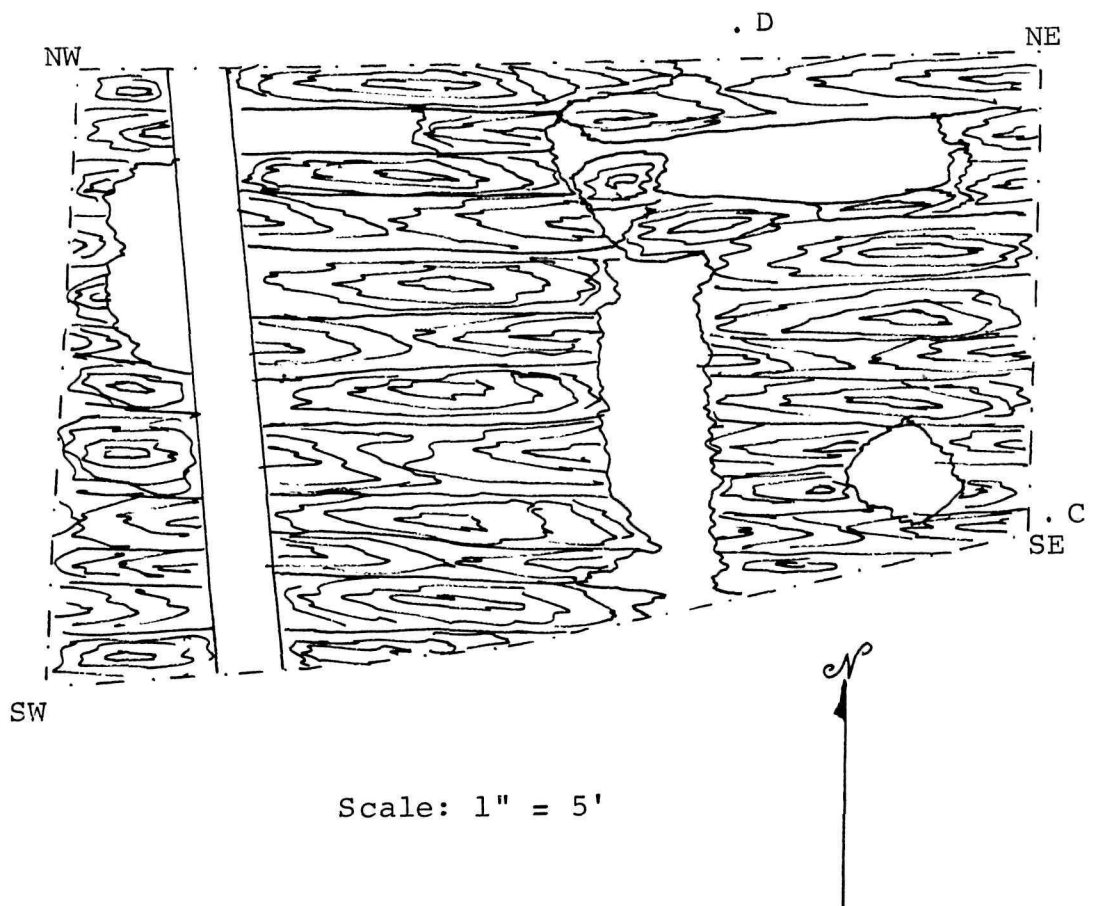
Appendix II - d. 5500C- View of wood feature found parallel to the moat.

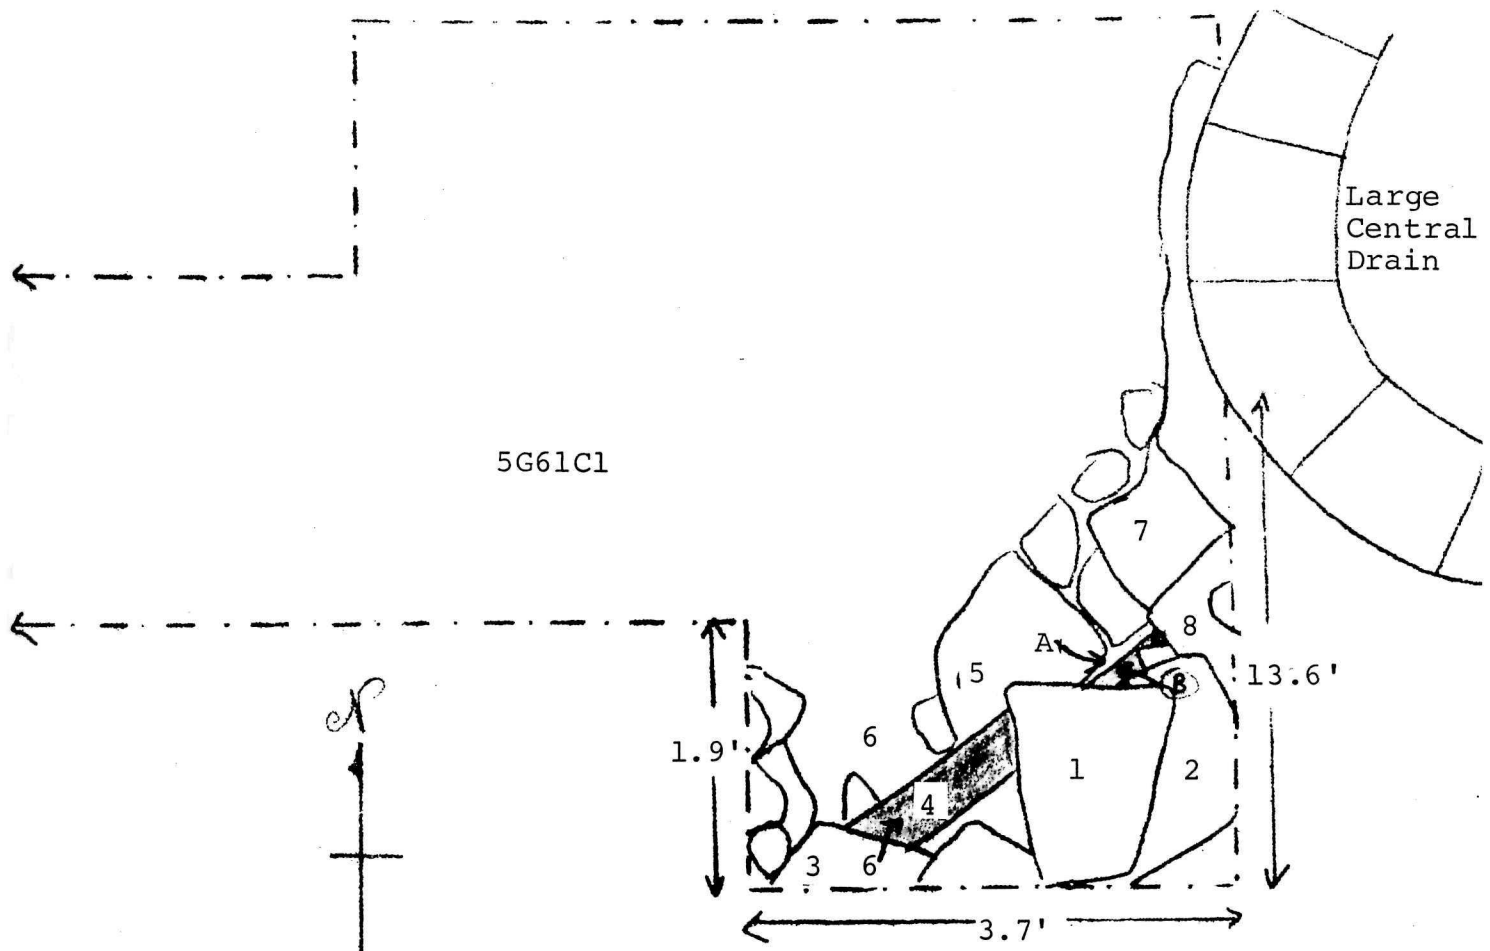
1 0.6' B.S.	5 3.25' B.S.
2 0.75' B.S.	6 3.85' B.S.
3 1.1' B.S.	7 1.6' B.S.
4 2.2' B.S.	8 3.1' B.S.

Note: Surface Level is same as large central drain wall.

Appendix II - e. View of area west of main cistern where different drains were found.

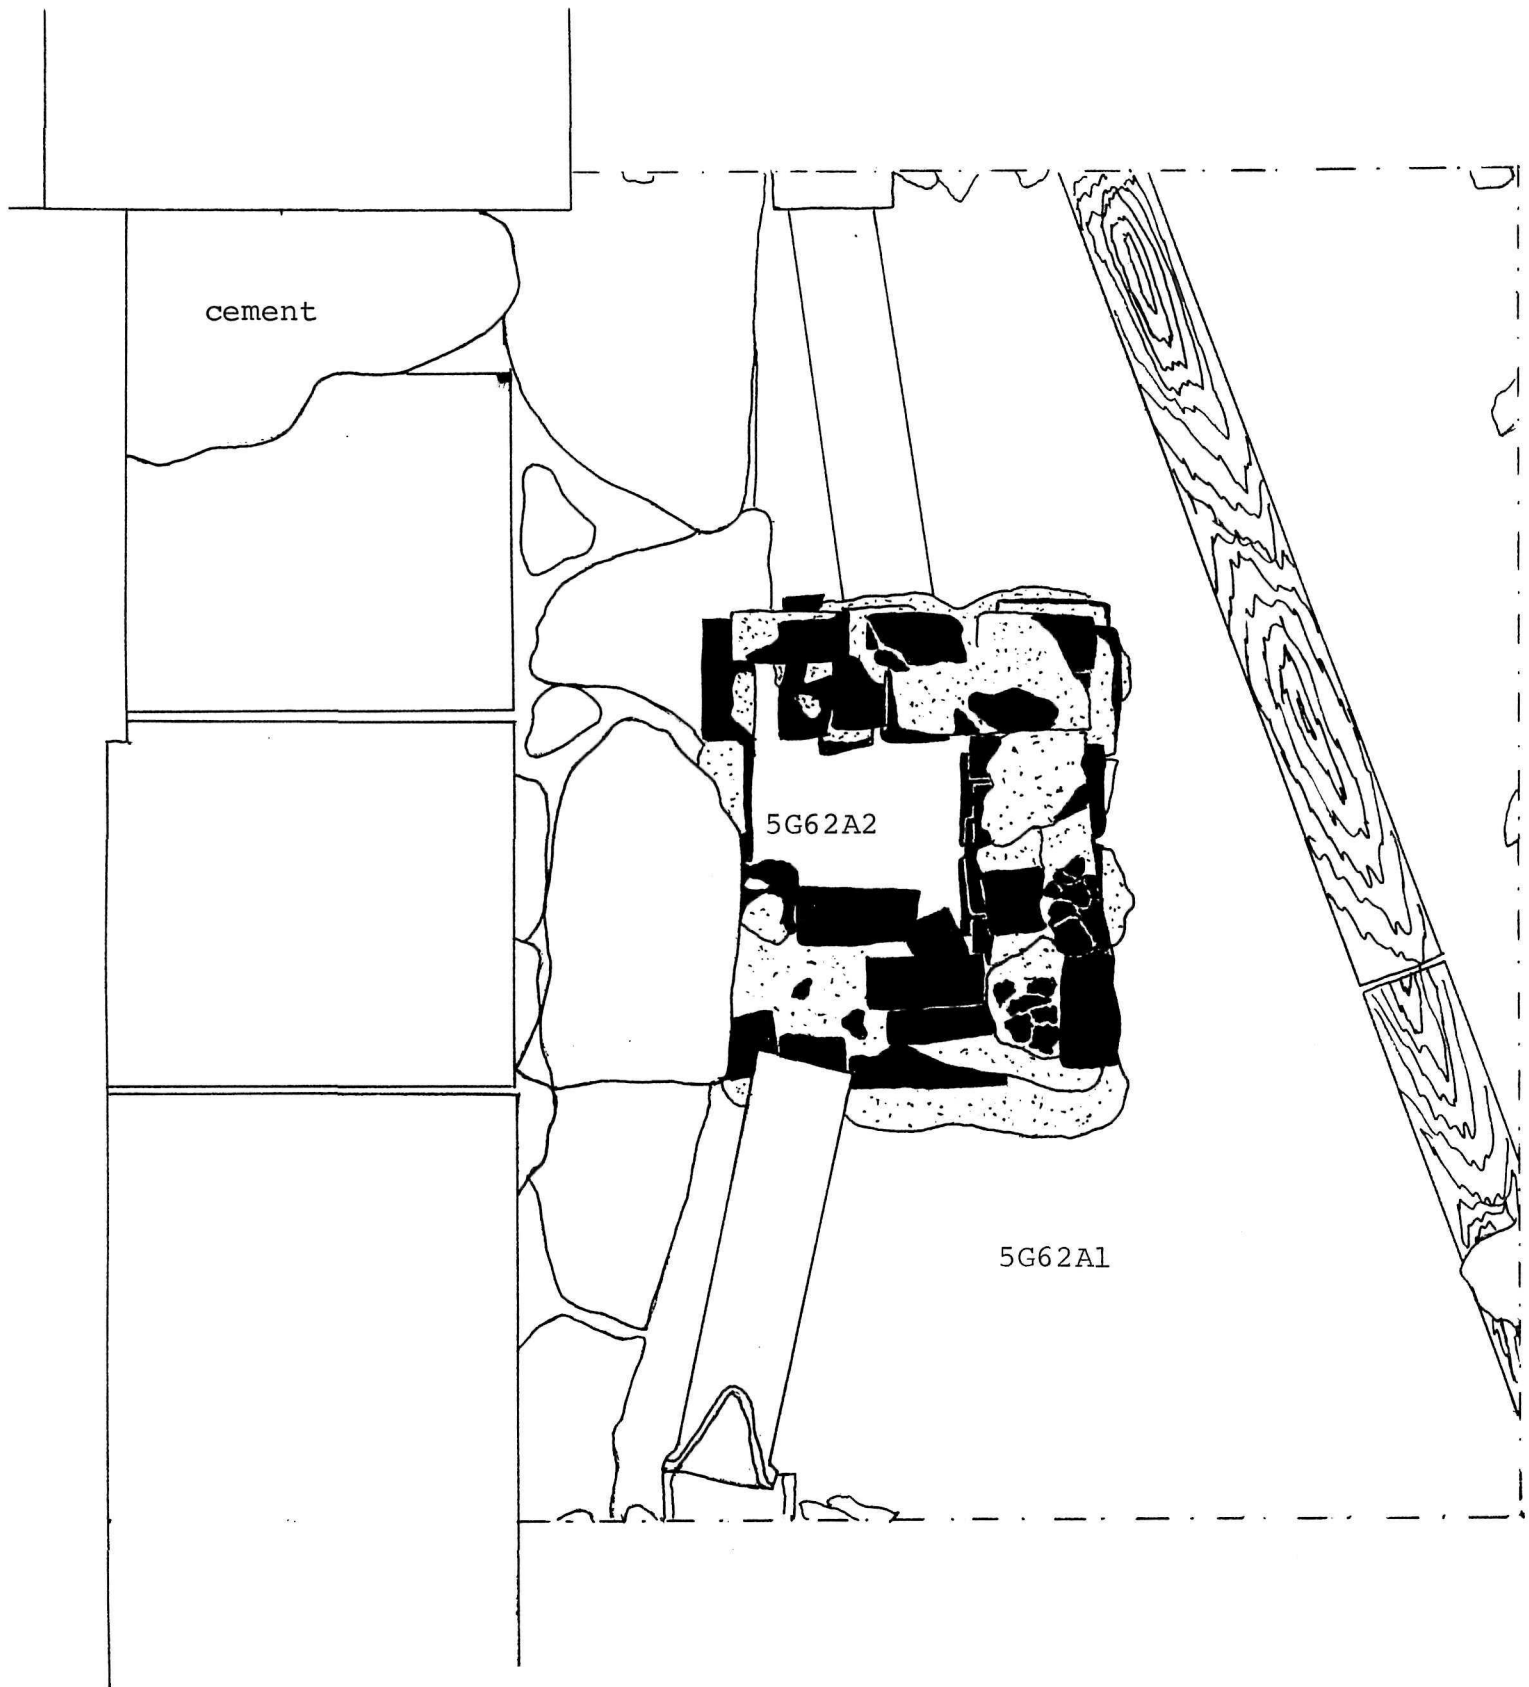
67-23-D16

Appendix II - f. View of northeast catch basin.

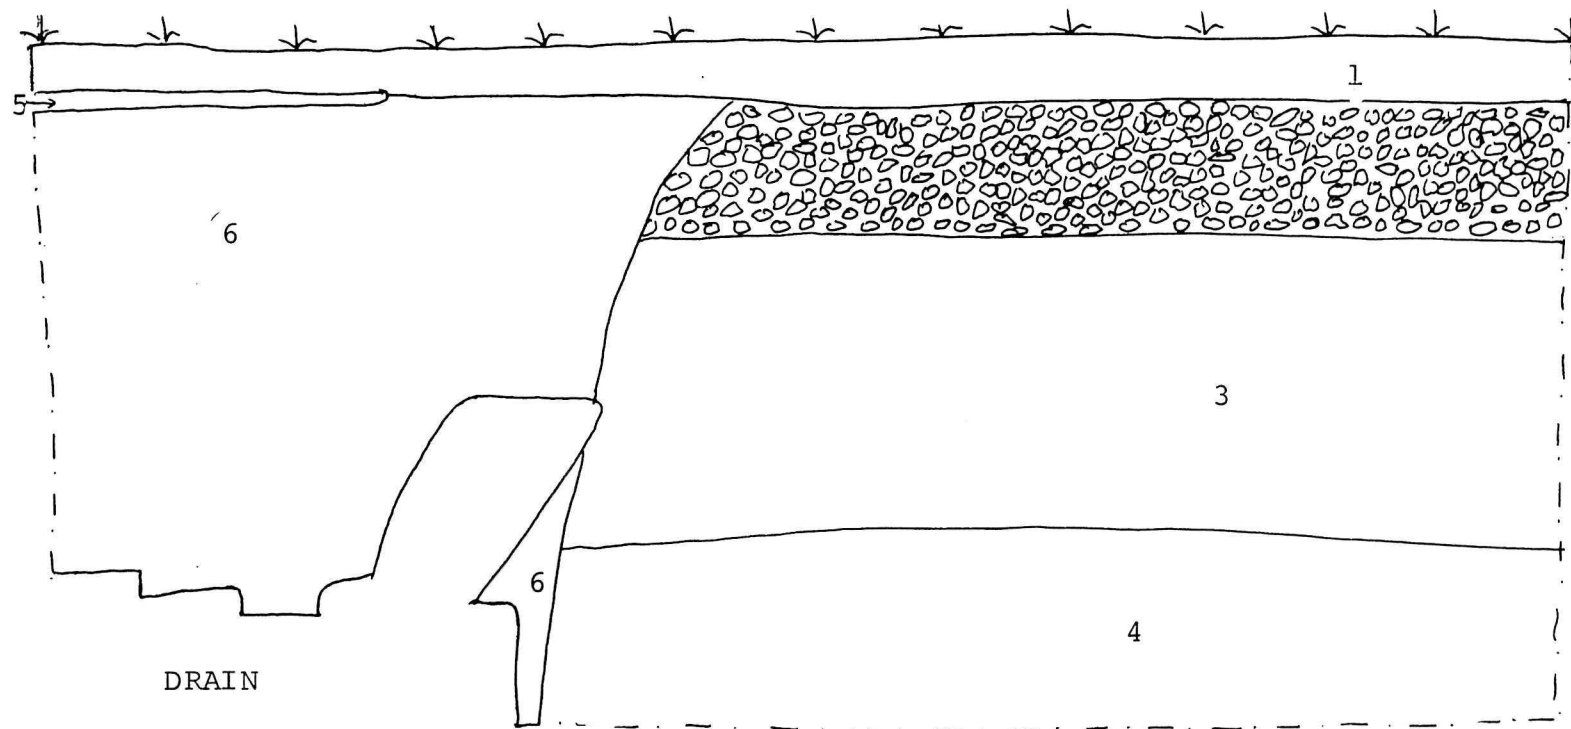
67-23-D31a

- 1 Very dark greyish brown loam (10 YR, 3/2)
- 2 Very dark greyish brown loam (10 YR, 3/2) / a heavy concentration of coarse gravel
- 3 Dark brown sand (10YR, 4/3)
- 4 Dark greyish brown sandy clay (10YR, 4/2)
- 5 Very dusky red ash (2.5 YR, 2/2)
- 6 A mixture of soil types # 1, 3 / 4.

5G63A - West Wall of Sone Feature

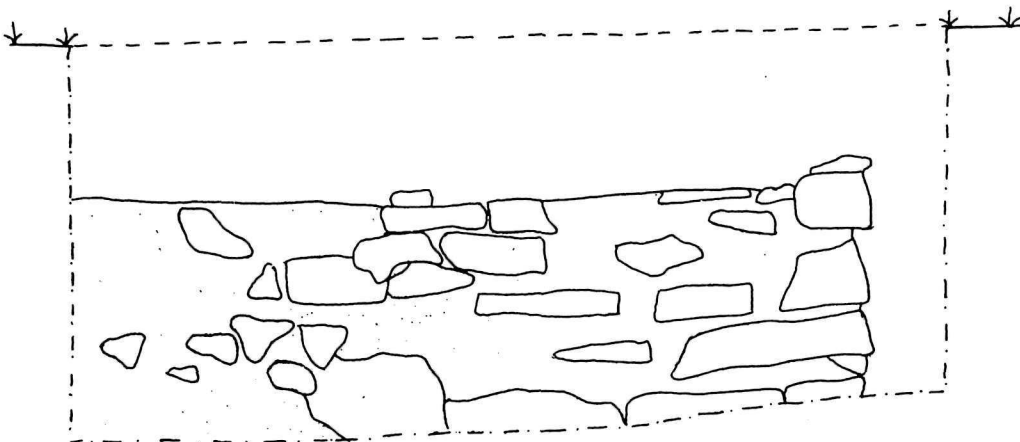
67-23-D31b

5G63A-South Wall of Stone Feature

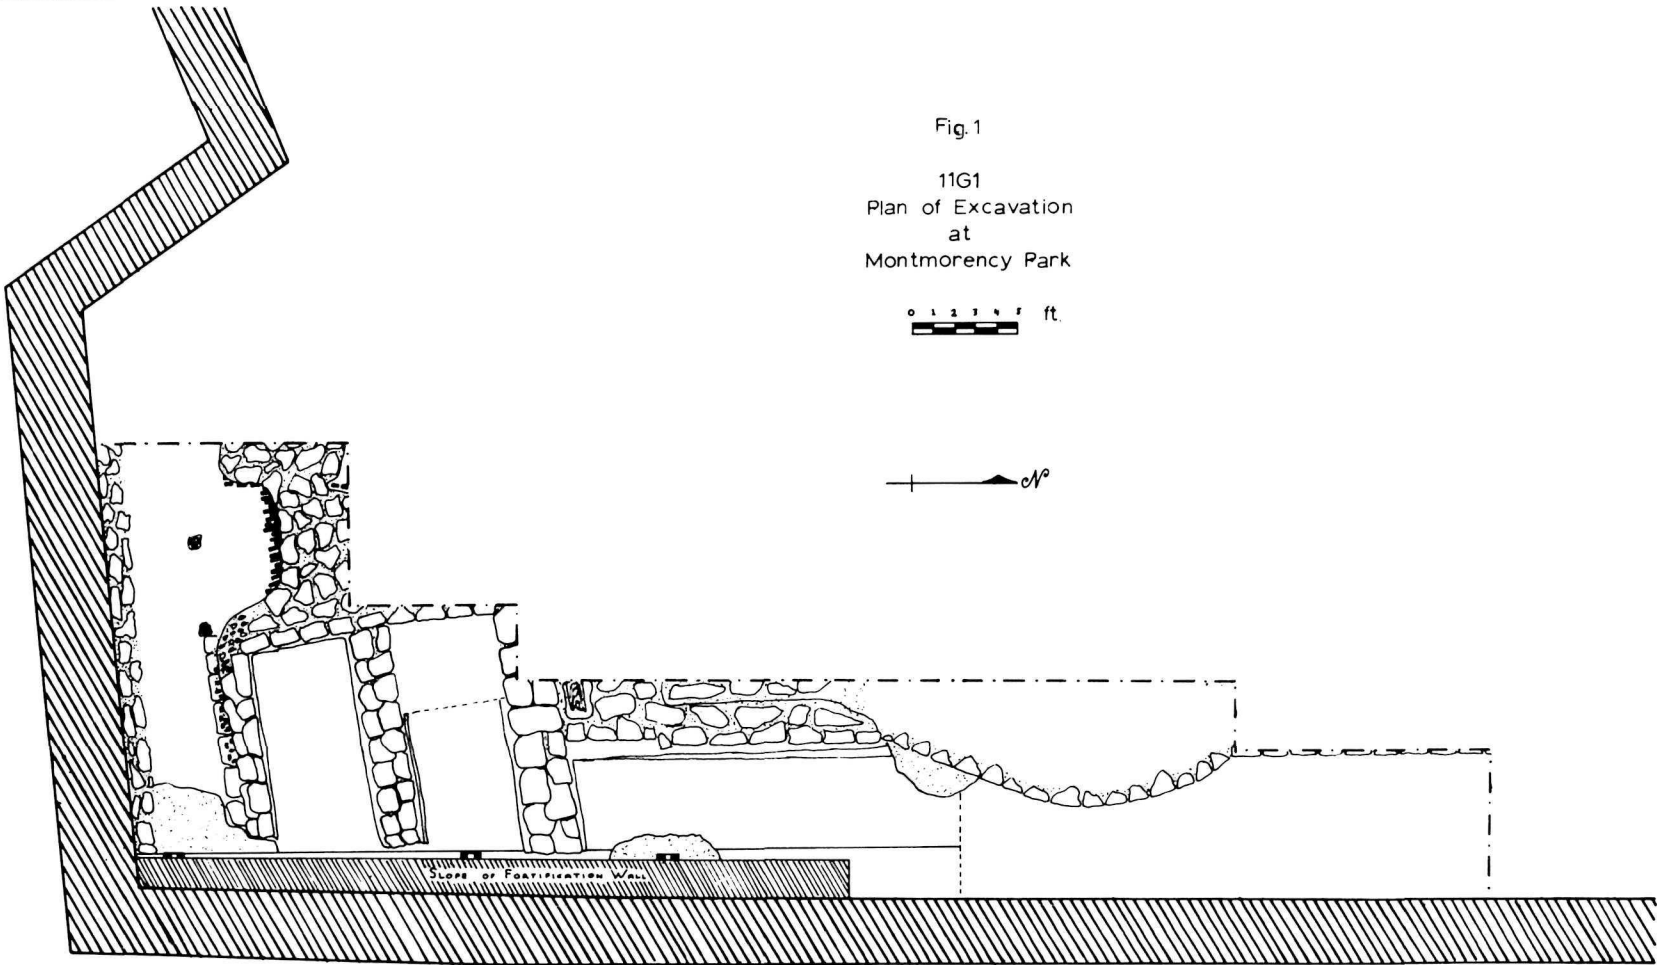
Fig. 1

11G1
Plan of Excavation
at
Montmorency Park

The curved wall covers a linear distance of 17.0' and a curved distance of 19.2'. The curve of the wall is somewhat pear shaped (Fig. 1), which virtually rules out the possibility of it being part of a traversing gun platform, since these are generally semi-circular in shape. Hence, its function remains a mystery - even more so after examining its unorthodox construction for this particular area.

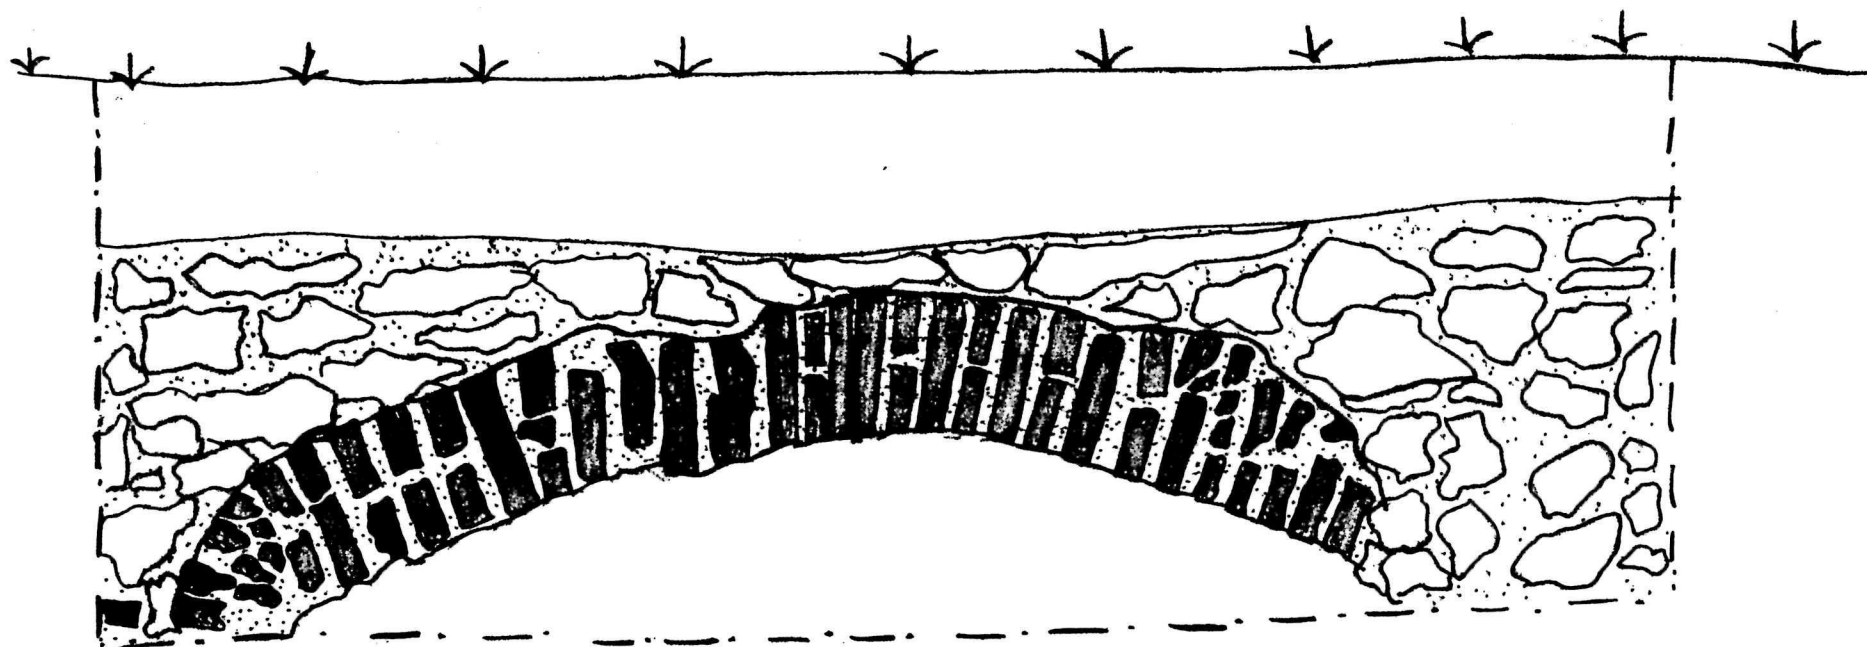
Fig. 3 View of the brick ceiling
of the casemate and the stone slabs
on top. Scale: 1" = 1'. Facing W.

bricks are arranged in alternating rows of horizontal and vertical bricks in a north-south pattern. A fragile yellowish mortar was used to cement the bricks together. The brick vault was 0.75' thick and covered with shale and stone slabs, again joined with mortar. Like the three east-west walls, a thin layer of mortar (max. 0.02' thick) covered these stones in order to make the entire area level for the gun platform on top. Thus the stone slab and mortar layer attains a maximum thickness of 0.3' directly over the keystone of the ceiling, and 1.75' over the two sides. (Fig. 3)
