NATIONAL HISTORIC PARKS
AND SITES BRANCH

MANUSCRIPT REPORT NUMBER
TRAVAIL INÉDIT NUMÉRO **133**

1967 SALVAGE EXCAVATION AT
FORT LENNOX, ILE-AUX NOIX

SALVAGE EXCAVATIONS AT
MONTMORENCY PARK, QUEBEC CITY: 1967-1968

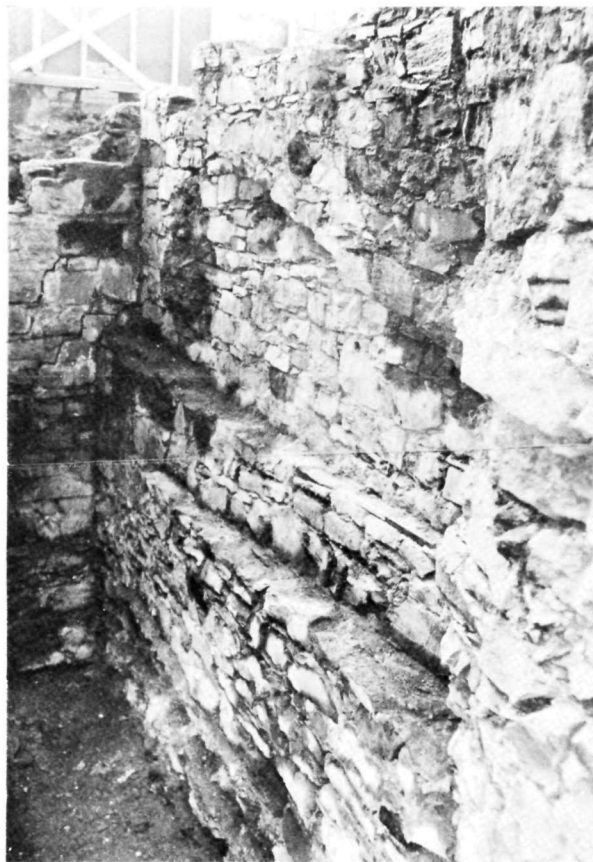
Fig 5

11G1D: View of ledges along the
base of the stone ramp. 2' scale
Facing southwest. 11G-103 & 104-X

Two ledges, or foundation extensions, exist on this wall. However, these ledges differ from those of the east-west walls in that they both taper, and, as a combination, form a straight wall (Fig. 5). The uppermost ledge, located at 124.2' A.S.L., extends from Wall No. 3 to the curved wall. At its south end it is 1.0' wide and from there it tapers to 0.2' at the north end. The lower ledge, located 1.5' below the upper one, starts 1.7' north of Wall No. 3 and it too continues to

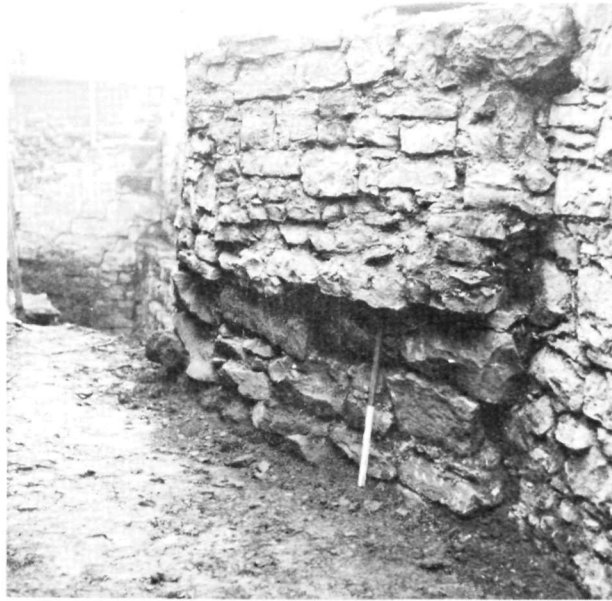
Fig. 6: View of north face of curved stone wall, facing southwest. 2' scale
11G-102-X

Below this well constructed portion of the wall (i.e. from 127.5' A.S.L. to 124.0' A.S.L.) the wall becomes highly irregular and leaves the smooth face of the top section, (Fig. 6). The stones are quite large - averaging 2.0' by 0.9' as compared with 1.5' by 0.3' or 0.9' by 0.2' in the top section. It is not known whether the wall continues in this fashion all the way down to the base, as excavation ceased at 124.0' A.S.L. However, a small portion of the south end of the curved wall was excavated for an additional 3.0' and here the stones become smaller again, ranging in size from 0.6' by 0.1' to 1.2' by 0.7'.

Both the north and south extremities of the curved wall have a jagged ending and do not appear to have ever been constructed with straight vertical corners (Fig. 6). This irregularity suggests that the straight wall was broken down or collapsed in this area and

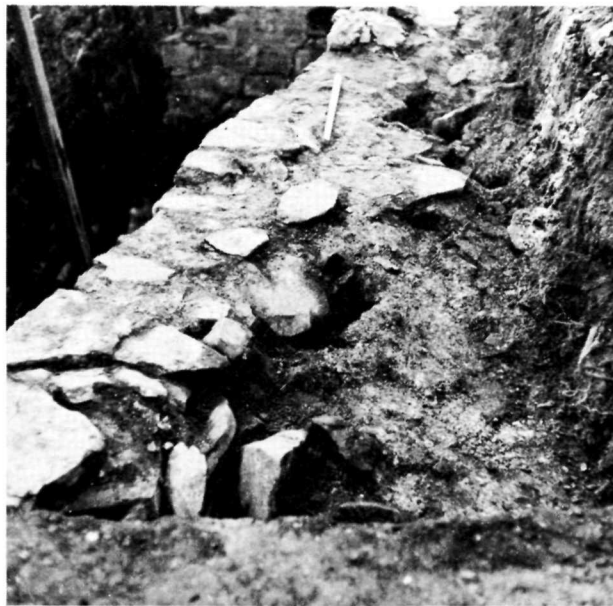
Fig. 7: View of the west face of the curved stone wall showing damaged area. Facing south. 2' scale. 11G-100-X

About $1/3$ of the area west of this wall was also excavated for a few inches, to determine where the west face of this wall was located. However, all that was revealed was a highly damaged west face of this wall (in somewhat the same condition as the south face of Wall No. 1). (Fig. 7.) Rubble and soil was all that was found in this area, besides the first apparently undisturbed stratigraphic layer of the site. Hence artifacts from this location may be useful later on, whereas artifacts from the rest of the excavation consist of a mixture of old French and British and modern pieces throughout.

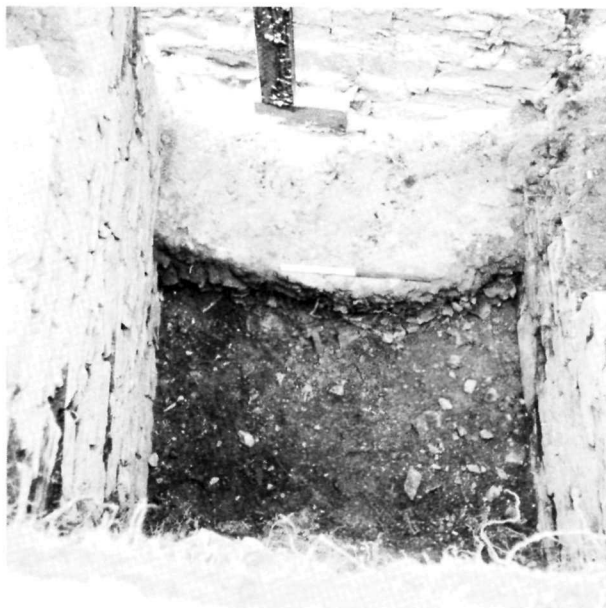
Fig. 8: View of cement layer between
Walls # 2 and 3, facing east. 2' scale
11G-78-X

The final feature of this excavation concerns a group of three concrete layers - concave in shape - which were attached to the east Fortification Wall. One layer was located between the southeast corner of the bastion and Wall No. 2. It covered part of Wall No. 1 and had a cut stone drain at its lowest point (123.2' A.S.L.) which led into an opening in the east Fortification Wall. The second layer was located between Walls 2 and 3, and this one had the cut stone drain at 123.0' A.S.L. (Fig. 8.) The third section lay north of Wall No. 3, with the drain located at 122.7' A.S.L. (Fig. 9). In all cases the layer of concrete was approximately 3.0' wide, from 0.2' to 0.3' thick and gradually sloped down to the Fortification Wall in a cone shape. They apparently served to remove excess water from the park as well as prevent such water from damaging the foundation wall below.

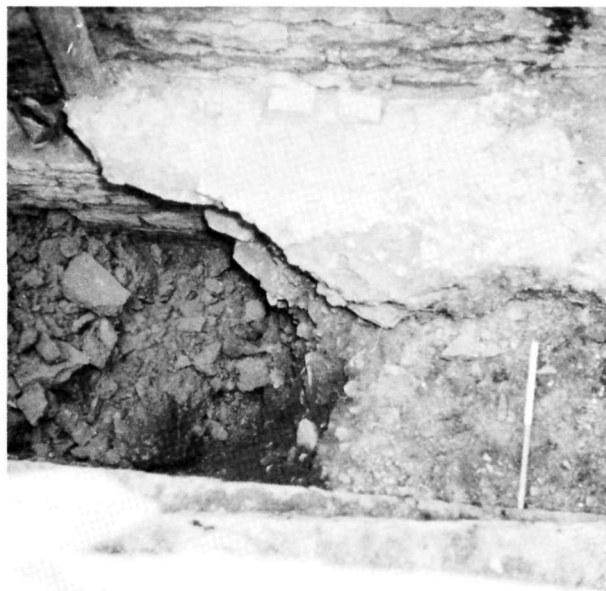
Fig. 9: View of cement layer north
of Wall # 3 plus cut stone drain at
base of depression. 2' scale, Facing
east. **11G-85-X**

- Fig. 1 - Plan of the Excavation.
- Fig. 2 - Drawing of the north face of Wall # 3 showing
overhang over the Fortification foundation wall.
- Fig. 3 - Drawing of the brick casemate ceiling and the
stone slabs above it.
- Fig. 4 - View of possible Gun Platforms in the southeast
bastion.
- Fig. 5 - Photo of the ledges along the base of the stone
ramp.
- Fig. 6 - Photo of the north face of the curved stone wall.
- Fig. 7 - Photo of the damaged west face of the curved
stone wall.
- Fig. 8 - Photo of the cement layer between Walls # 2 and 3.
- Fig. 9 - Photo of the cement layer between Wall # 3 and the
recess in the sloping Fortification Wall.
