ARCHAEOLOGICAL INVESTIGATIONS AT THE
COACH-HOUSE SITE, BELLEVUE HOUSE NHP,
KINGSTON, ONTARIO

by Philip E. Gerrard

Gerrard & Hossack Restoration Consultants

1981

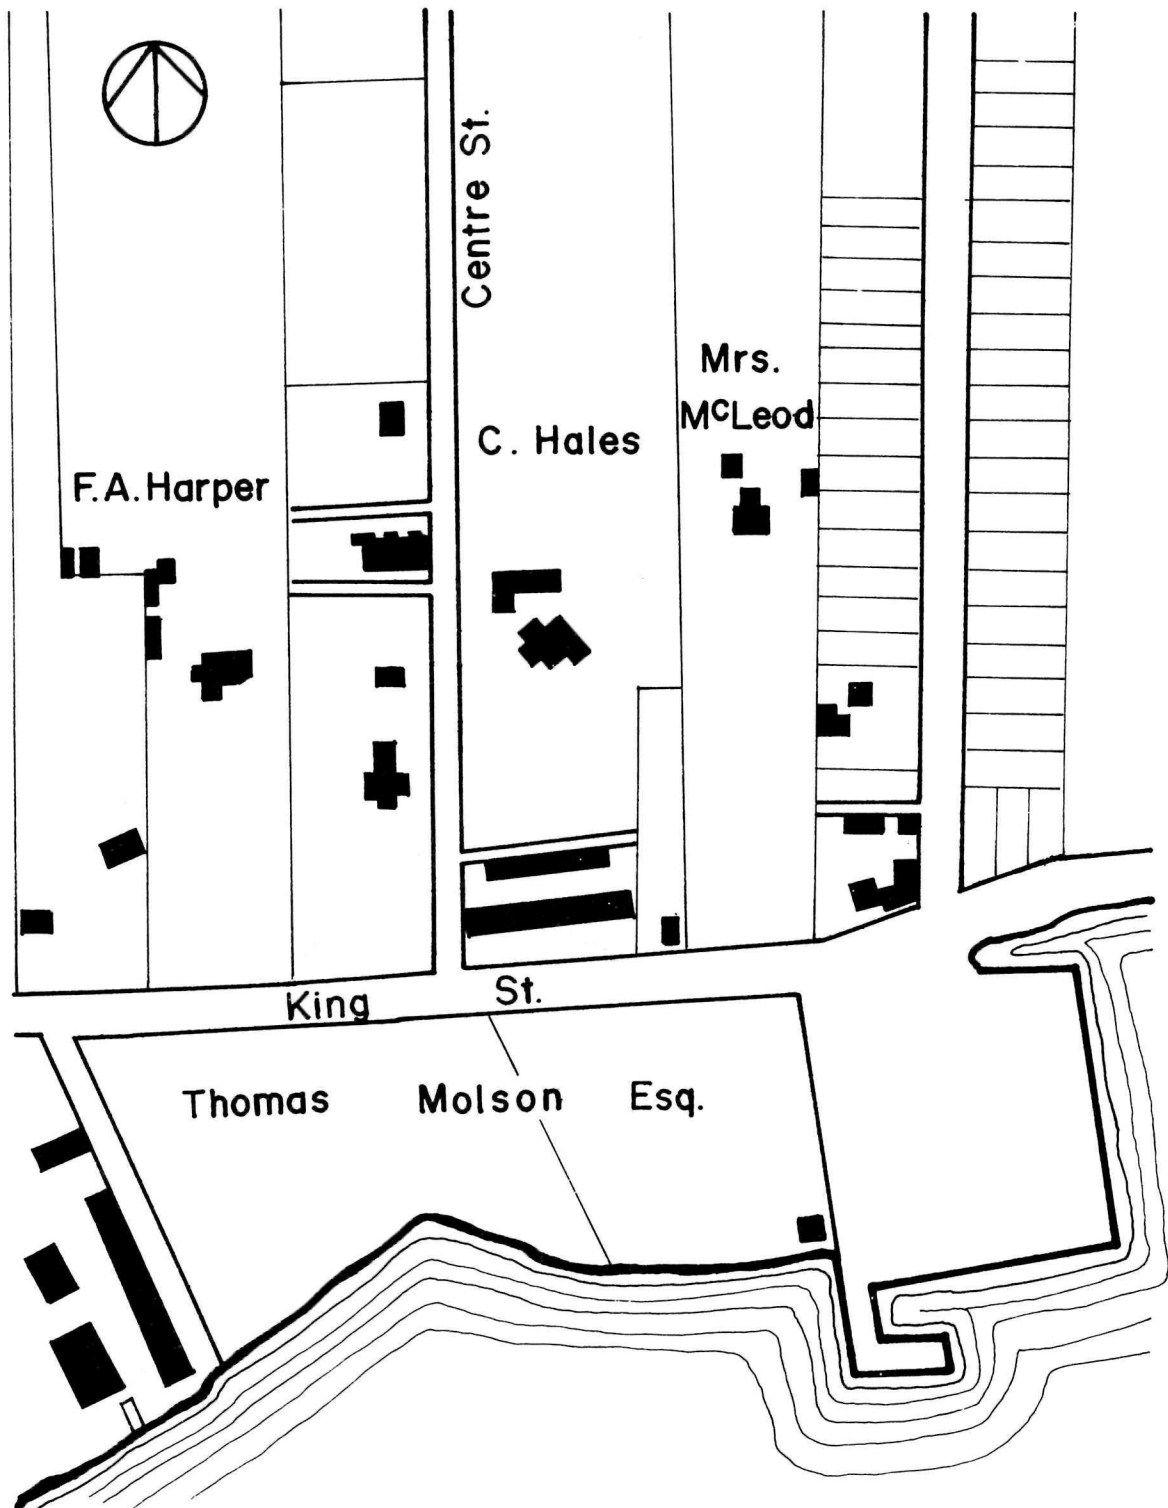
1850 SURVEY PLAN

Figure 1 "Plan of the City and Liberties of Kingston", dated 1850, by Thos. Eraser Gibbs showing Bellevue (C. Hales property). The north wing is not shown on the L-shaped coach-house. (Douglas Library, Queens University). Re-drawn by D. Shouldice.

The coach-house was built in conjunction with Bellevue House and therefore could date to as early as c.1840. The first historical documentation of the structure does not occur until 1850 (Figure 1). The building stood until c.1955 when it was demolished for the construction of a house (the present administration building).

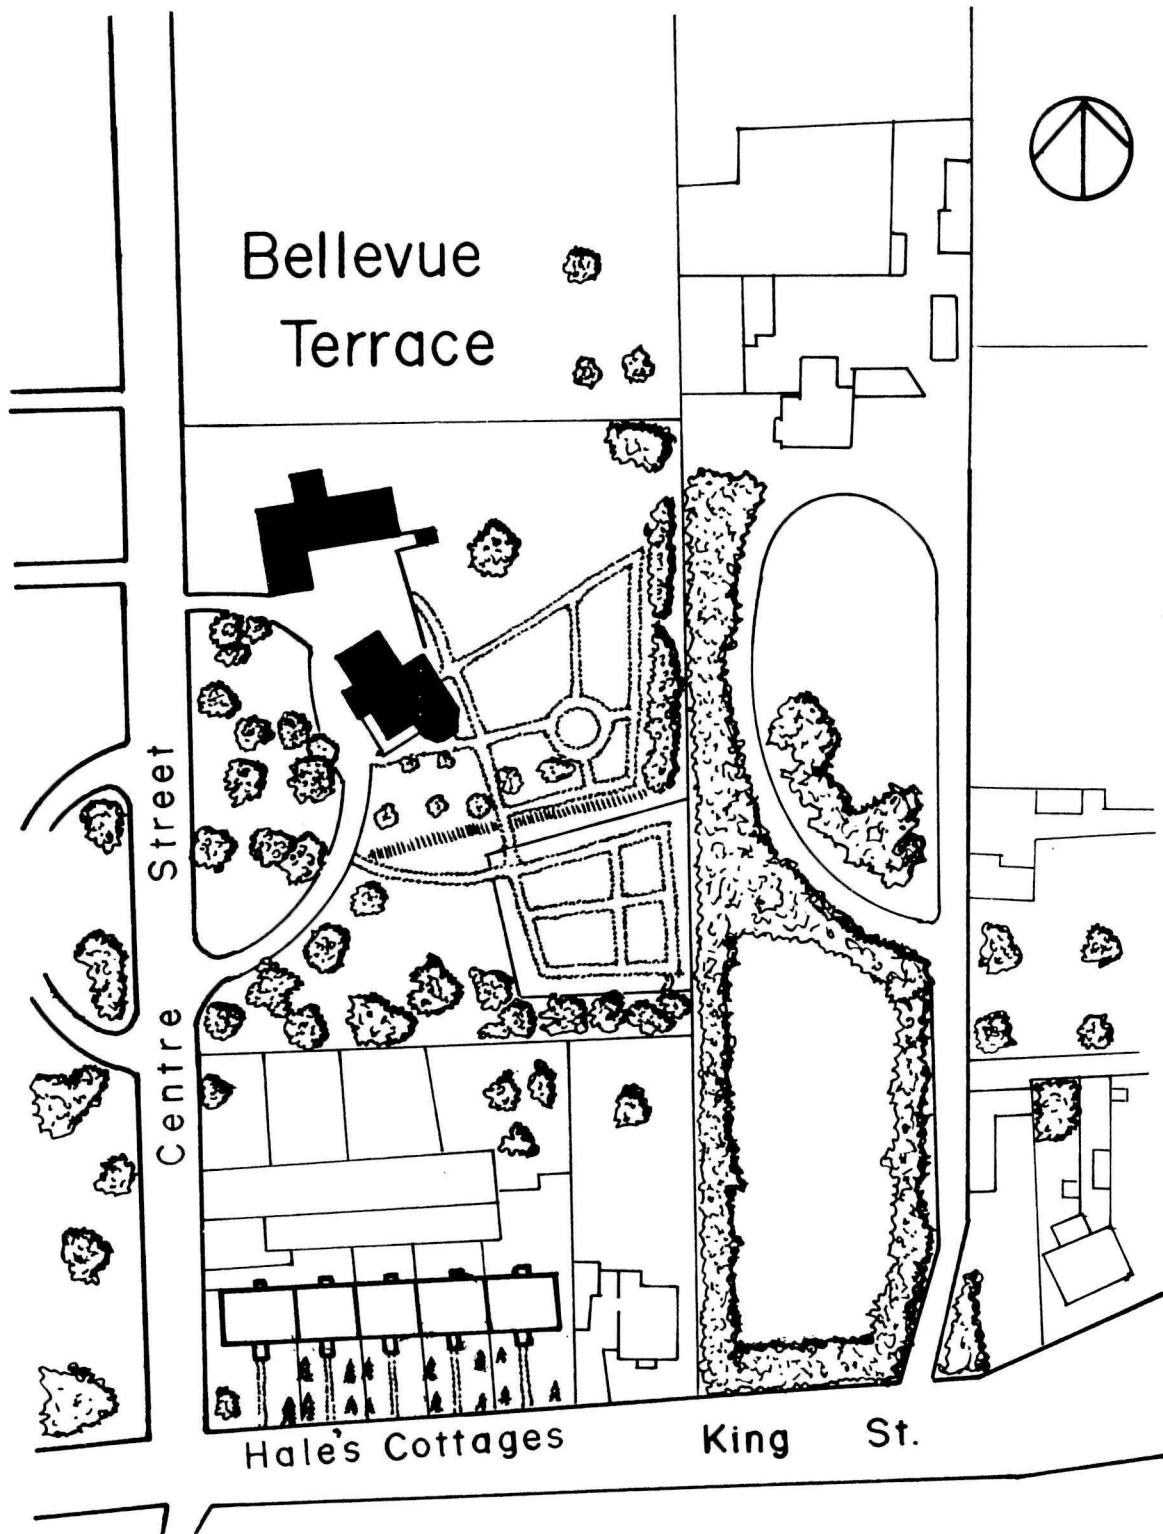
1869 FORTIFICATIONS PLAN

Figure 2 "Plan of Kingston and its environs", dated 1869, by Lieut. H.S. Sitwell showing Bellevue House, its grounds and the coach-house. The north wing is shown attached to the L-shaped coach-house. (Public Archives of Canada). Re-drawn by D. Shouldice.

The location of the privy and the fence between it and Bellevue House can be re-evaluated in light of the findings of this report. The historic documentation (Figure 2) shows the fence located from one corner of Bellevue House to the south-east corner of the coach-house. The existing fence

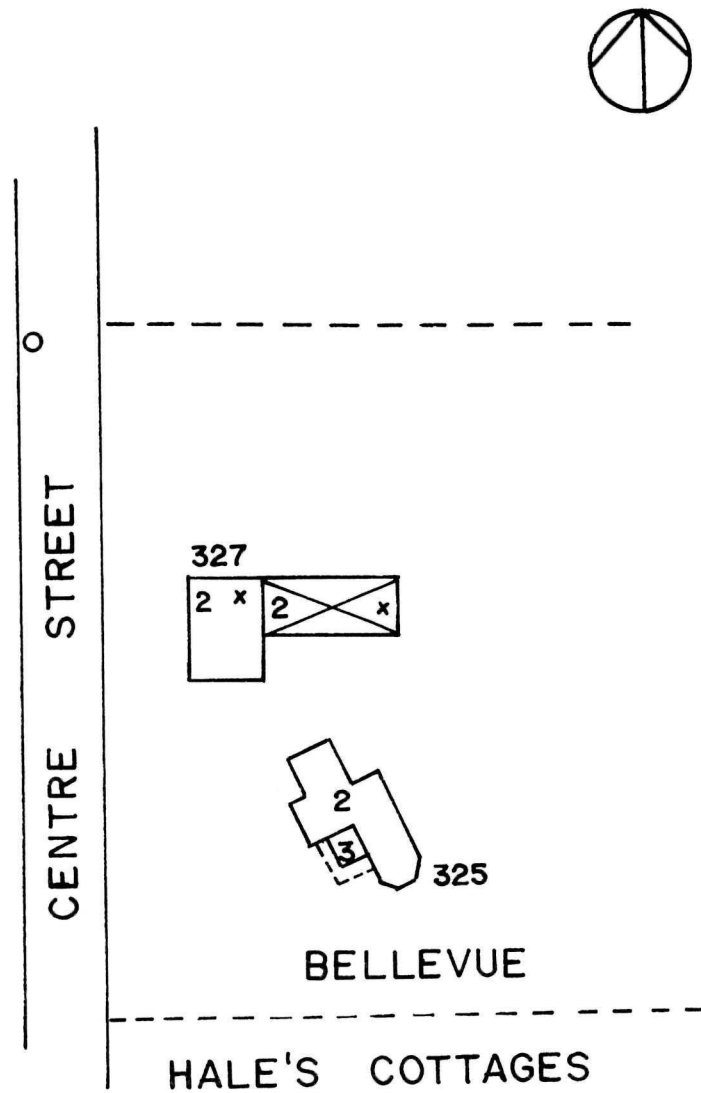
1908 FIRE INSURANCE PLAN

Figure 3 Kingston Insurance Plan, dated 1908. The legend on the original indicates that both structures are stone masonry. The coach-house is two storeys (2) with a wood or wood shingle roof (x). The diagonal cross through the east half of the building indicates that it is a stable. Re-drawn by D. Shouldice.

It is also possible that the main portion of the coach-house was built in two different sections. The 1908 Insurance Plan (Figure 3) indicated that the east and west ends of the building had two separate functions. These functions were undoubtedly carried over from the nineteenth century and may possibly date back to the time of construction of the building. In that case, the coach-house may have been built in two parts at two different times to accomodate two distinct functions.

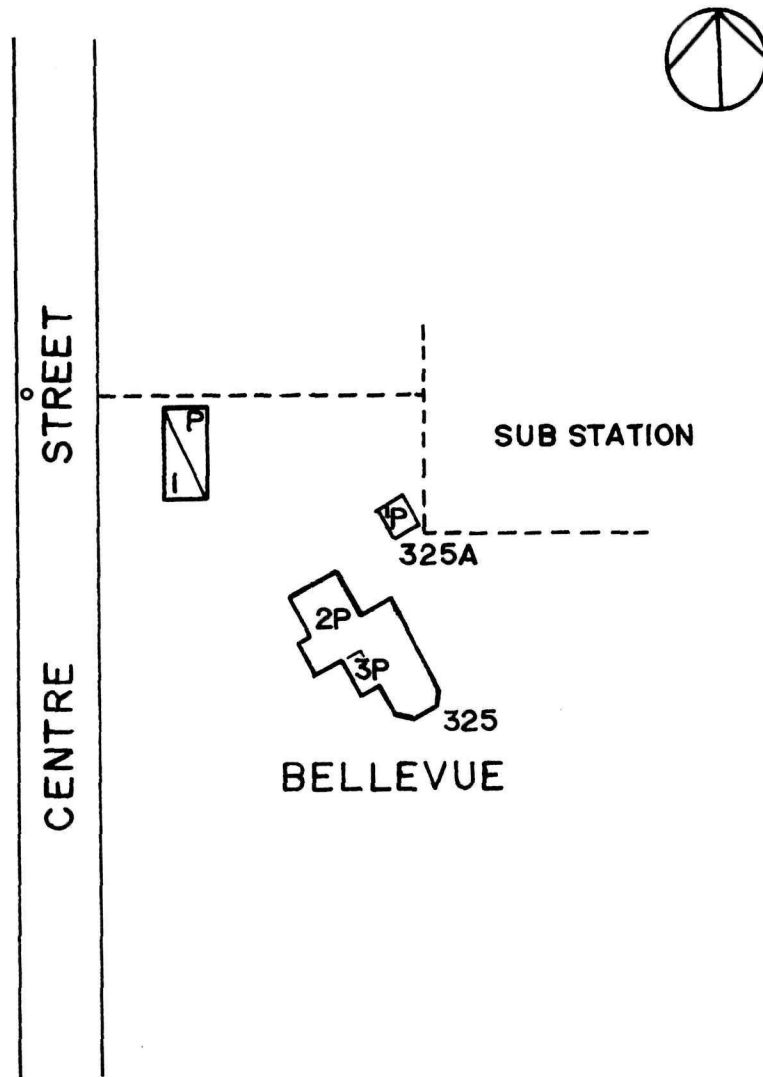
1963 FIRE INSURANCE PLAN

Figure 4 Kingston Insurance Plan, dated 1963. The coach-house has been demolished and the administration building bungalow has been built on part of the site. There is also a small unidentified building on the property near the Sub-station. Re-drawn by D. Shouldice.

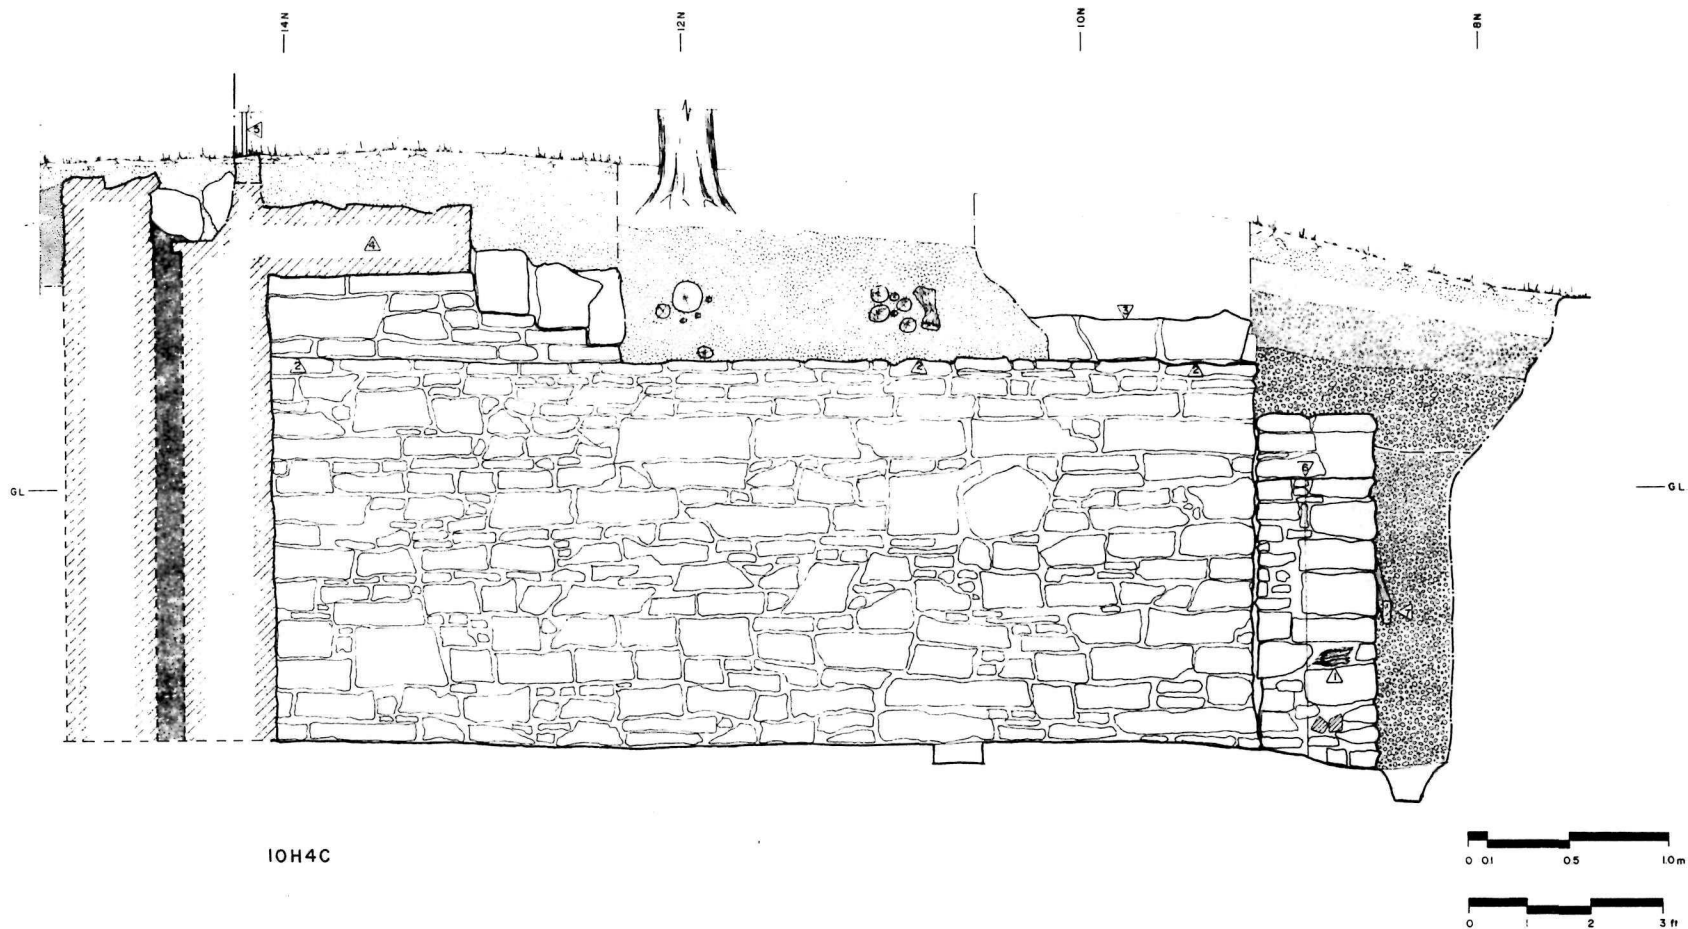
Figure 11

GERRARD & HOSSACK BUILDING RESTORATION CONSULTANTS	<div>1. WOOD SET IN MORTAR</div> <div>2. TOP OF WALL</div> <div>3. SPRINGER LINE FOR VAULT</div> <div>4. SECTION THROUGH VAULT</div> <div>5. WIRE FENCE</div>	<div>6. LOCATION OF ORIGINAL DOOR FRAME</div> <div>7. WOOD</div>	<div>LEGEND</div> <div><div></div> MORTAR</div> <div><div></div> BRICK</div> <div><div></div> WOOD</div> <div><div></div> CAVITY BETWEEN MASONRY WALLS</div> <div><div></div> BEDROCK IN SECTION</div> <div><div></div> GRID LINE</div> <div>GL</div>	Site: BELLEVUE NHP COACH - HOUSE ARCHAEOLOGY	Dwg. Title: 10H4C EAST PROFILE	
					Scale: 1:10	Date: FEB 81
					Drawn: D.E.S.	Checked:

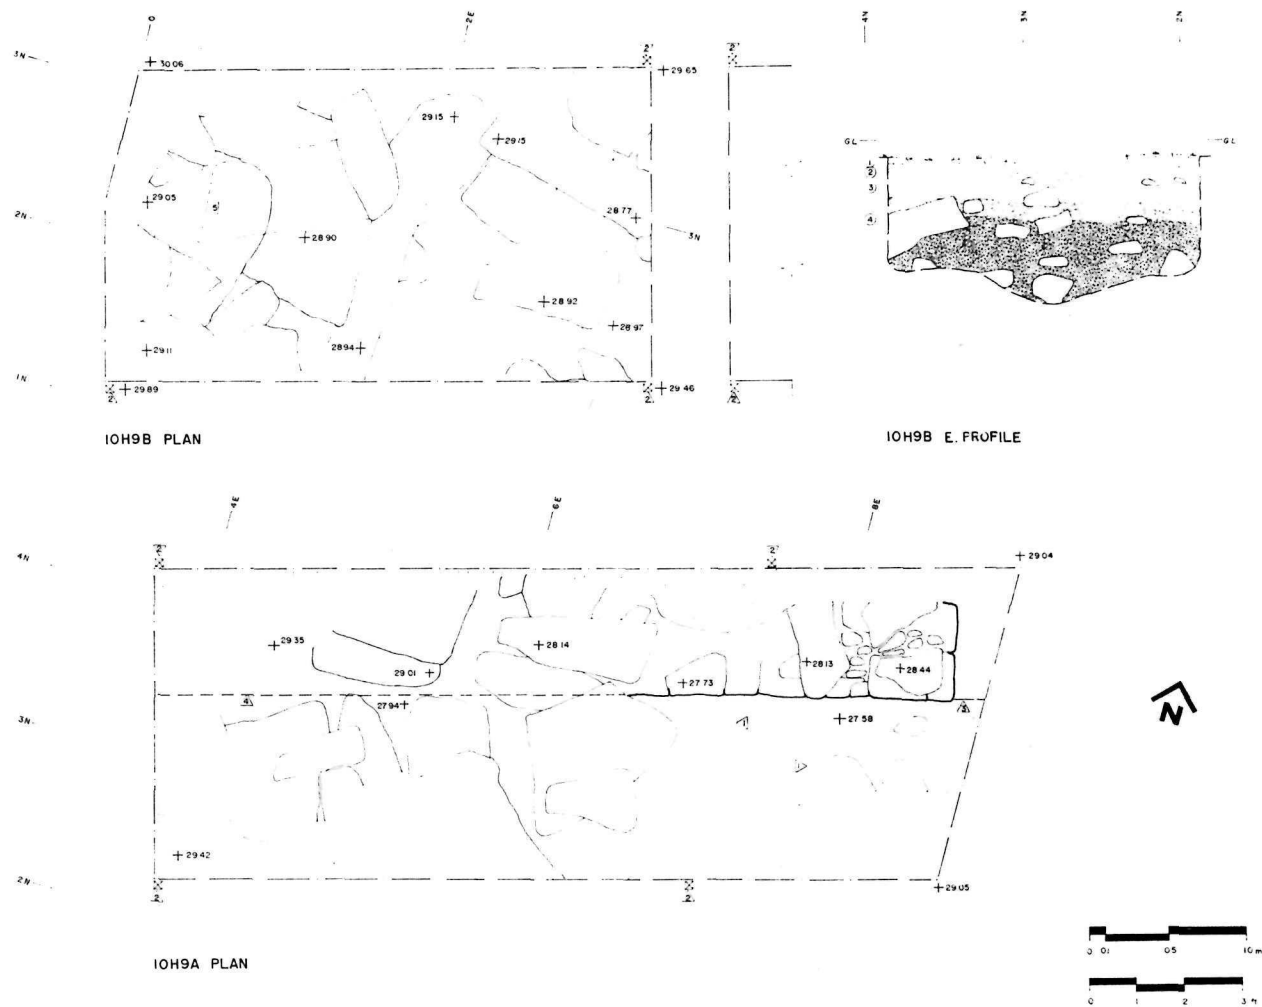
Figure 23

GERRARD & HOSSACK RESTORATION CONSULTANTS	NOTES		LEGEND	Site BELLEVUE NHP COACH-HOUSE ARCHAEOLOGY	Swg Title IOH9A, 9B PLAN, EAST PROFILE	
	1. POSITION OF REMOVED BULKHEAD	5. DOTTED LINE REPRESENTS ORIGINAL POSITION OF ROCK			Scale PLAN 91	Drawn Checked
	2. FILL STAKES		GL. MORTAR GRID LINE			
	3. DOOR SILL					
	4. PROJECTED EXTERIOR FACE OF WALL					
	5. ROCK LIFTED TO VERTICAL POSITION

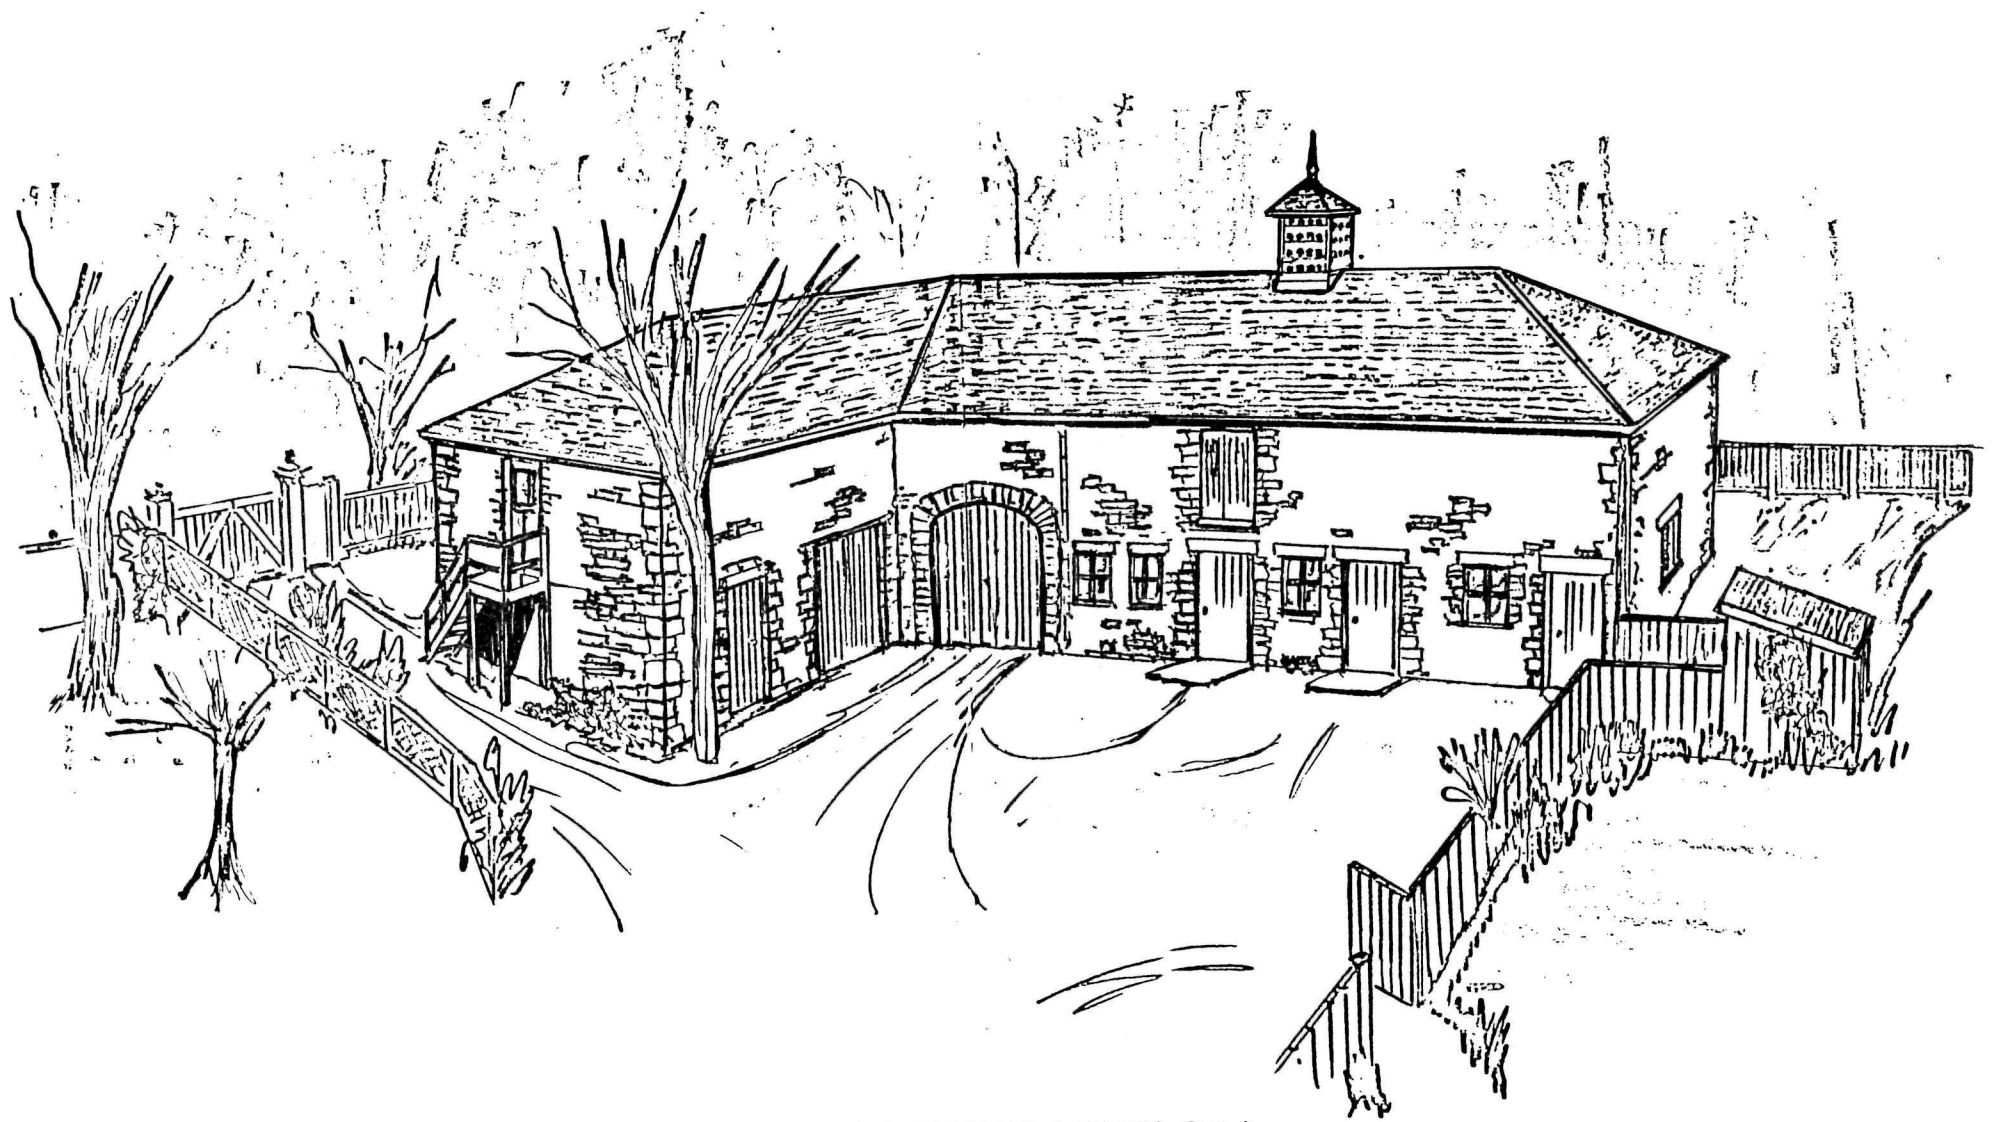
COACH-HOUSE RECONSTRUCTION

Figure 27 Reconstruction of Coach-house showing the south and east facades (Dixon 1969: 36).

Mr. Gordier also seemed to remember that the roof-line of the west end of the coach-house was a gable-end type as opposed to the hip type roof as shown in Figure 27 (Dixon 1969: 36).

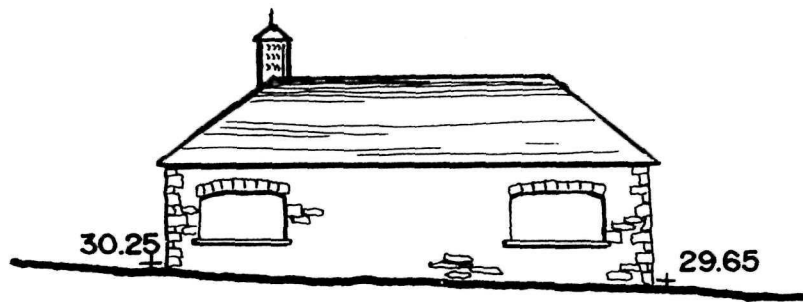
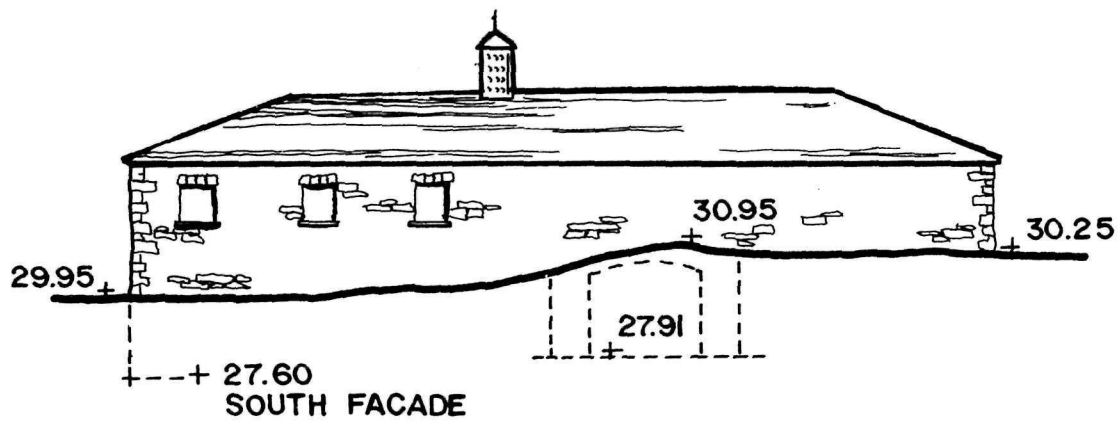
COACH-HOUSE RECONSTRUCTION

Figure 28 Reconstruction of Coach-house showing the north and west facades as described by a local resident (W. Gordier pers. com., 28 Nov. 1980). The geodetic elevations indicate the early grade levels. Drawn by D. Shouldice.

WEST ELEVATION
1:200

NORTH ELEVATION
1:200

WINDOW SIZE &
LOCATION CONJECTURED

Additional details concerning the north and west facades of the coach-house were provided in an interview with Mr. W. Gordier (pers. com., 28 Nov. 1980). According to this source the north side of the building had three or four "normal" size windows in the second storey level (this was grade level on that side of the building). The west (Centre Street) facade of the coach-house had two very wide and low windows. The heads of these two windows were slightly arched (Figure 28). However, these statements are in conflict with some of the existing documentation (Evans 1979: 6).

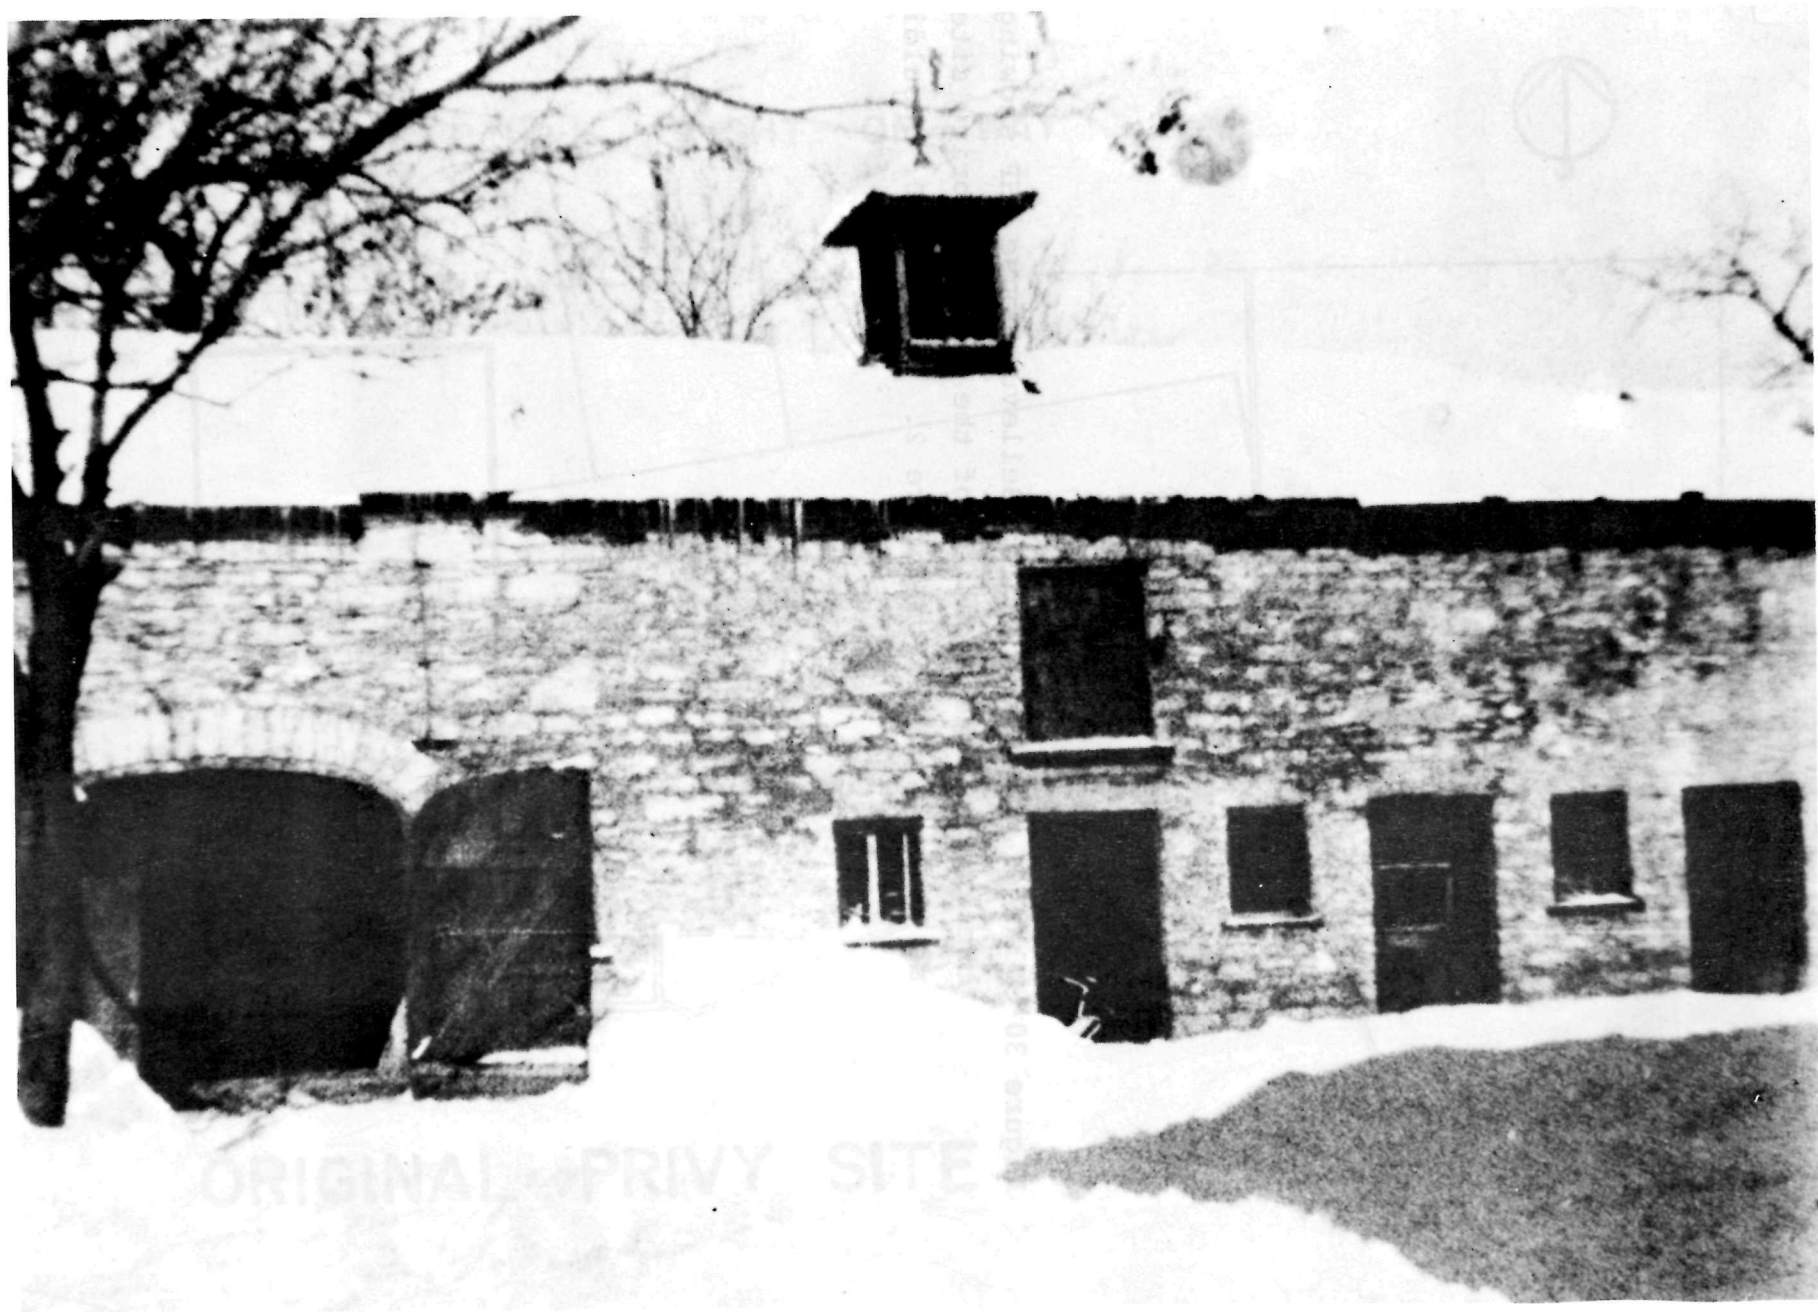
Figure 29 View of the south facade of the coach-house.
(Original photograph owned by D. Attack of Kingston).

A door at the second storey level (Figure 29) probably serviced a hay loft. The position of the doorway in the photograph could indicate that such a loft extended across the entire east end of the building (above the stall area).

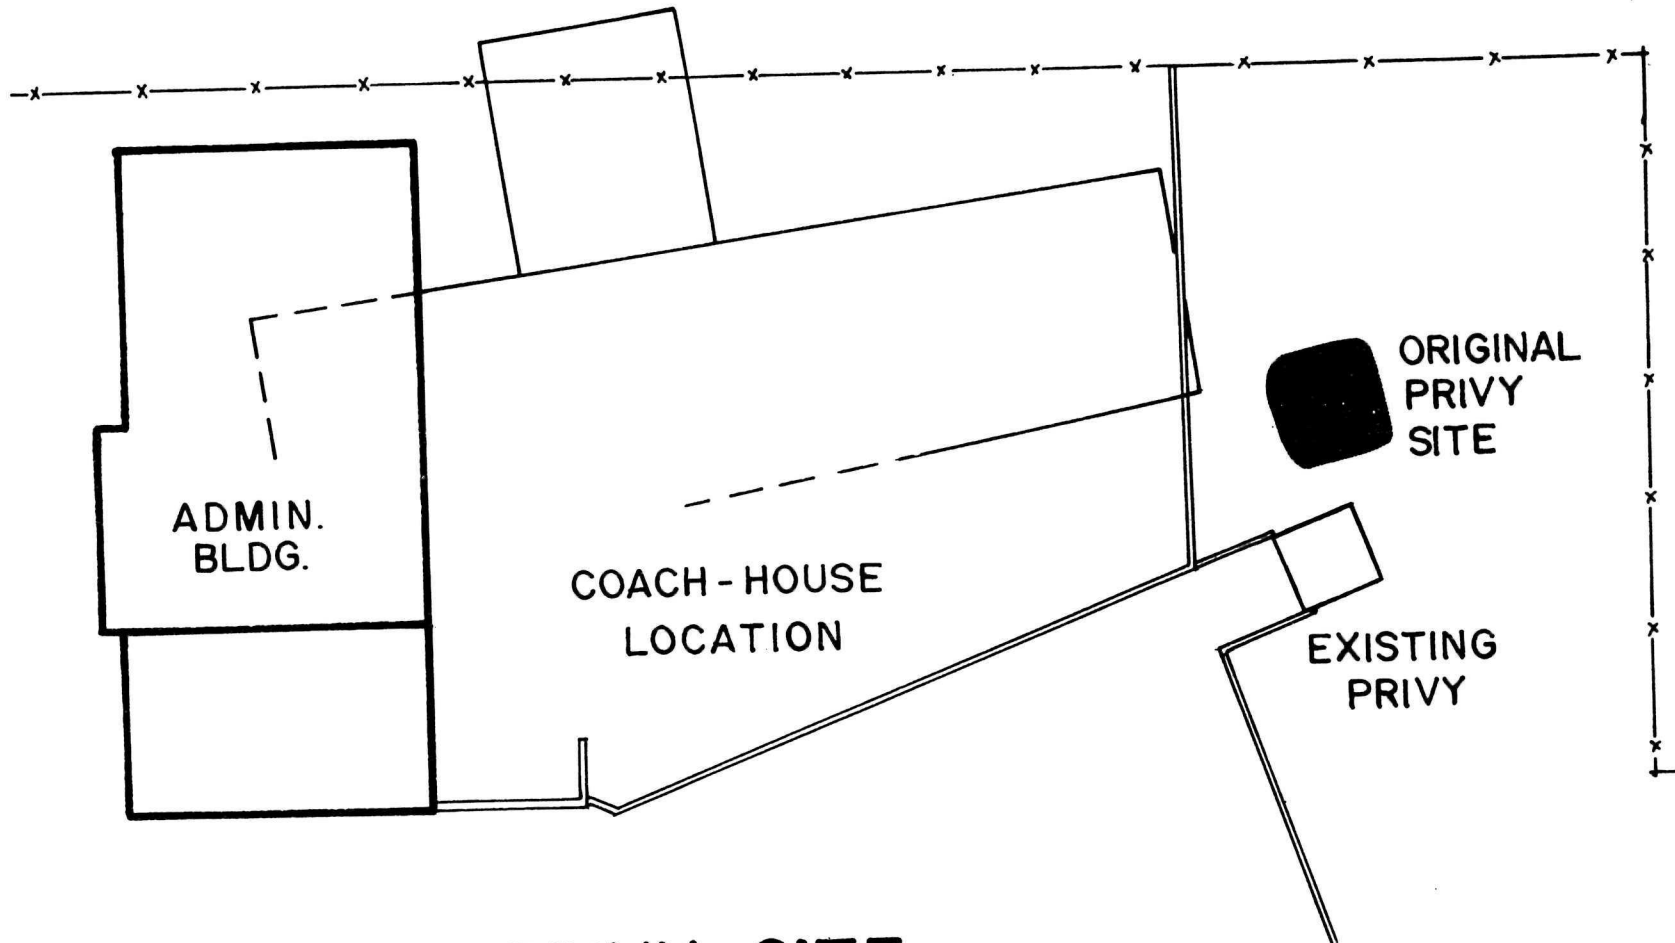
ORIGINAL PRIVY SITE

Figure 30 Plan of the north end of Bellevue House NHP showing the approximate location of the original privy site as extrapolated from Figure 2. Drawn by D. Shouldice.

does not follow this line exactly and it is not tied into the corner of the coach-house. However, more important than that, is the location of the privy. The original privy was in a direct line with the south face of the coach-house. Therefore, it would be located to the north-east of the existing (reconstructed) privy. Interpretation of the historic documentation indicates that the site of the original privy is still on the Bellevue House property (Figure 30). In view of the fact that most of this important component should still be intact, it is strongly recommended that this area be handled with the utmost sensitivity to the potential archaeological resources and should ultimately be excavated.
