RESEARCH BULLETIN

No. 151

York Factory National Historic Site Archaeology

Gary Adams

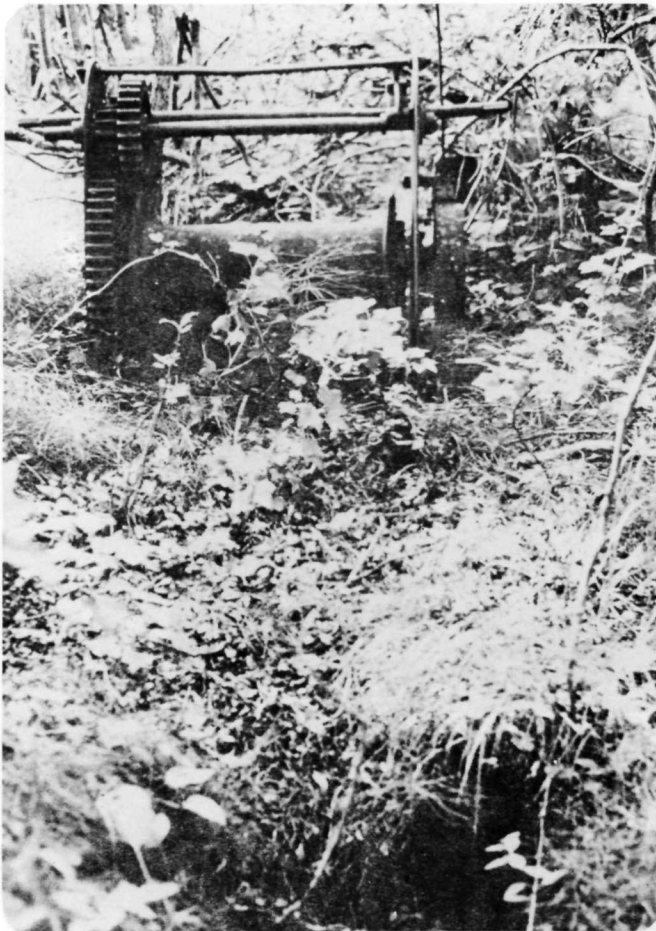
Figure 1. Winch at drydock, as seen from drydock (Photo by G. Adams).

A survey of the drydock was also conducted although dense bush and lack of proper instruments precluded a detailed survey. However, a general description of the feature was provided. The drydock was an excavated trench that inclined from the beach to the level of the land. It was about 16 m wide and 8 m deep at the mouth and had three wooden tracks at the bottom that probably served as ramps. The remaining section was 30 m long with two anchored winches (Figure 1) and a deadman near the head of the trench (32.5 m from beach).

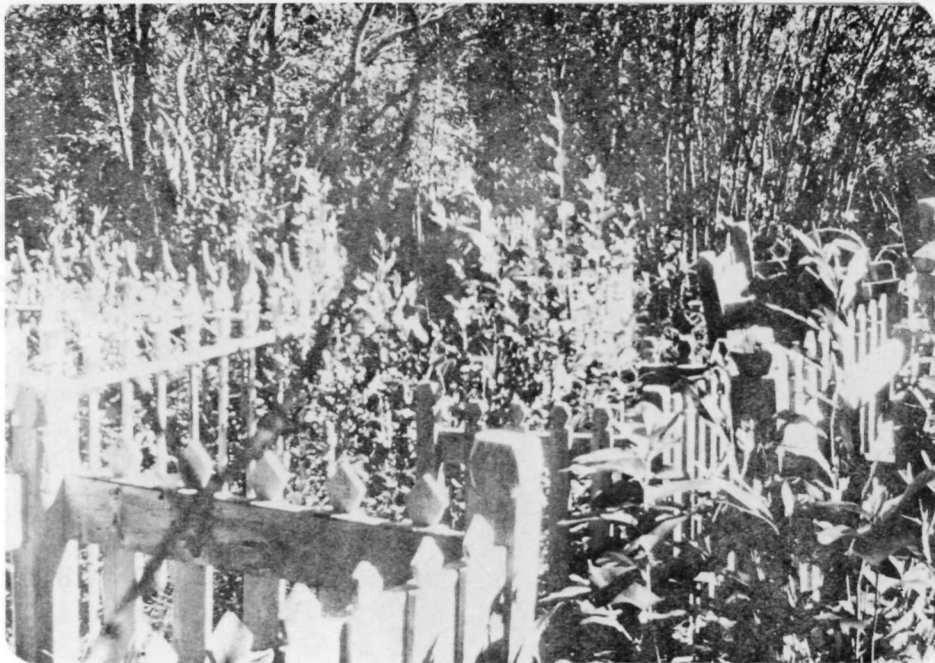
Figure 2. View of graves at York Factory (Photo by D. Tataryn).

The third area to be examined was at the graveyard. A total of 79 graves was inventoried. The relative location of each was recorded along with information on size, fence decoration, identification of interred individuals, grave orientation and condition. This survey mapped approximately two-thirds of the visible graves (Figure 2).

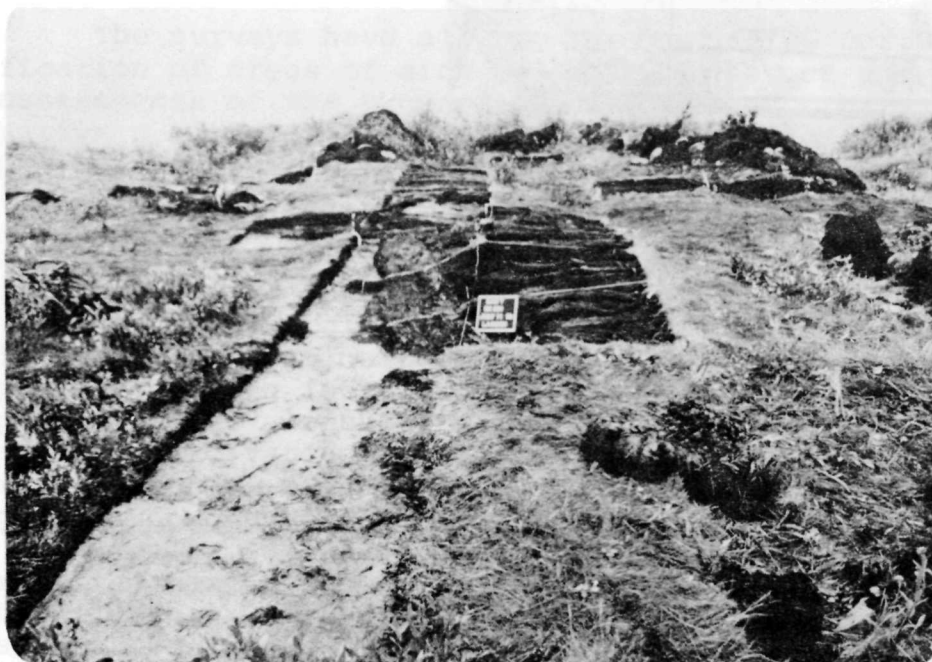
Figure 3. Boat ramp excavations, looking east
(Photo by G. Adams).

The ramp was constructed on four, parallel sill logs that lay in an east-west direction from the river. They were flattened on top and bottom, set about 2 m apart and sunk into prepared trenches. Over these logs were laid planks varying from 17 cm to 25 cm in width and from 5 cm to 12 cm in thickness (Figure 3). They were approximately 6 m long and the thicker planks were notched to fit over the logs. The overall length of the ramp was 13.9 m from the west end to the point where it was suspended upon pylons. Historic photos indicate that the suspended dock reached well out into the Hayes River.

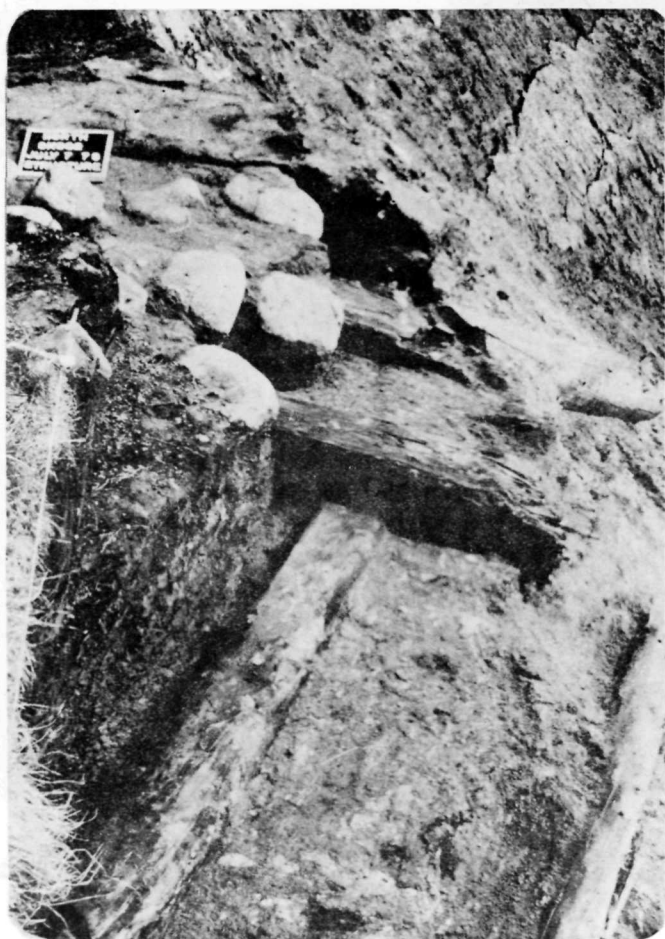
Figure 4. Unidentified log feature. It is shown here as partially excavated with some of the stone pile covering intact (Photo by G. Adams).

Operation 2 was conducted at an unidentified feature that was partially eroded. The feature itself consisted of four logs used to create some form of support system. A trench was excavated in the shape of a cross with one length paralleling the river. Each arm was about 390 cm long, 90 cm wide and 90 cm deep. Into each side were set two parallel logs, each approximately 320 cm long and 20 cm wide with a 30 cm gap between (Figure 4). Both ends of each log have been notched and one large nail was found in several notches.

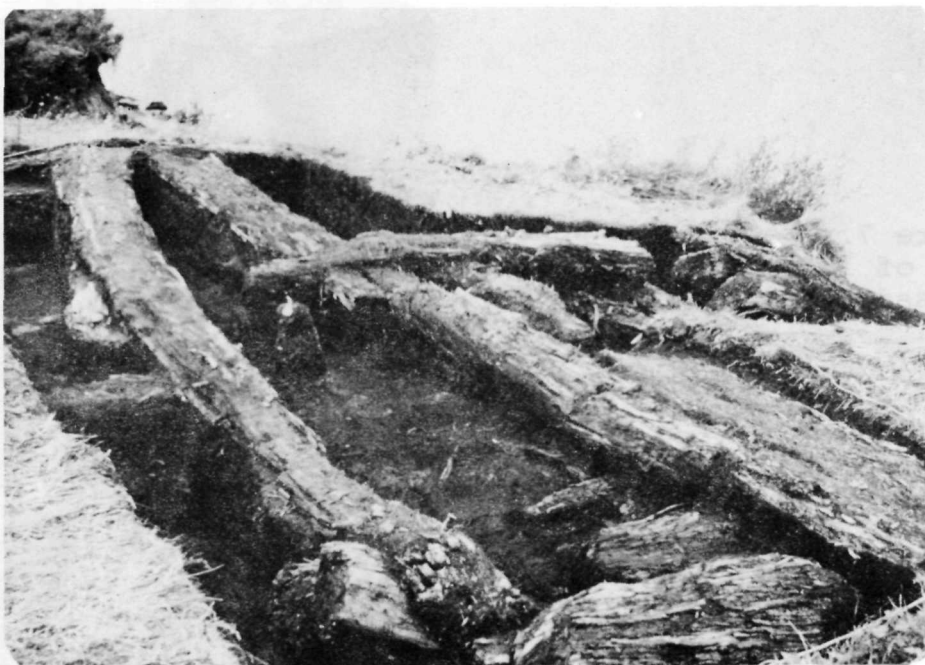
Figure 5. Portion of unidentified structure in Operation 5, looking north (Photo by G. Adams).

The second structure had only the west wall remaining so, precluding extensive documentation, very little could be noted about it. The overall length of the west wall appeared to be about 12 m with logs resting on large log sleepers. There was about 2 m of remains to the east of the wall so that the original length of the north-south wall was totally undefined. Most of the building was covered in a thick layer of wood chips, particularly at the north end (Figure 5).

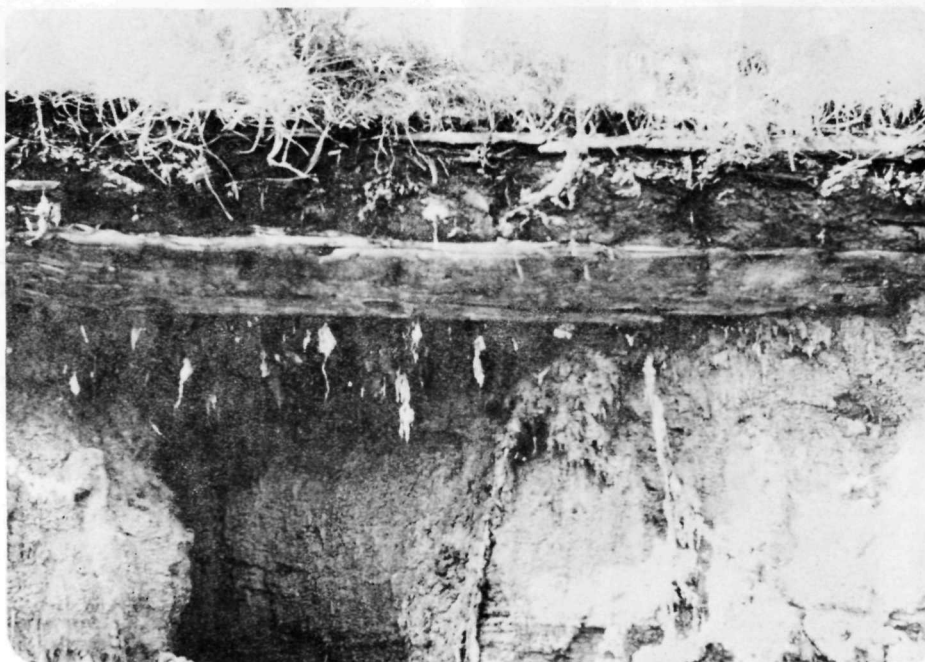
Figure 6. Collapsing section of boardwalk, looking west (Photo by J. Hamilton).

The artifact collection for Operation 6 occurred when about a 30 m length of boardwalk collapsed into the river, exposing some cannonballs and a few other small items (Figure 6). Operation 7 artifacts were collected from the mouth of a collapsed drain or ramp feature to the immediate north of the sawmills.

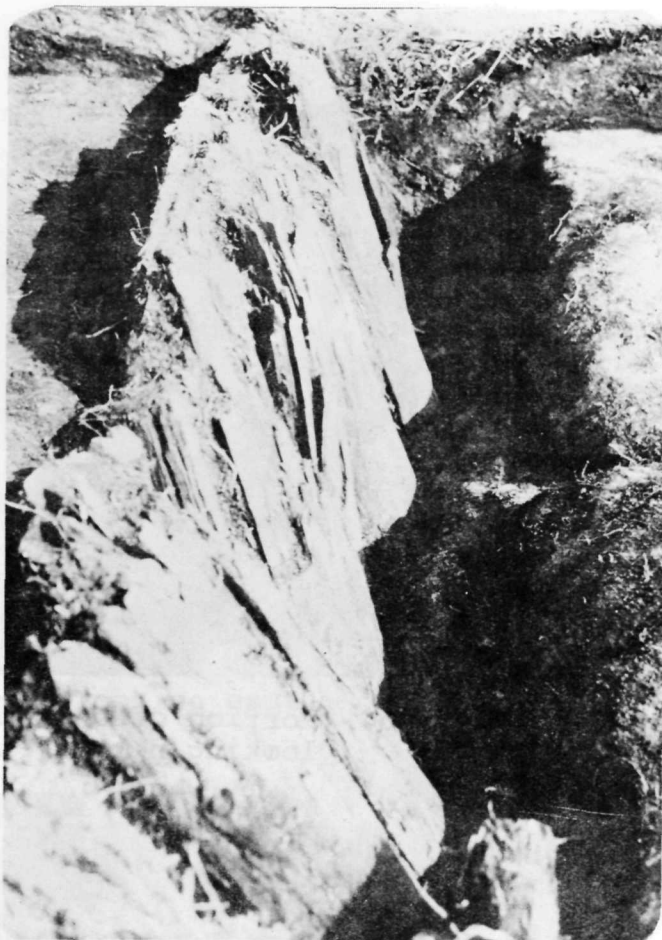
Figure 7. Section of south wall of 1830-1927 occupation palisade (Photo by G. Adams).

Operation 8 included 6 m² excavated to discern the nature of the eroding southeast corner of the York Factory palisade. The palisade was found to be constructed of round logs, set on end in a 40 cm deep trench. There was no sign of support posts in the area excavated (Figure 7).

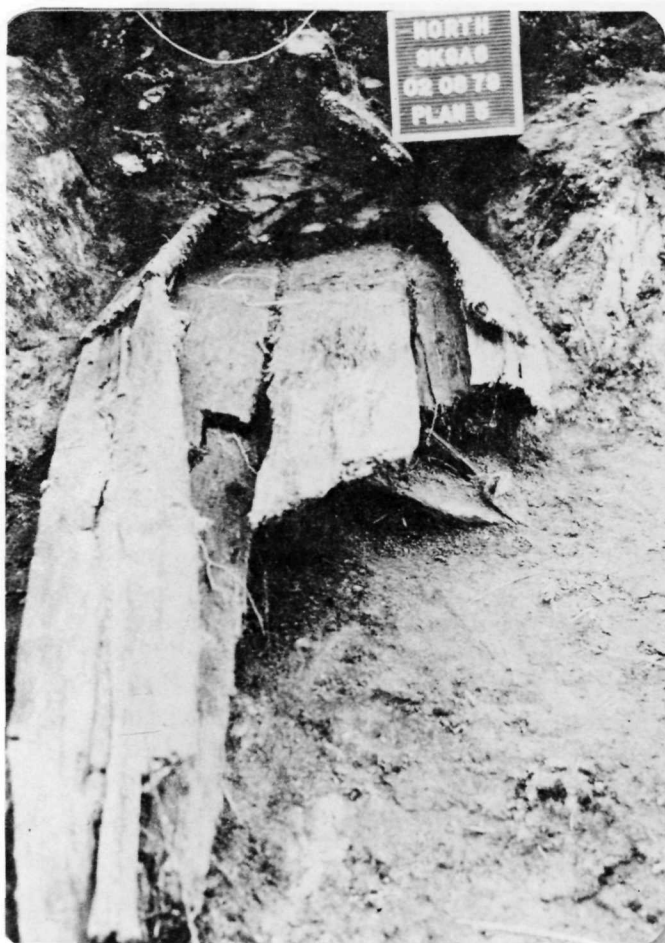
Figure 8. Collapsed south end of a drainage ditch (Photo by G. Adams).

Operation 9 was adjacent to Operation 8 and was excavated to identify an unknown feature which was eventually identified as a drainage ditch. This ditch ran north-south, just outside the palisade, and was wood encased. The south end of it has eroded into a gully (Figure 8).
