RESEARCH BULLETIN

No. 168

Archaeology at St. Andrew's Rectory, 1980*

Peter J. Priess, Prairie Region, Winnipeg

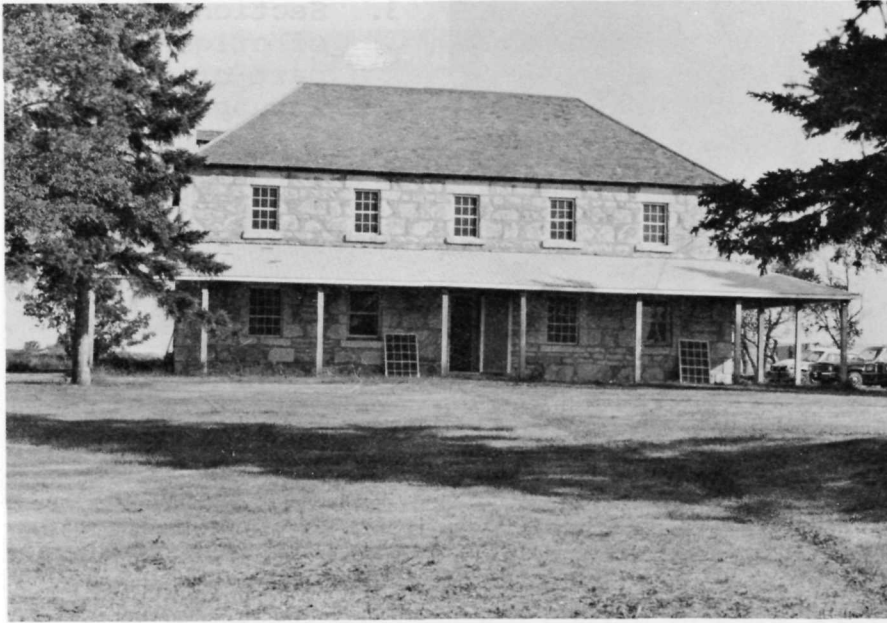
1. Front of rectory; verandah is relatively recent.

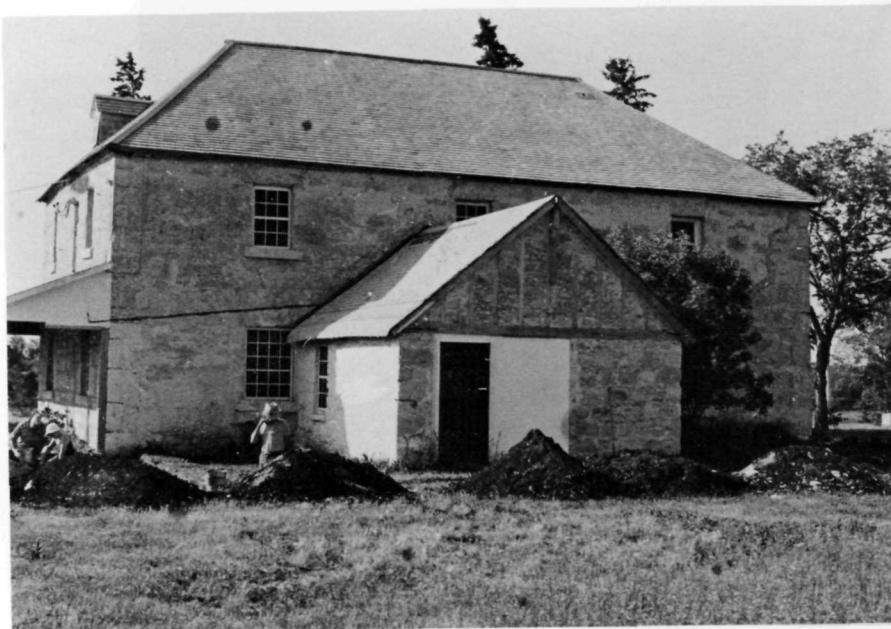
2. Rear of rectory with second annex.

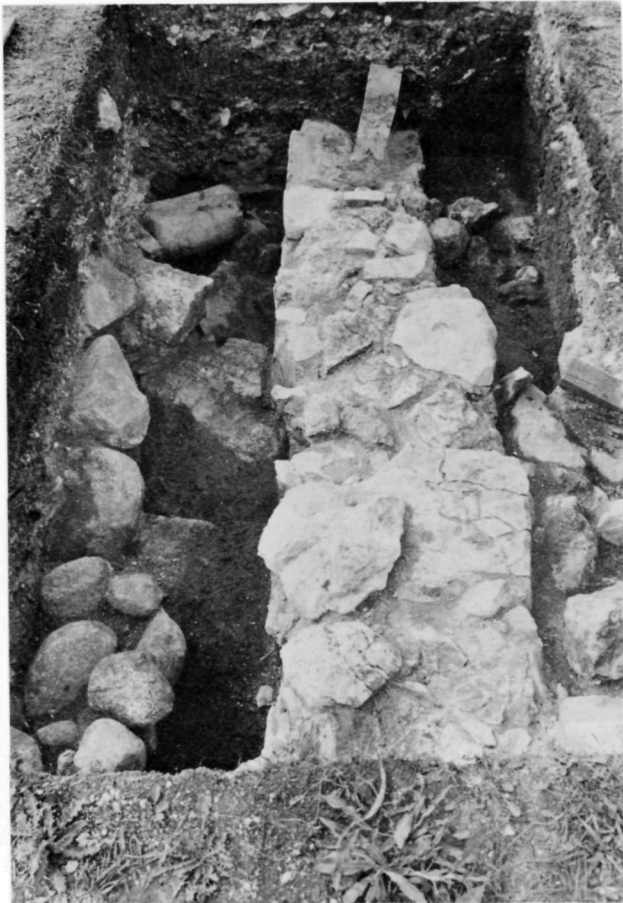
3. Section of foundation
of original annex;
part of annex cellar
in upper left corner.

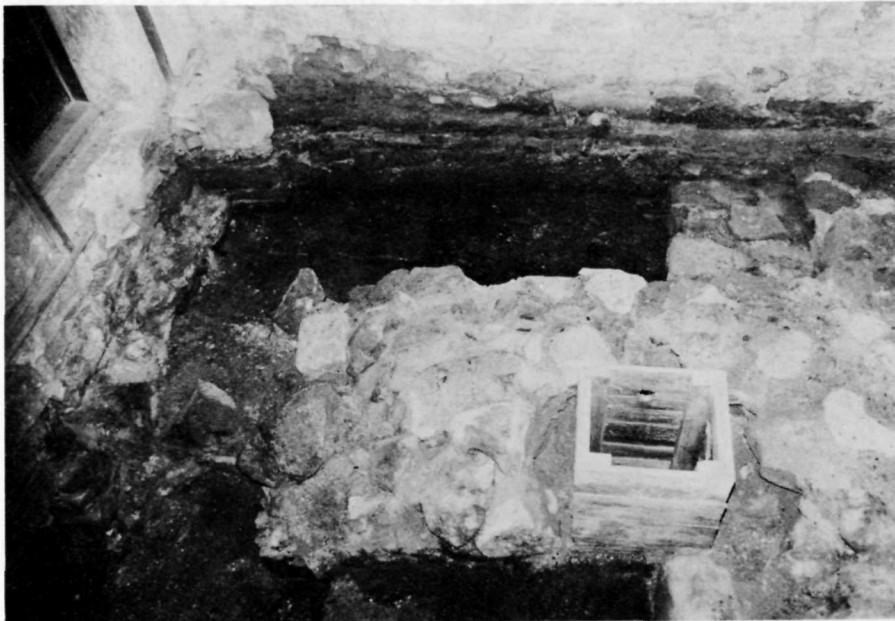
4. Section of foundations of original annex and
structure predating original annex; inside
present annex.

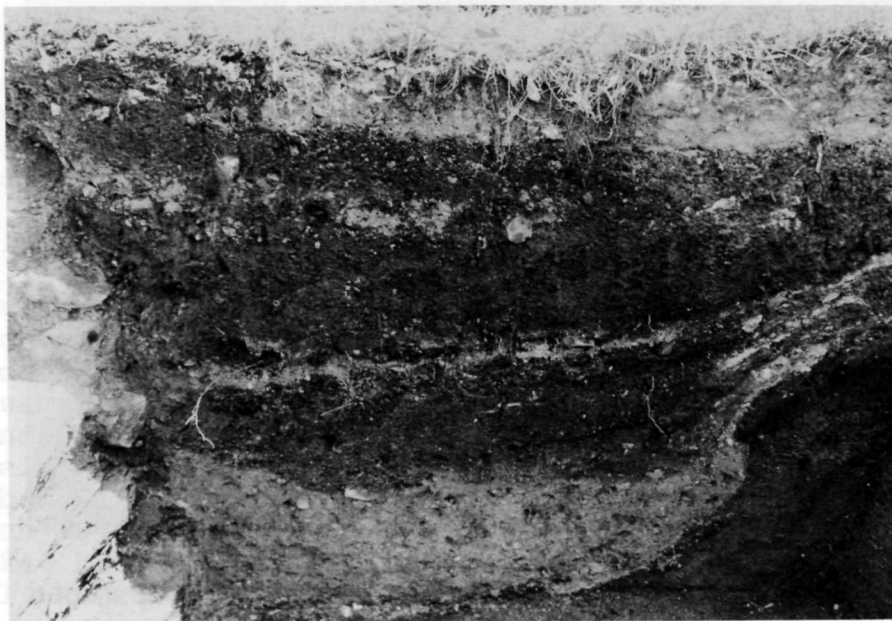
6. Filled cellar predating original
annex; annex foundation cuts through
fill at extreme left of photo.

Excavation in the area of the annexes also uncovered evidence of earlier occupations in the form of a small, uncribbed cellar and a shallow stone foundation, the two features possibly being part of one structure. The cellar was irregularly square, very roughly dish-shaped and shallow. There was no evidence of cribbing and it would have been little more than a storage pit under the floor. The majority of the cellar's depth had been filled with a crushed limestone before excavation of the builder's trench for the original annex foundation (Fig. 6). It had also been cut through by trenches for the second annex. Unfortunately the cellar fill was generally deficient of artifacts with none to suggest a date of filling.
