# RESEARCH BULLETIN

No. 185

## Archaeology at St. Andrew's Rectory - 1982

Peter J. Priess

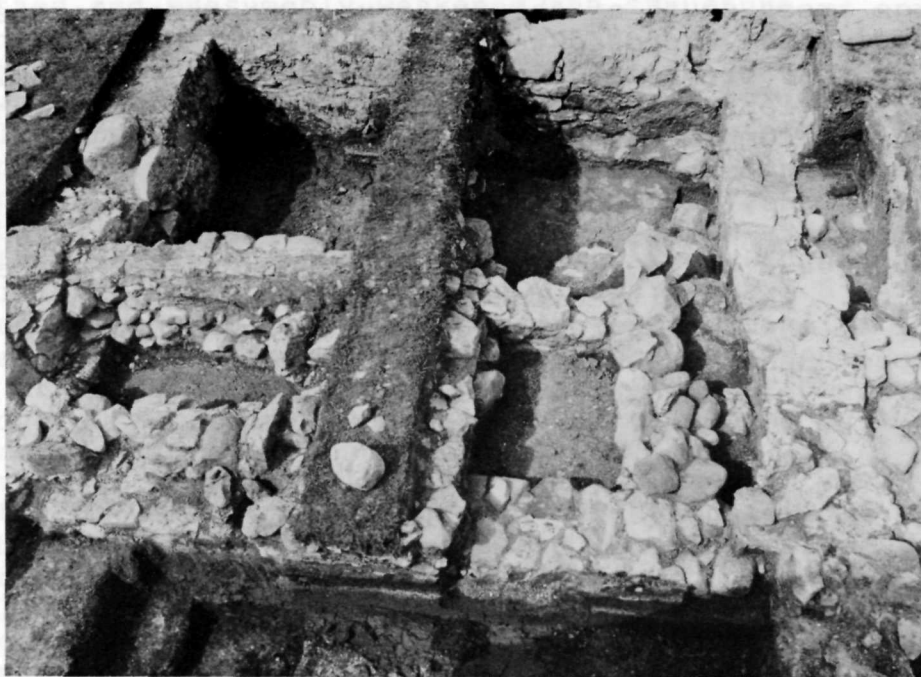
Figure 1. Excavated annex remains, facing away from rectory; cellar is across top of photograph. (Photo by author.)

No major new discoveries regarding the annex (Figs. 1, 2) were made. As previously interpreted it was a single storey structure of mortared limestone with a cellar (Figs. 3, 4) across its west end and a lean-to against its west wall. The annex was found to be 6.45 m wide and 10.25 m long, along its south wall. Foundation thickness was variable, up to 0.74 m, but the wall built on it was more regular at about 0.6 m. The cellar had used the north, south and west foundations as its walls. For the east side it had a separate wall 0.36 m thick and apparently not tied at either end to the annex foundations. Cellar width had been about 2.47 m, length about 5.25 m. The cellar floor seems to have been raised over the years by frost heaving but its original depth is estimated to have been at least 1.4 m. (Fig. 4). There is no evidence that the cellar ever had more than a clay floor.

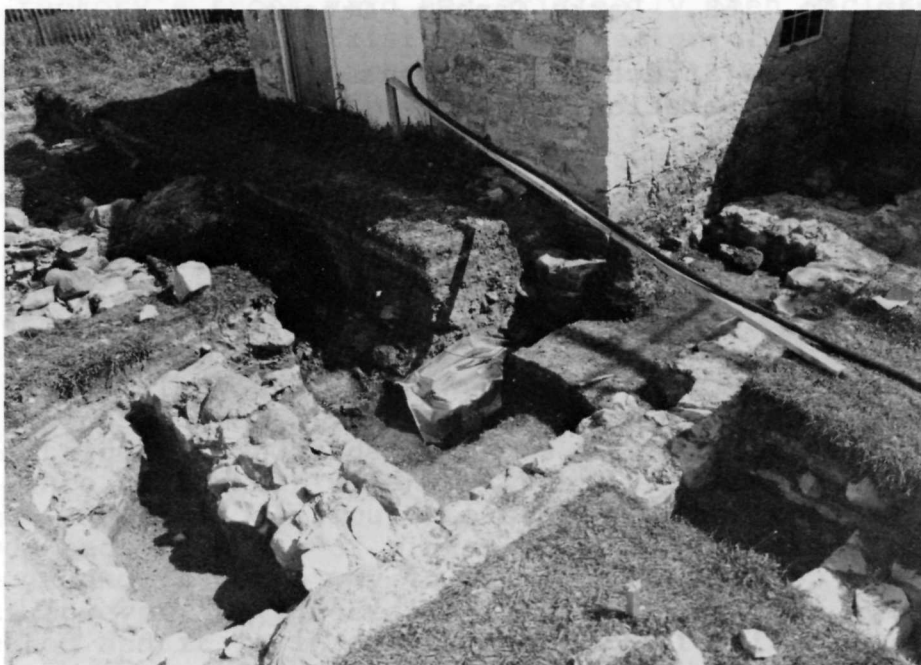
Figure 2. Excavated annex remains, facing southwest corner of second annex; south foundation extends obliquely across photograph and south end of eastwall is at centre right. (Photo by author.)

The nature of the annex's east wall was further substantiated by the discovery of the final segment of the east foundation (Fig. 2) at a distance of about 3.0 m from the rectory as anticipated. The annex's south wall had continued and been attached to the rectory's west wall. The annex itself had been a separate building, some 3.0 m from the rectory but connected to it by a covered, possibly enclosed, passageway.

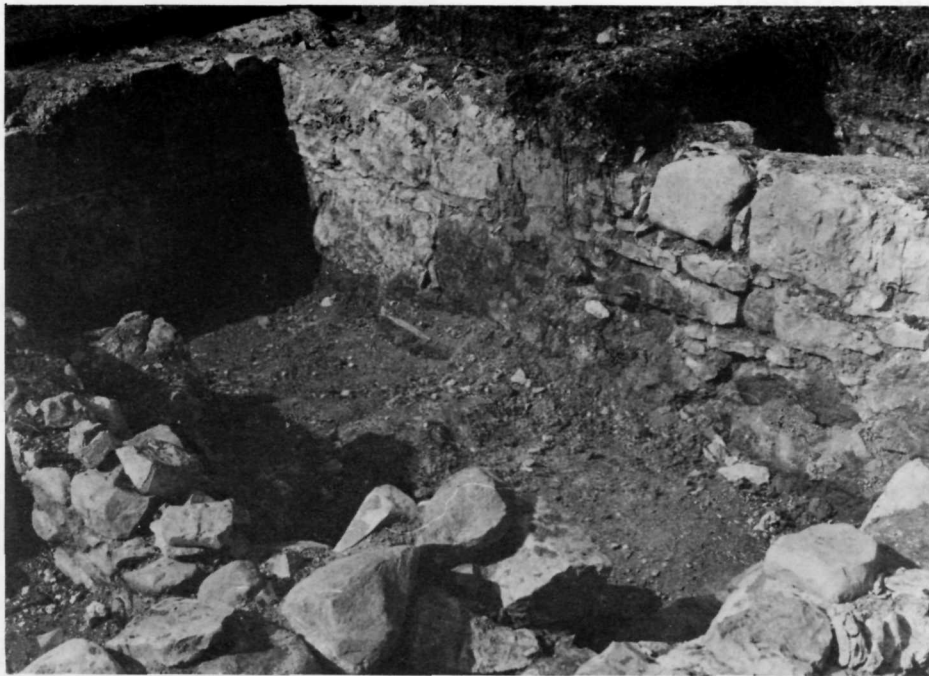
Figure 3. Annex cellar; floor is an approximation of original floor level. (Photo by author.)

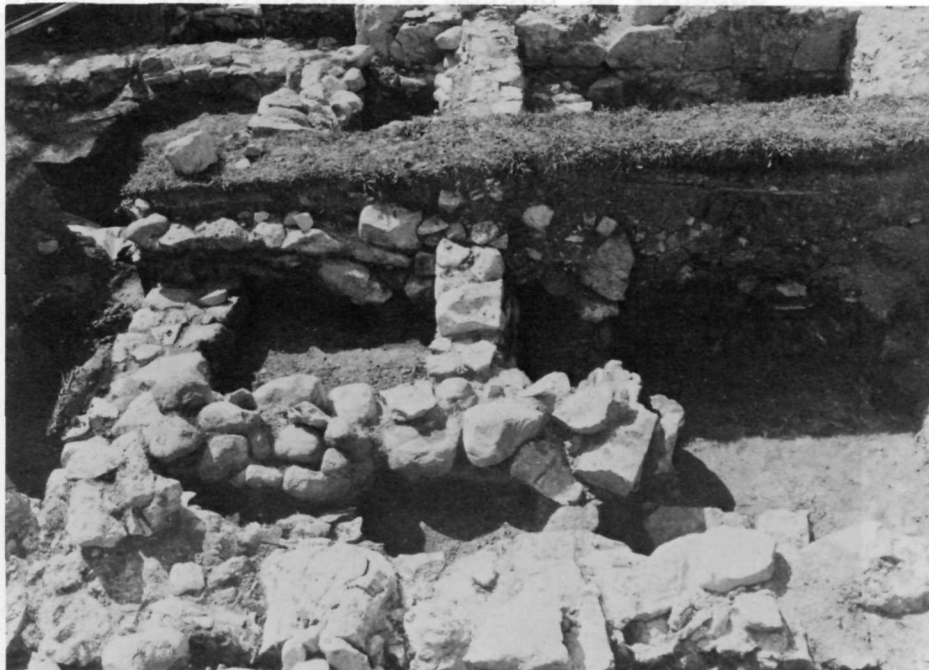
Figure 4. Annex remains; new east wall for renovation of original annex extends from centre to top centre of photograph. Cellar appears to right of this wall. (Photo by author.)

end had been retained, provided with a new east wall and used for another half century as a free-standing outbuilding. This was reflected in an almost complete foundation, 0.4 m thick (Fig. 4), built on top of the ruins of the cellar's east wall (Fig. 5) and extending from the south foundation almost to the north foundation. This would have reduced the annex's length to 3.8 m but included its original door in the north wall. The renovated annex would have occupied approximately the same location as the original cellar and initially, also included the original lean-to.

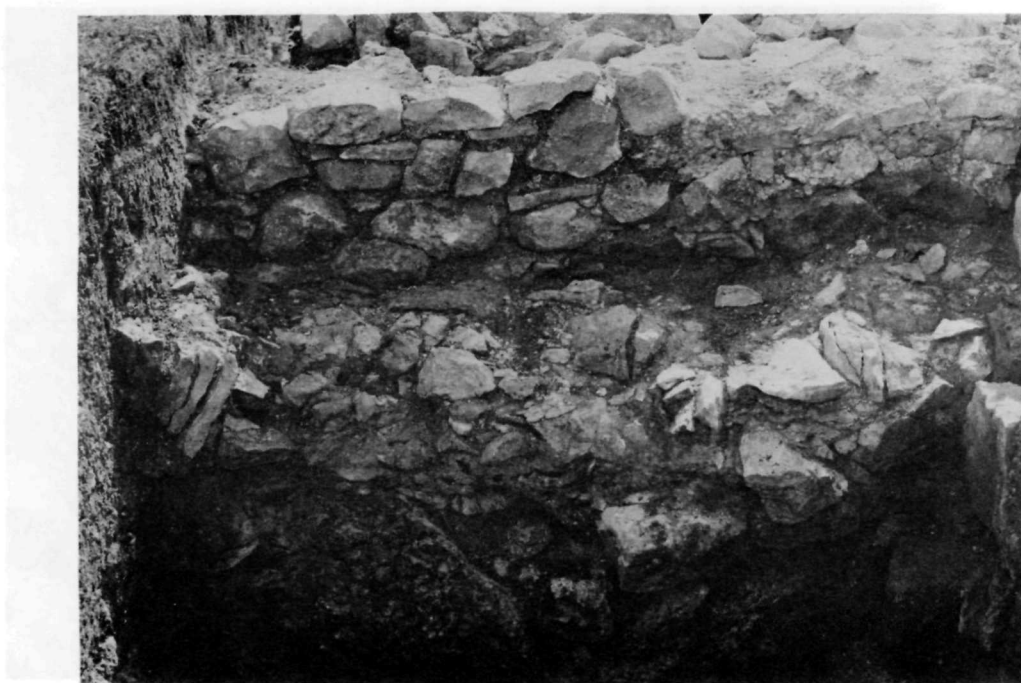
Figure 5. Construction details: south end of cellar's east wall, now extensively displaced, appears at bottom of photograph; east wall for renovation of original annex is directly above it. (Photo by author.)

The excavations again provided indications of the quality of workmanship or design for the annex. All walls around the cellar had been affected to some degree by ground pressure. The east wall was the most severely affected, having been moved more than half a metre (Fig. 5). The north wall was bowed inward and the west wall stood at an angle. Construction had not

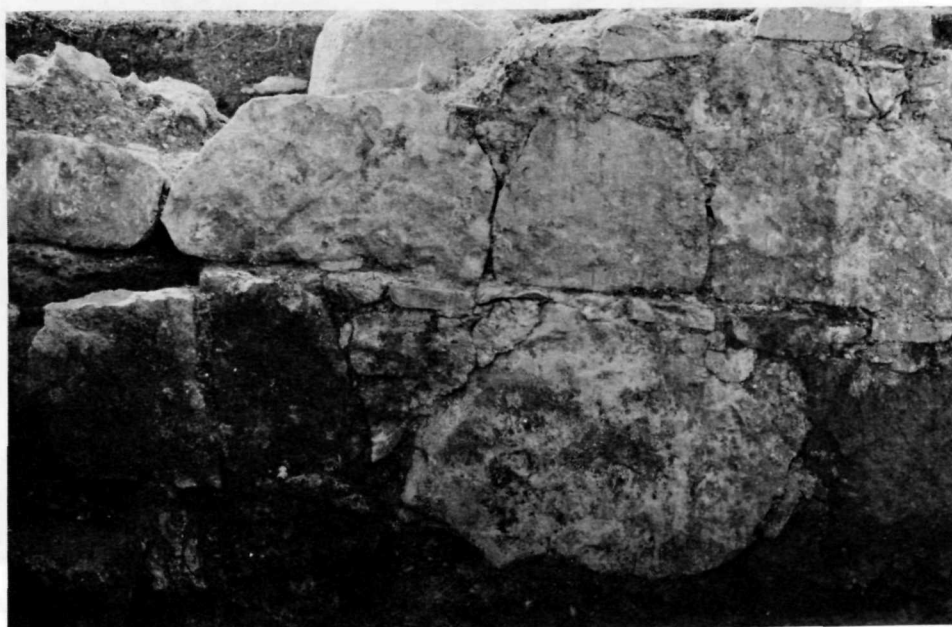
Figure 6. Construction detail: inner surface of south foundation in cellar area; note presence of a continuous line between courses, possibly representing a levelling course. (Photo by author.)

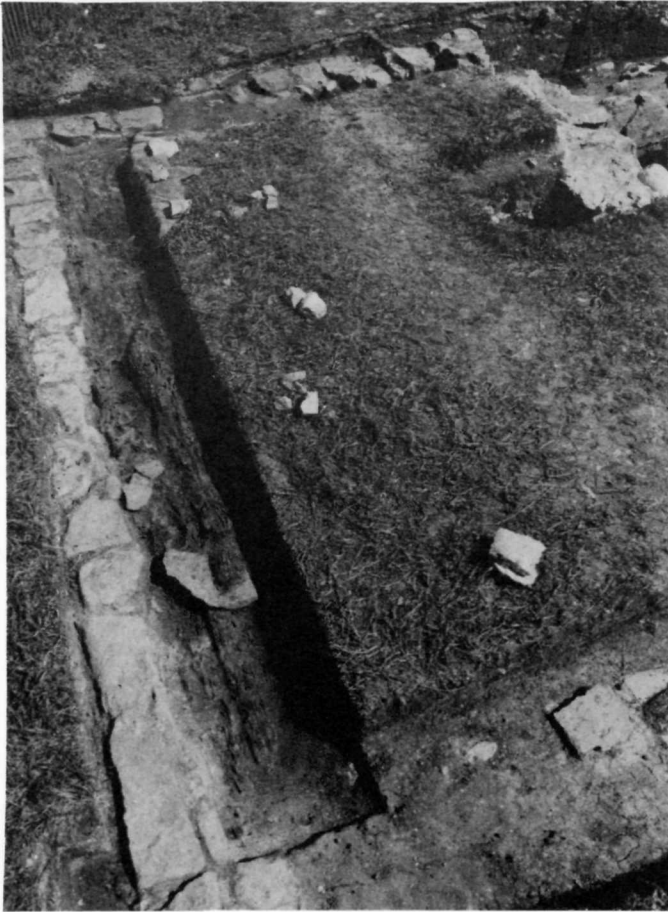
Figure 7. Lean-to footing and portions of flooring; northwest corner of annex appears in top right corner of photograph. (Photo by author.)

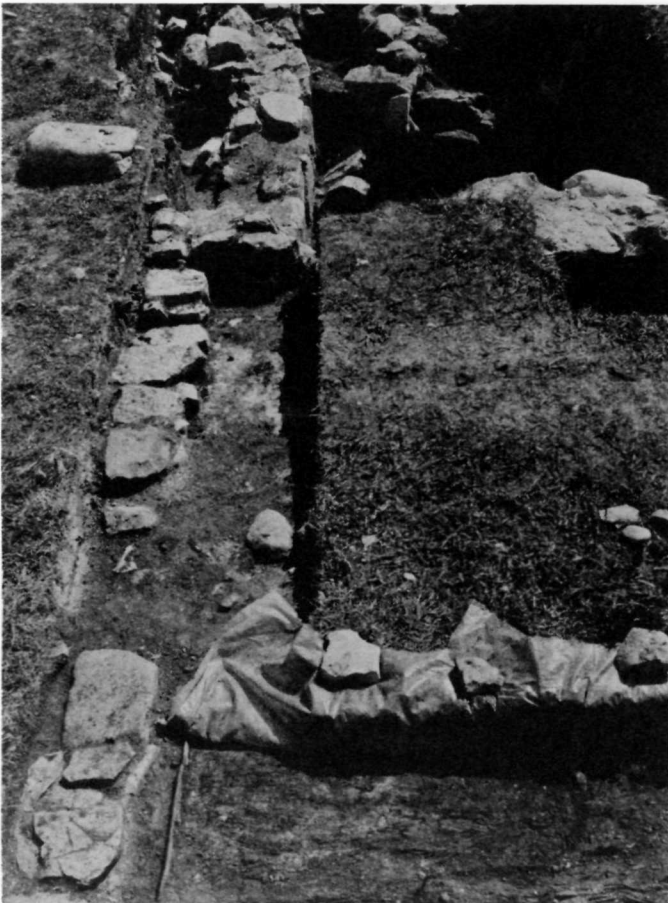
Figure 8. Lean-to, north footing; note how footing aligns with annex foundation. (Photo by author.)

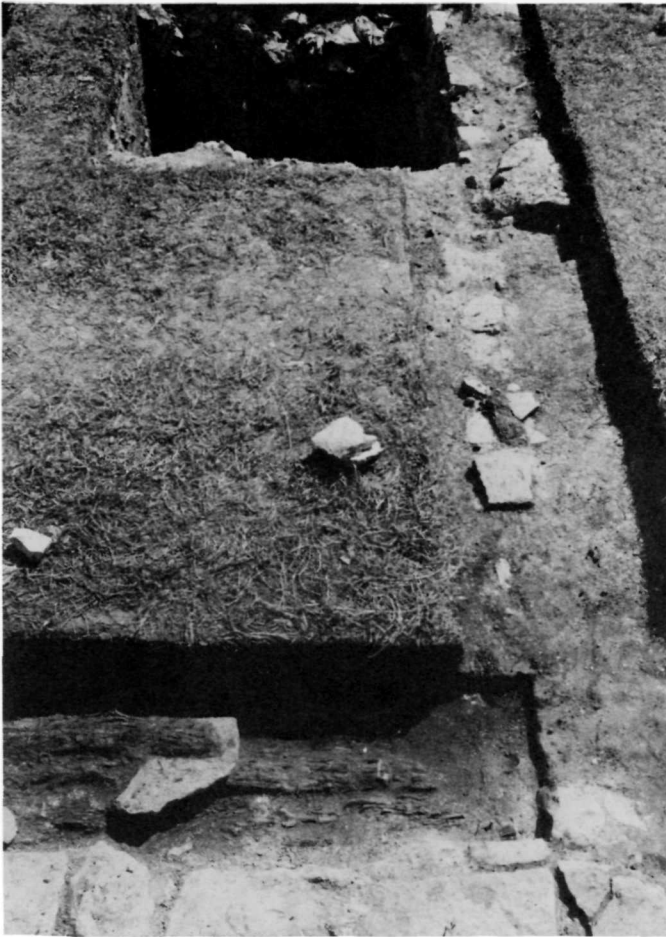
Figure 9. Lean-to south footing; note how footing does not align with annex foundation. (Photo by author.)
